NAME: DPO1 Development Plan - 28 Redbank Road, Stratford

Arboricultural Impact Assessment Report

Site: 28 Redbank Road, STRATFORD.

14 February 2025: V1

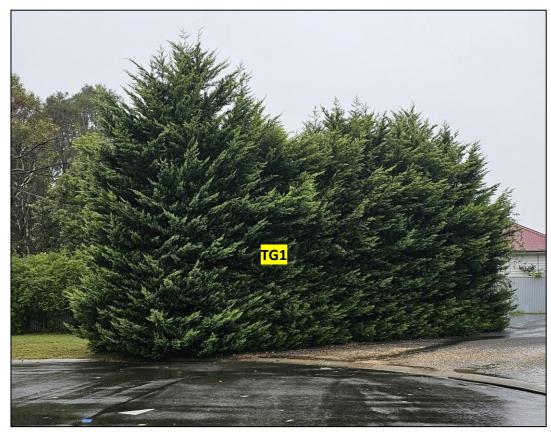
Figure 1: Showing Tree Group 1.

The plans are showing the drainage trench is to be bored under the **Tree Group 1** and showing the entry and exit points will be outside of the 2.2m TPZ radius at a depth of greater than 800mm. **Therefore, there will be no direct impact on this group of trees.**

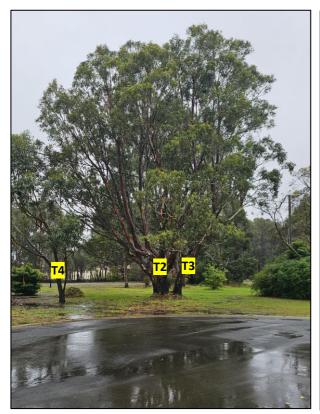
Figure 2: Showing Trees 2, 3 & 4.

The plans are showing the drainage trench is to be bored under the 12.5m TPZ radius of **Tree 2** and not under or within the SRZ. The plan is showing there is proposed to be two (2) pits for access to the connection points (which will need to be excavated within the TPZ although not within the SRZ. The proposed pits are to be no greater than 1.0m square in area therefore in total, this is an incursion of 2.0m² of the 489.3m² TPZ area or 0.5%.

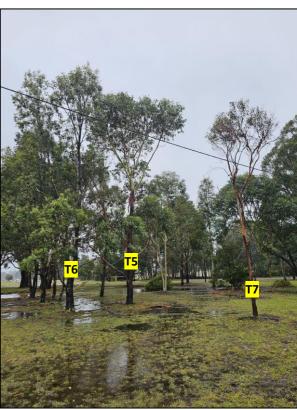
Figure 3: Showing Trees 5, 6 & 7.

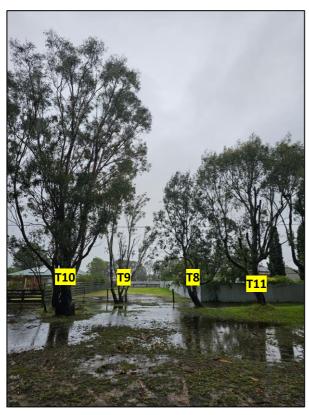
Figure 4: Showing Trees 8, 9, 10 & 11.

3.1.2 Trees 8 & 9 will need to be removed as they will be detrimentally impacted on by the proposed crossover excavation works which crosses through their relevant SRZ (Refer Figure 7).

- Tree 10 6.0% (proposed crossover)
- Tree 11 5.5% (proposed crossover)

The plans show that either the proposed crossover or drainage connection construction works will incur an encroachment of 10% or less and not within their SRZ therefore, with proper tree protection measures the proposal is unlikely to be detrimental to the long-term health or stability and these trees and they will remain viable post construction works.

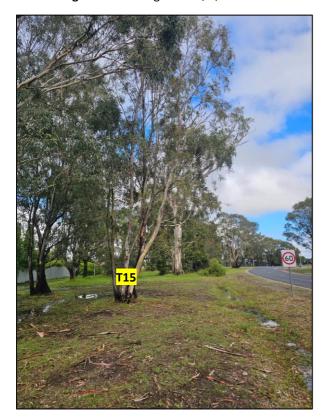
Figure 6: Showing Tree 15.

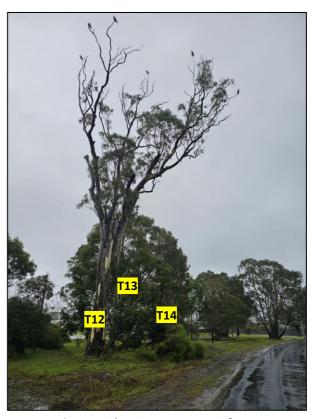
Figure 5: Showing Trees 12, 13 & 14.

• Tree 12 – 12.1% (proposed crossover is 3.4% + Bin Collection Zone 8.7%)

The plans show the TPZ encroachment of the proposed crossover construction works will have a greater than 10% encroachment of the TPZ radius although not within the SRZ radius of **Tree 12**, although the proposed 51.4m² or 8.7% Bin Collection Zone area encroachment is to be "Sprayseal bitumen" which is laid directly above grade abutting the edge of Redbank Road therefore this will not require any below ground construction works and is expected to have little to no direct impact upon the root system of **Tree 12**.

To minimise tree impacts the depth of the excavation works needs to be kept to a minimum, be undertaken under the supervision of a Project Arborist so that any tree roots exposed can be pruned and not severed. The proposed surfacing material to be laid at existing grade within minimal scraping.
