# **Arboricultural Impact Assessment Report**

Site: 28 Redbank Road, STRATFORD.

14 February 2025: V1

**Arb Inspect Tree Risk Management Services Pty Ltd**

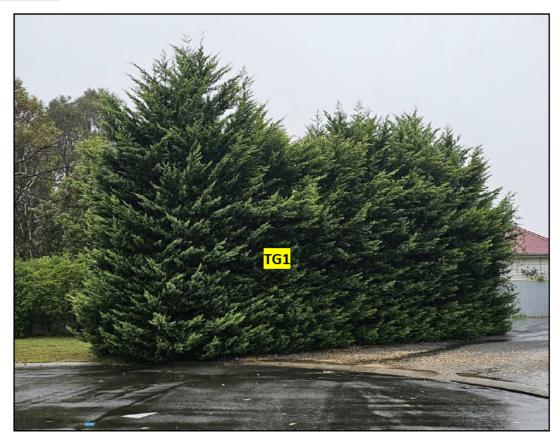
Figure 1: Showing Tree Group 1.

The plans are showing the drainage trench is to be bored under the **Tree Group 1** and showing the entry and exit points will be outside of the 2.2m TPZ radius at a depth of greater than 800mm. **Therefore, there will be no direct impact on this group of trees.**

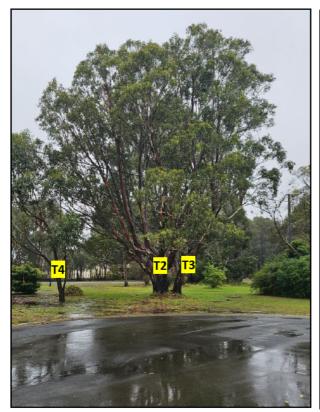
Figure 2: Showing Trees 2, 3 & 4.

The plans are showing the drainage trench is to be bored under the 12.5m TPZ radius of **Tree 2** and not under or within the SRZ. The plan is showing there is proposed to be two (2) pits for access to the connection points (which will need to be excavated within the TPZ although not within the SRZ. The proposed pits are to be no greater than 1.0m square in area therefore in total, this is an incursion of 2.0m² of the 489.3m² TPZ area or 0.5%.

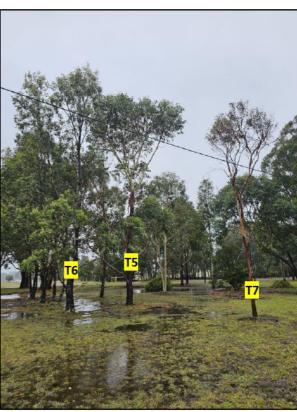
Figure 3: Showing Trees 5, 6 & 7.

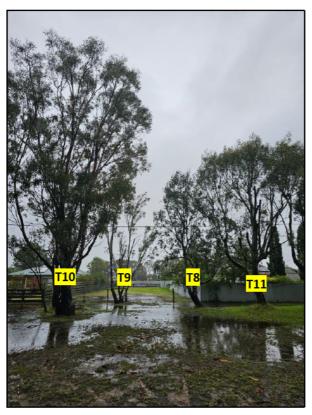
**Figure 4:** Showing Trees 8, 9, 10 & 11.

**3.1.2** Trees 8 & 9 will need to be removed as they will be detrimentally impacted on by the proposed crossover excavation works which crosses through their relevant SRZ (Refer Figure 7).

- Tree 10 6.0% (proposed crossover)
- Tree 11 5.5% (proposed crossover)

The plans show that either the proposed crossover or drainage connection construction works will incur an encroachment of 10% or less and not within their SRZ therefore, with proper tree protection measures the proposal is unlikely to be detrimental to the long-term health or stability and these trees and they will remain viable post construction works.

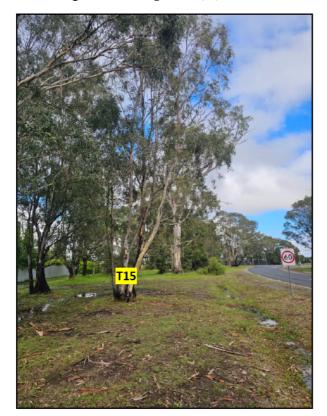
**Figure 6:** Showing Tree 15.

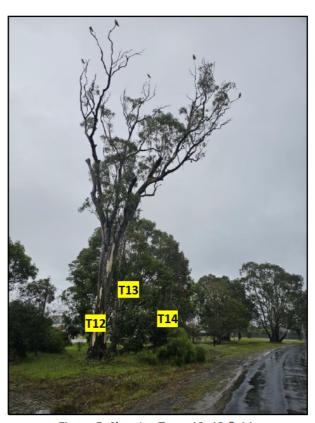
Figure 5: Showing Trees 12, 13 & 14.

• Tree 12 – 12.1% (proposed crossover is 3.4% + Bin Collection Zone 8.7%)

The plans show the TPZ encroachment of the proposed crossover construction works will have a greater than 10% encroachment of the TPZ radius although not within the SRZ radius of **Tree 12**, although the proposed 51.4m² or 8.7% Bin Collection Zone area encroachment is to be "Sprayseal bitumen" which is laid directly above grade abutting the edge of Redbank Road therefore this will not require any below ground construction works and is expected to have little to no direct impact upon the root system of **Tree 12**.

To minimise tree impacts the depth of the excavation works needs to be kept to a minimum, be undertaken under the supervision of a Project Arborist so that any tree roots exposed can be pruned and not severed. The proposed surfacing material to be laid at existing grade within minimal scraping.
