Place name: All Saints Anglican Church Complex

Architectural Style: Federation Gothic
Designer / Architect: Not known
Construction Date: 1908

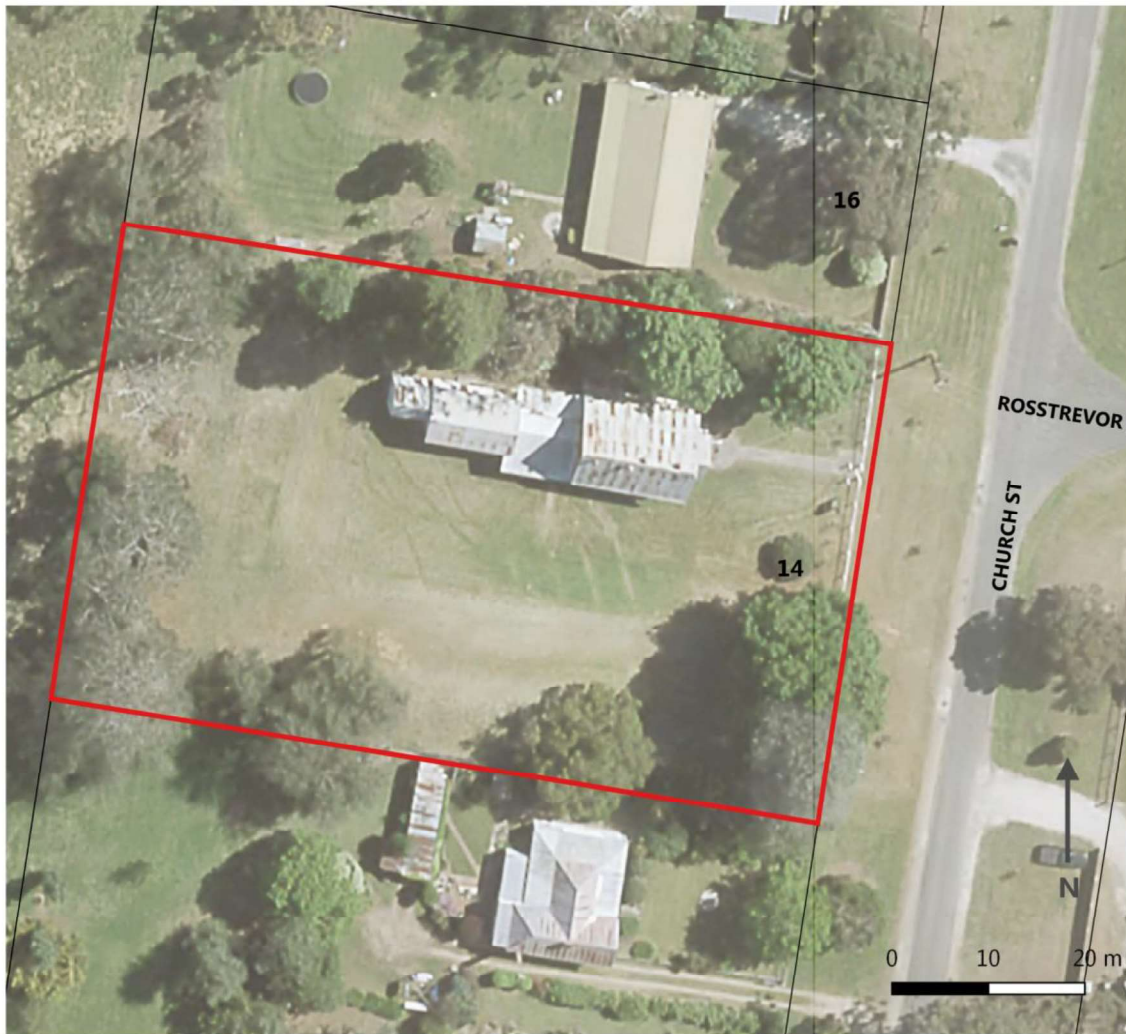
Map of recommended boundary for Heritage Overlay

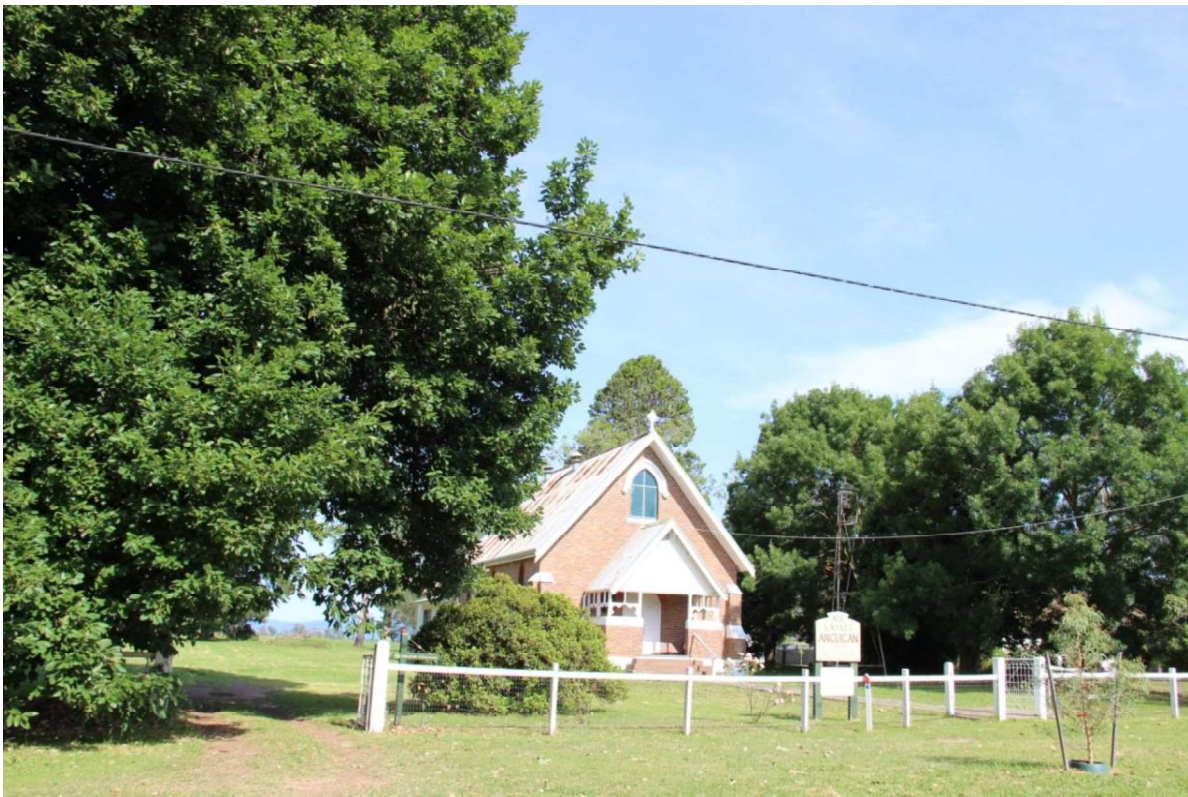
Figure D1. The picturesque setting of the church complex. The church has a deep set back, behind an early (in part) fence and gates. The boundary is lined with a number of mature exotic trees. The church has a steep-pitched gabled roof and is constructed of red brick with rendered (overpainted) dressings and coping to the buttresses on the side elevations. A dominant feature is the large entrance porch at the centre of the facade, with timber tracery.

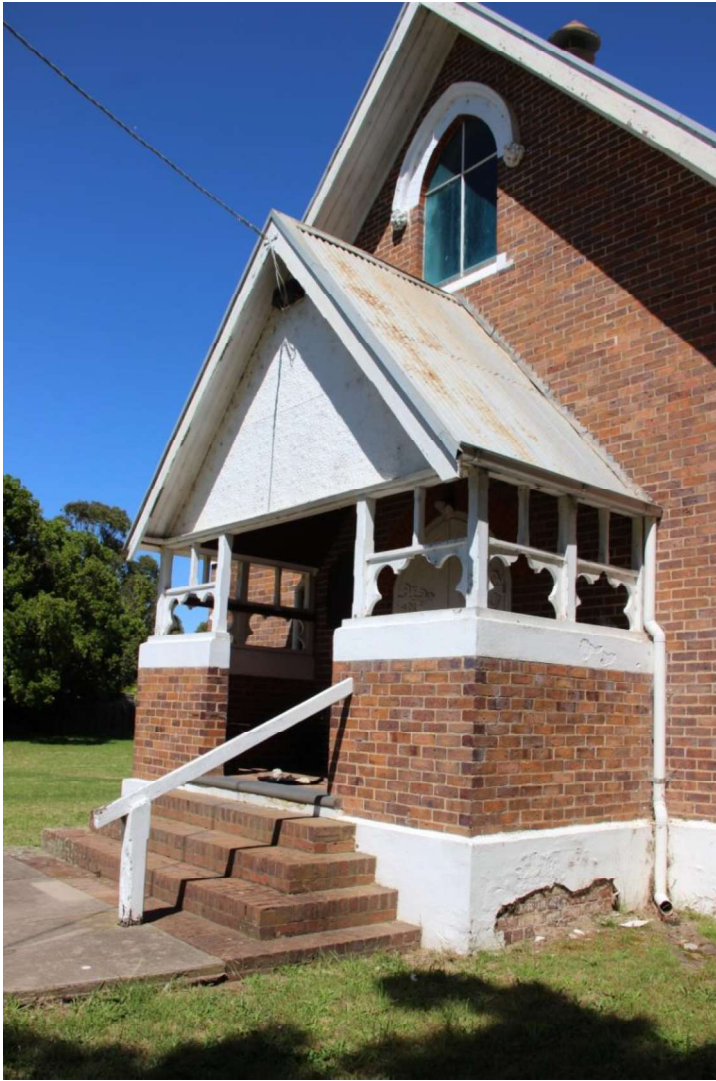
Figure D2. The entrance porch with the pressed metal cladding to the gabled end imitating a rough-cast render, timber tracery and brick balustrade. Note the damp damage to the render of the plinth.

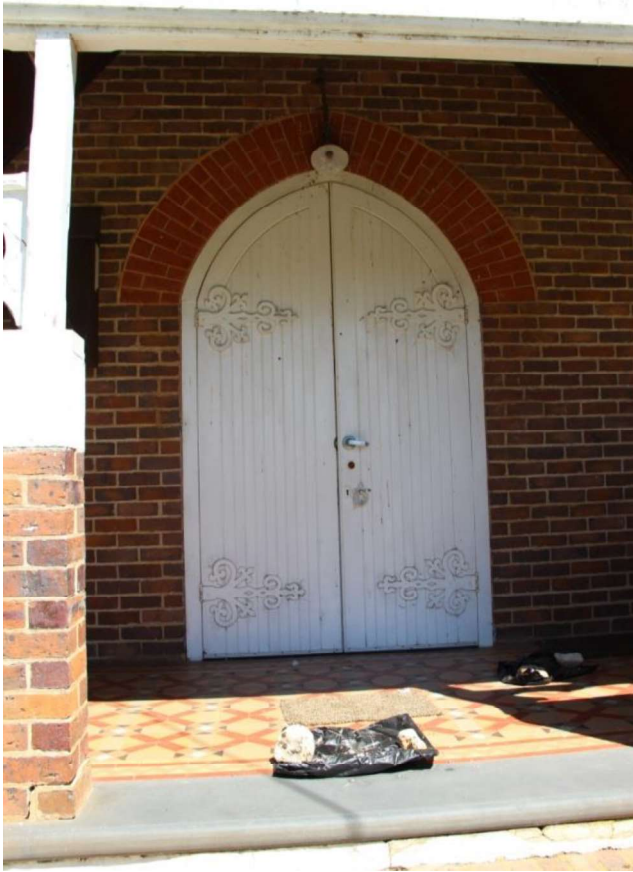
Figure D3. The entrance porch has the original tessellated tile floor. The entrance doors are pointed arched double timber ledged doors, framed by a slightly pointed-arch of radiating tuck pointed red-brick voussoirs above.

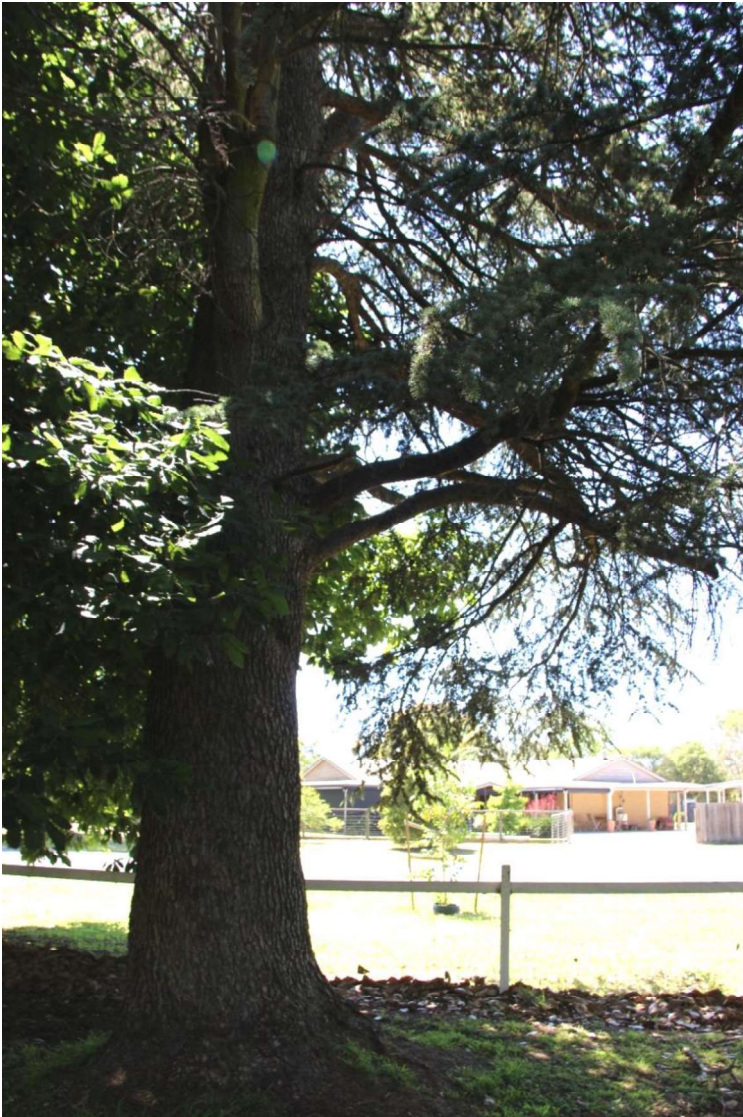
Figure D11. Next to the oak on the front boundary is a Blue Cedar (*Cedrus atlantica* f. *Glauca*). It is a good example of the variety and is in good condition.

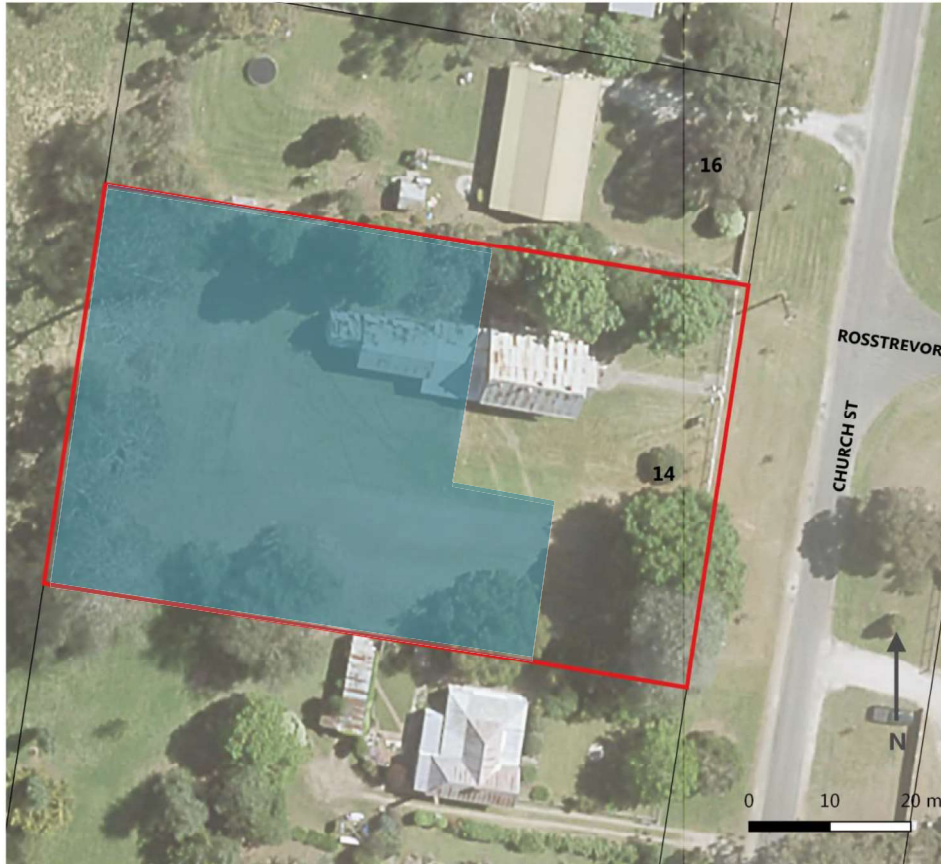
NOTE: The blue shaded area is the preferred location for additions and new development. The 1885 former timber church and the former timber vestry should **not** be demolished, but could be relocated within the blue area if needed.
