Place name: Commercial Hotel

Architectural Style: Interwar Mediterranean
Designer / Architect: Not known
Construction Date: 1930

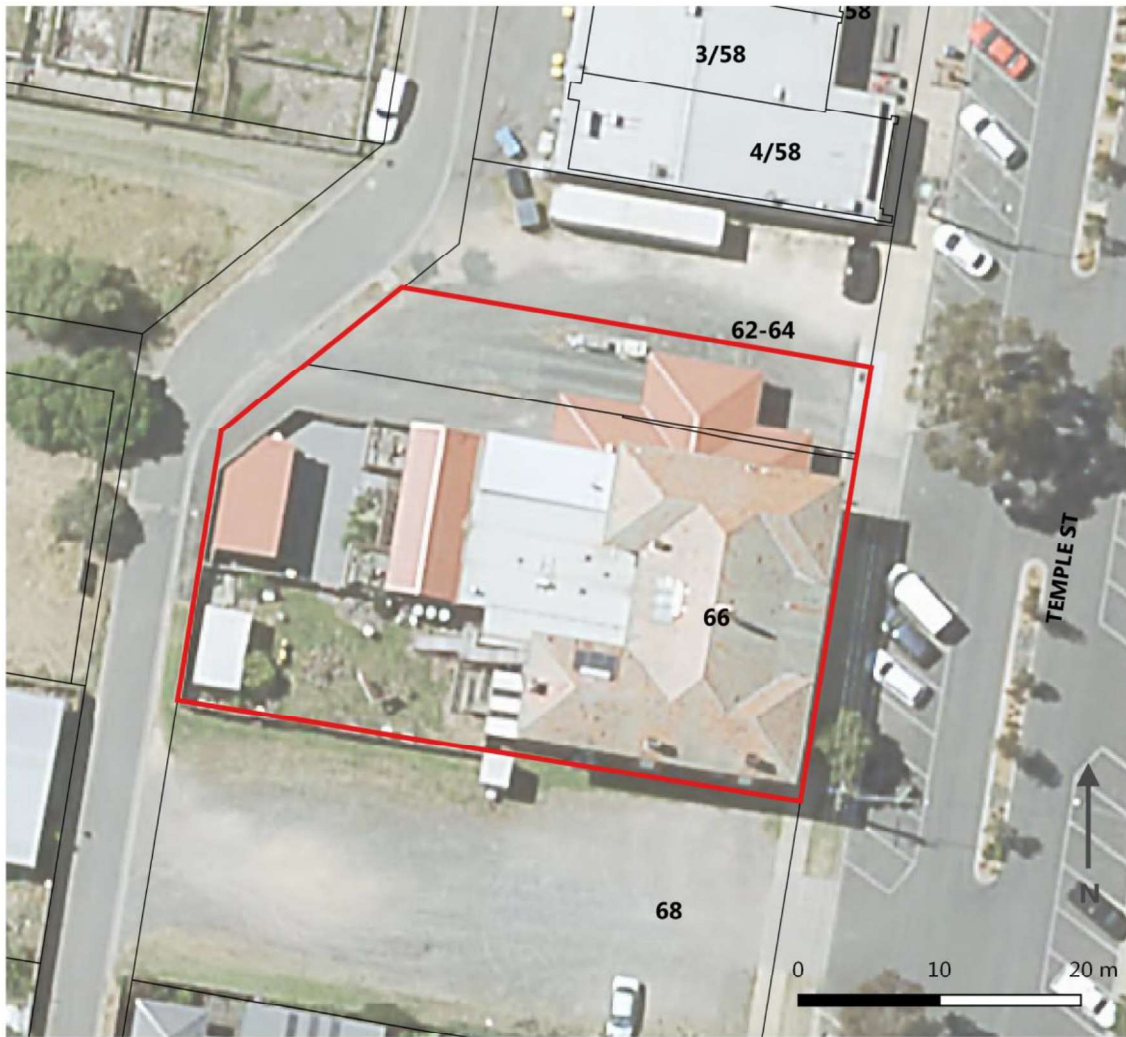
Map of recommended boundary for Heritage Overlay

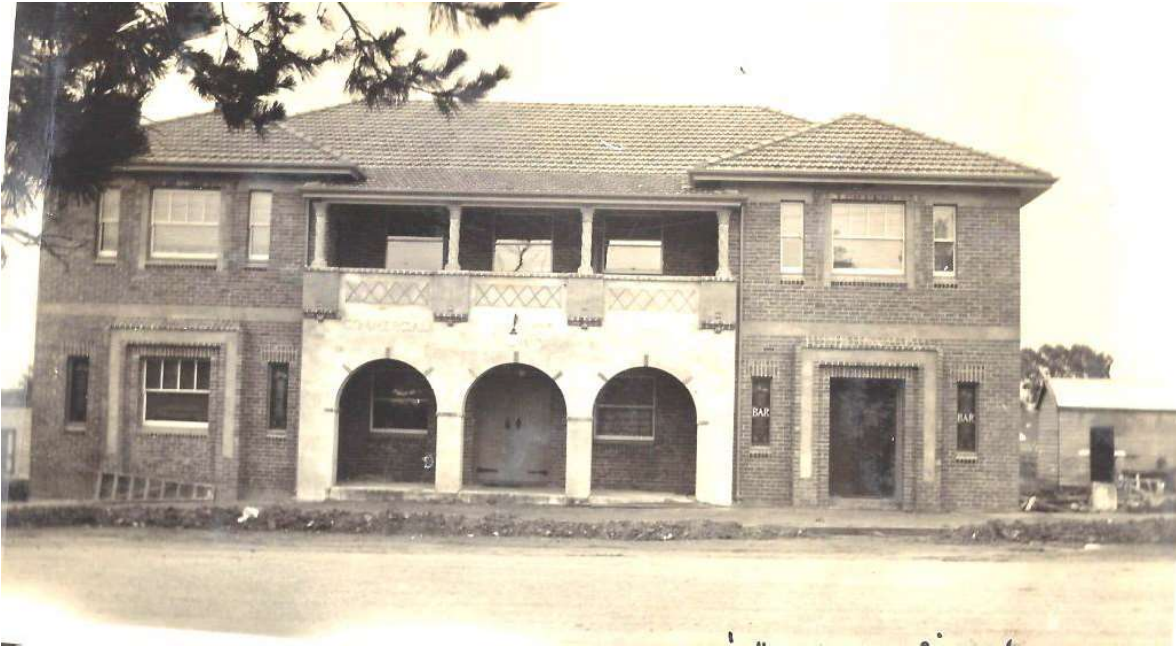
Figure H1. The hotel soon after its completion in 1930. The original timber entrance doors were evident and the render unpainted. It appears to have had leadlight in the narrow windows on the ground floor at this date (since removed at the north end) (HDHS).

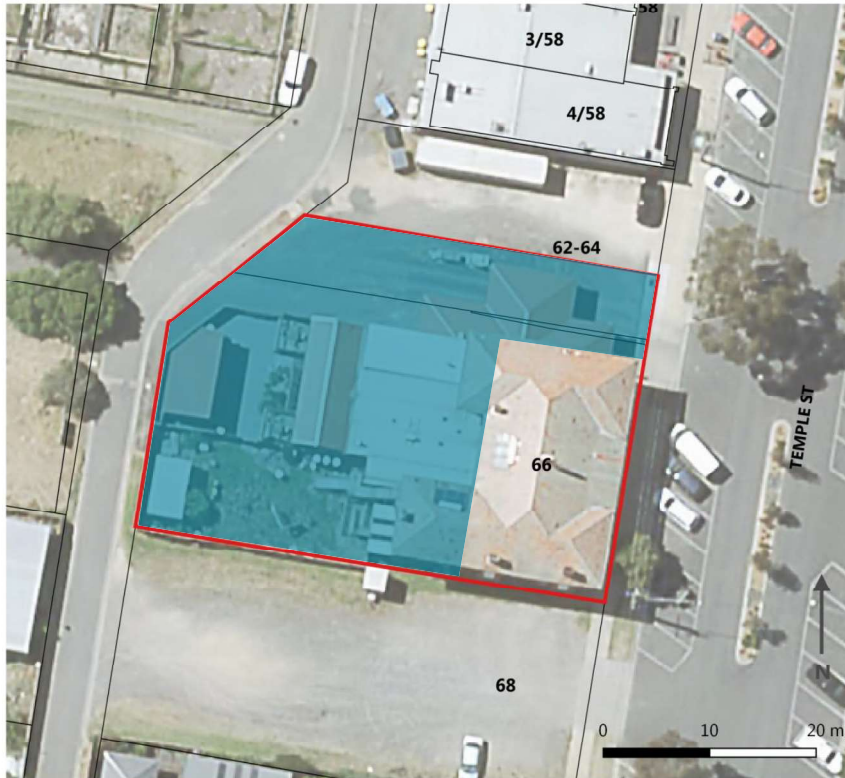
NOTE: The blue shaded area is the preferred location for additions and new development
