Locality: BOISDALE
Place address: 1 MAIN STREET
Citation date 2016
Place type (when built): Church
Recommended heritage protection: Local government level
Local Planning Scheme: Yes
Vic Heritage Register: No
Heritage Inventory (Archaeological): No

Place name: Boisdale Uniting Church (former)

Project: Wellington Shire Stage 2 Heritage Study
Client: Wellington Shire Council
Author: Heritage Intelligence Pty Ltd
Date: 12/2/16

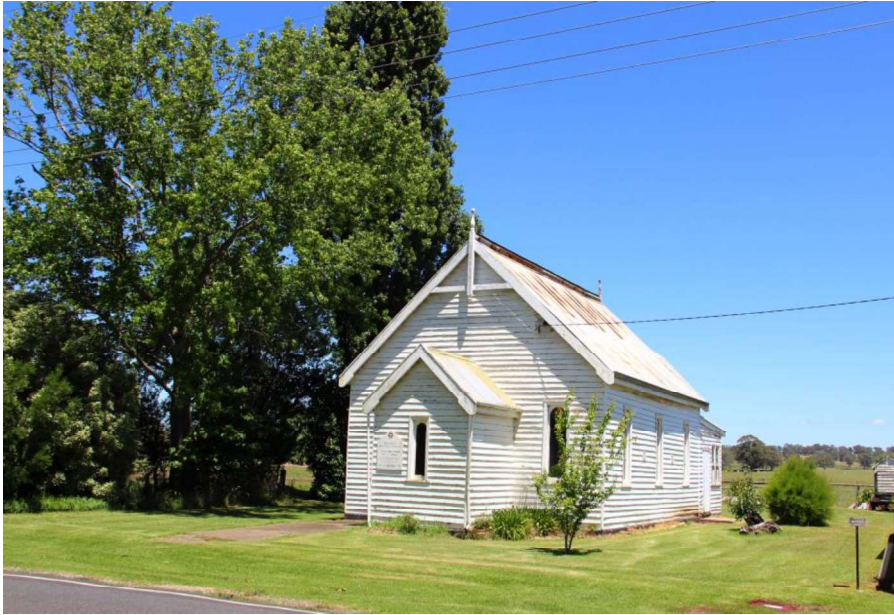
Figure D1. The church is set back in a small lot, with mature exotic trees on the southern boundary. The weatherboard church is rectangular in plan with an entrance porch at the centre of the facade. The 1921 church is in fair-poor condition but retains a very high level of integrity.

Figure D1. The church is set back in a small lot, with mature exotic trees on the southern boundary. The weatherboard church is rectangular in plan with an entrance porch at the centre of the façade and the WC is on the far right of the photo.

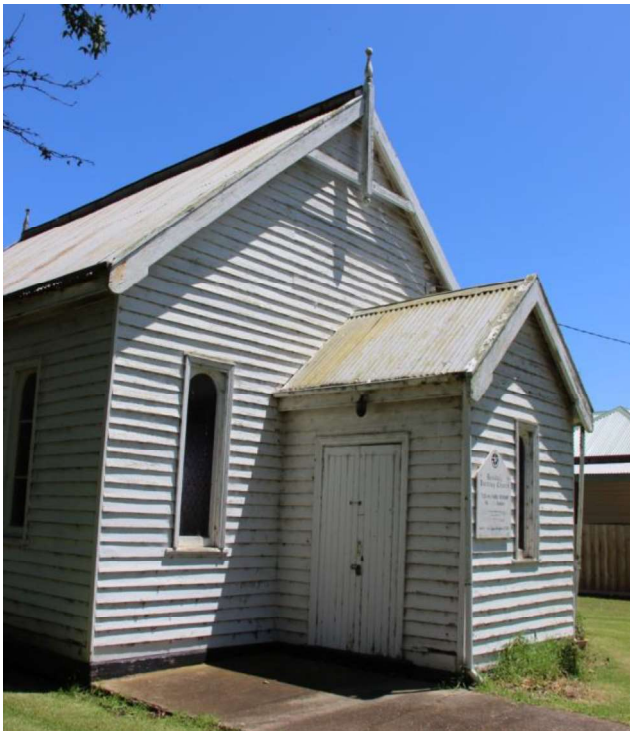
Figure D2. The gabled roof is clad with lapped corrugated iron with one long vent to the ridge. The gabled-ends have simple decorative lobed bargeboards, and a turned timber finial at the apex of the gable, which extends below to a pendant, attached to a cross beam. The small entrance porch has a gabled roof and a pair of timber framed and ledged doors on its south side. The unique windows to the nave and porch have square-headed, moulded frames with a plain sill; set within is a semicircular-arched window. The windows to the facade and porch have a single-pane of coloured glass.

Figure D2. The gabled roof is clad with lapped corrugated iron and both the gabled-ends have simple lobed bargeboards, and a turned timber finial and pendant attaching to a horizontal member below. The entrance porch has a gabled roof and a pair of timber framed and ledged doors on the south side. The unique windows to the façade and porch have a single-pane of coloured glass.

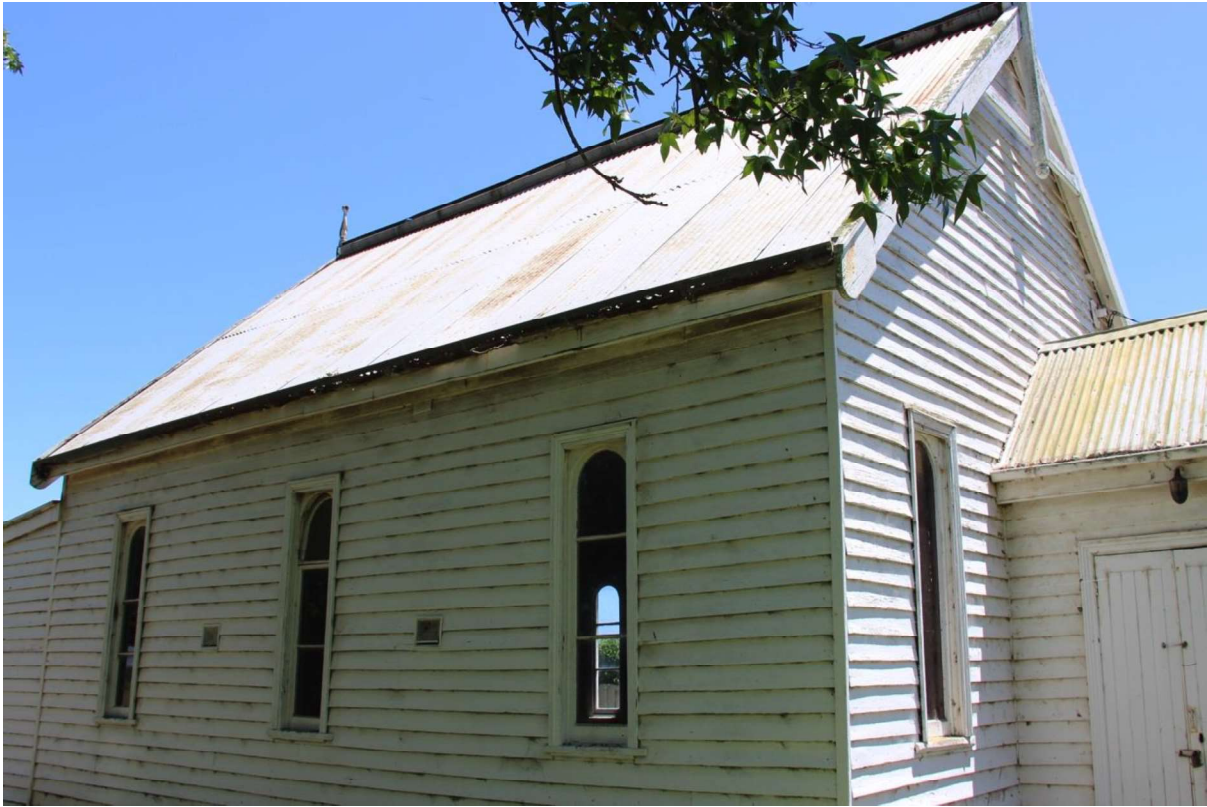
Figure D3. The side elevations comprise three tall windows, with small vents in-between. The windows to the nave have clear glass in three parts; the top portion being a round arched hopper window (not all are original).

Figure D3. The side elevations comprise three tall windows, with small vents in-between. The windows to the nave have clear glass in three parts; the top portion being a hopper window. The central window has an open hopper in the photo above (not all windows are original). To the rear of the church is the later skillioned-roof addition which is not significant.

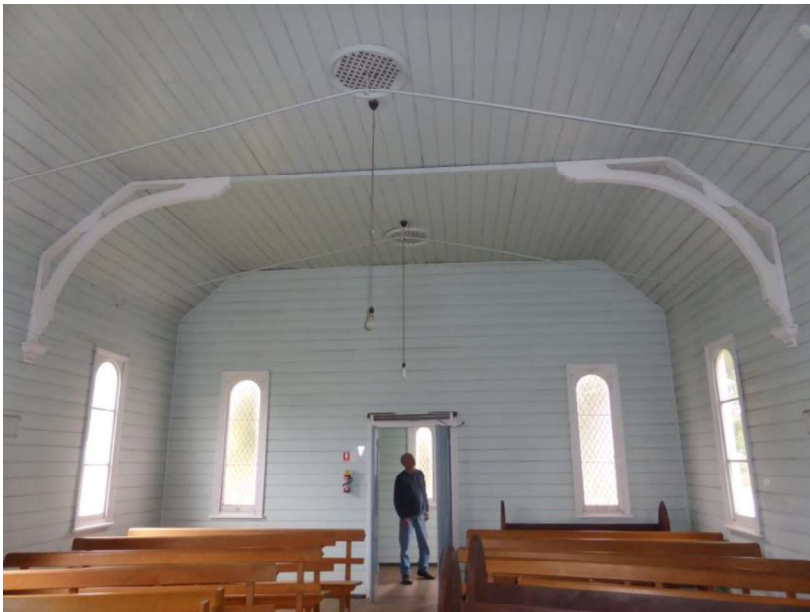
Figure D4. The interior of the nave is entirely lined with timber boards (overpainted in white) with a coved ceiling, metal trusses and decorative timber trusses. Round decorative cast iron (?) vents are located in the ceiling with the metal trusses supported through the middle of them.

Figure D4. The timber-lined interior of the church with its covered ceiling, metal trusses, decorative metal ceiling vents and decorative timber trusses. (BHG).
