Locality: BOISDALE
Place address: 35-39 MAIN STREET
Citation date 2016
Place type (when built): Stables, blacksmiths, wheelwrights, residence
Recommended heritage protection: Local government level
Local Planning Scheme: Yes
Vic Heritage Register: No
Heritage Inventory (Archaeological): No

Place name: Stables, Blacksmiths & Wheelwrights and Blacksmith's House (former)

Project: Wellington Shire Stage 2 Heritage Study

Author: Heritage Intelligence Pty Ltd

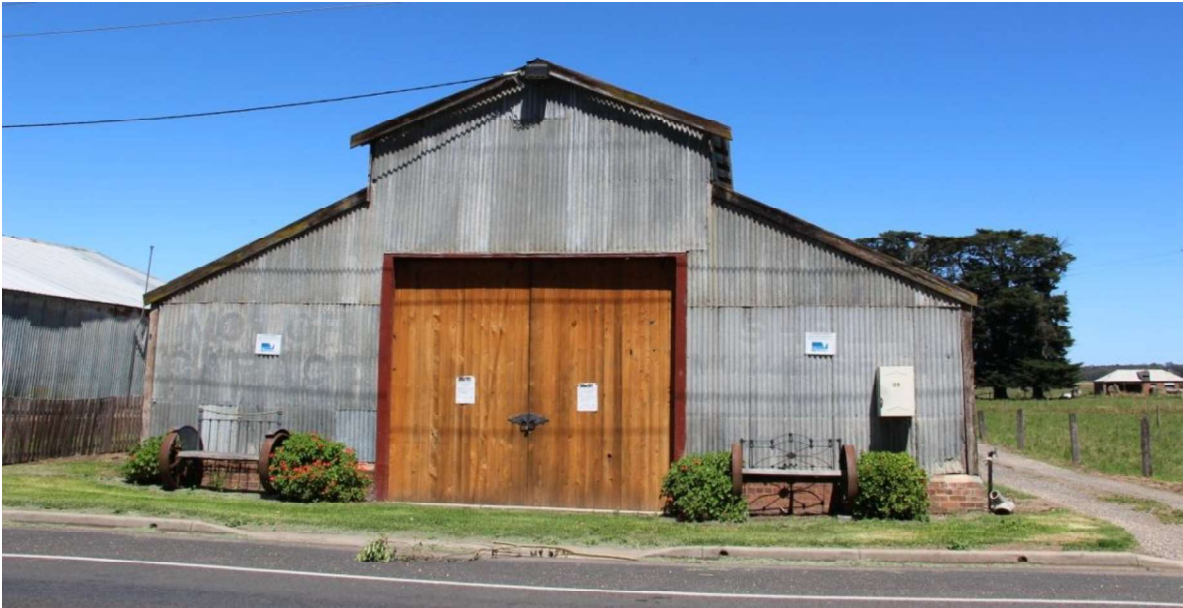
Figure D1. The stables building is one of a pair of buildings that originally occupied the site (the stables building to the north was removed in the 1970s). The stables are a large timber-framed (with large sleepers) building with a brick plinth (with rendered coping) and walls clad with corrugated

galvanised iron. A clerestory projects from the ridge, with a gabled roof also clad with corrugated iron. The words 'Motor Garage' and 'Shell Motor Spirit' can still be seen on the facade (the paint mostly worn away). Double timber doors are located at the centre of the façade (which are recent reconstructions of the original timber doors.).

The roof cladding was replaced with galvanised corrugated iron in 2015. Conservation and adaptive use works are being carried out on the building; the rafters to the roof have been replaced and the original skylights have been replaced with laser light, in the larger roof planes. Overall, the c1910 stables are in good condition and retain a medium level of integrity.

Figure D1. The former stables building at the north end of the row, at no. 39 Main Street.

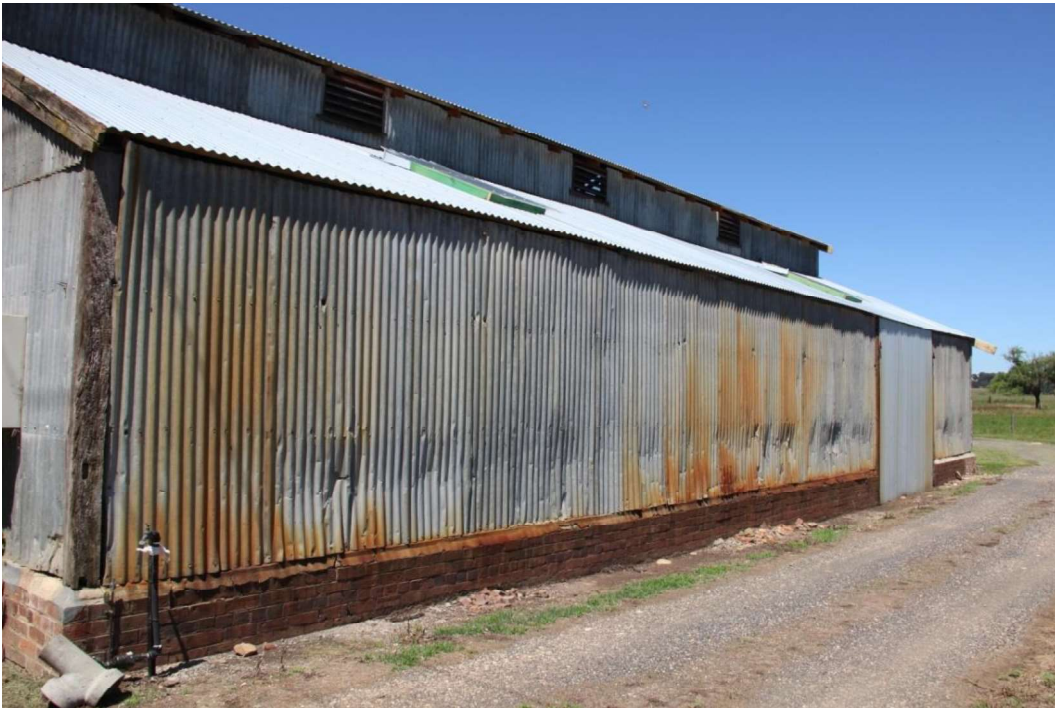
Figure D2. On the side elevations, there are timber louvered vents to the clerestory. There is one large opening on both of the side elevations (with recent cladding), but no other openings otherwise.

Figure D2. The northern elevation of the stables, with the galvanised corrugated iron walls sitting on the brick plinth, the timber-louvered vents to the clerestory level, and modern skylights to the roof planes below. One large opening is located on this side elevation.

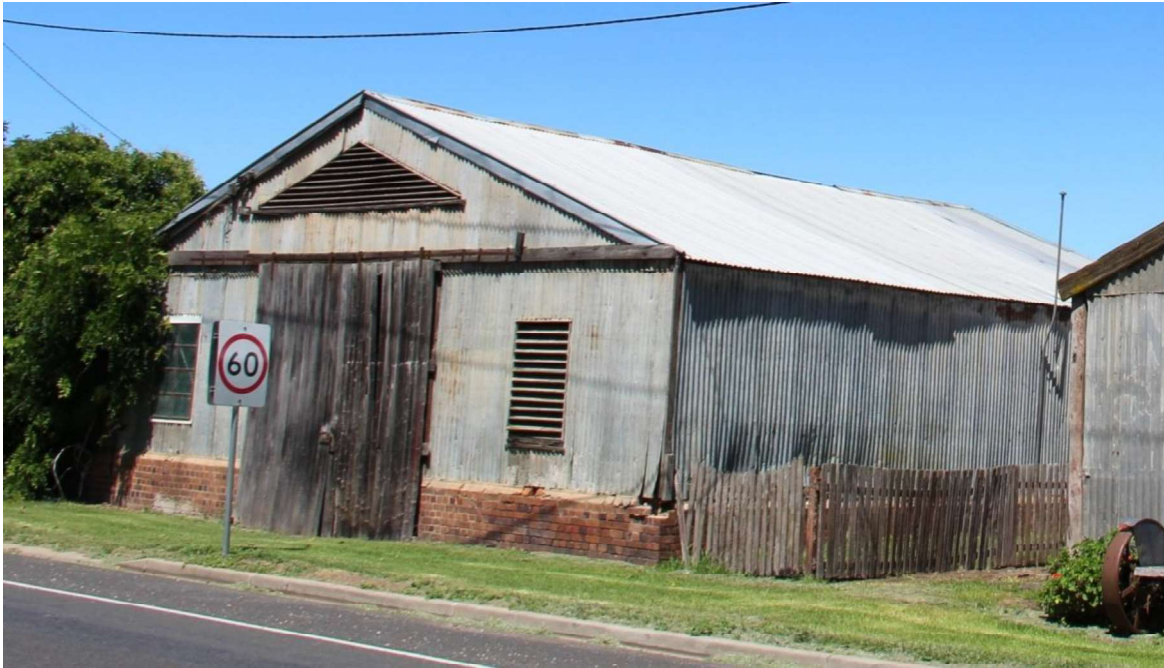
Figure D3. The blacksmiths and wheelwrights building is a gabled-roof building with the walls and roof clad with corrugated galvanised iron. The building has a brick plinth with rendered coping. The gabled-end to the façade has a large triangular timber-louvered vent. Timber sliding doors (probably original) are located at the centre of the façade with the original sliding mechanism on the exterior of the facade. To the right is a timber-louvered window; this has been replaced on the left of the façade with a later glazed window.

Figure D3. The blacksmiths and wheelwrights building at 37 Main Street. The gabled roof building retains its original sliding timber door, galvanised iron cladding and brick plinth and some timbered louvered openings.

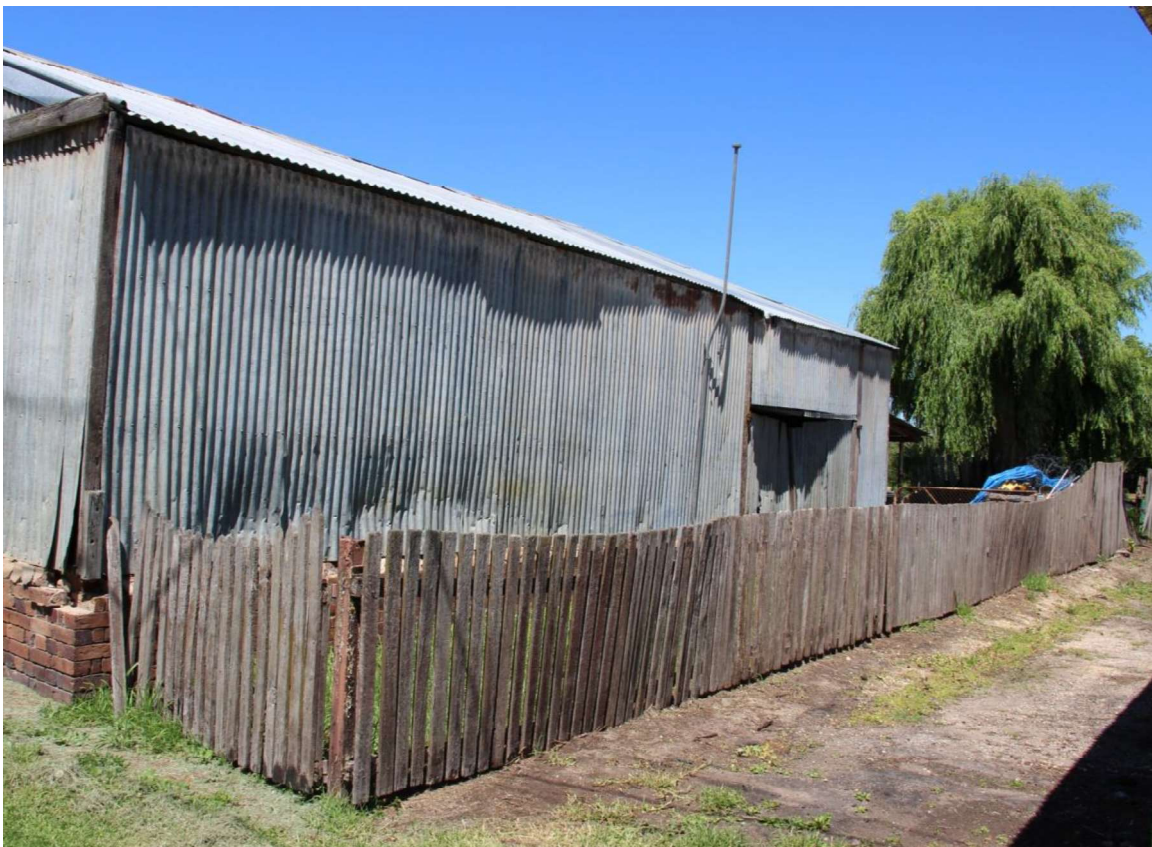
Figure D4. The north elevation of the blacksmiths and wheelwrights building comprises one large door near the rear of the building. A skillion-roof verandah is located on the west (rear) elevation (the date of this is not known). A weathered timber picket fence is located on the eastern and northern boundaries of the building (although it appears to be an early fence, it was not evident in this location in a photo dating to c1980, which indicates that it may have been relocated to this location). The blacksmiths and wheelwrights building is in fair to good condition and retains a high level of integrity.

Figure D4. The north elevation of the blacksmiths and wheelwrights with one large opening near the rear of the building and a skillion-roof verandah off the rear elevation. The timber picket fence appears to be an early construction and may have been relocated to this location post-c1980.

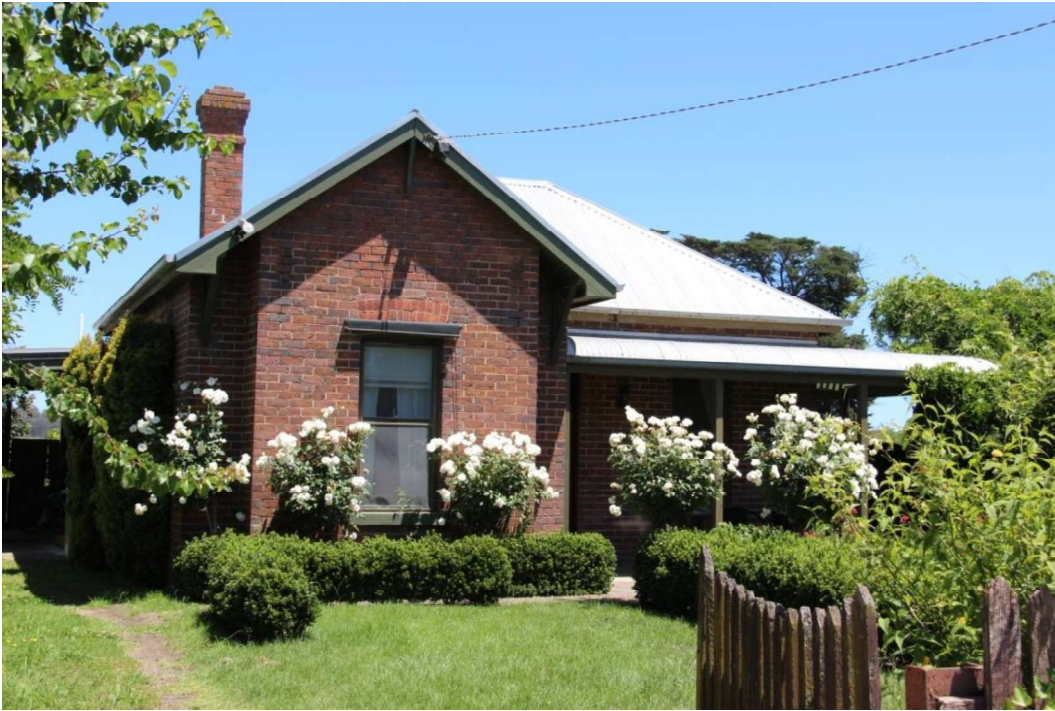
Figure D5. The blacksmith's house is a typical Federation era brick construction with a hip-and-gabled roof clad with corrugated iron. The house was constructed with bricks made at the brick kiln on the Foster property. A tall corbelled brick chimney remains on the southern roof plane (Figure D6). To the left of the façade is a projecting gabled-bay (the decorative timberwork to the gabled-end, as evident in Figures H1 & H2, has been removed) with a one-over-one timber sash window, with red-brick voussoirs radiating above and a rendered (overpainted) sill. A bull-nosed profile verandah is located to the right of the façade and returns on the north elevation (the verandah appears to be a later construction, replacing the original which was only located on the facade). Modern extensions have been added to the rear (west) of the building. Overall, the c1907 house is in very good condition and retains a medium to high level of integrity. The blacksmith's house is set back within a garden setting, behind what is probably the original timber picket fence.

Figure D5. The blacksmith's house is a typical Federation era brick construction with a hip-and-gabled roof and projecting gabled bay to the left of the facade, and (modern) return verandah to the right. It is located in a garden setting with an early (possibly original) timber picket fence.

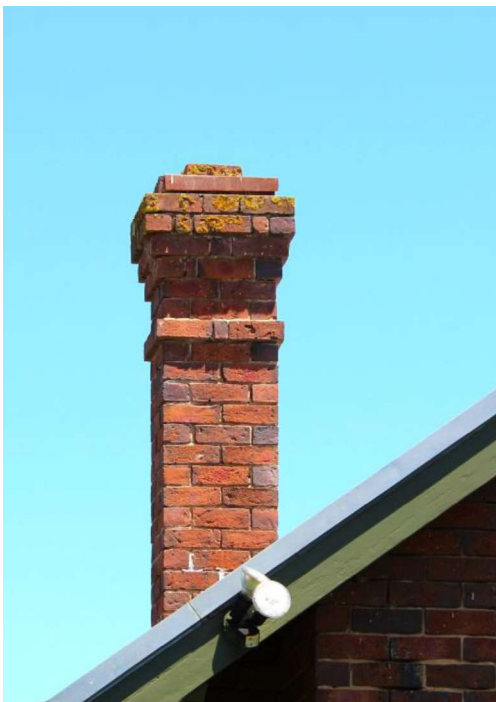
Figure D6. Detail of the corbelled chimney made of the bricks from the Foster family kiln. The chimneys on other Foster sponsored homes in Boisdale are very similar.

Figure D6. Detail of the corbelled chimney made of the bricks from the Foster family kiln. The bricks and chimneys on other Foster sponsored homes in Boisdale are very similar.
