**Locality:** BRIAGOLONG  
**Place address:** 4 CHURCH STREET  
**Citation date** 2016  
**Place type (when built):** Church, Tree  
**Recommended heritage protection:** Local government level  
Local Planning Scheme: Yes  
Vic Heritage Register: No  
Heritage Inventory (Archaeological): No

**Place name:** Briagolong Uniting Church and Dutch Elm

Project: Wellington Shire Stage 2 Heritage Study  
Client: Wellington Shire Council  
Author: Heritage Intelligence Pty Ltd  
Date: 12/2/16

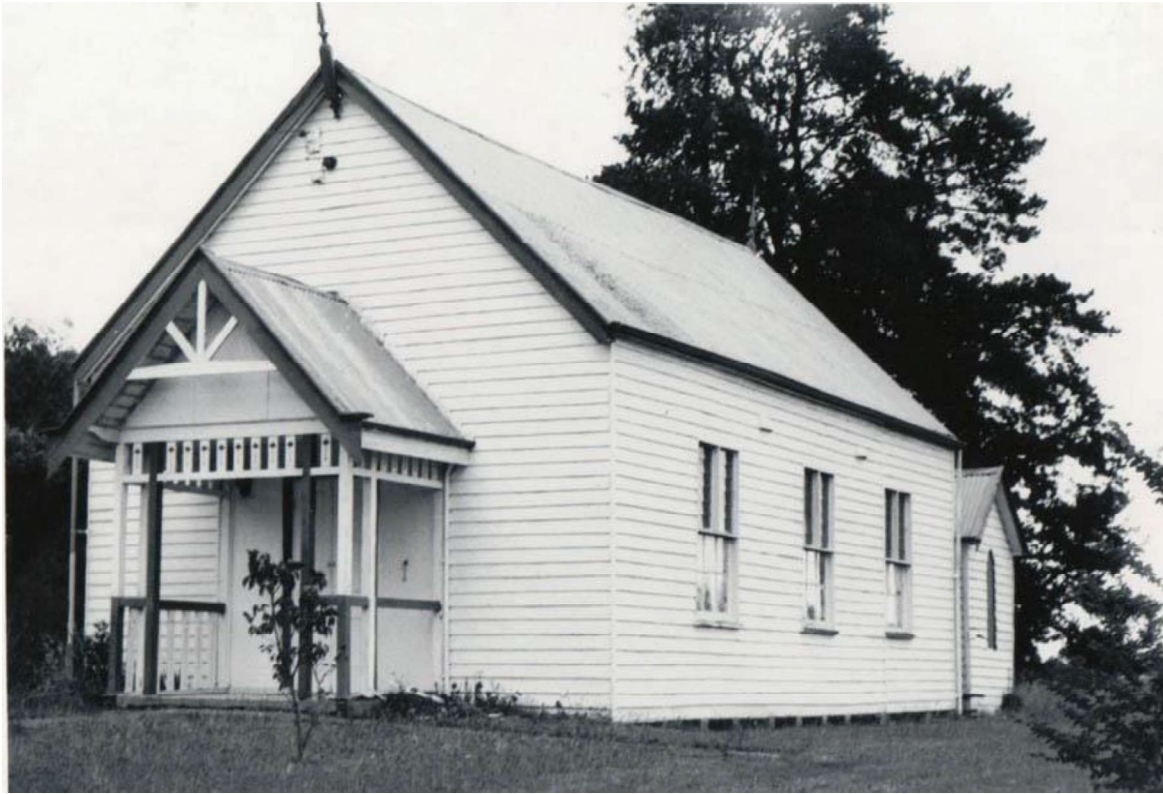
**Figure H1.** The church in 1976. The original porch with a pointed arch window had been relocated to the rear, and a c1970s porch added at the front. The top sashes of the side windows have been replaced with louvres. The finials to the roof evident here, have since been removed. (MDHS, ID. P02788VMFF 1976).

- 4.4. Reconstruct the missing finials to match those shown in Figs H1 and H3.

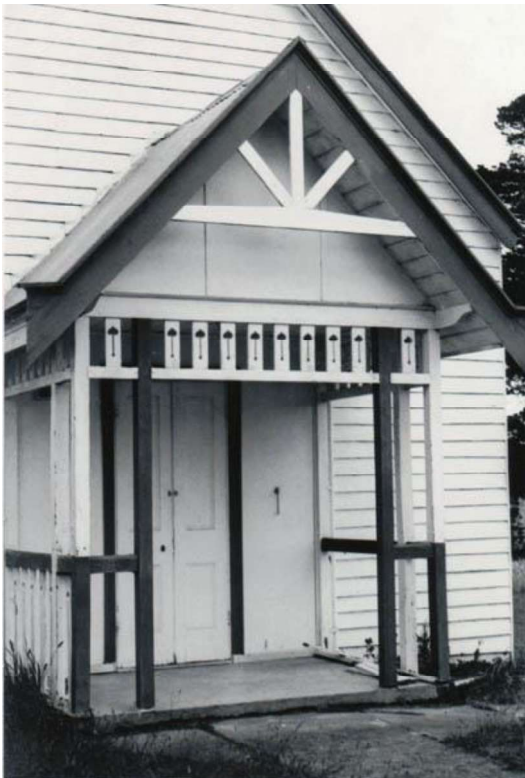
**Figure H2.** Detail of the porch in 1976, which probably dates to the early 1970s (MDHS, ID P02787VMFF 1976).

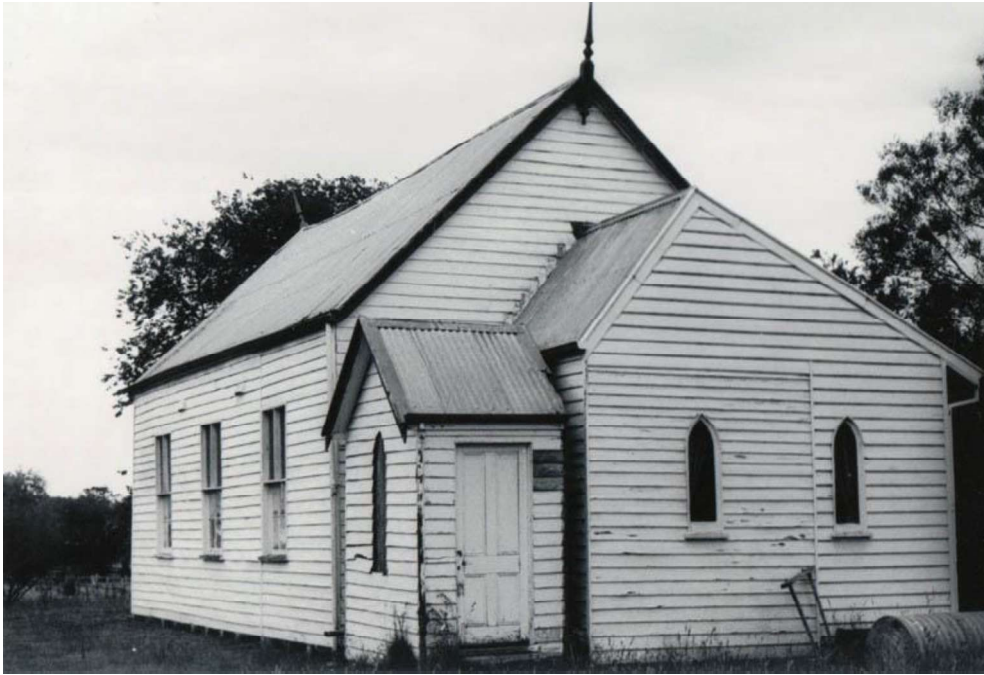
**Figure H3.** The rear elevation in 1975, showing the ‘relocated original front porch’ on the left (since removed), and an early addition to the right with similar pointed-arch windows (MDHS, ID P02785VMFF 1976).

- 4.3. Porch. Remove the existing porch and reconstruct the original design as seen in Fig H3 at the facade.

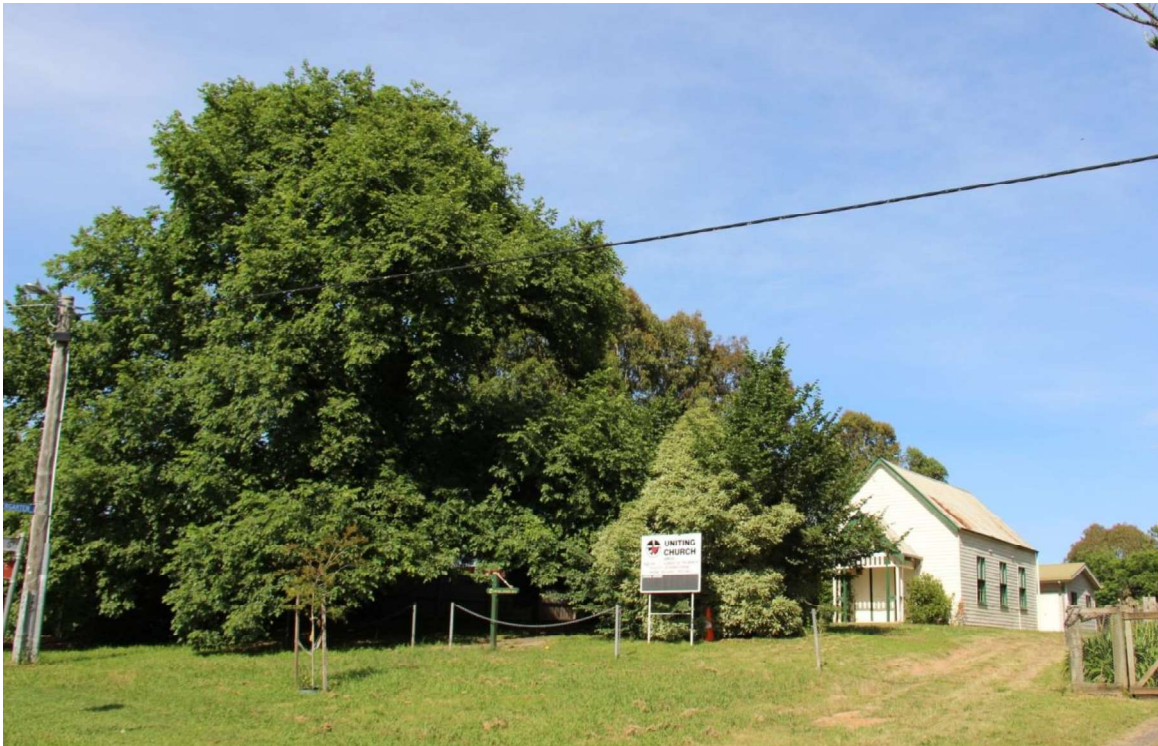
**Figure D1.** The church is located on the west side of Church Street, looking east down Cahill Street. The building has a deep setback and is located on a slight rise, behind a mature Dutch Elm on the front boundary. A modern chain fence runs along the front (east) boundary.

**Figure D1.** The picturesque church has a deep setback and is located on a slight rise, behind a mature Elm on the front boundary. A modern chain fence runs along the front (east) boundary.

- 4.5. Fences. Construct a timber picket fence 1.4m high or lower, across the front boundary.

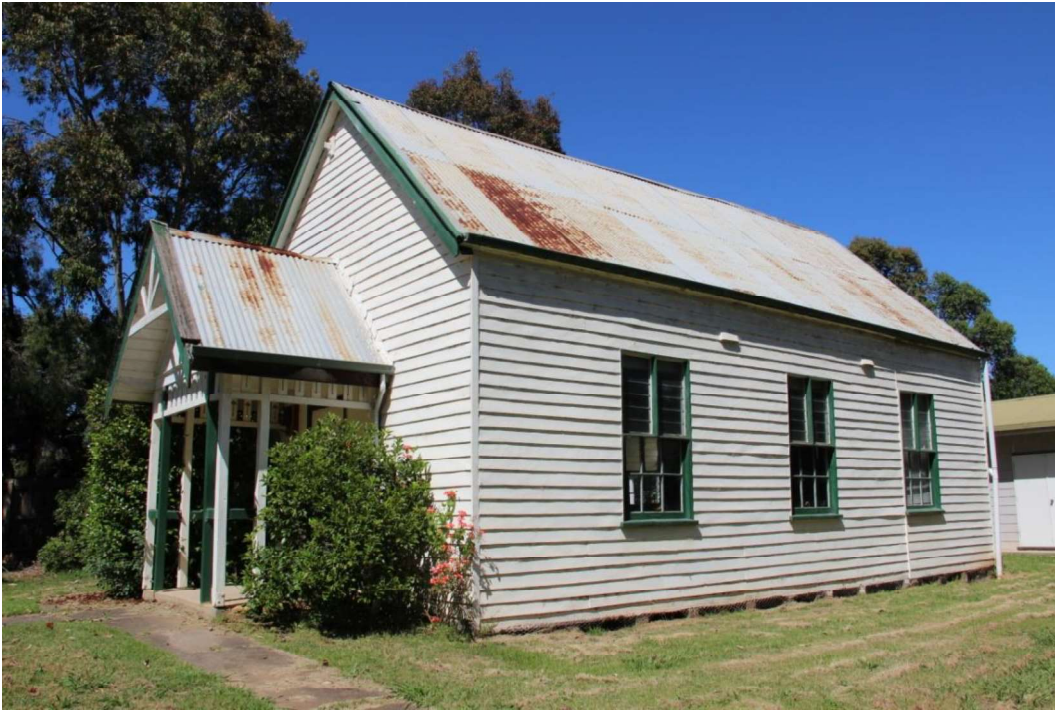
**Figure D2.** The modest weatherboard church has a gabled roof clad in corrugated iron, with plain bargeboards to the gabled ends, reflecting a simplified version of a Victorian era Carpenter Gothic church. The side elevations consist of three windows, with six-paned sash windows to the bottom half, with a pair of modern louvered windows above, which replaced six-paned sash windows.

**Figure D2.** The modest weatherboard church has a gabled roof clad in corrugated iron, with simple bargeboards to the gabled ends, reflecting a simplified version of a Carpenter Gothic church. The side elevations consist of three windows, with six-paned sash windows to the bottom half, with a pair of modern louvered windows above.

- 4.2. Windows. Remove the louvres, and construct 6-pane timber sashes to match the bottom ones.

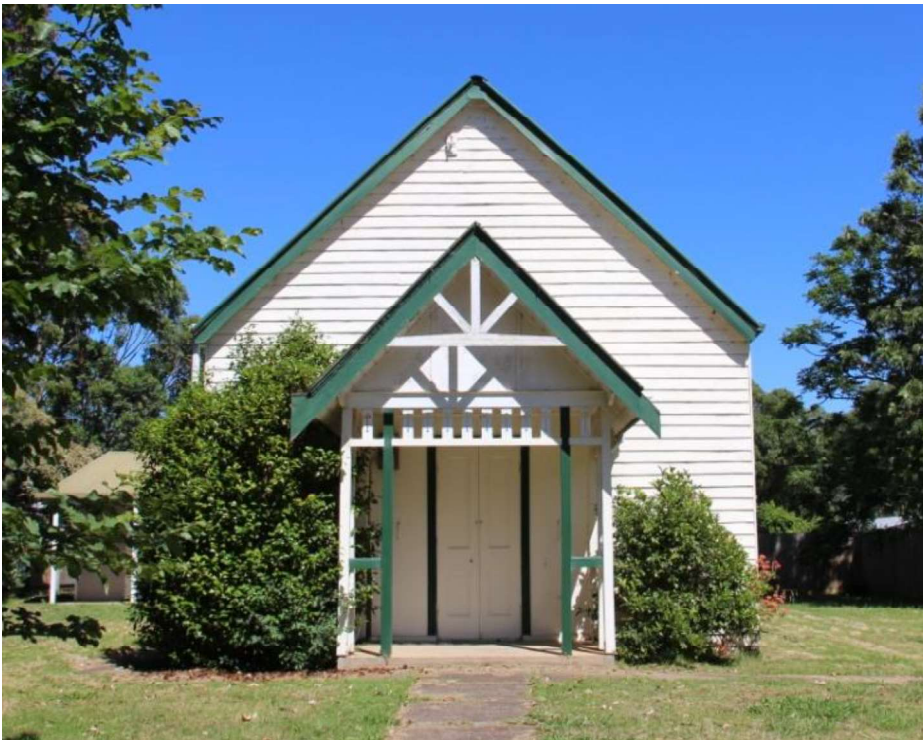
**Figure D3.** The façade has a c1970s central entrance porch with a concrete floor, gabled roof clad with corrugated iron, and a jettied timber valence and frieze. The section of nave beneath the porch is clad with fibro-cement sheets either side of the timber entrance doors, suggesting that the existing entrance porch replaced the earlier one that was temporarily relocated to the rear of the nave (since removed) (see Figs H1 and H3).

**Figure D3.** The façade has a c1970s central entrance porch.

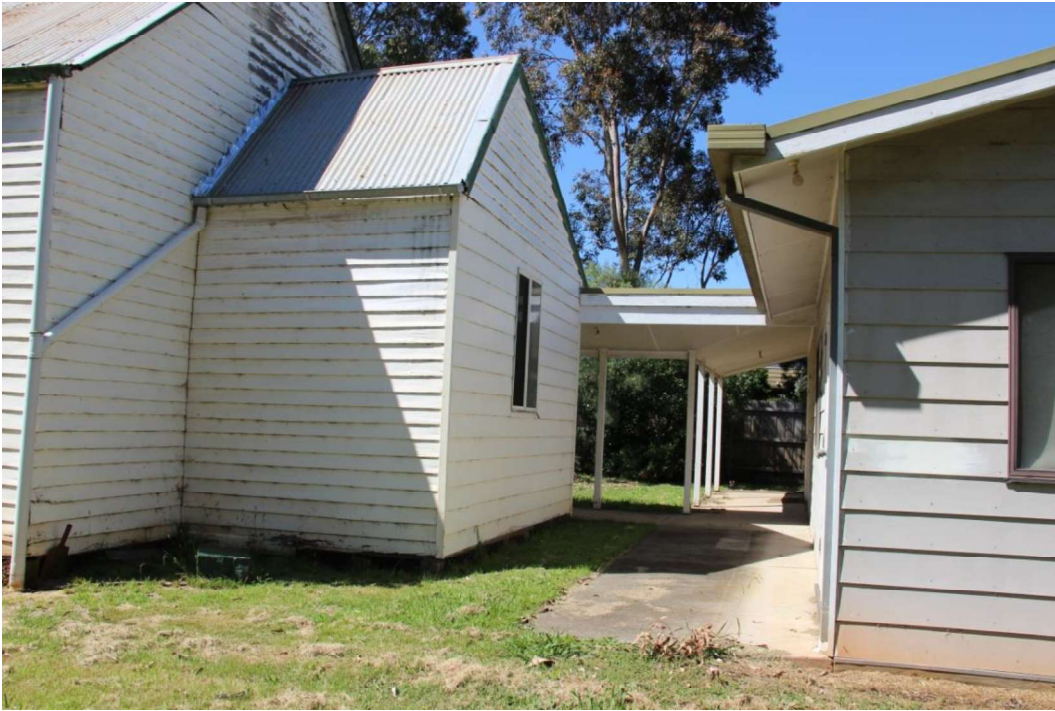
**Figure D4 & Aerial.** At the rear (west end) of the church is a small timber addition with a (uneven) gabled roof clad with recent corrugated iron, and a modern aluminum window to the west elevation (original pointed-arch windows since removed). Some of the weatherboard cladding appears to match the 1874 church, which suggests that this section may in part be original or early, but is largely altered.

**Figure D4.** At the rear (west end) of the church is a small timber addition with a (uneven) gabled roof. To the west of the church is a modern weatherboard building.

2. **Additions And New Structures**
  - 2.1. New structures should be restricted to the rear of the property as shown in the blue polygon on the aerial map. The weatherboard extension at the rear is not significant and can be demolished.

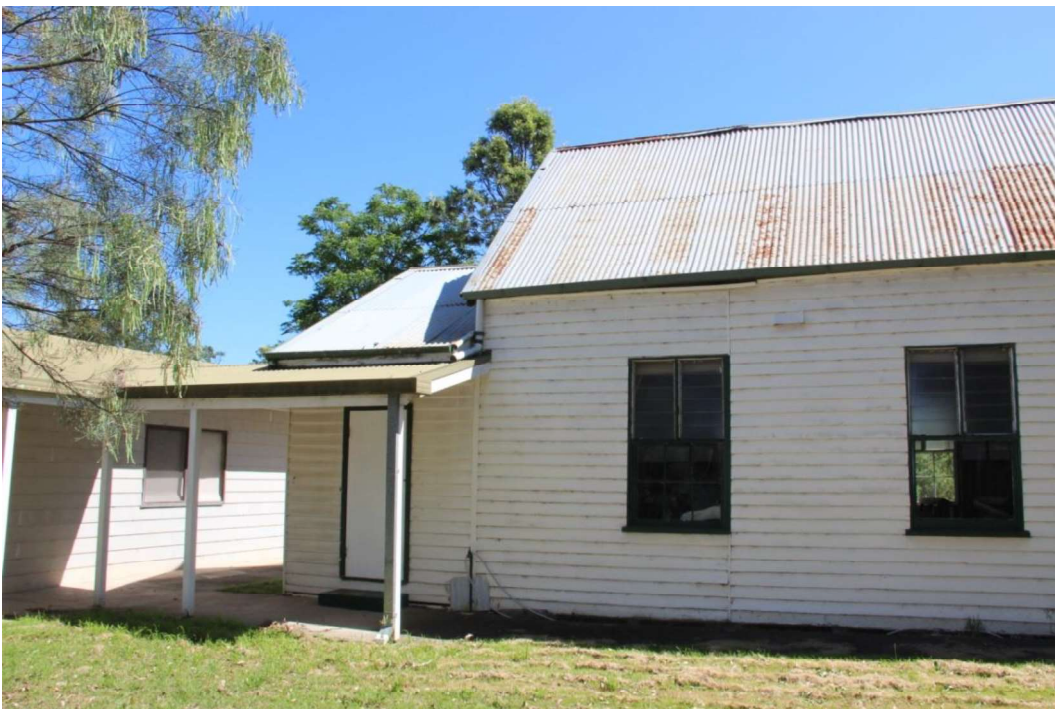
**Figure D5.** The modern weatherboard building is connected to the smaller weatherboard room attached to the rear of the church by a modern breezeway, that covers an entrance to the church off the southern elevation.

**Figure D5.** The rear section of the southern elevation. The modern weatherboard building to the rear of the 1874 church is connected to the smaller weatherboard room attached to the rear of the church by a modern breezeway that covers an entrance to the church off the southern elevation.

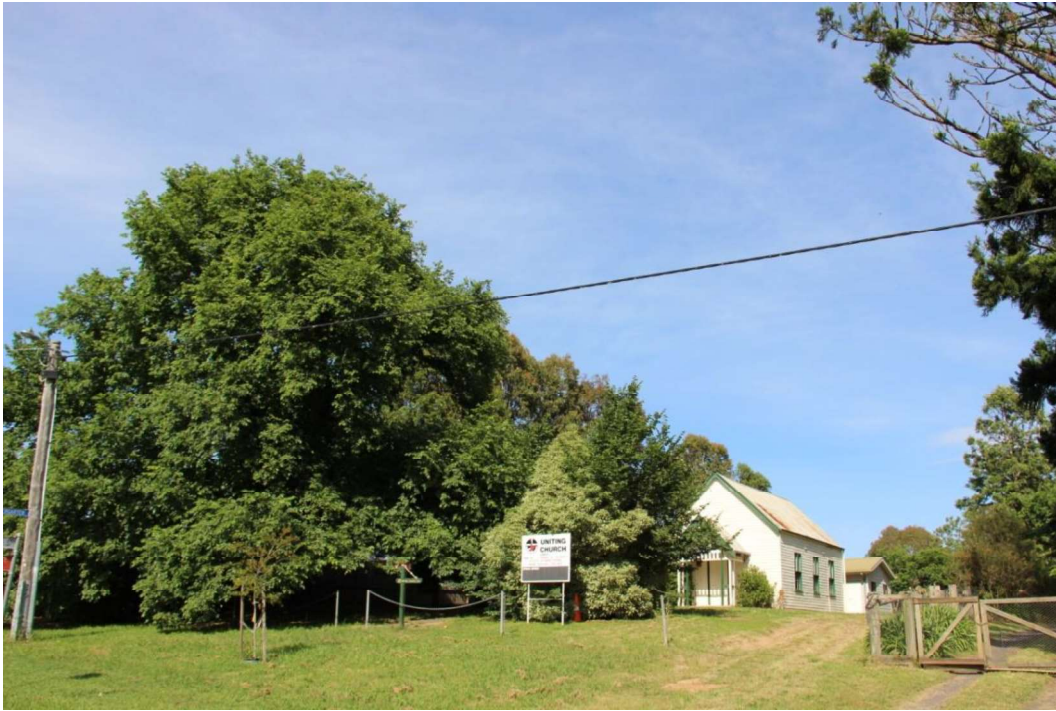
**Figure D6.** A large mature Dutch Elm (*Ulmus x hollandica*) is located inside the front (east) boundary, which probably dates to 1876, soon after the construction of the church. The Elm is in good condition and is a large example of the species.

**Figure D6.** The large mature Dutch Elm (*Ulmus x hollandica*) is located inside the front (east) boundary. The Elm is in good condition and is a large example of the species.
