Locality: COWWARR
Place address: 8-10 CHURCH STREET
Citation date 2016
Place type (when built): Church, lock-up
Recommended heritage protection: Local government level
Local Planning Scheme: Yes
Vic Heritage Register: No
Heritage Inventory (Archaeological): No

Place name: Christ Church and lock-up

Project: Wellington Shire Stage 2 Heritage Study
Client: Wellington Shire Council
Author: Heritage Intelligence Pty Ltd
Date: 12/2/16

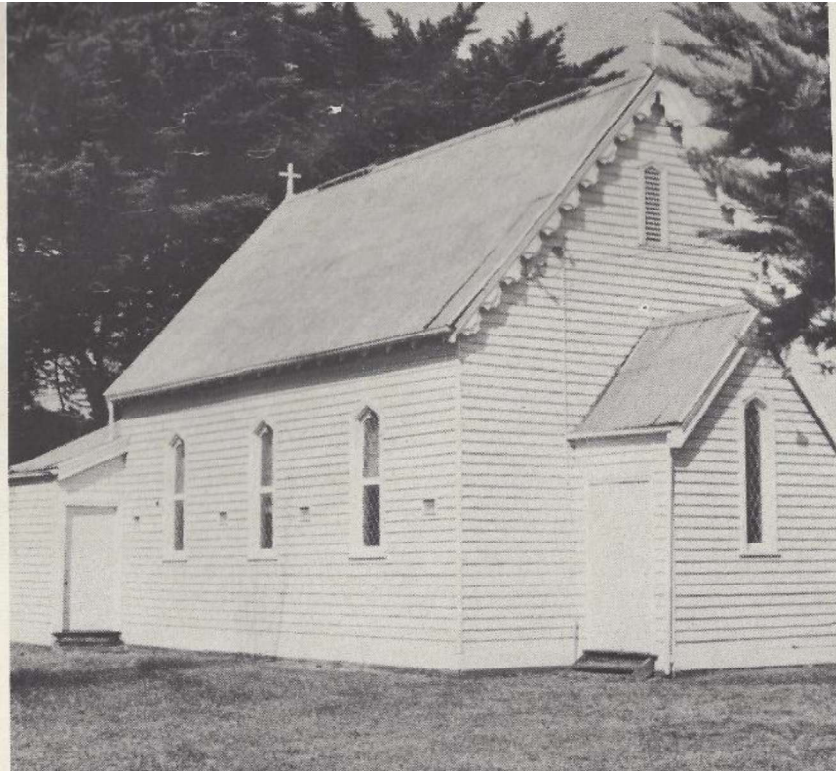
Figure H1. Photo dating to 1971 showing the gabled-roof timber building, ridge vents, Gothic leadlight windows, crosses at the gable peaks, entrance porch, and section to the rear. The large gable-end had a decorative bargeboard (which has since been removed) (Maddern 1971). This photo is evidence that the building remains very intact in 2016.

4.1. Reconstruct the decorative barge boards to match those shown in Fig H1.

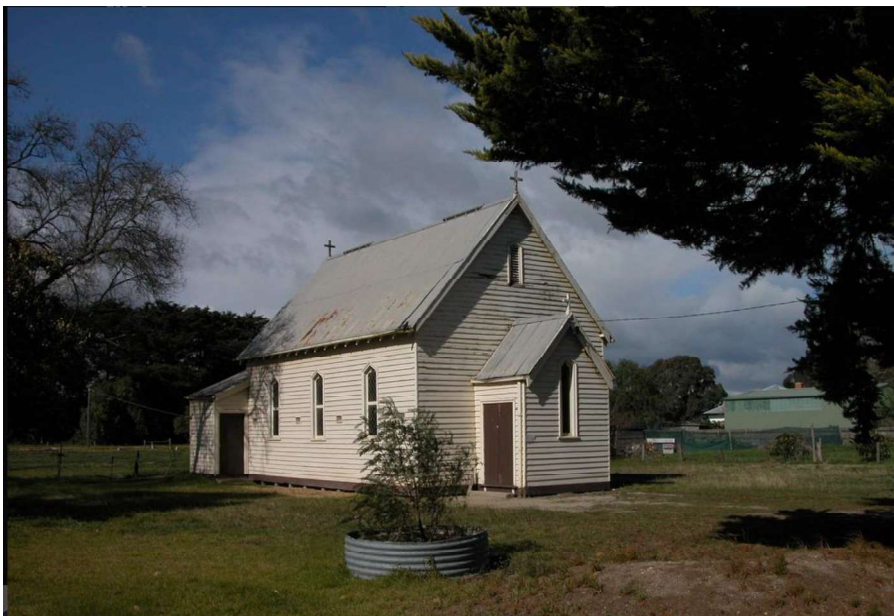
Figure H2. A photo dating to 2008 that shows that some of the mature cypress remained at this date, but have since been removed (Flickr).

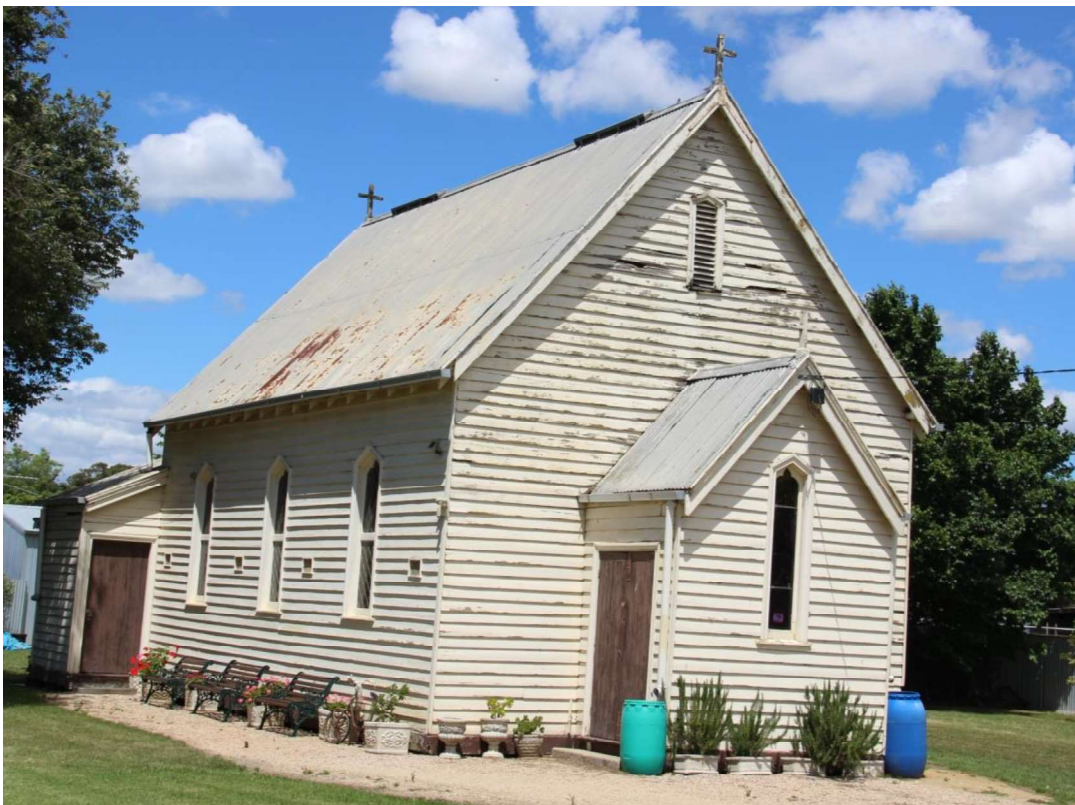
Figure D1 & D2. The picturesque weatherboard church has a steep-pitched gable roof clad with in short sheet corrugated iron and two vents at the ridge. The eaves to the side elevations have exposed rafter ends. The peak of the gabled ends have crosses at the apex and the gabled end of the facade has a louvered vent (the ornate bargeboards have been removed). The facade has a small entrance porch to the centre, with a gabled-roof and timber doors off the north side. The narrow Gothic windows to the porch and nave have pointed-arched frames and recessed within are leadlight windows (with a diaper pattern to the nave) with a trefoil motif to the top. Small vents are located between the windows on the side elevation. To the rear of the church is a weatherboard section with a lower roofline and entrance off the north elevation (the date of which has not been confirmed). The 1901

church is in good condition (although the paint, and some weatherboards are in very poor condition), and retains a very high level of integrity.

Figure D1. The facade of the church with the central entrance porch, with Gothic arched windows, a Gothic arched vent in the gable end and three crosses at the apex of each gable.

5.2.1. The original external timber doors and windows require careful repair and painting, as do the weatherboards. It is important to repair rather than replace when possible, as this retains the historic fabric. This may involve cutting out rotten timber and splicing in new timber, which is a better heritage outcome than complete replacement.

6.1. Various timbers are rotting mainly due to a lack of timely maintenance. Birds are nesting inside the front wall, gaining access through the holes in some weatherboards.

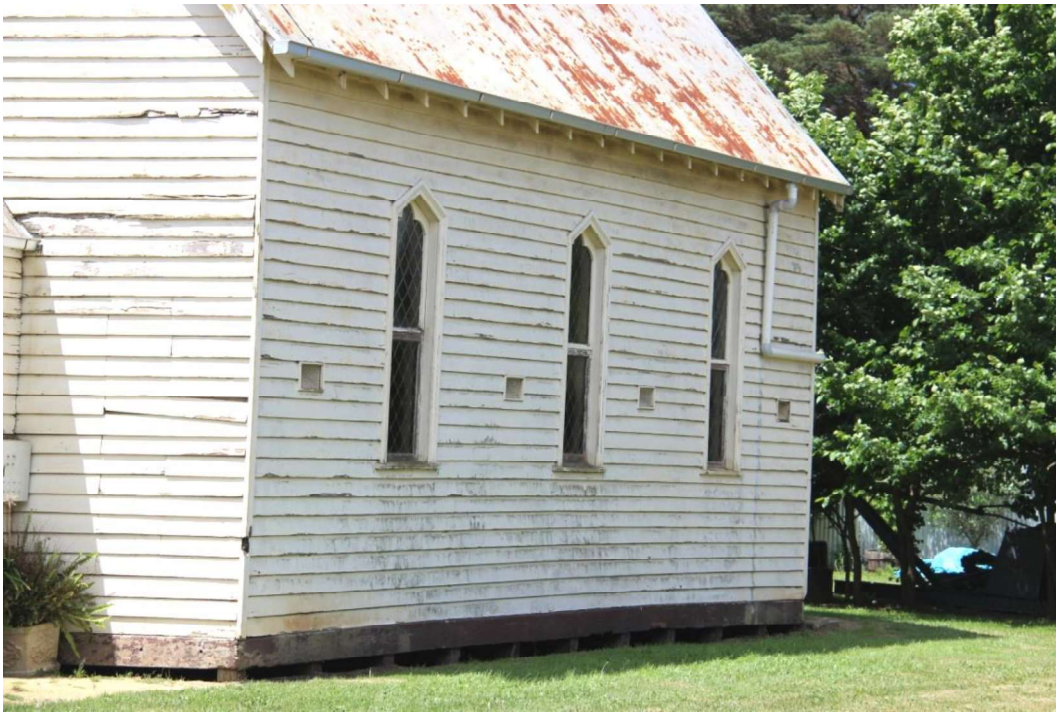
Figure D2. The south elevation with the three leadlight windows in a diaper pattern and trefoil motif to the top, set within the pointed-arched timber frame.

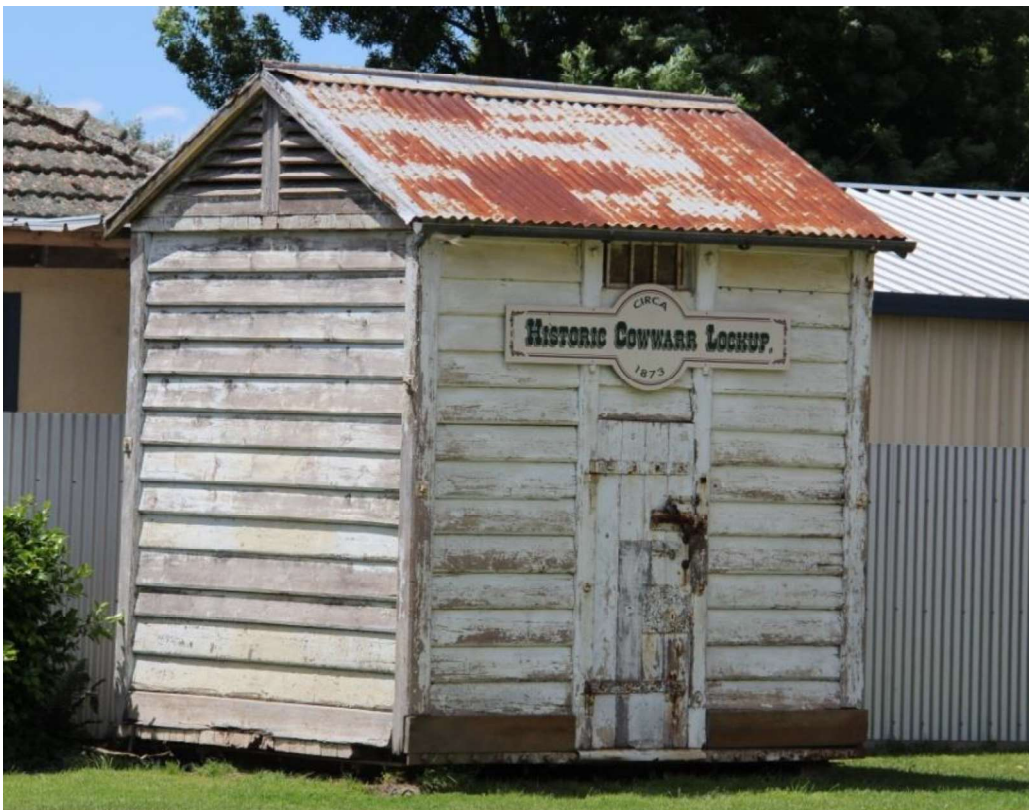
Figure D3. The small weatherboard lock-up has a gabled roof clad with early corrugated iron, with half-round spouting, and timber louvered vents to the gabled ends. For security purposes, the construction is an iron cage (the metal bars at the base can be seen below door level), clad in timber weatherboards, with solid timber flooring which is repeated at the ceiling (running lengthways; the ends visible on the side elevations). The lockup retains an early door with full-width hinges and a number of locks, and a metal grill to a vent above. A modern sign attached to the building reads 'Historic Cowwarr Lockup circa 1873'. The c1873 lockup appears to retain a high level of integrity and is in fair condition.

Figure D3. The small iron cage lockup with its gabled roof, half-round spouting and weatherboard wall cladding. It retains timber vents at the gable ends, a metal grill above the door, and its original (or an early) door with full-width hinges and a number of early locks.

- 4.2.1. Use galvanised corrugated iron roofing, spouting, down pipes and rain heads.
- 4.2.2. Do not use Zinalume or Colorbond or plastic.
- 4.2.3. Use ogee profile spouting, and round diameter down pipes on the church, but use half-round spouting on the lock-up.

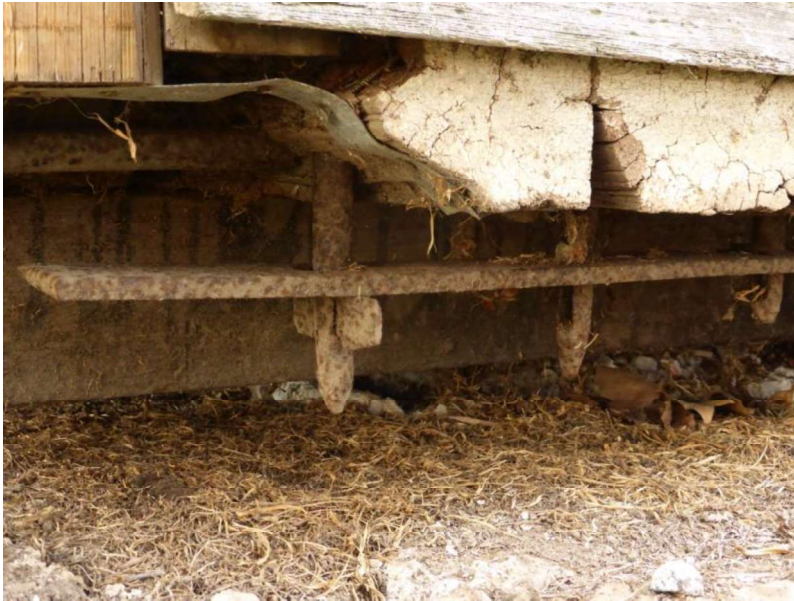
Figure D4. The lock up is constructed of an iron cage clad in timber, making it suitable for prefabrication and easily transported. The ends of the iron rods of the frame can be seen at the level below the door.

Figure D4. The lock up is constructed of an iron cage clad in timber, making it suitable for prefabrication and easily transported. The ends of the iron rods can be seen at the level below the door.
