Place name: St Brigid's Catholic Church Complex

Statement of Significance

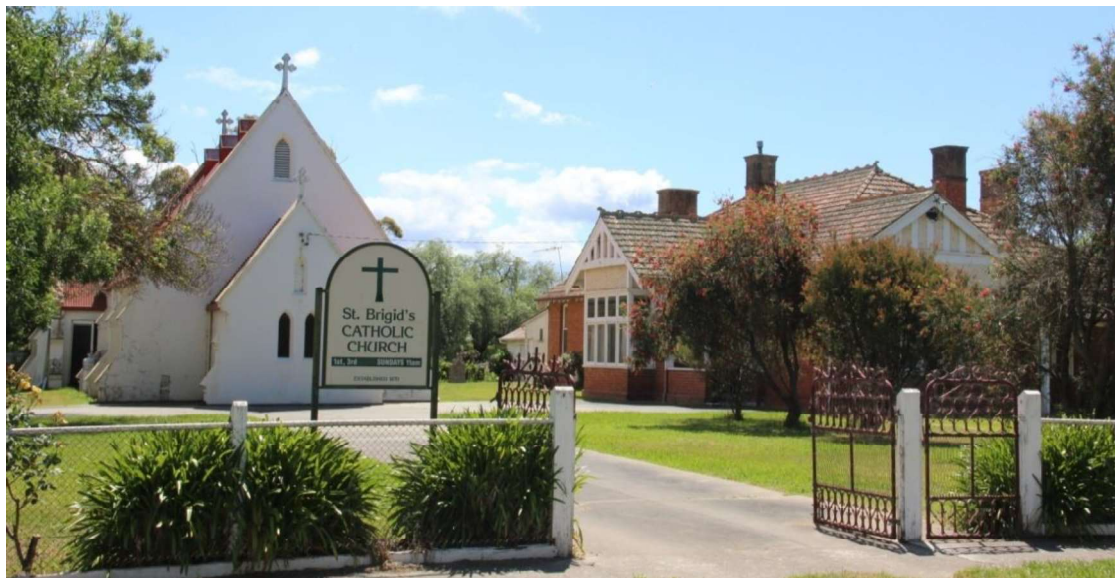
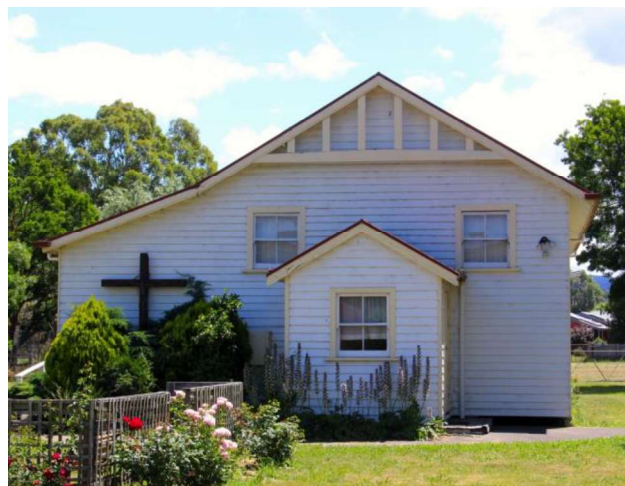
Architectural Style: Victorian Gothic; Federation Queen Anne; Interwar Arts and Crafts
Designer / Architect: J. H. W. Pettit (church); Reed, Smart & Tappin (parish house);
A. A. Fritsch (hall)
Construction Date: 1870 (church), 1904 (parish house), 1919 (hall)

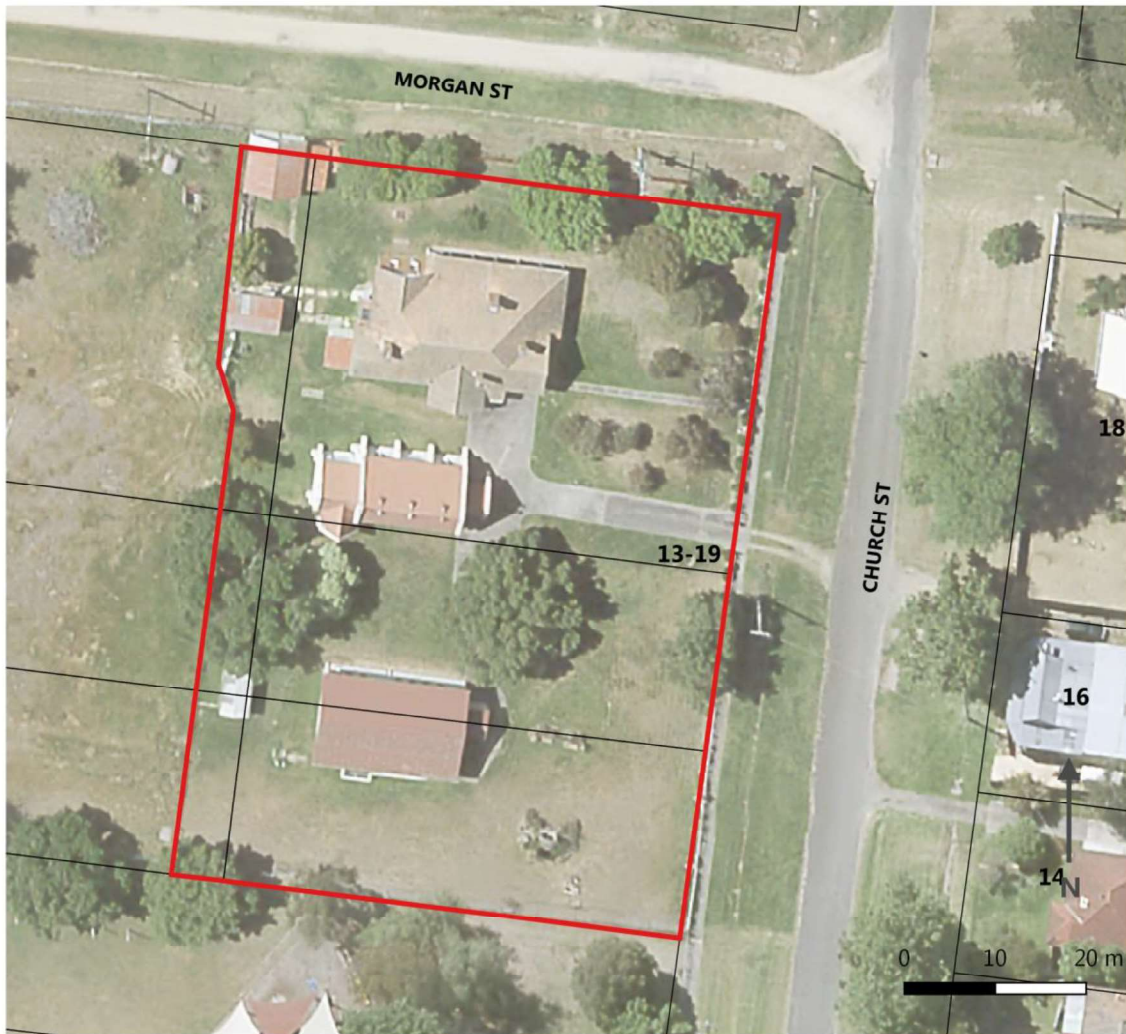
Map of recommended boundary for Heritage Overlay

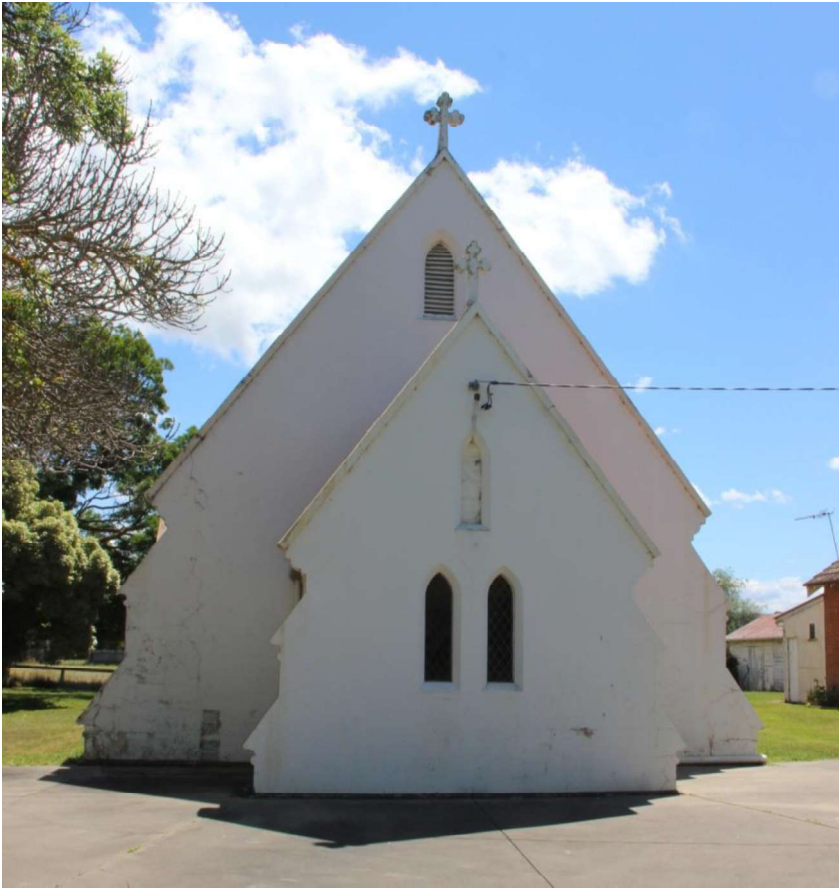
Figure D1. The 1870 church is rendered (overpainted white) and is Victorian Gothic in style. The church has a steeply-pitched gabled roof, parapets to the gabled ends, rendered walls with ruled lines to create an ashlar effect and a central entrance porch.
