Locality: HEYFIELD
Place address: 46 MACFARLANE STREET
Citation date 2016
Place type (when built): Church (Primitive Methodist)
Recommended heritage protection: Local government level
Local Planning Scheme: Yes
Vic Heritage Register: No
Heritage Inventory (Archaeological): No

Place name: Heyfield Uniting Church and Memorial

Project: Wellington Shire Stage 2 Heritage Study
 Client: Wellington Shire Council
 Author: Heritage Intelligence Pty Ltd
 Date: 12/2/16

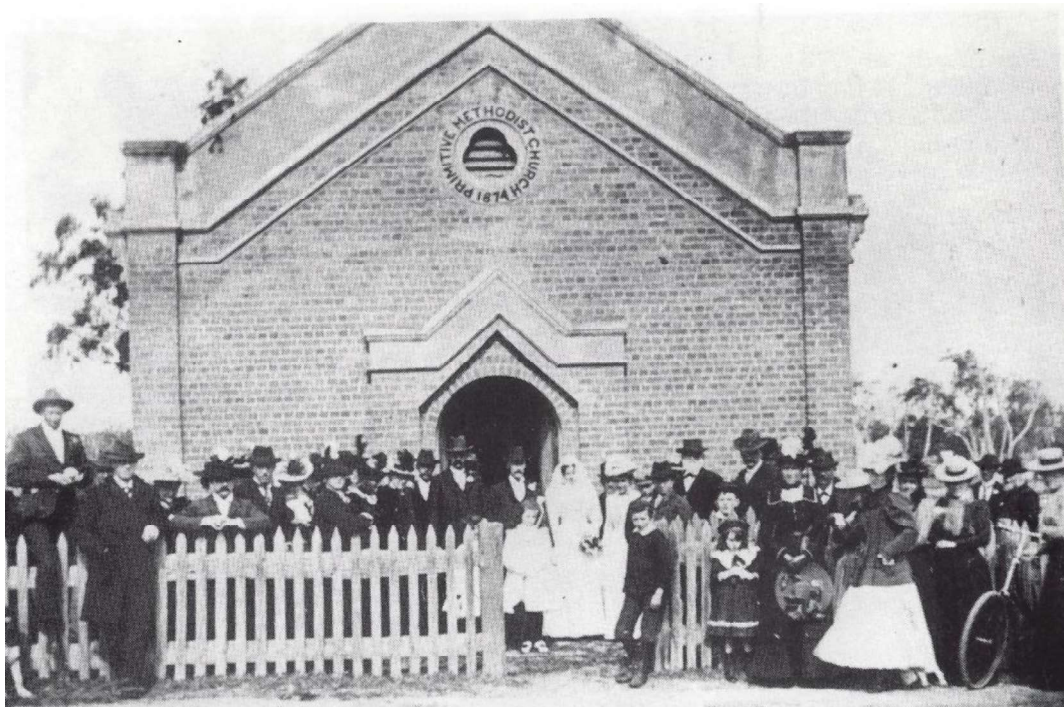
A photo dating to 1903 (Figure H1) showed a wedding party at the church, prior to the addition of the porch. The front elevation remained face brick with cement render coping (all since overpainted). 'Primitive Methodist Church 1874' was written in the circle surrounding the trefoil-shaped vent in the gable-end. The entrance porch was framed by a bold triangular, pointed arch moulding reflecting the parapet behind, with a brick semi circular arched doorway (it is not known if these features remain

Figure H1. A wedding party at the church in 1903, in front of the original entrance porch, before the existing porch and buttresses were constructed (HDHS).

- 4.2.1. Reconstruct a timber picket fence 1.4m high or lower, across the front boundary, to the same design as the one shown in Fig H1.

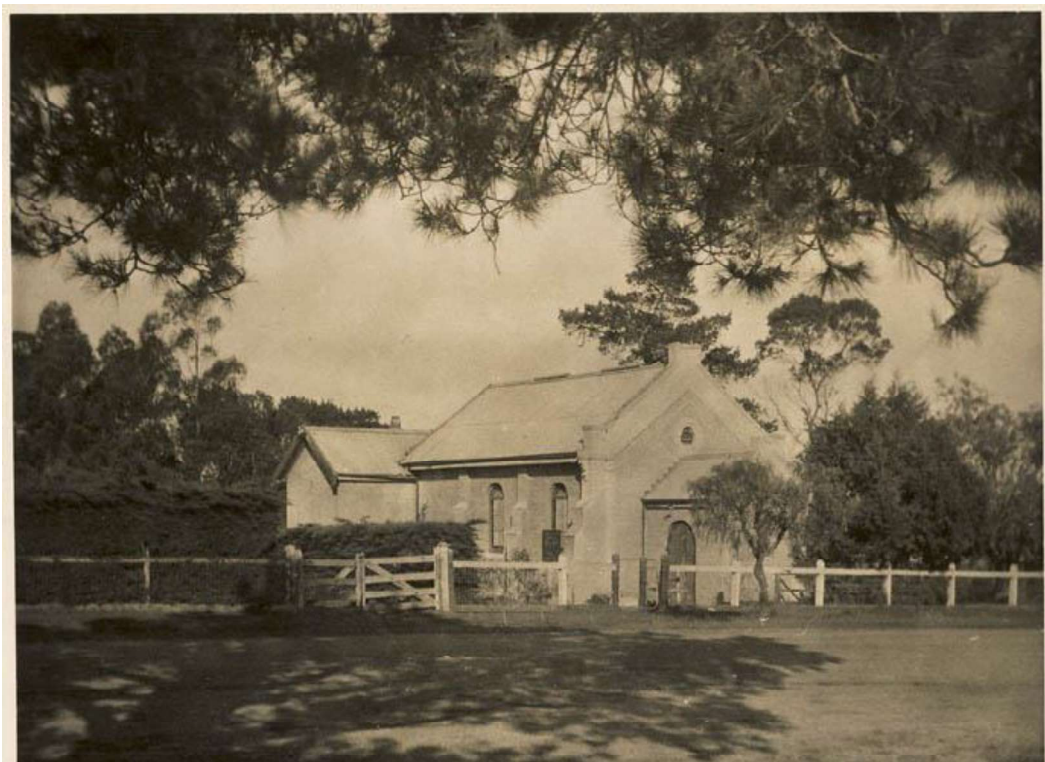
A photo dating to post-1913 (Figure H2) showed the church with the chancel, entrance porch and buttresses added to the side elevations of the church. The church exterior remained unpainted. There was no cross at the peak of the parapet at this date and the roof was clad with corrugated iron. The front boundary was enclosed with a timber-framed fence by this date (since removed) (HDHS).

Figure H2. A photo dating post-1913, after the existing porch, vestry and buttresses to the side elevations were constructed (HDHS).

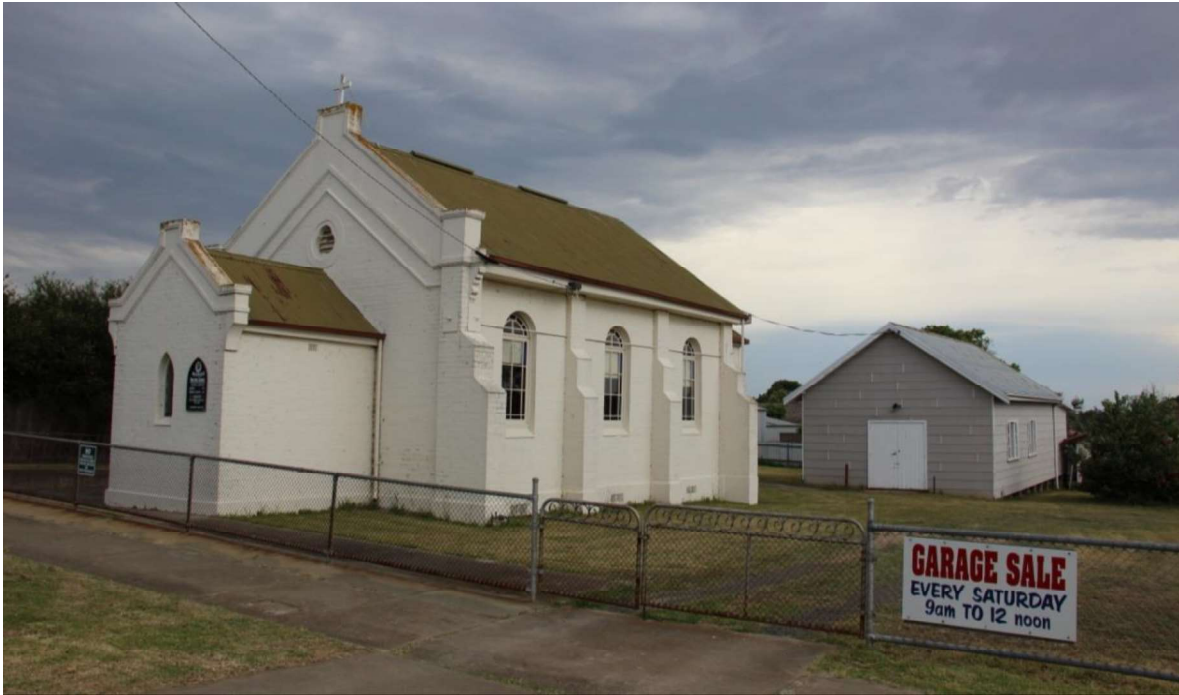
Figure D1. The brick (overpainted) church is modest in size and detail. The church has a gabled roof with a rendered (overpainted) parapeted gable to the facade (with ruled incised lines to create an ashlar effect) and sits on a rendered plinth. The roof is clad with (recent) corrugated iron with ridge vents. The pitch of the roof is repeated by two string courses on the gabled-end of the facade. A cross appears at the peak of the gable. Beneath the string courses is a small trefoil-shaped vent within a circular brick opening. At the centre of the facade is a small 1913 entrance porch, which imitates the parapeted gable of the nave behind. The porch (dating to 1913) has a small pointed-arch window facing Macfarlane Street.

Figure D1. The brick (overpainted) church is modest in size and detail. The church has a gabled roof with a rendered (overpainted) parapeted gable to the facade. At the centre of the facade is a small entrance porch (1913), which imitates the details of the parapeted gable of the nave behind.

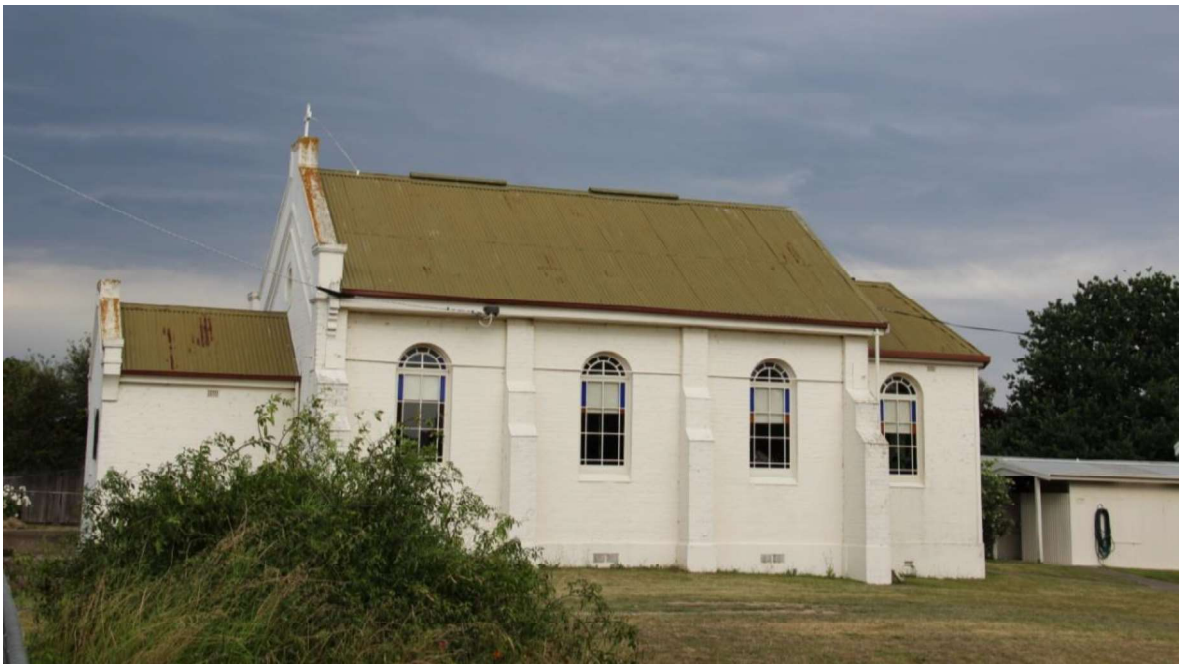
Figure D2 & D3. The side elevations comprise three bays created by buttresses (added in 1913). Each bay has a single semi-circular arched window. The buttresses have been reinforced externally with metal rods. A chancel (built in 1913) at the southern end of the church has a window of the same design on its west elevation. A small outbuilding is located on the western boundary, behind the church (probably facilities).

Figure D2. The west elevation. The side elevations comprise three bays created by buttresses (added in 1913). Each bay has a single semi-circular arched window. A chancel at the southern end of the church has a window of the same design on its west elevation.

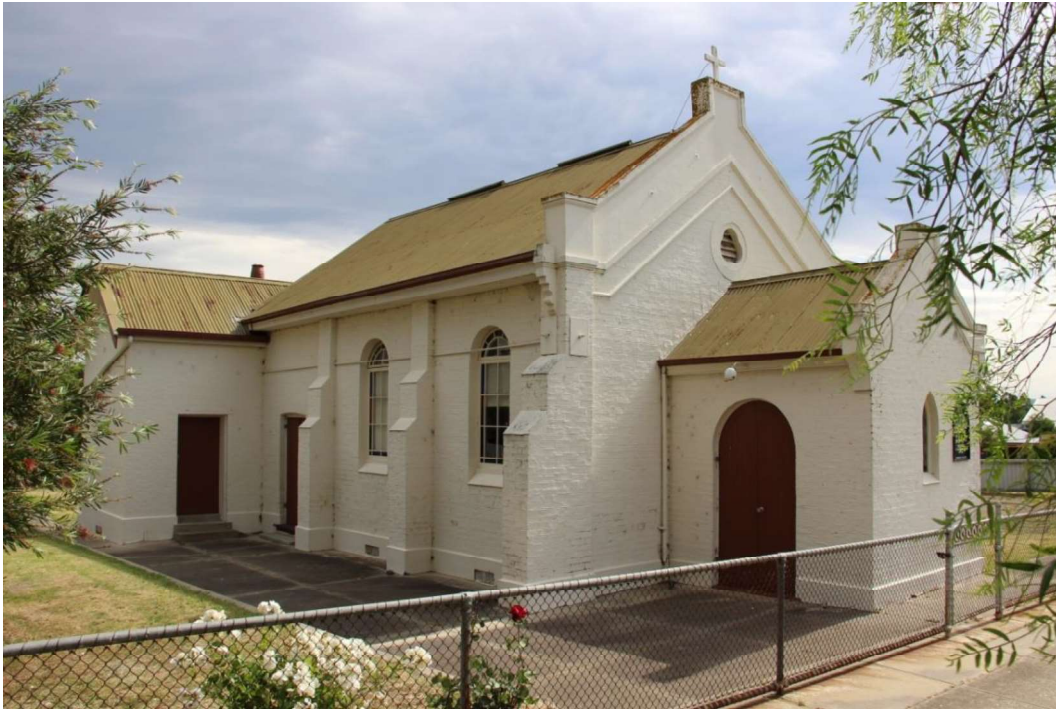
Figure D3. The vestry projects to the east off the chancel, entered by a door facing north. Another timber door is located on the third bay of the east elevation of the church. The entrance porch has a semi-circular arched door and opening on its east side.

Figure D3. The east elevation. The vestry projects to the east off the vestry and is entered by a door facing north. Another timber door is located on the third bay of the east elevation. The entrance porch has a semi-circular arched door and opening on its east side.

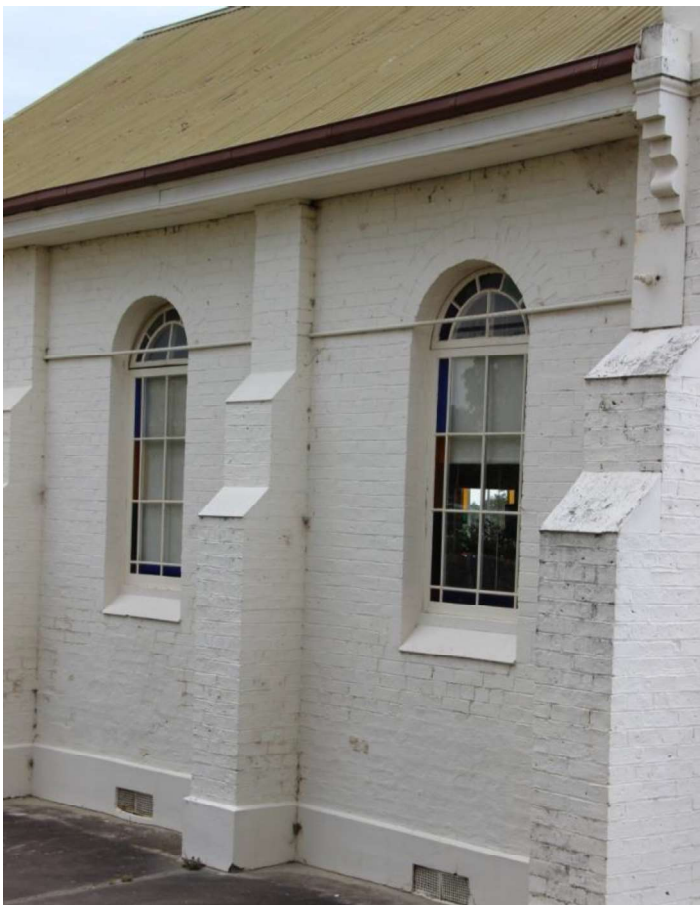
Figure D4. A detail of the semi-circular arched windows shows that they are multipane windows with a border of blue and red-coloured glass. The round segmented section at the top may be a hopper window.

Figure D4. A detail of the semi-circular arched windows shows that they are multipane windows with a border of blue and red-coloured glass. The round segmented section at the top may be an

openable, hopper window.
