**Locality:** HEYFIELD  
**Place address:** 22-40 TEMPLE STREET  
**Citation date** 2016  
**Place type (when built):** Church, Primary School  
**Recommended heritage protection:** Local government level  
Local Planning Scheme: Yes  
Vic Heritage Register: No  
Heritage Inventory (Archaeological): No

**Place name:** Heyfield Primary School and 1875 Church of England (former)

Project: Wellington Shire Stage 2 Heritage Study  
Client: Wellington Shire Council  
Author: Heritage Intelligence Pty Ltd  
Date: 12/2/16

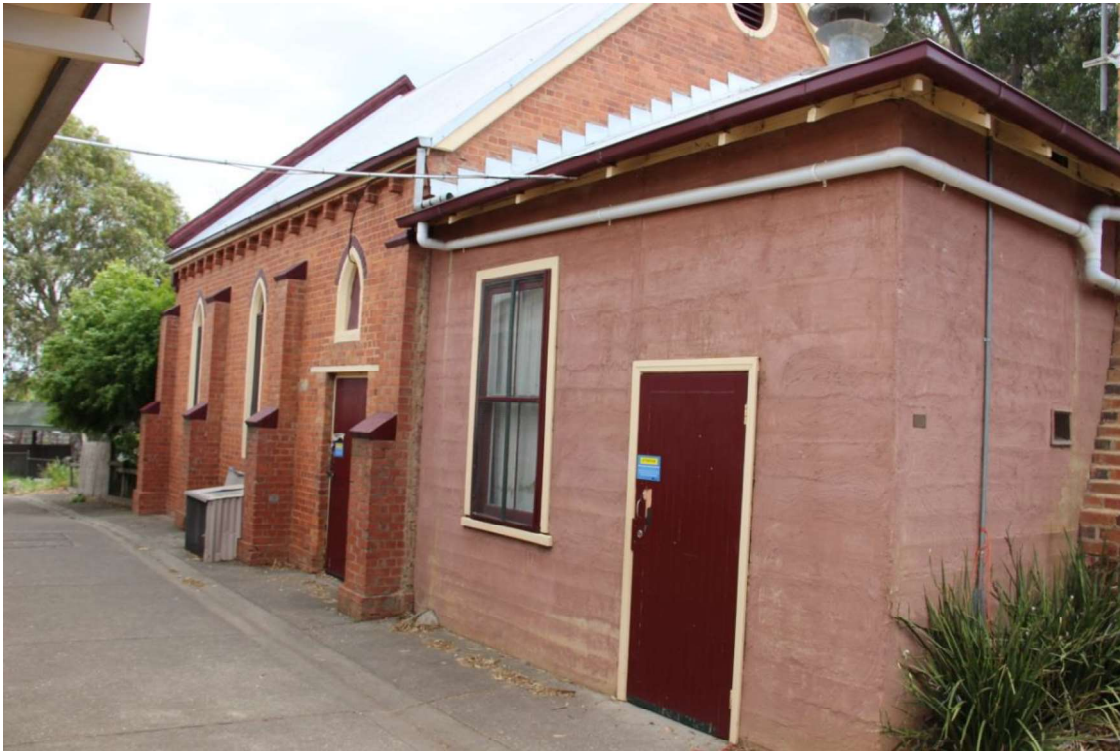
**Figure D1.** The east elevation. The modest church is constructed of red-brick in an English bond, with a brick plinth and gabled roof clad in (recent) corrugated iron and a rendered (overpainted) parapet to the facade (south elevation).

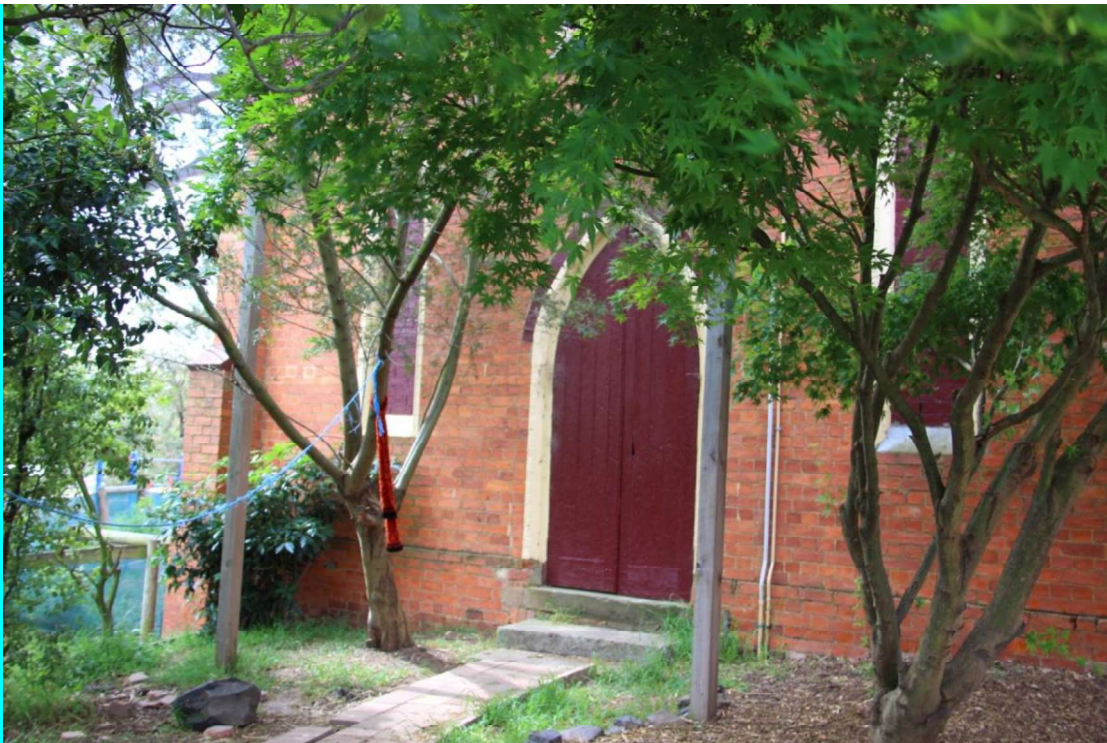
**Figure D2.** The facade (although difficult to see behind close foliage) has a central entrance with a pointed-arch and double timber ledged and framed doors, with a rendered surround (overpainted). The entrance is reached by two steps. To either side are two single pointed-arch

blind windows (see Figs H1 & H2.)

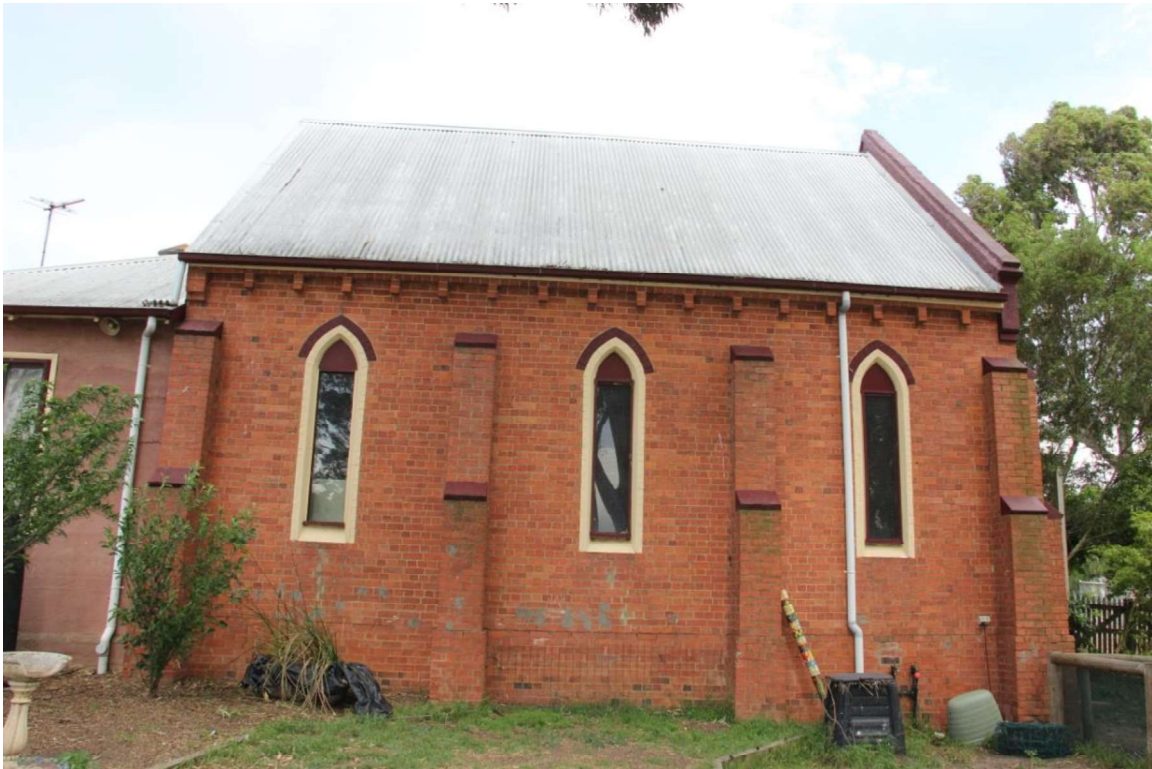
Figure D3. The west elevation. The side elevations comprise three bays, divided by four tall buttresses with rendered coping. Each bay has a single pointed-arch window with plain glass and a rendered surround (overpainted) and radiating (half) voussoirs (overpainted) at the arch. There are no sub floor vents.

- 6.10. Subfloor ventilation is critical. There is (no?) ventilation to the sub floor space of the 1875 building and the sub floor vents in the 1907 building are in poor condition and up to 50% blocked by paint. Check that sub floor vents are not blocked and introduce additional ones if necessary. Ensure the exterior ground level is 250mm or more, lower than the ground level inside the building. Good subfloor ventilation works for free, and is therefore very cost effective. Do not rely on fans being inserted under the floor as these are difficult to monitor, they will breakdown as they get clogged with dust, paint, etc, and there are ongoing costs for servicing and electricity.

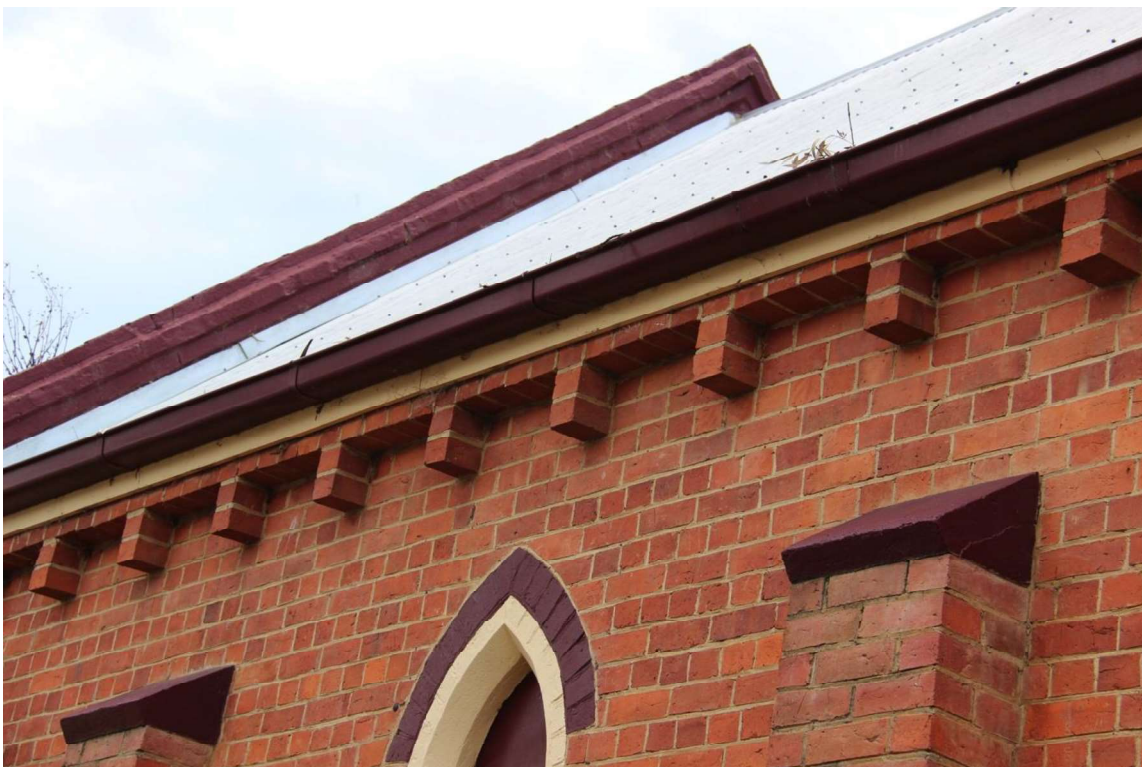
Figure D4. Architectural details: corbelled eaves decoration, rendered buttress coping, pointed

arch with voussoirs. The bricks and coping were not designed to be painted.

- 4.3.2. Paint removal on the 1875 brick building. It is strongly recommended that the paint be removed chemically (never sand, water or soda blast the building as this will permanently damage the bricks, mortar and render and never seal the bricks or render as that will create perpetual damp problems.) Removal of the paint will not only restore the elegance of the architecture, but it will remove the ongoing costs of repainting it every 10 or so years.

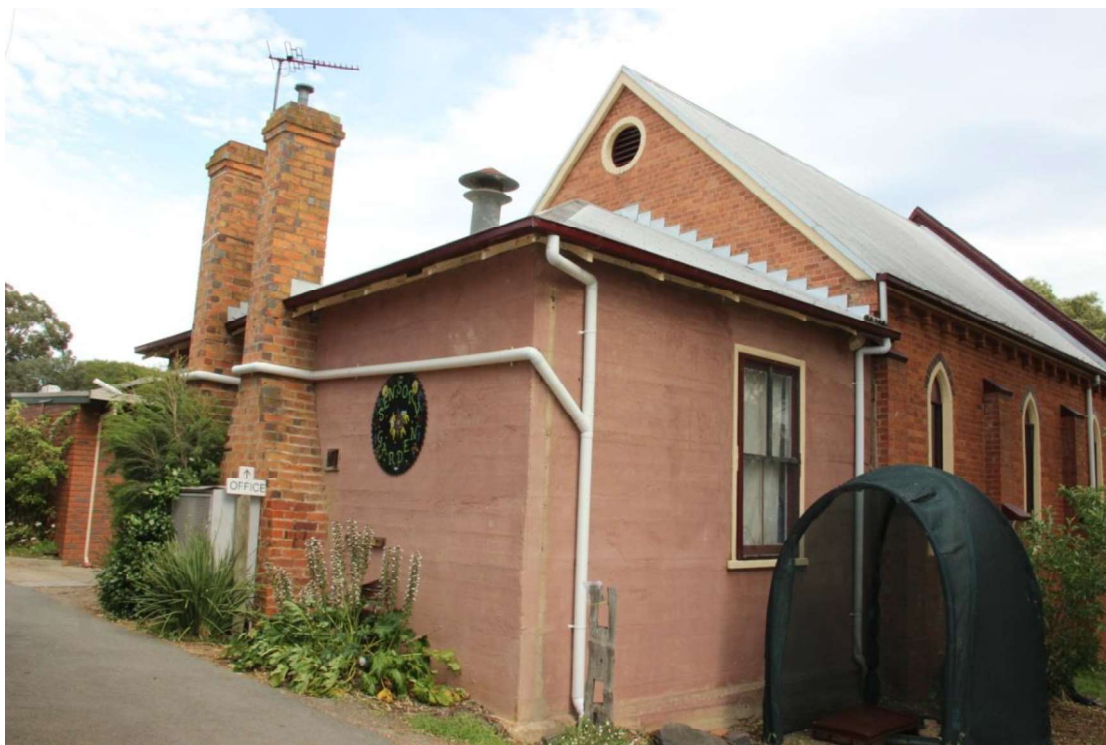
To the rear (north) of the church is the c1930s concrete construction addition with timber-framed two-over-two sash windows to the side elevations and a timber-ledged and framed door. To the rear of this addition are two earlier large external brick chimney stacks with corbelled caps. This concrete addition is not significant. The concrete extension appears to have blocked any sub floor ventilation to the 1875 building, which will promote damp, rot, termites and timber floor failure.

Figure D5. The north elevation of the 1875 church has a small round vent to the top of the gabled-end. To the rear (north) of the church is the concrete construction addition which is not significant. To the rear of this addition are two early large external brick chimney stacks with corbelled caps.

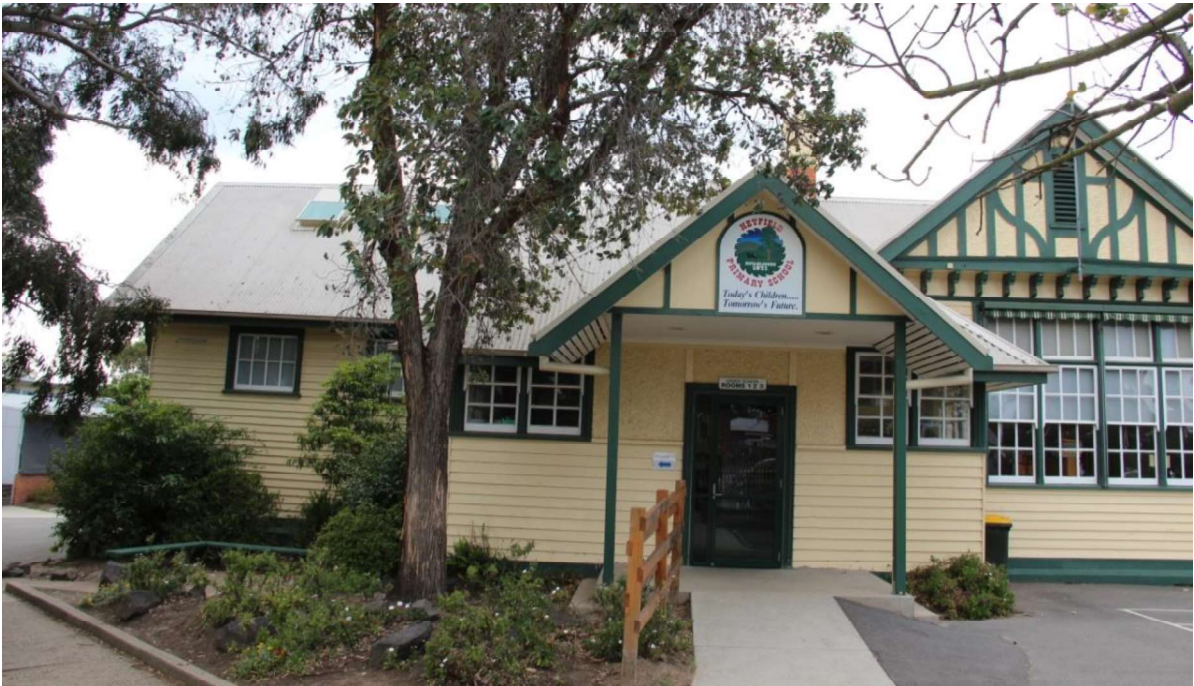
Figure D7. The facade facing Temple Street, comprises a large gabled-end to the right side and a central entrance. The central entrance is a wide opening that enters a projecting hipped-bay. Windows sit beneath the eaves of the bay, alternating with panels of roughcast render and timber strapping.

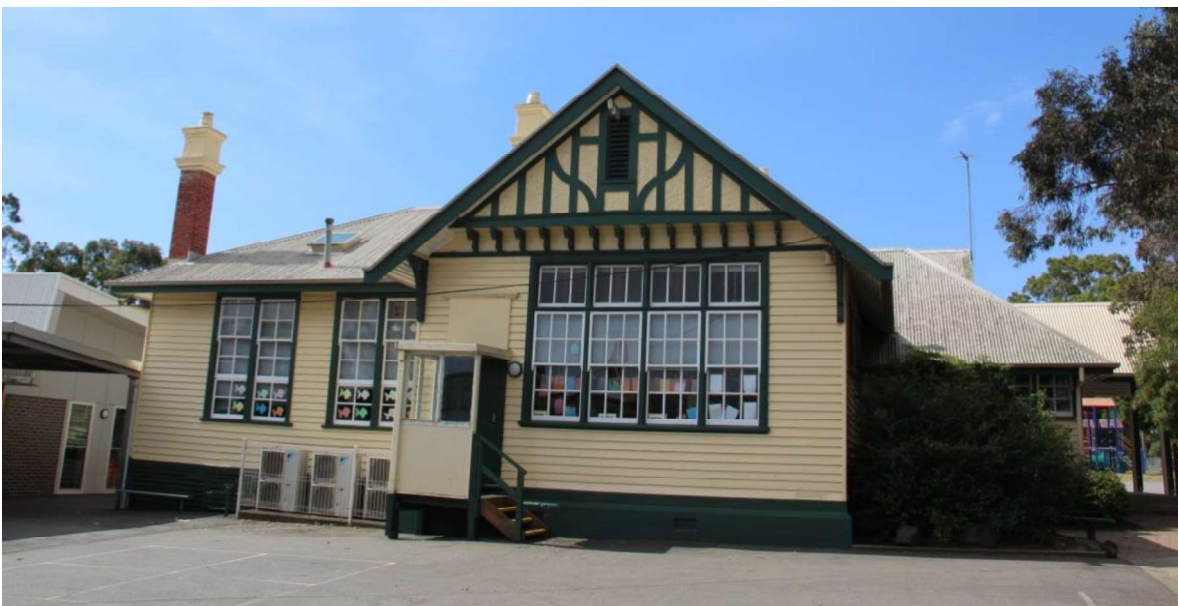
Figure D8. The south elevation (facing Harbeck Street) of the 1907 building has a large gabled bay. The western section of the building with a hipped roof was not constructed in 1907 (see Figure H3) but probably soon after, as it has the same architectural details and chimney as the 1907 building, however it does not sit on a masonry plinth.

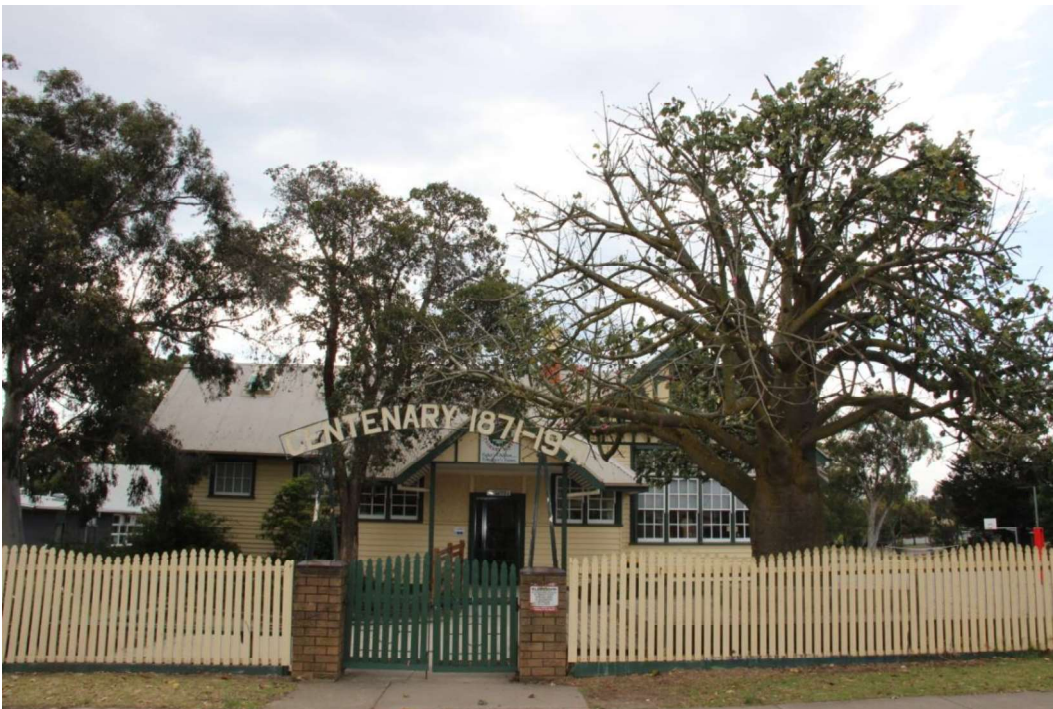
**Figure D10.** The entrance to the school on the east boundary is a gate with brick piers and metal gates (with attached palings). Above is a metal arch with letters reading 'Centenary 1871-1971', suggesting this entrance was built in 1971. Inside the boundary to the right of the entrance is a large Lacebark Tree (*Brachychiton discolor*), which dates to c1920. It is not in good condition as it appears to be suffering stress from possum damage (Hawker 2016).

Figure D10. The entrance to the school on the east boundary is a gate with brick piers and metal gates (with attached palings). Above is a metal arch with letters reading 'Centenary 1871-1971', suggesting this entrance was built in 1971. Inside the boundary to the right of the entrance is a large Lacebark Tree (*Brachychiton discolor*).
