Locality: MAFFRA

Place address: DUKE STREET: 2-12, 7~21\PP5490, 8~21\PP5490, 9~21\PP5490 & 10~21\PP5490

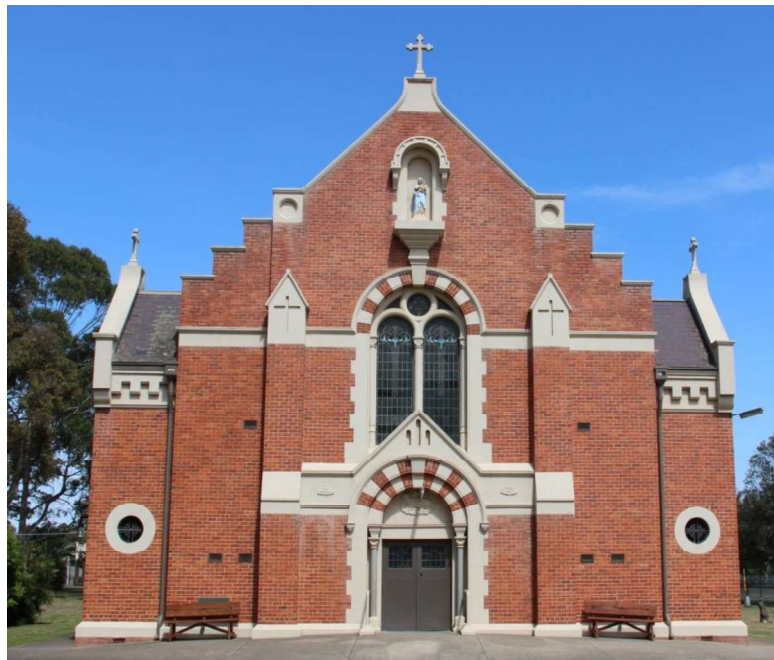
Place name: St Mary's Catholic Church Complex

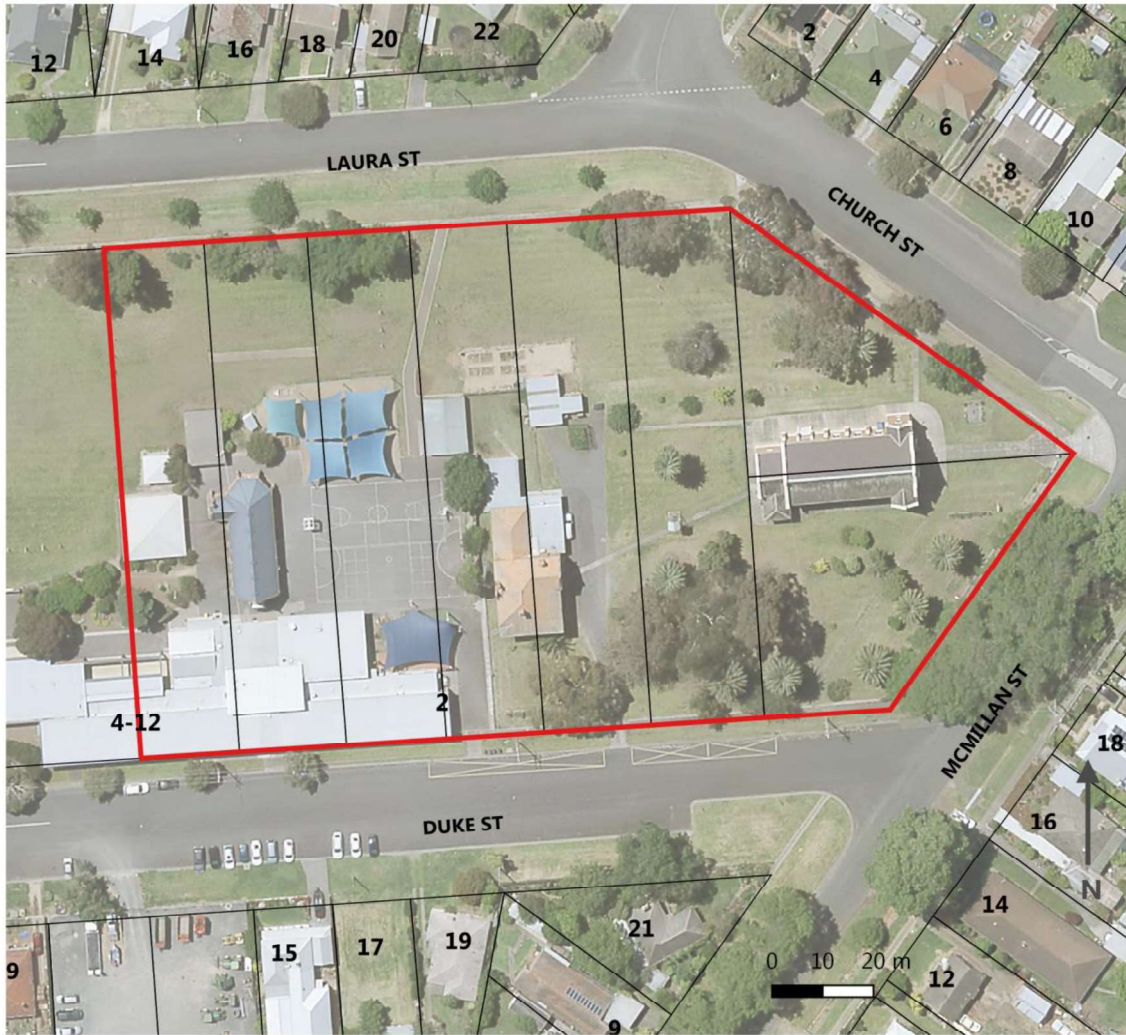
Map of recommended boundary for Heritage Overlay

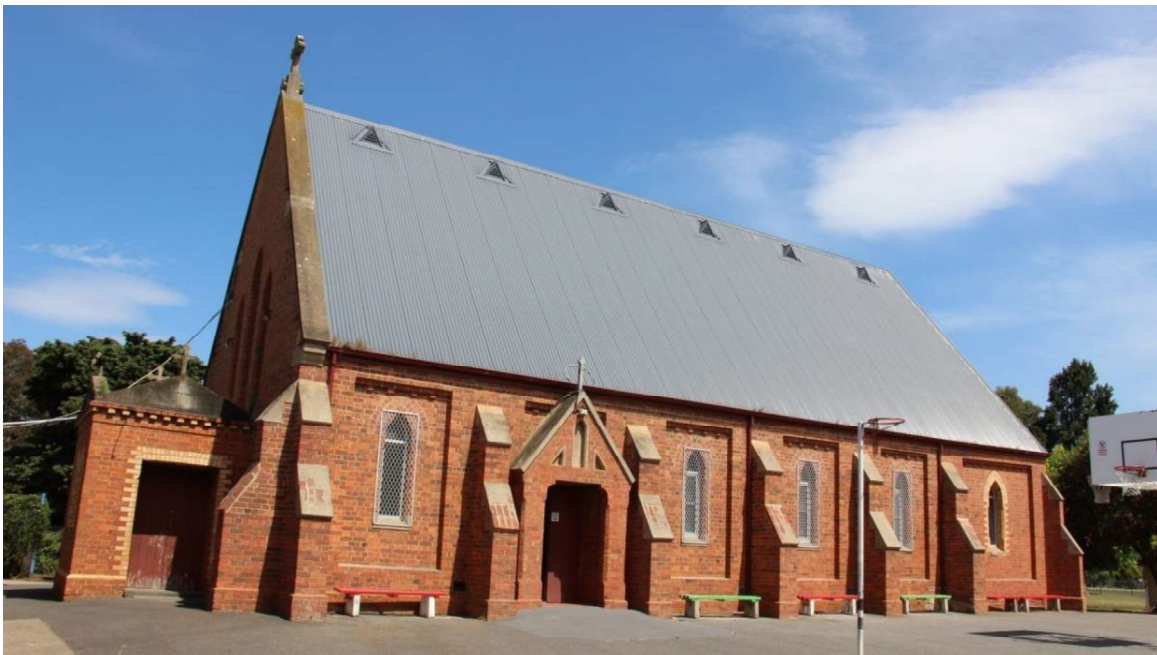
Figure D2. The east elevation. The side elevations are broken into five bays by wide two-tiered buttresses with rendered coping. Each bay has a recessed panel, with corbelled bricks to the top,

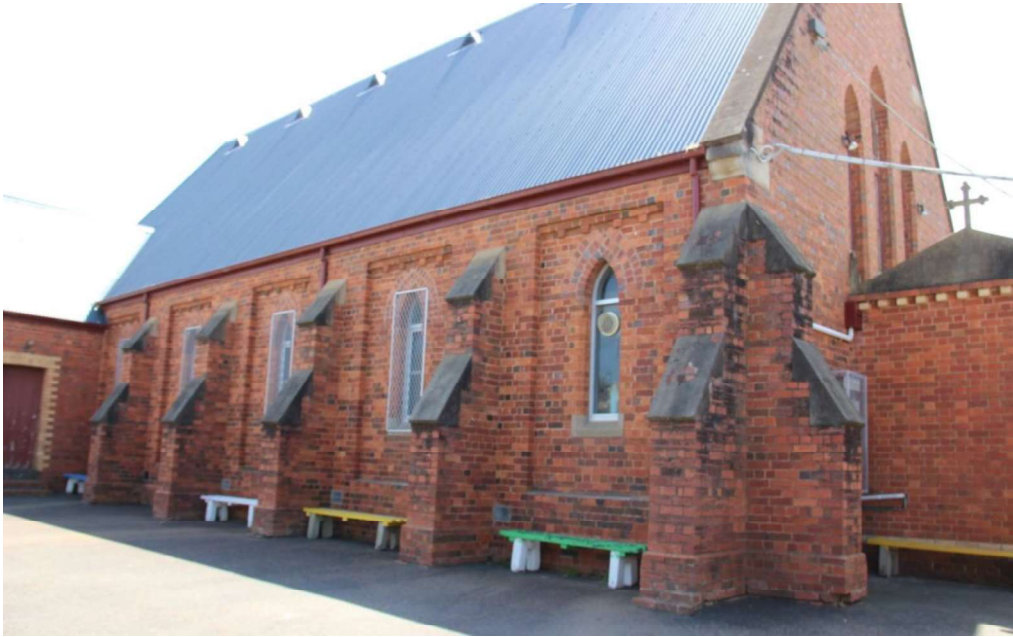
Figure D3. The west elevation. The pointed-arch windows of the side elevations have three rows of radiating brick voussoirs, chamfered bricks to the sides, and a renders sill. All of the windows have been replaced with modern aluminium-framed windows in a sympathetic style, most covered with a modern security grill to protect the windows in the sports grounds that surround the church.

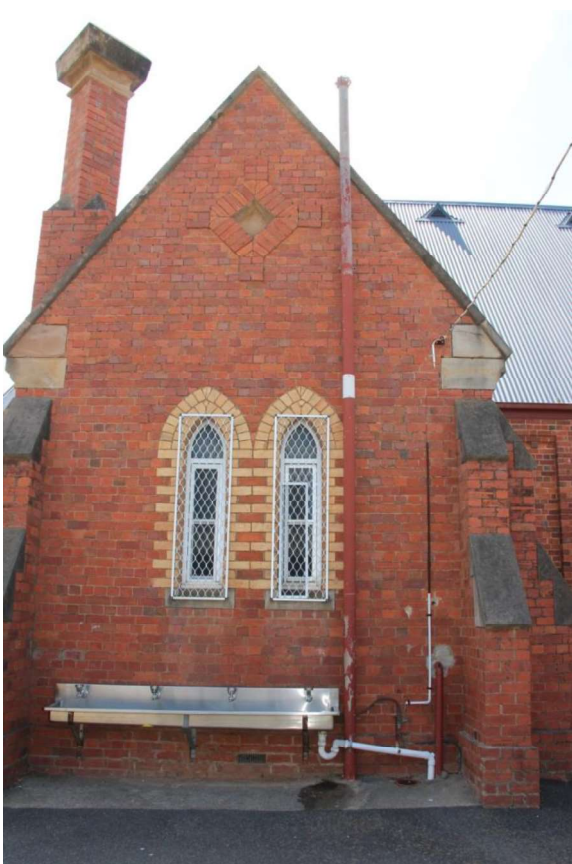
Figure D4. At the rear of the west elevation is a vestry (1893) with a parapeted gable, large chimney (the top half angled) with a wide rendered cap. The west side of the vestry has an

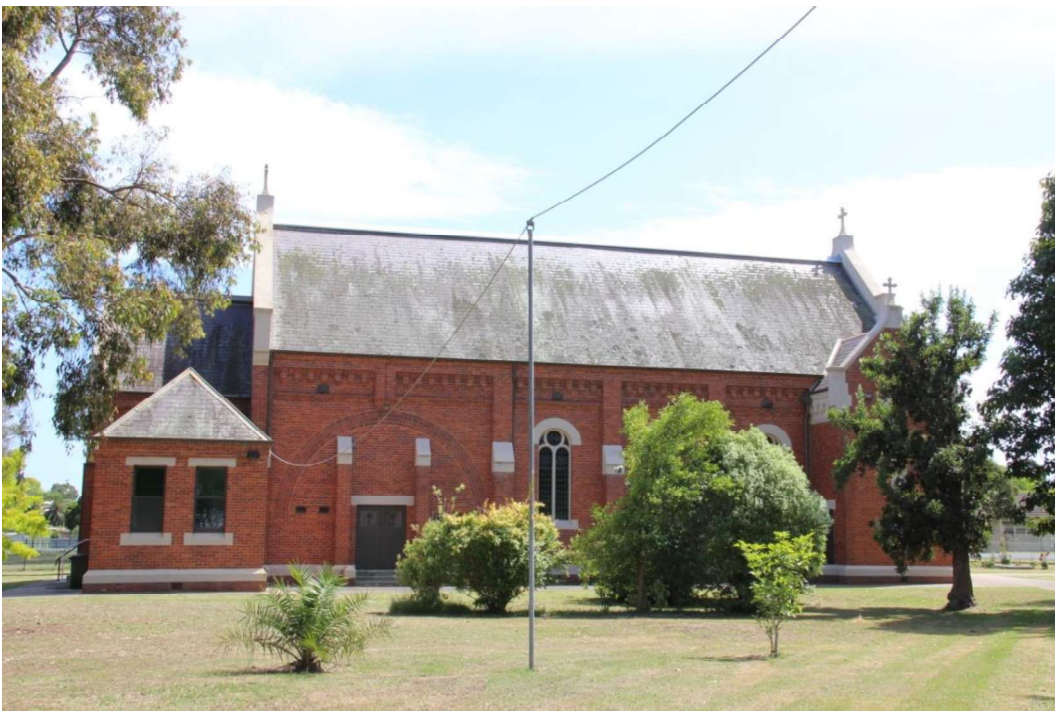
Figure D12. The side elevations comprise the projecting bay behind the facade, followed by four narrow bays broken up by buttresses, and a large (double) bay at the west end. These bays at the west end have brickwork forming a large arch, narrower buttresses and central double timber doors, anticipating the addition of transepts that have not yet eventuated.

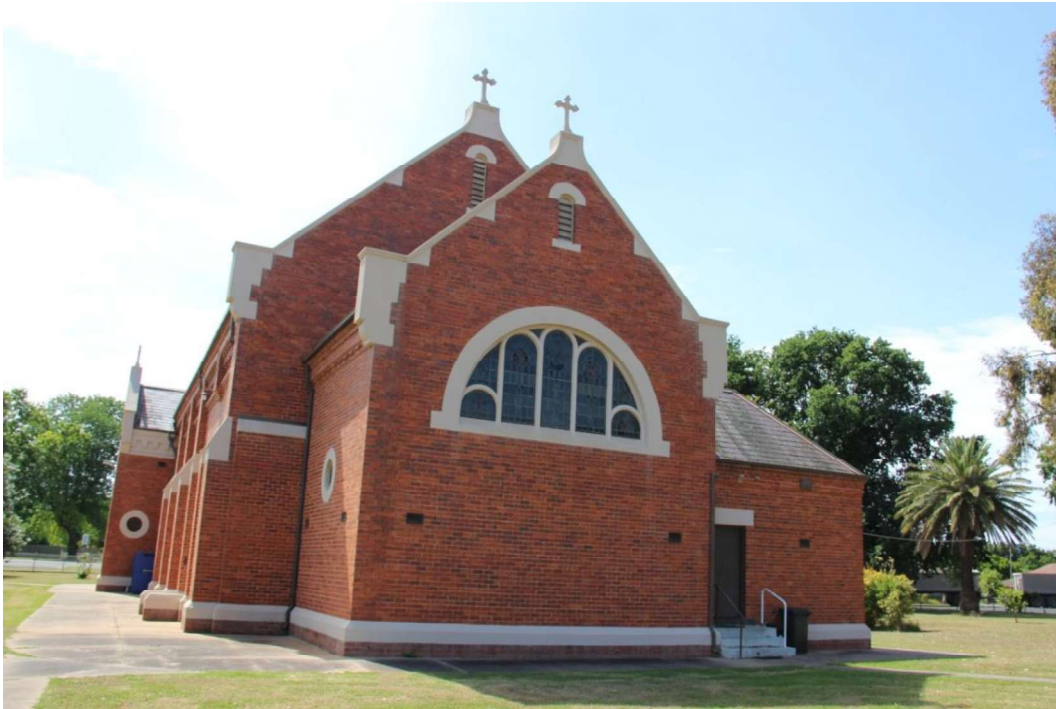
Figure D13. The west (rear) end of the church has a large chancel with a parapeted gable that imitates the details of the elevation behind. Its west face has a large high-set Diocletian window with a five-part window with leadlight. A small hipped-roof vestry projects off the south elevation of the chancel with an entrance off the west side and square-headed windows to the south side (Figure D12).

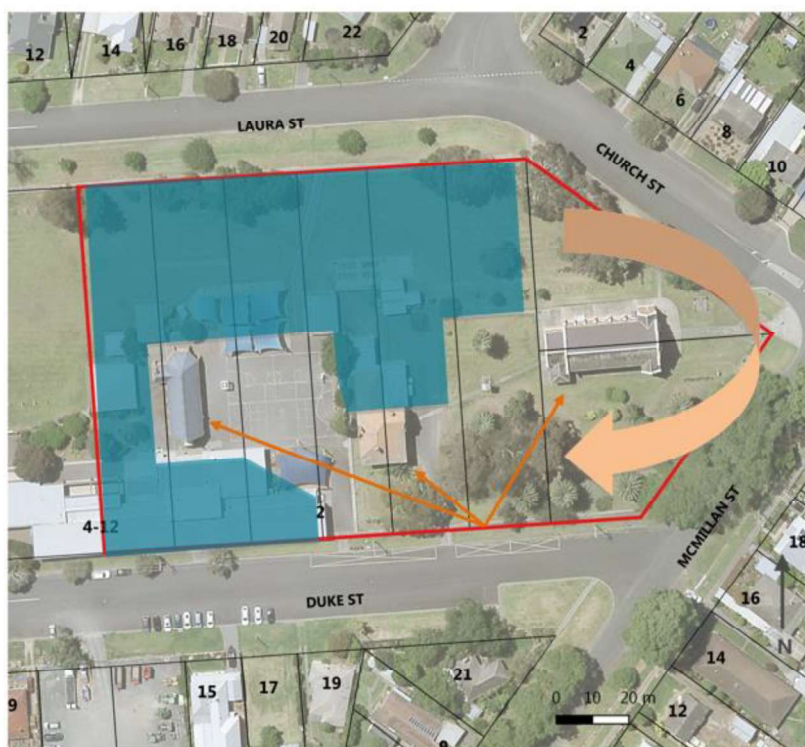
NOTE: The blue shaded area is the preferred location for additions and new development, and the orange arrows illustrate important view lines which need to be retained.
