**Locality:** MAFFRA  
**Place address:** 2 JOHNSON STREET  
**Citation date** 2016  
**Place type (when built):** Hotel  
**Recommended heritage protection:** Local government level  
Local Planning Scheme: Yes  
Vic Heritage Register: No  
Heritage Inventory (Archaeological): No

**Place name:** Macalister Hotel

Project: Wellington Shire Stage 2 Heritage Study  
Client: Wellington Shire Council  
Author: Heritage Intelligence Pty Ltd  
Date: 12/2/16

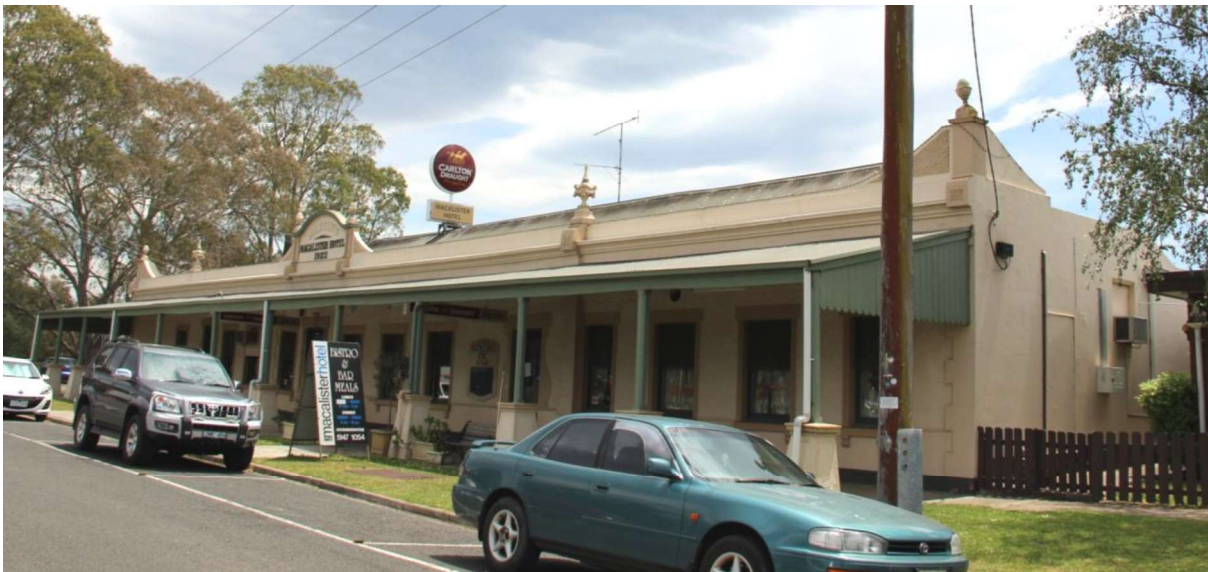
**Figure D1.** The hotel has a long rendered (overpainted) facade (1922), with a parapet that is accentuated at the centre of the facade and at the corners only. A single ornate urn is located on each side of the central parapet, towards the corners. A skillion-profile verandah, with timber cladding to the top of the ends, is supported by timber posts and squat piers.

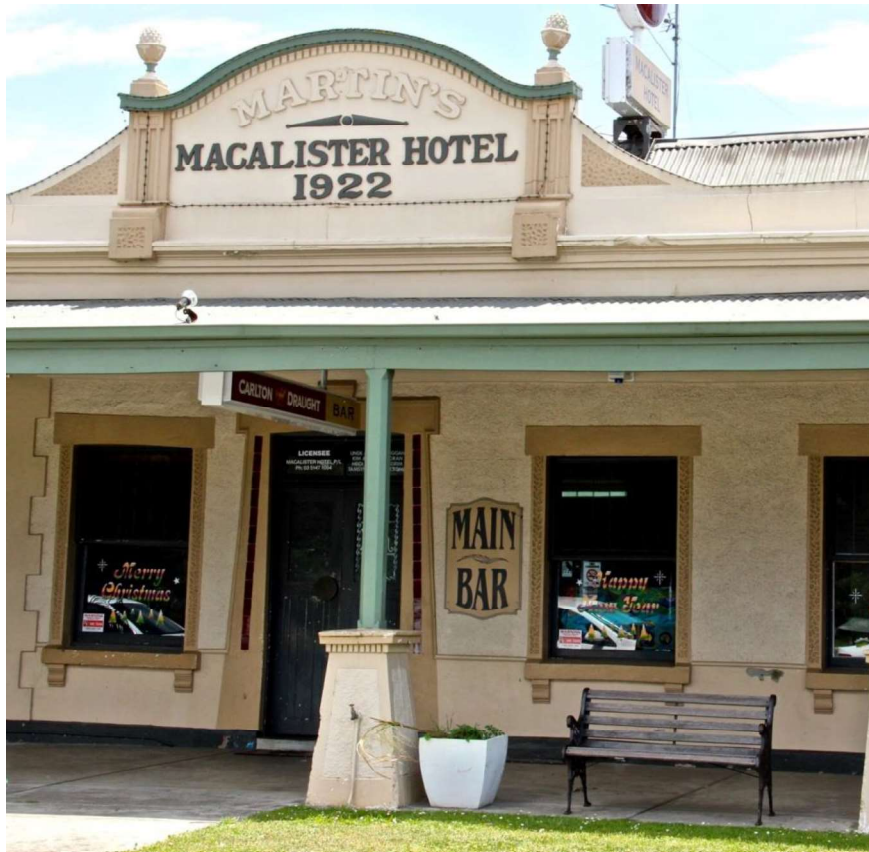
Figure D2. The ornate central parapet read's 'Martin's Macalister Hotel 1922' in relief. Behind the parapet, the gabled-roof of the (possibly c1863) building behind is evident. Beneath the verandah, this join in the building is marked by a vertical band of smooth rendered quoining.

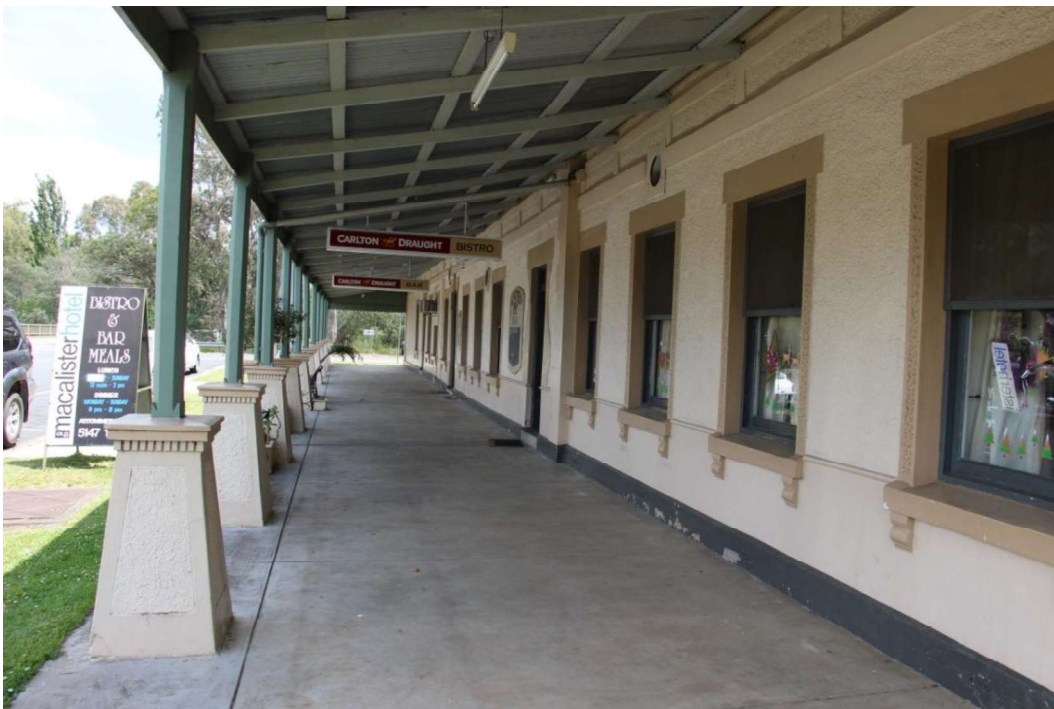
Figure D3. The facade has a rendered plinth at the base. The bottom quarter of the wall has smooth render, while the top section of the wall has rough-cast render. The verandah is supported by stop-chamfered timber posts on large tapered piers (in the shape of a battered pylon, reflecting

the Egyptian style).

- 7.1. There are signs of damp in the walls under the verandah, and above plinth level just above the concrete floor.
- 7.2. Signs of damp include: paint bubbling and peeling off, render falling off, moss growing in the mortar, white (salt) powder or crystals on the brickwork, existing patches with grey cement mortar, the timber floor failing, and lime mortar falling out of the joints. These causes of damp are, in most cases, due to simple drainage problems, lack of correct maintenance, inserting the concrete verandah floor next to the solid masonry walls, ( the original floor would have been timber boards on a timber sub floor frame with air circulating underneath,

to allow the brick walls and footing to evaporate moisture from them. With the concrete floor, the water is sucked up the walls above the floor and starts to evaporate at that point. Other causes including sealing the walls with paint, sub floor ventilation blocked, or the ground level too high on the outside. The concrete floor has blocked most sub floor vents completely, although some have about 20% above the concrete.

- 7.3. Always **remove the source** of the water damage **first** (see more details below). It is recommended to remove of all the concrete floor, lowering the ground level, building a new sub floor structure using concrete stumps and timber or steel sub floor to support timber boards. However, it is also possible to cut back a strip along the length of the building, adjacent to the wall. (See D. Young, "Salt Attack and Rising Damp" for more details.)

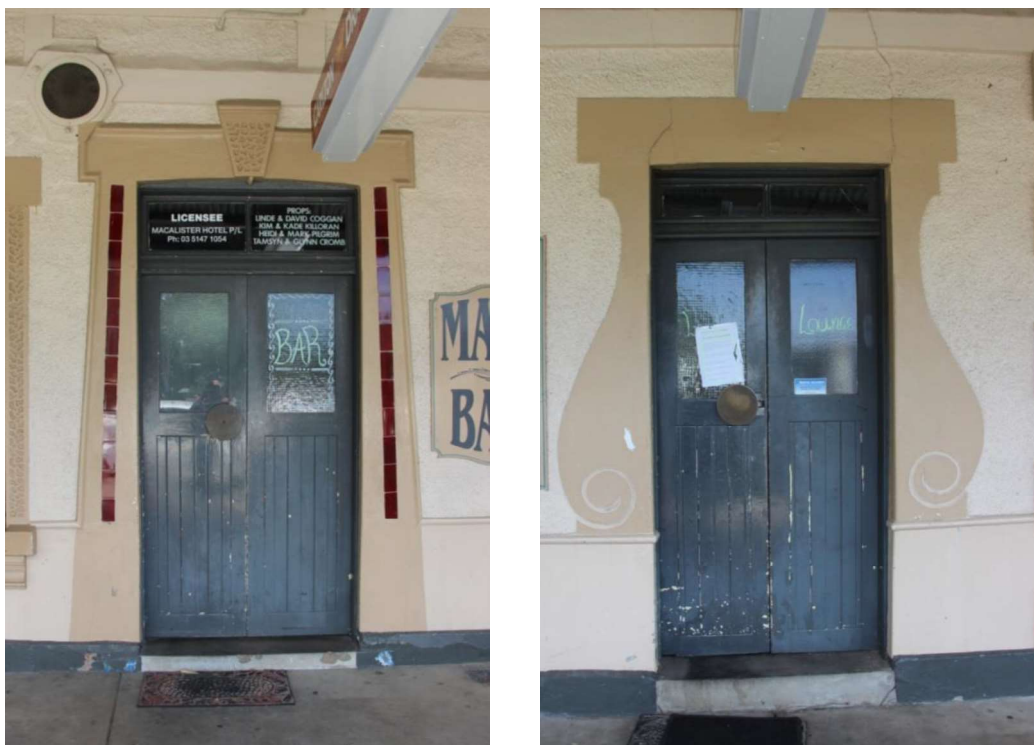
Figure D4. The surrounds to the doors of the facade are varied and elaborate. The main entrance has an Egyptian styled entrance comprising a rendered lintel, a bold keystone with vermiculation and tapered sides with a vertical line of red glazed tiles. Other entrances have a surround with a rendered lintel which extends to the sides in large lobed pattern at the base.

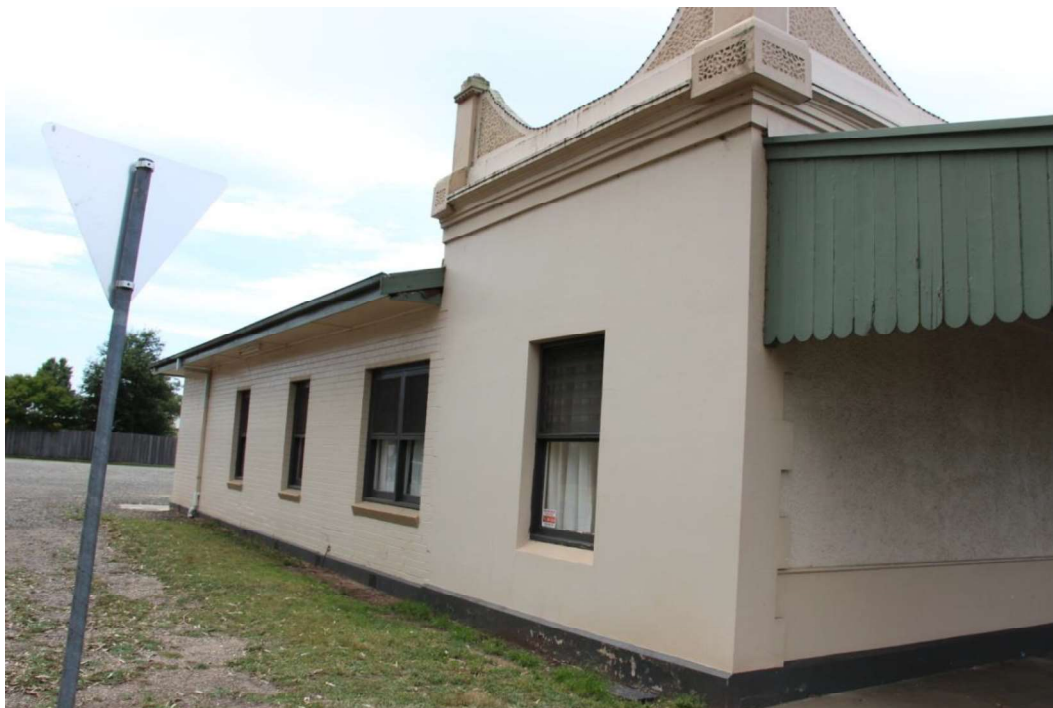
Figure D5. The 1922 facade continues on the west elevation to the width of one bay, where the parapet is again accentuated above. The post-1939 brick addition extends to the north.
