**Place name:** St Andrew's Uniting Church

**Architectural Style:** Federation Romanesque  
**Designer / Architect:** H. W. & F. B. Tompkins  
**Construction Date:** 1904, 1922

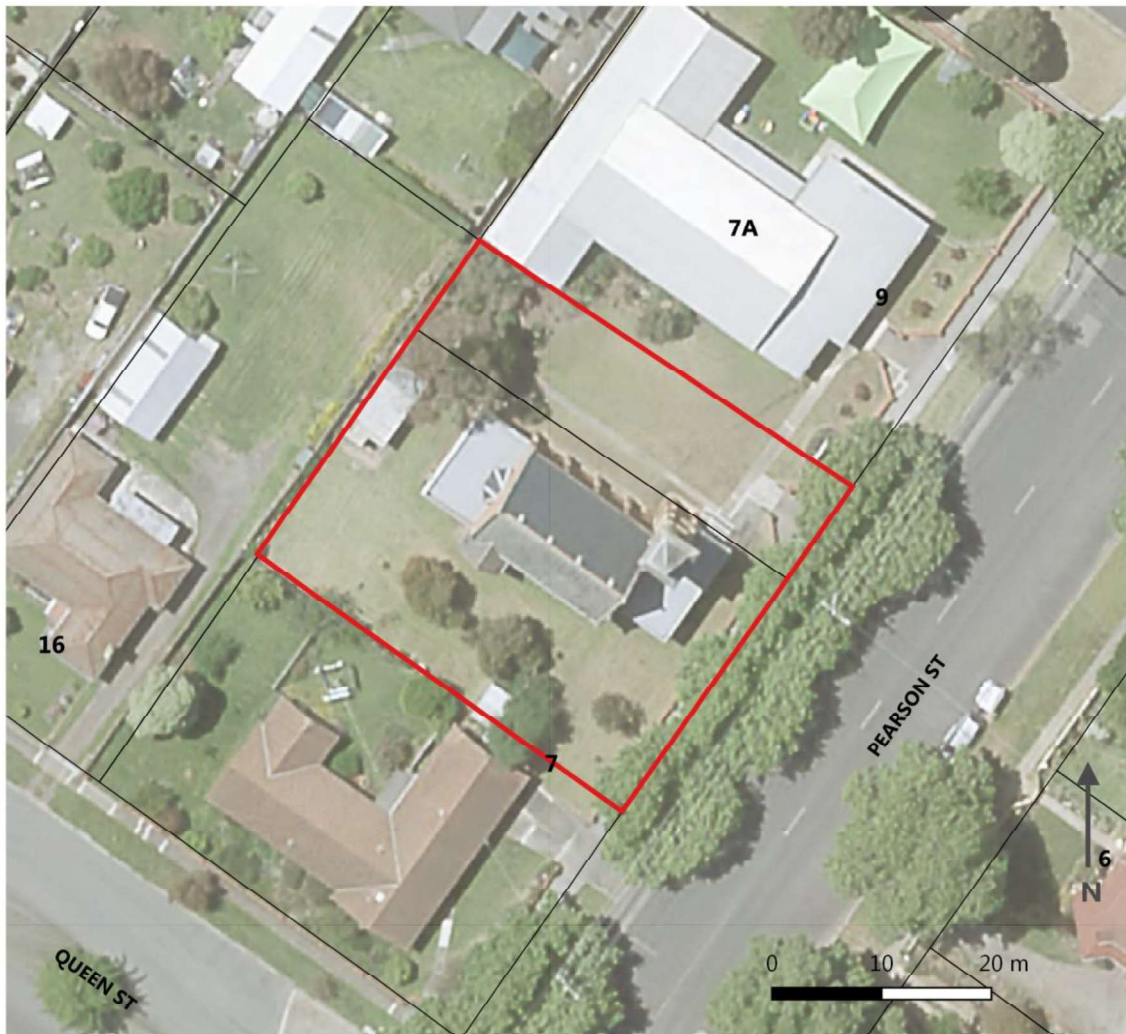
## Map of recommended boundary for Heritage Overlay

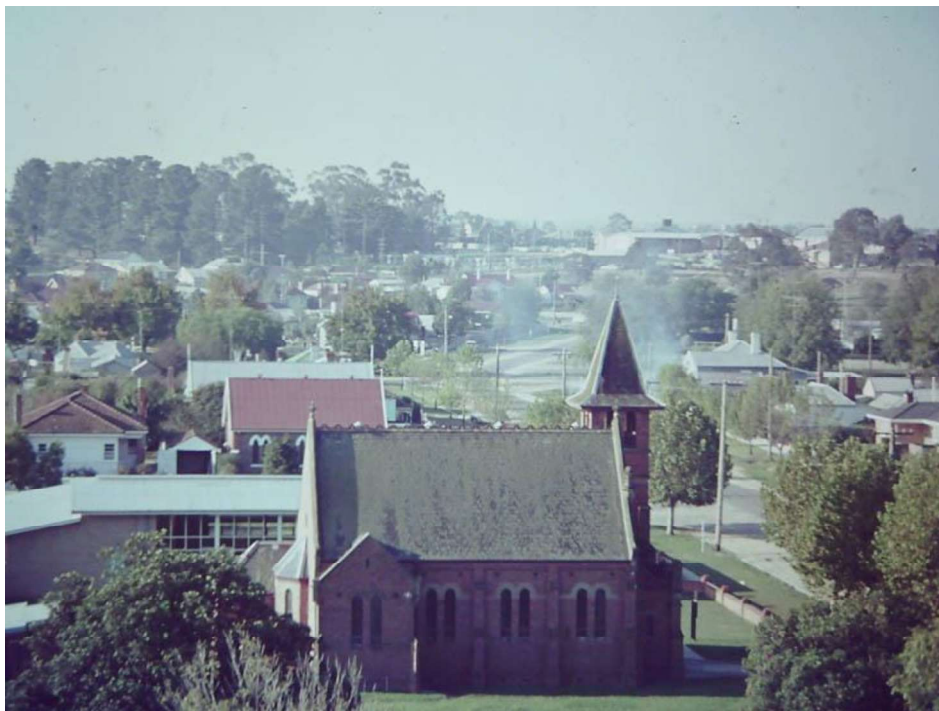
**Figure H4.** A photo dating to the 1970s that shows the south elevation of the church. The rear of the church had a small bay window (the roofline of which is still evident in 2015 above the later addition) and small vestry projecting to the west (remains as part of a later extension). The picket fence has been replaced with the brick one (MDHS, ID. P04962VMFF 1970s).

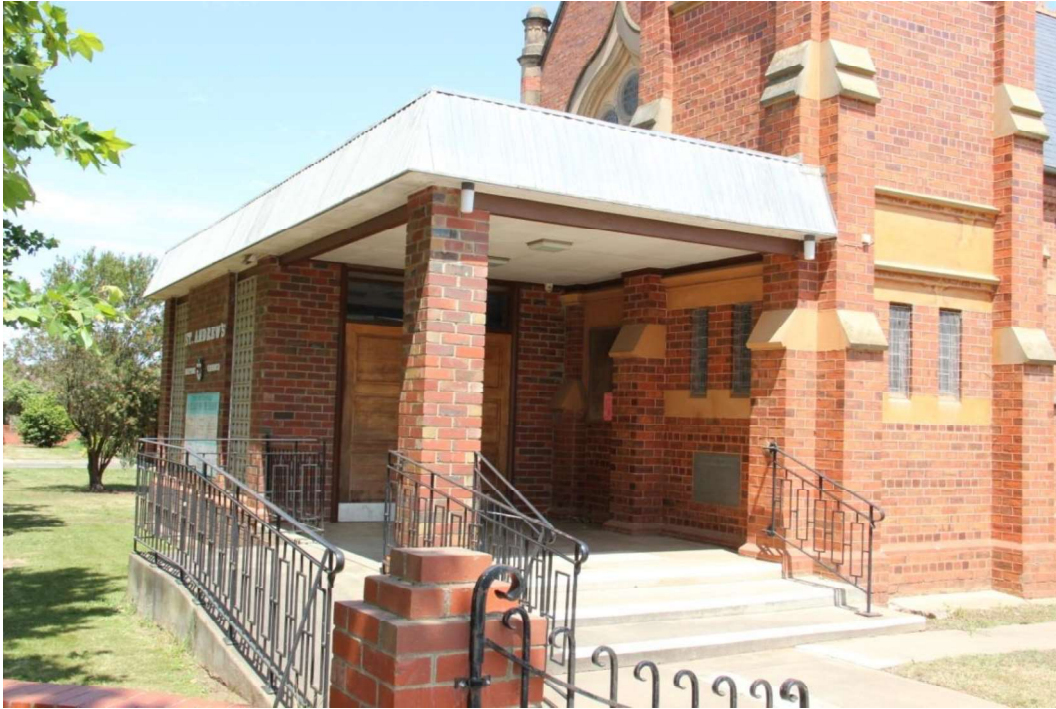
Figure D3. The original entrance porch was removed and replaced with a modern flat-roofed brick entrance porch and foyer, post-1970s. A modern concrete ramp and stairs lead to the entrance with a metal balustrade.

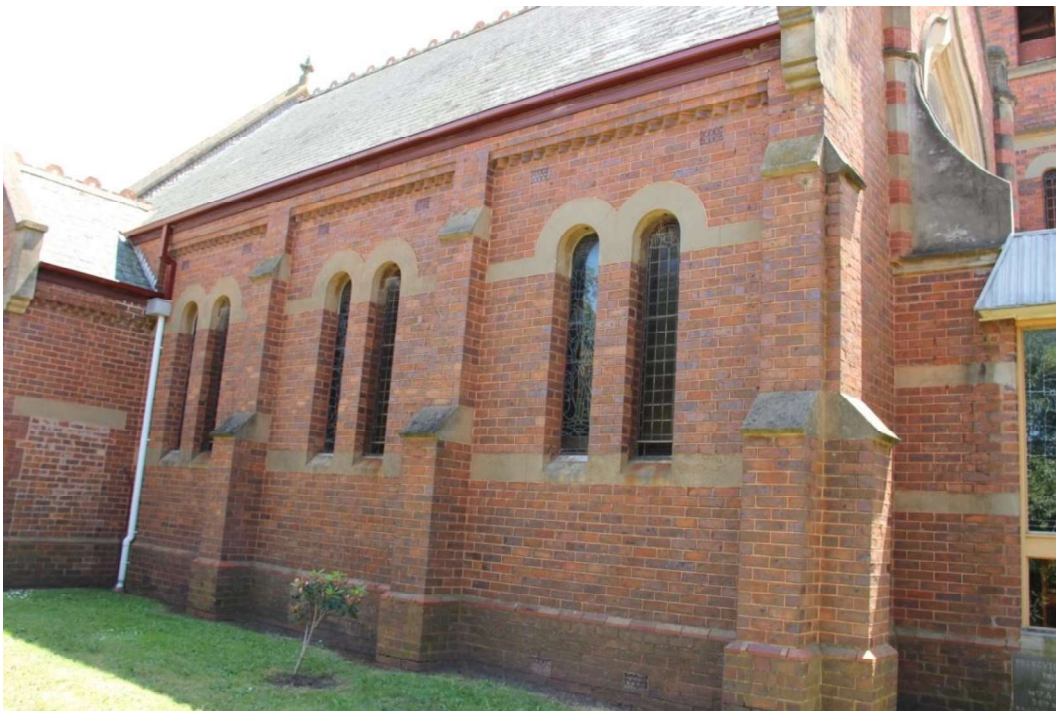
Figure D4. The side elevations are broken into four bays by buttresses with rendered coping. Each bay holds a pair of tall, narrow round-arched windows with (pictorial or geometric) leadlight. Pictured is the south-west elevation, with the vestry to the rear.

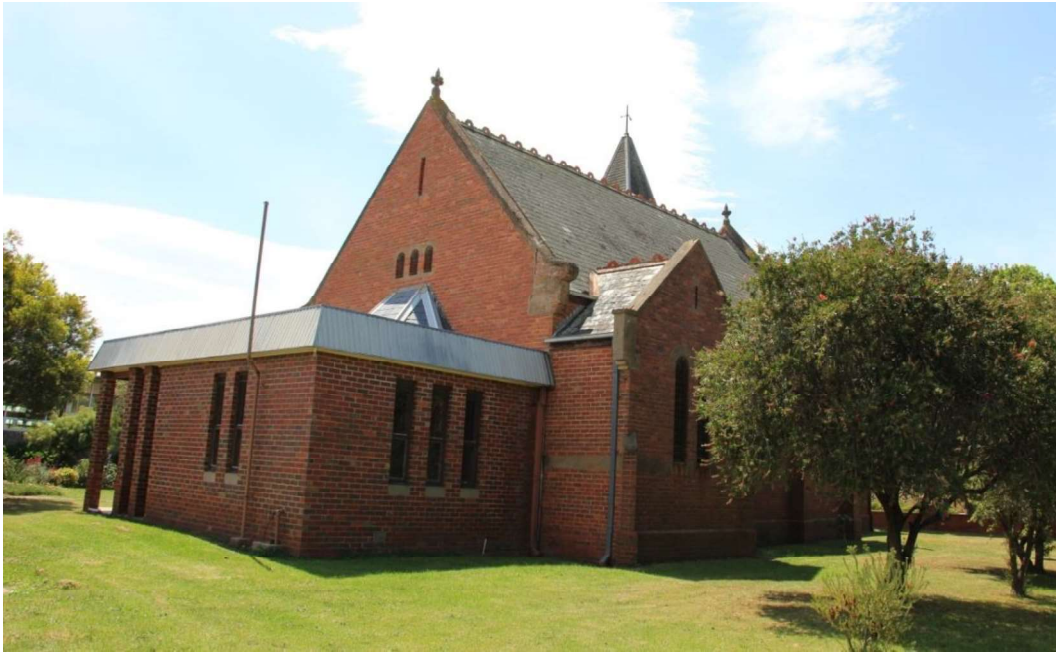
**Figure D5. The rear (north-west) elevation of the church showing part of the roofline of the 1904 bay window, concealed (or removed) by the post-1970s flat-roofed addition. Projecting off the south-west (side) elevation is a small vestry, with the same architectural detail as the 1904 nave.**

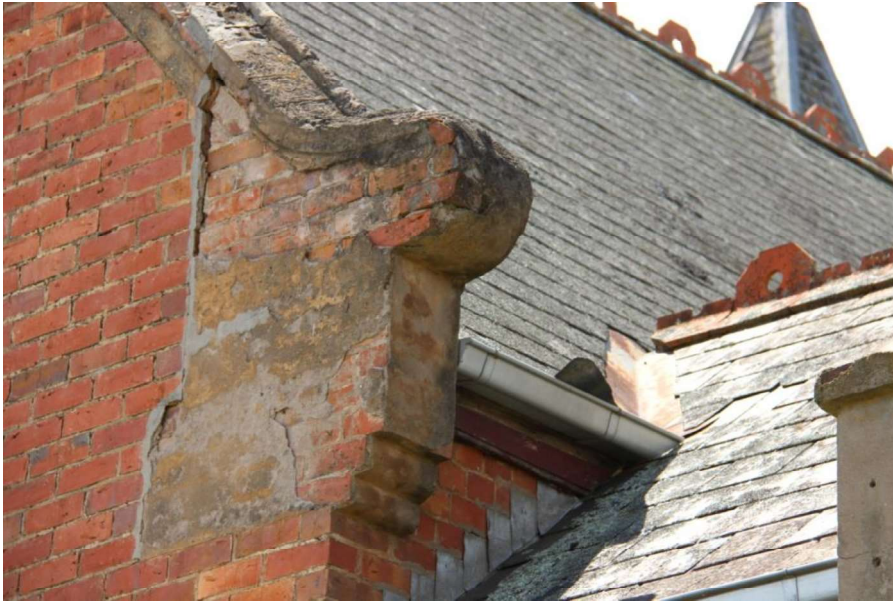
**Figure D7. A detail of the cracking of the parapet coping in the rear gable-end.**
