Locality: STRATFORD
Place address: 20 TYERS STREET
Citation date 2016
Place type (when built): Shop, Bakery, Residence
Recommended heritage protection: Local government level
Local Planning Scheme: Yes
Vic Heritage Register: No
Heritage Inventory (Archaeological): No

Place name: Bakery (former), Shop and Residence

Project: Wellington Shire Stage 2 Heritage Study
Client: Wellington Shire Council
Author: Heritage Intelligence Pty Ltd
Date: 12/2/16

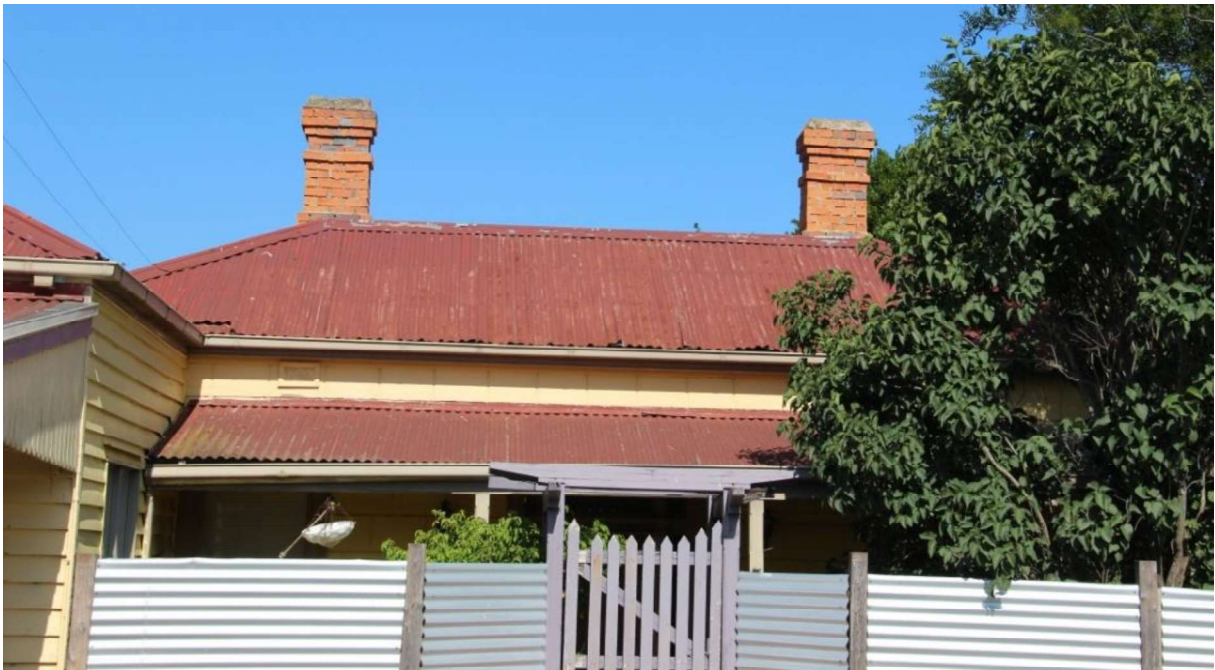
Figure D1 & Aerial. The house has an M-hip roof, clad with corrugated iron (painted to the front and side elevations), and a verandah to the facade which returns on the south elevation. The house retains two corbelled brick (unpainted) chimneys that are constructed (not by a skilled bricklayer) of handmade red bricks. A skillion-roof verandah is clad with corrugated iron (painted), supported by stop-chamfered timber posts. The house is concealed behind a recent tall fence. The facade is clad with timber-ashlar cladding while the remainder of the house is clad with weatherboard. An entrance at the centre of the facade has a door with sidelights and highlights, in the Victorian style.

The late Victorian residence is in fair to good condition and retains a high level of integrity, as visible from the street.

Figure D1. The house has an M-hip roof, clad with corrugated iron, and a verandah to the facade which returns on the south elevation. The house retains two corbelled brick (unpainted) chimneys that are constructed of handmade red bricks. A skillion-roof verandah is clad with corrugated iron (painted), supported by stop-chamfered timber posts.

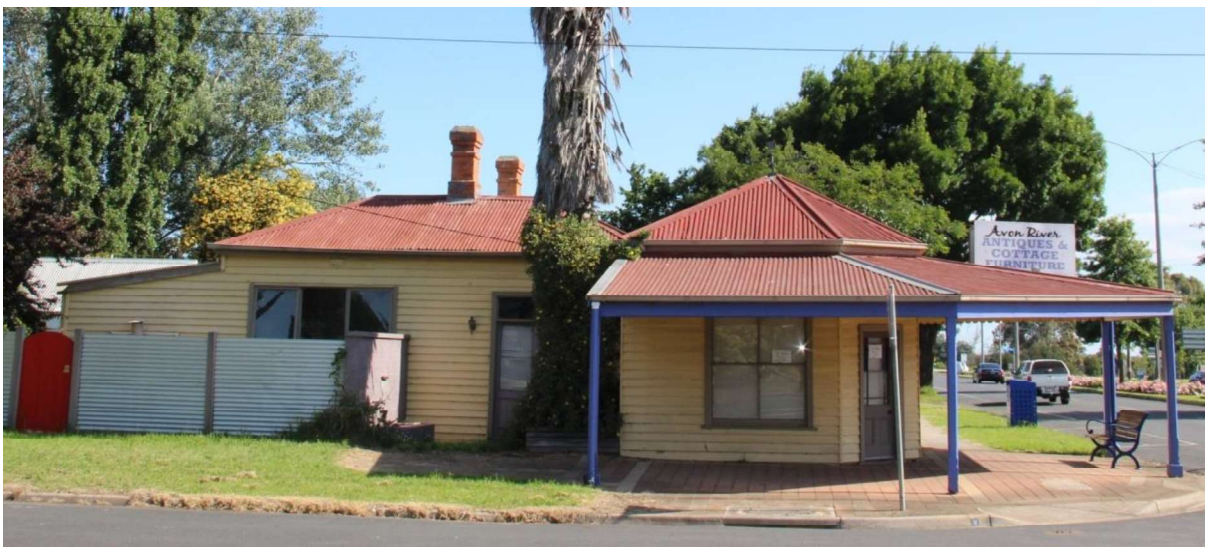
Figure D2. The north elevation has weatherboard cladding and modern timber doors and windows. The weatherboards continue to create a skillion-roof section at the rear (east) of the house.

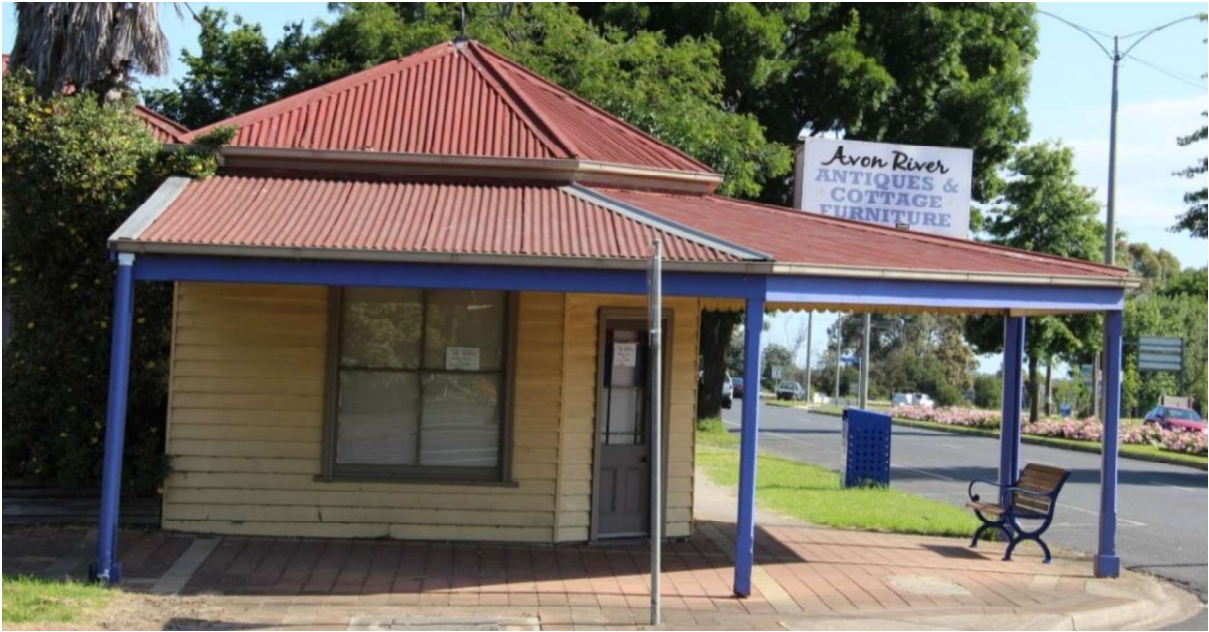
Aerial & Figure D3. The small weatherboard corner shop has a faceted hipped roof clad in corrugated iron (painted). The original wide verandah extends over the pedestrian footpath, is clad

with galvanised corrugated iron, has (recent) round-edged scalloped boarding to the sides, and is supported by shop-chamfered timber posts, some with a timber base. The entrance is located in the chamfered corner with a timber panelled door with panels of glazing to the top 2/3.

The c1890s weatherboard shop is in good condition and retains a high level of integrity.

Figure D3. The small weatherboard corner shop has a faceted hipped roof clad in galvanized corrugated iron (painted). The original wide verandah extends over the pedestrian footpath, is clad with galvanized corrugated iron, has round-edged palings to the sides, and is supported by shop-chamfered timber posts, some with a timber base.

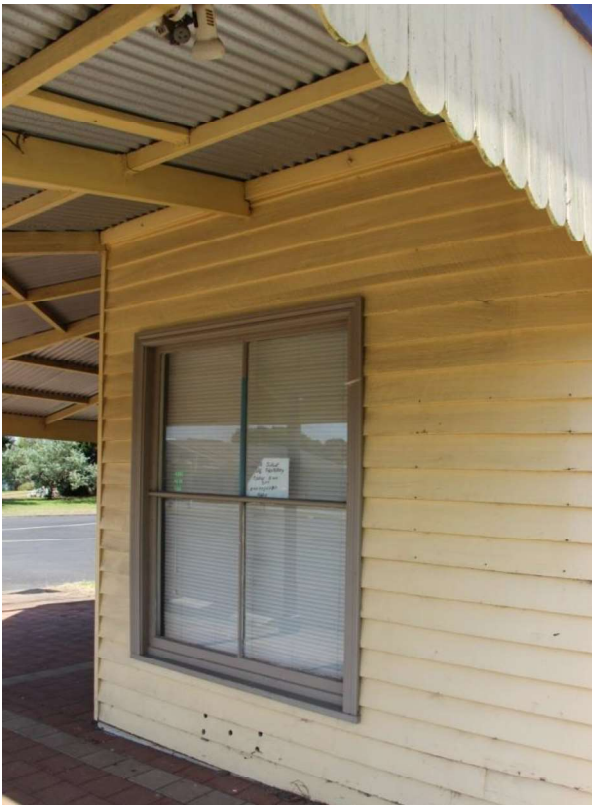
Figure D4. The two main elevations of the shopfront have large timber windows. The south and east elevations also have timber windows.

Figure D4. The two main elevations of the shopfront have large timber windows.

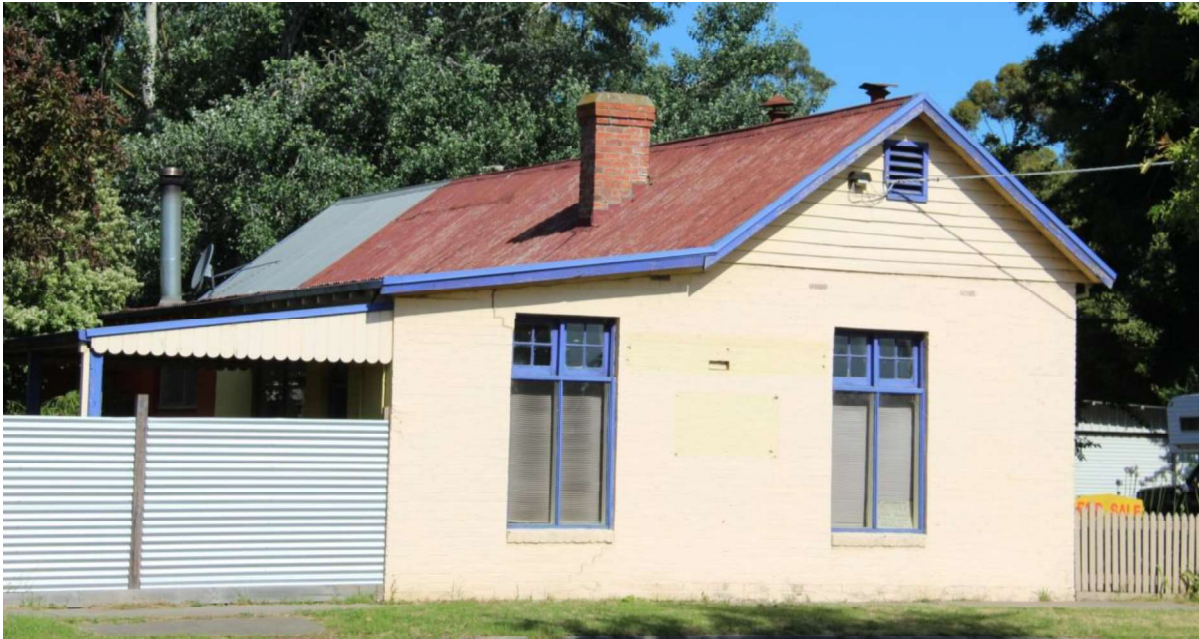
Figure D5, D6 & Aerial. The large brick (overpainted) bakery has a gabled roof clad in galvanised corrugated iron (painted) with round vents (c1900) to the roof, a corbelled brick chimney (unpainted) and exposed rafter ends to the eaves. The gabled end to Tyers Street is clad with weatherboards, with a rectangular vent. Off the north elevation is a skillion-roof section with exposed rafter ends and brick cladding at the east side. Off this extends a lower (recent) skillion-roof verandah with round-edged scalloped boarding, to the Tyers Street elevation, supported by stop-chamfered timber posts.

The north elevation (underneath the verandah) has a timber door with panels of glazing to the top, and a three-pane highlight (with vertical glazing bars). This elevation also has large timber windows.

The c1900 bakery is in good condition and retains a moderate level of integrity.

Figure D5. The north elevation of the bakery, and the east elevation fronting Tyers Street. The large brick (overpainted) bakery has a gabled roof clad in galvanized corrugated iron (painted) with round vents (c1900) to the roof, a corbelled brick chimney (unpainted) and exposed rafter ends to the eaves. The gabled end to Tyers Street is clad with weatherboards, with a rectangular vent. The lower skillion with the scalloped boarding is recent. The windows may date from c1900, but may be second hand windows inserted into this wall when the building ceased being used as a bakery.

4.2.3. Paint removal: It is strongly recommended that the paint be removed chemically from the bakery (never sand, water or soda blast the building as this will permanently damage the bricks, mortar and render. Never seal the bricks or render as that will create perpetual damp problems). Removal of the paint will not only restore the elegance of the architecture, but it will remove the ongoing costs of repainting it every 10 or so years.

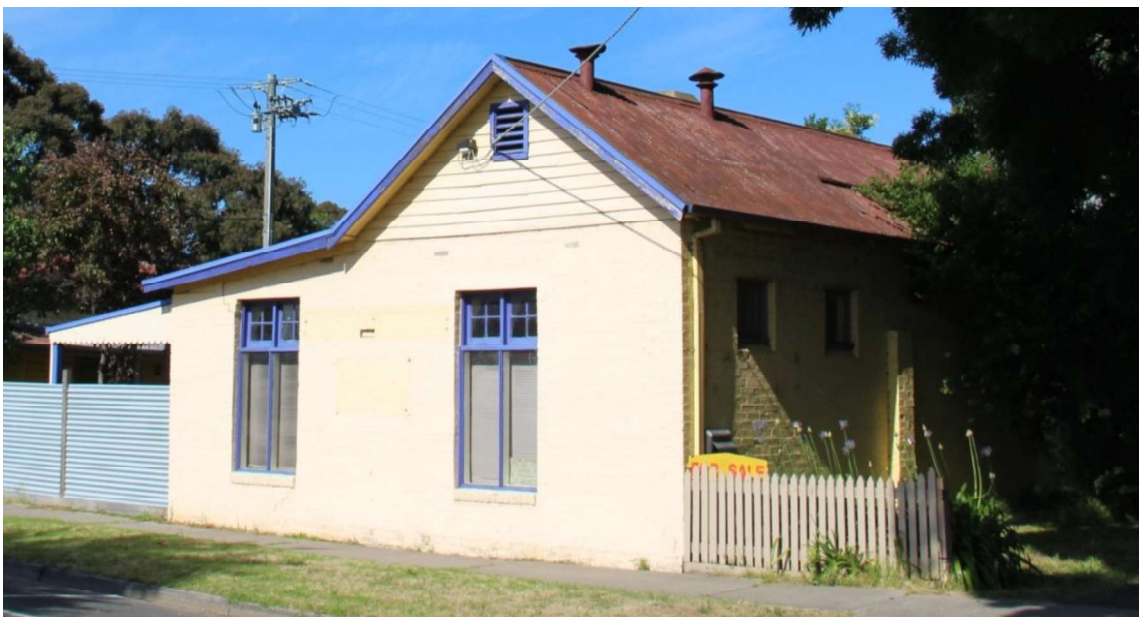
Figure D6. The east elevation has two pairs of tall timber windows with a four-paned window to the top quarter, with brick sills and rendered (overpainted) lintels. These windows may date from c1900, but it is unlikely that they were located on this wall whilst the building was used as a bakery. They may be second hand windows inserted into this wall when the building ceased being used as a bakery (to be confirmed). The south elevation has small windows (one retains a four-paned window), also with brick sills and rendered lintels. The south elevation has an (one visible) engaged brick pilaster, which probably reinforced the building at the location of the oven, to hold the weight of the sand which insulated it.

Figure D6. The east end of the bakery and to the right is the south elevation. The east elevation has two pairs of tall timber windows with a four-paned window to the top quarter, with brick sills and rendered (overpainted) lintels. These windows may date from c1900, but it is unlikely that they were located on this wall whilst the building was being used as a bakery. They may be second hand windows inserted into this wall when the building ceased being used as a bakery. The south elevation has small windows (one retains a four-paned window), also with brick sills and rendered lintels.
