Place name: Carter's Corner and Residence

Architectural Style: Victorian Italianate
Designer / Architect: Not known
Construction Date: 1889

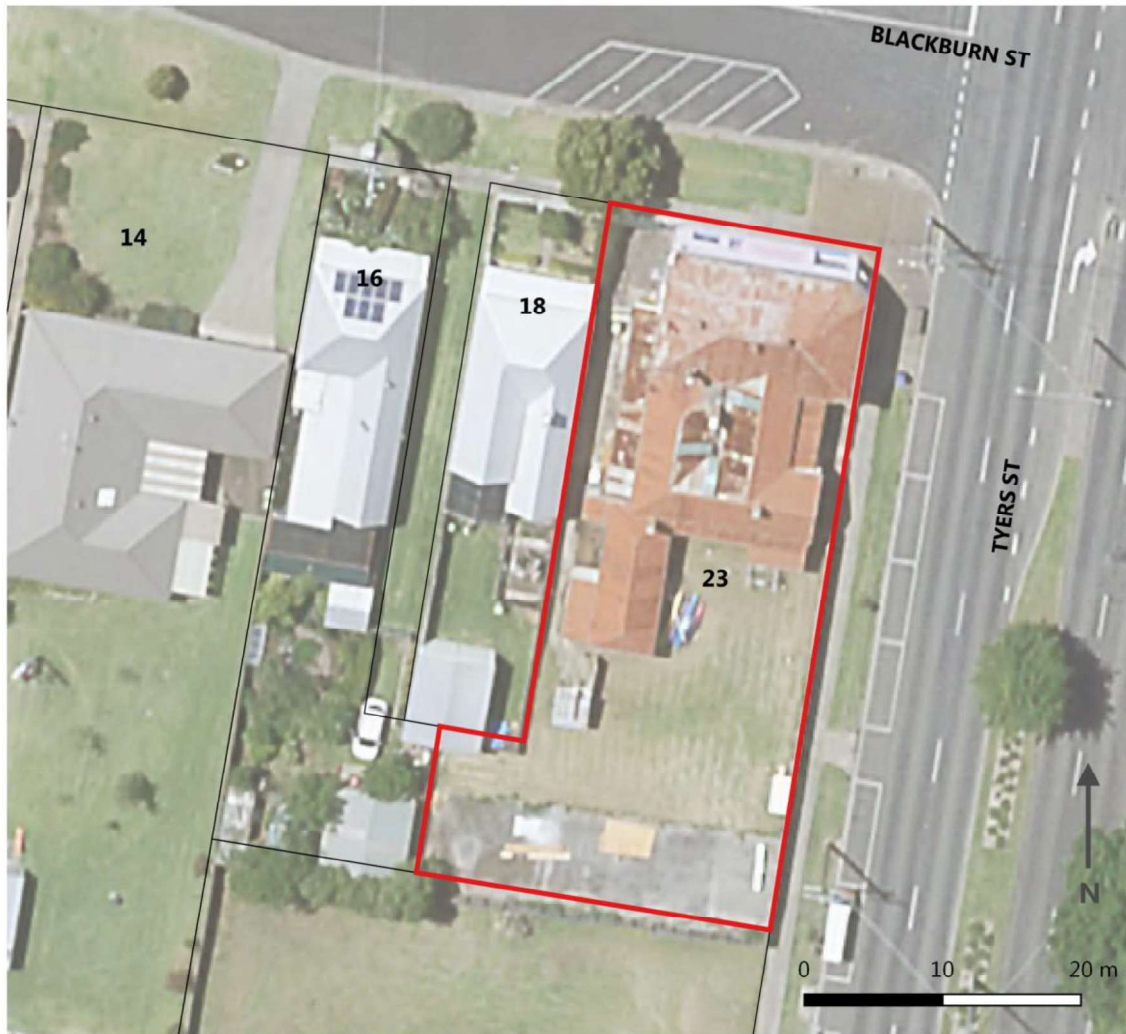
Map of recommended boundary for Heritage Overlay

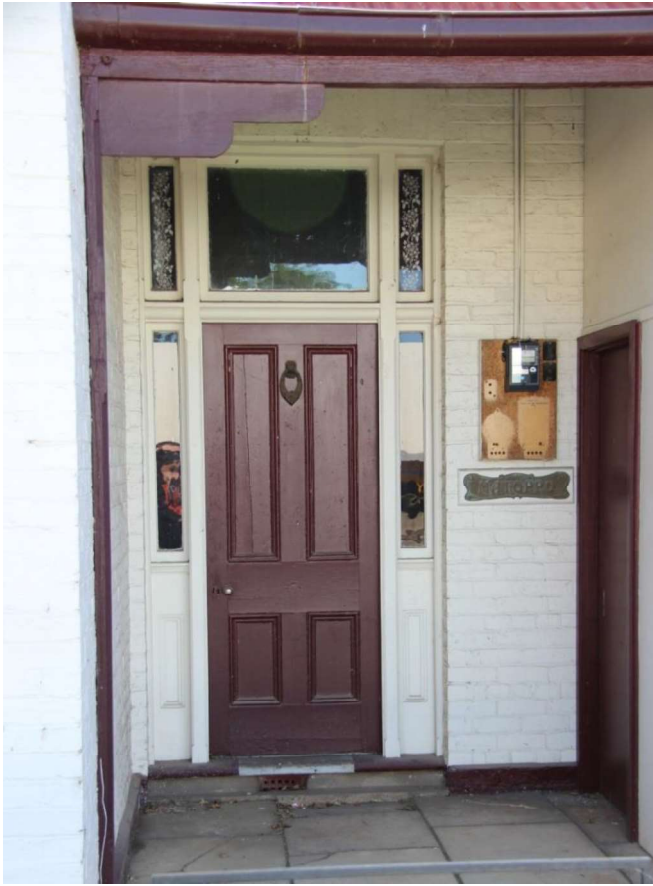
Figure D3. The Victorian entrance has a timber panelled door with sidelights above timber panels, and highlights with stained glass; above are radiating brick voussoirs. The bricks have been painted.

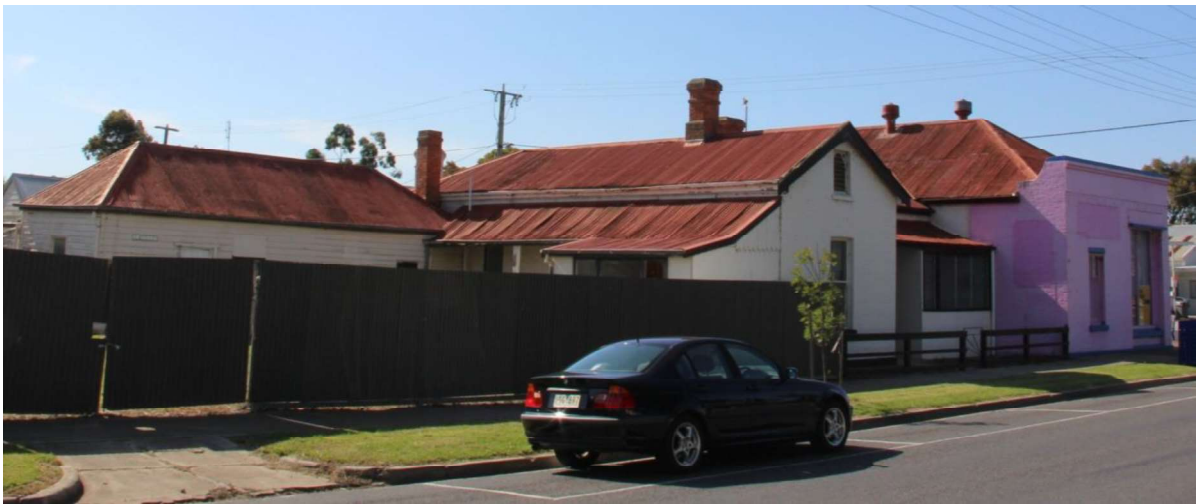
Figure D4. View showing the significant shop, residence and early large hipped-roof outbuilding. Off the south elevation of the house is a skillion-roof verandah clad in galvanised corrugated iron.

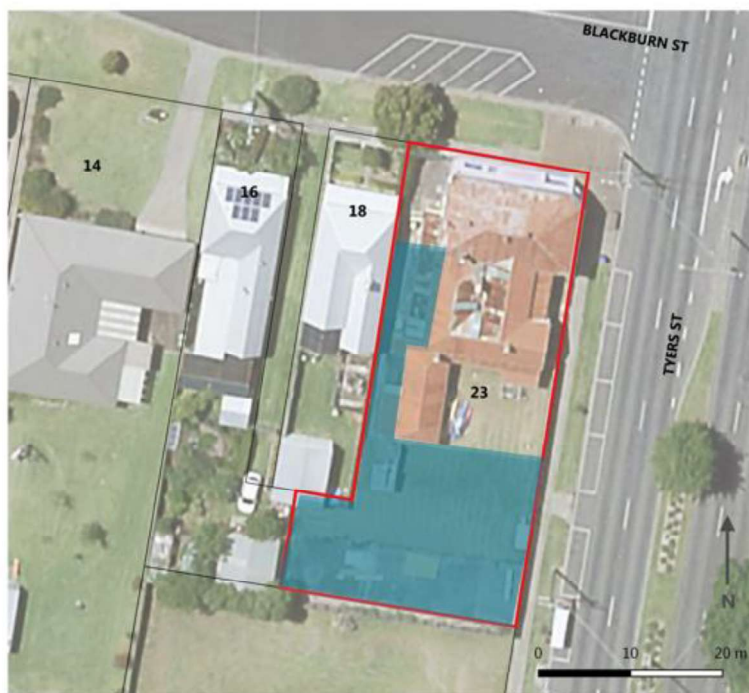
NOTE: The blue shaded area is the preferred location for additions and new development
