Locality: STRATFORD
Place address: 58 TYERS STREET
Citation date 2016
Place type (when built): Bank
Recommended heritage protection: Local government level
Local Planning Scheme: Yes

Vic Heritage Register: No
Heritage Inventory (Archaeological): No

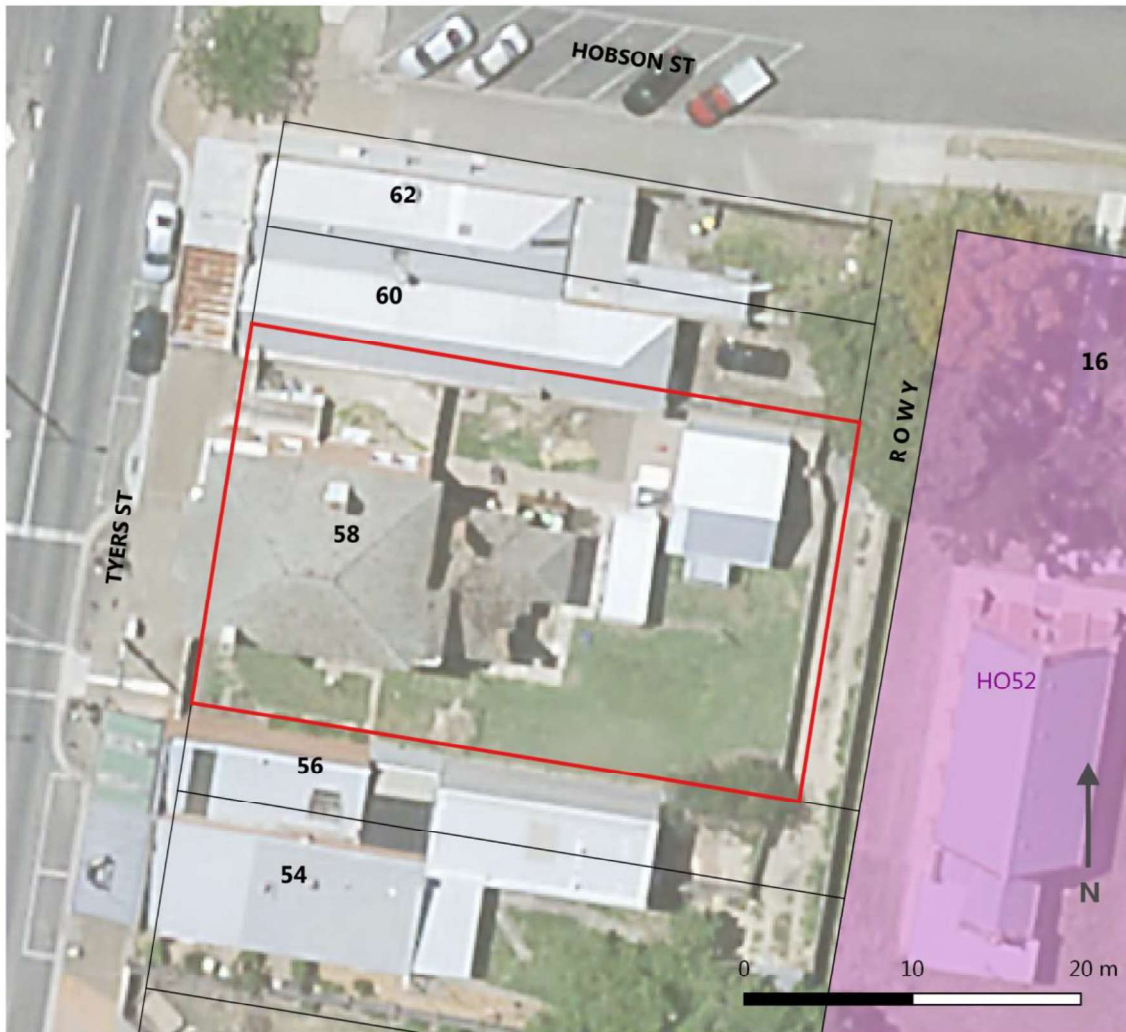
Map of recommended boundary for Heritage Overlay

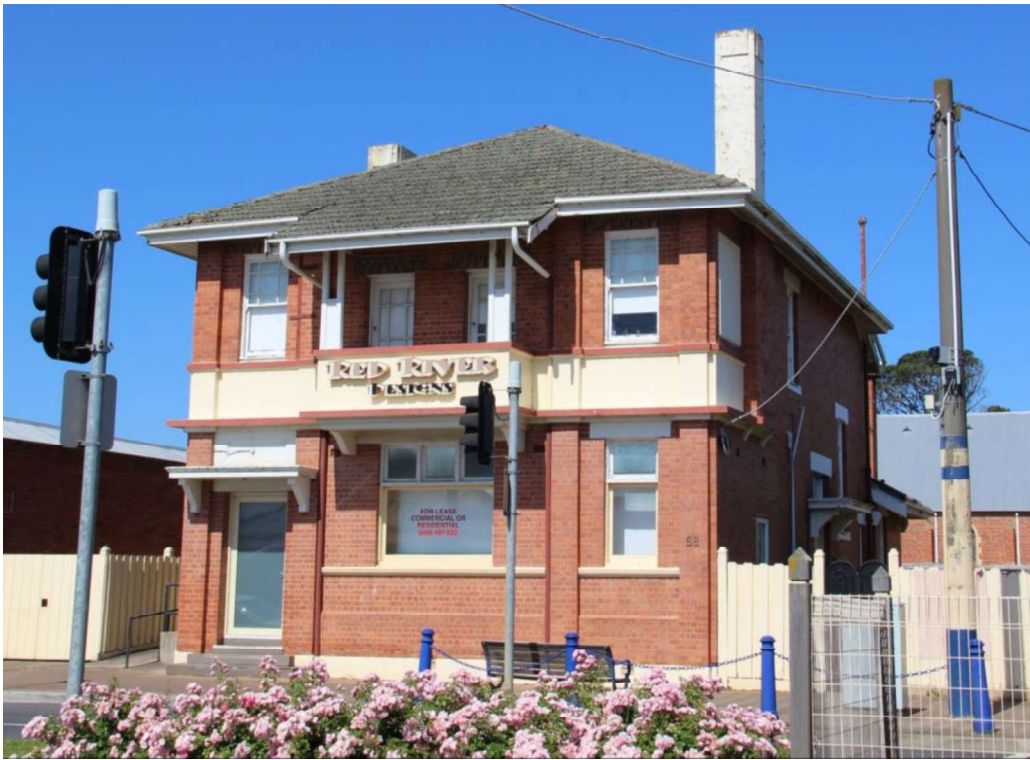
Figure D1. The facade (east elevation) with its low-pitched hipped roof, continuing over the projecting balcony to the first floor.

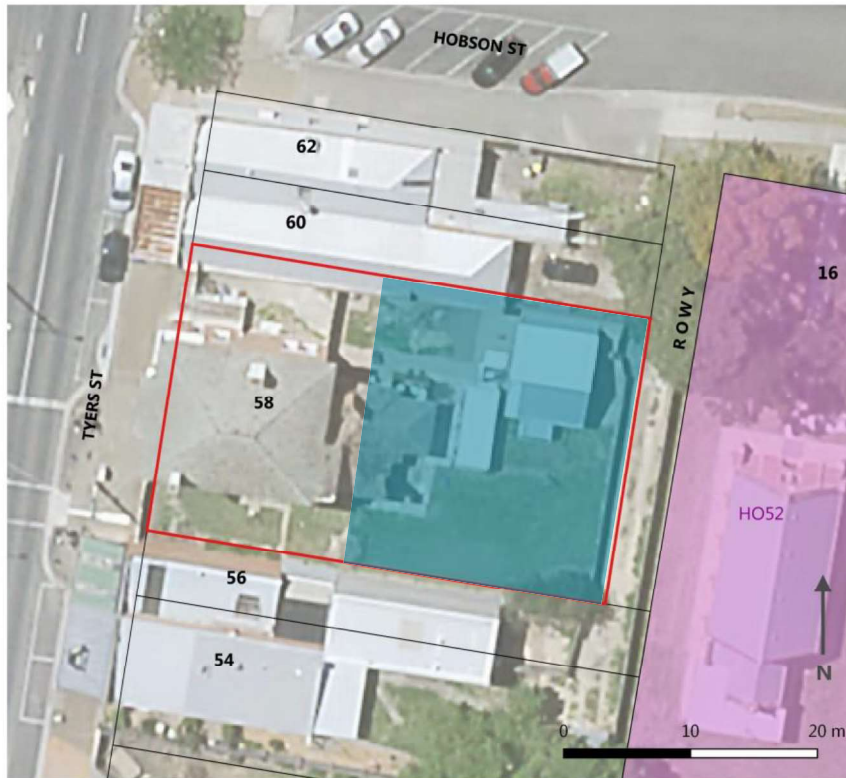
NOTE. The blue shaded area is the preferred location for additions and new development
