Locality: YARRAM
Place address: 95-99 COMMERCIAL RD
Citation date 2016
Place type (when built): Church
Recommended heritage protection: Local government level
Local Planning Scheme: Yes
Vic Heritage Register: No
Heritage Inventory (Archaeological): No

Place name: Holy Trinity Anglican Memorial Church & Memorials

Project: Wellington Shire Stage 2 Heritage Study
Client: Wellington Shire Council
Author: Heritage Intelligence Pty Ltd
Date: 12/2/16

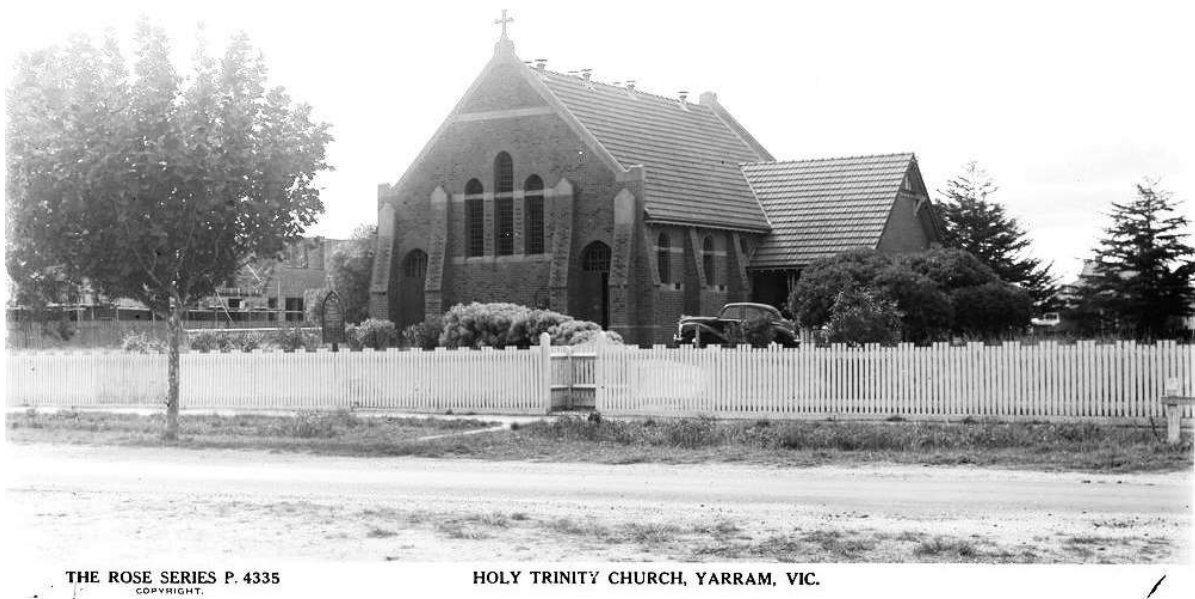
A photo dating between c1920 and 1954 (Figure H1) showed the church before the modern narthex was added to the facade (SLV). The facade comprised the three central windows flanked by buttresses to either side. Between each pair of buttresses on either side, were entrance doors with highlights. The south elevation of the church appeared as it does in 2015 (except for the modern concrete ramp), with the large gabled-roof south porch. A timber flat topped picket fence ran long the west boundary with pedestrian access visible to the south of the church. The grounds were landscaped at this date.

Figure H1. A photo dating between c1920 and 1954 showing the church before the modern narthex was added to the facade. The gabled-roof porch projected from the south elevation (SLV, Rose series ; P. 4335.).

- 4.1. Demolish the non significant narthex and:
 - 4.1.1. restore the front elevation and original position of the Foundation Stone.
 - 4.1.2. Regild the gold leaf lettering on the Foundation Stone.
- 4.2. When the square spouting and downpipes need replacing:
 - 4.2.1. Use galvanised spouting, down pipes and rain heads.
 - 4.2.2. Don't use Zinalume or Colorbond.
 - 4.2.3. Use Ogee profile spouting, and round diameter down pipes.
- 4.3. Fences
 - 4.3.1. Reconstruct the flat topped timber picket fence shown in Fig H1.

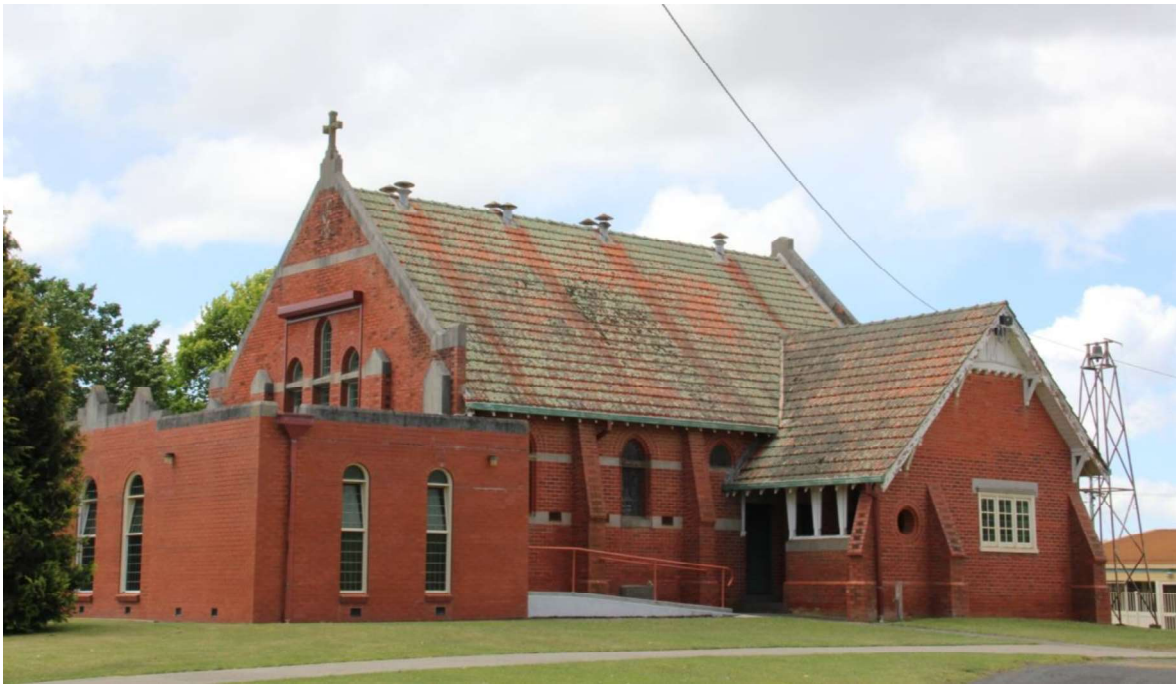
Figure D1. The church is constructed of expertly tuck pointed red brick, with a tall brick plinth, a steeply-pitched roof clad in terracotta tiles (with lichen) and rendered parapeted gables. Original round metal vents are located along the ridge of the roof. The wide eaves have exposed rafter ends.

The gabled end of the 1918 facade has three tall (slightly) pointed-arch windows to the centre, with geometric leadlight. Four buttresses, with decorative render, are visible.

A modern single-storey flat-roofed narthex, built in red brick, has been added to the facade of the building. The addition has attempted to be sympathetic in design but is ultimately intrusive to the 1918 building and is not significant. A modern retractable blind has been added to the three windows to the facade of the 1918 church. A modern concrete ramp provides access to the narthex.

Figure D1. The church is constructed of tuck pointed red brick, with a tall brick plinth, a steeply-pitched roof clad in terracotta tiles (with lichen) and rendered parapeted gables. Round metal vents are located along the ridge of the roof. At the rear of the southern elevation is a large gabled-roof porch, built in 1918. A modern single-storey flat-roofed narthex has been added to the facade of the building.

6.3.4. Do not attempt to clean the lichen off the terra cotta tiles. The lichen is doing no harm, but removing it usually does damage the tiles, the lichen is attached with a root system, and when the lichen is removed, parts of the tile surfaces is also removed and left pitted with crevices, which in turn makes it less waterproof, and the crevices collect dirt and the lichen regrows again.

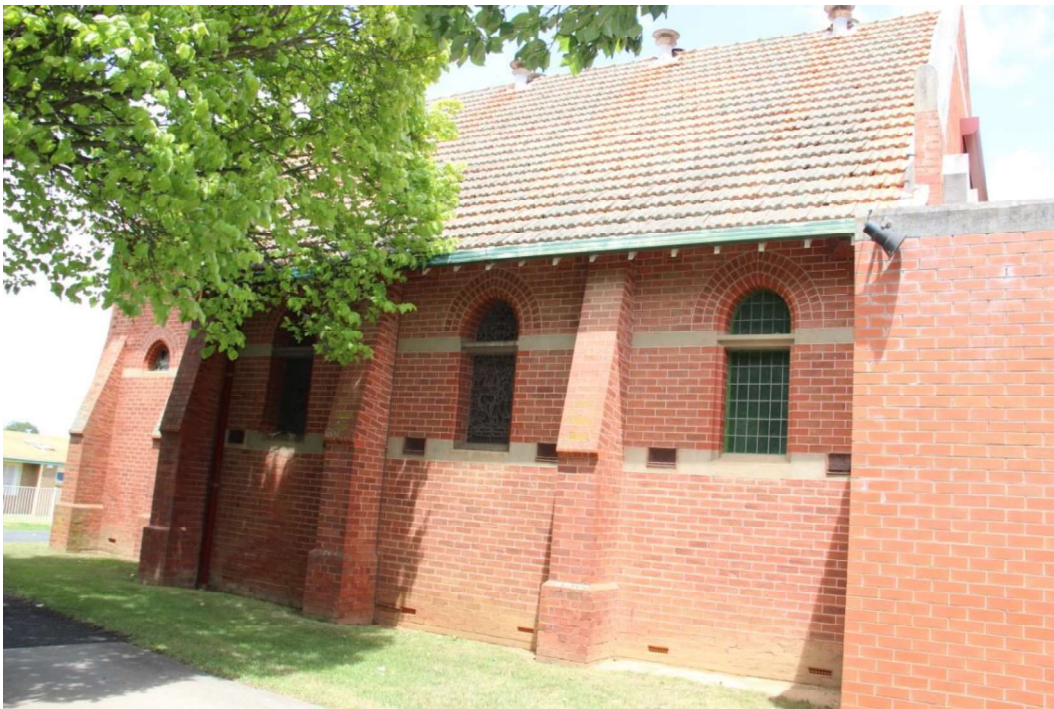
The north elevation comprises three main bays, with windows with geometric leadlight or stained glass memorial windows. To the rear of the church is a bay with shorter eaves, two smaller buttresses and two small windows with pictorial stained glass.

Figure D2. The north elevation. The side elevations are broken into bays by wide brick buttresses. The bays have a single (slightly pointed) arched window with three rows of bricks voussoirs radiating above. Two bands of decorative render run across the wall planes of the side elevations at sill level and the spring point below the arch.

7.1. There is damp in the base of parts of the wall, but particularly on the north side, near the Foundation Stone. See below for symptoms to look for and how to fix the problem.

- 3.1. There is a solid concrete ramp to provide entry to the narthex on the north side of the church. This has been built up against the brick work of the church, which blocked the sub floor vents and is likely to cause chronic damp in the church walls. It should be removed and replaced with a ramp that does not touch the brick walls and allows clear ventilation underneath to the walls and sub floor vents. See 3.2 below.
- 3.2. Ramps
 - 3.2.1. Removable ramp construction
 - 3.2.1.1. A metal framed ramp which allows air to flow under it, to ensure the subfloor

vents of the building are not obstructing good airflow under the floor, which will allow the wall structure to evaporate moisture, reduce termite and rot attack to the subfloor structure and reduce rising damp in brick/stone walls.

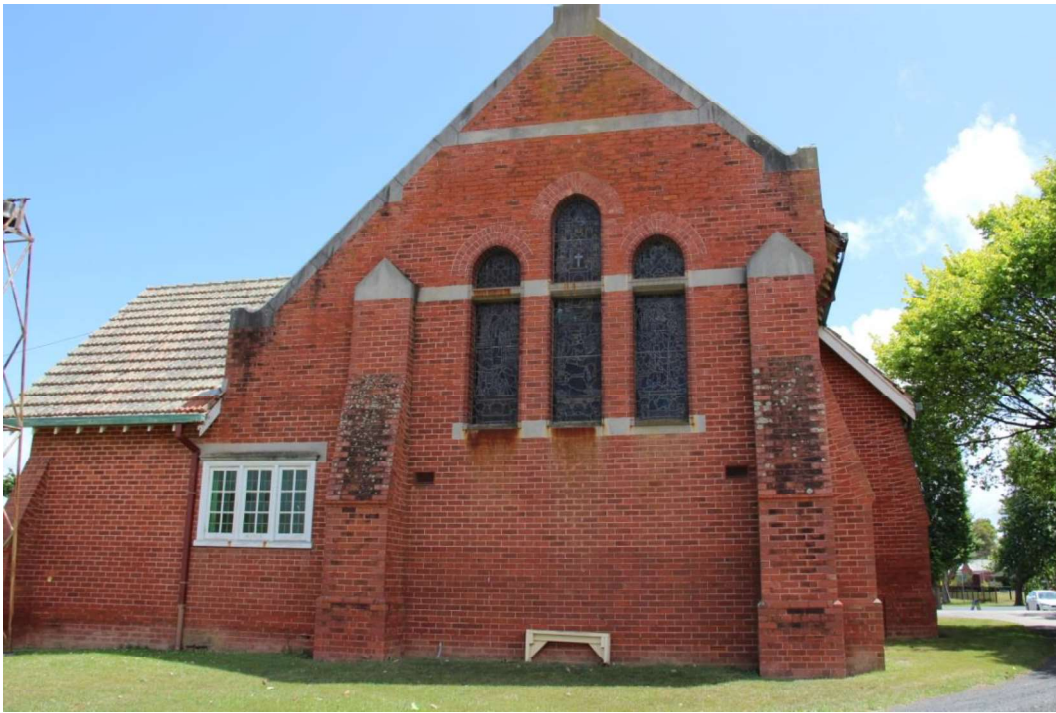
Figure D3. The rear (east) elevation has the same detail as the facade and three large (slightly pointed) arch windows with stained glass. To the left of the rear elevation is the wall of the south porch and a grouping of three square-headed windows (with the same detail as the other windows of the porch). The brickwork of this elevation indicates that the porch was built at the same time as the nave of the church.

Figure D3. The rear (east) elevation has the same detail as the facade and three large (slightly pointed) arch windows with stained glass. To the left of the rear elevation is the wall of the south porch and a grouping of three square-headed windows.

6.4.2. Some timber work, such as the barge boards on the east end, require careful repair and painting.

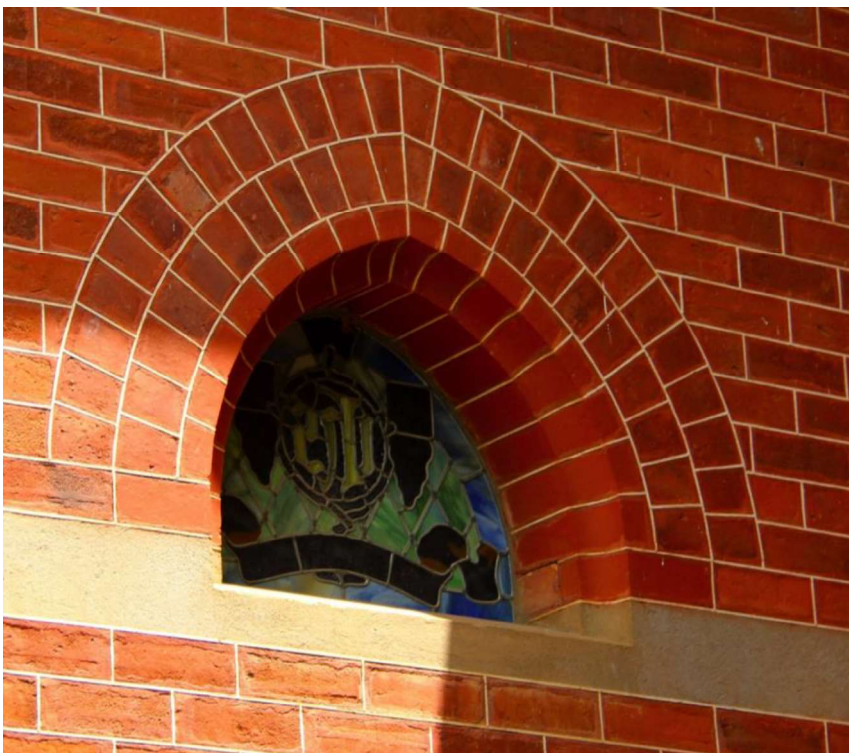
Figure D6. A detail of the exquisite 98 year old brickwork and tuck pointing of the lime mortar, unpainted render and lead lighting, which is all in excellent condition. It should never be painted or treated with any modern sealants. This is testimony to the excellent design, quality of the materials, the builder's skills, and the skills of the craftsmen who created the tuck pointing and lead light by hand

Figure D6. Detail of the exquisite 98 year old brickwork and tuck pointing of the lime mortar, unpainted render and lead lighting, which is all in excellent condition. It should never be painted or treated with any modern sealants. This is testimony to the excellent design, quality of the materials, the builder's skills, and the skills of the craftsmen who created the tuck pointing and lead light by hand.

- 5.1. Mortar: Match the lime mortar, do not use cement mortar. Traditional mortar mixes were commonly 1:3 lime:sand.
- 5.2. The tuck pointing and brickwork on this 1918 building is exemplary, and nearly 100 years old, but it is now a rare craft and expensive to repair or reconstruct, which makes caring for the existing tuck pointing particularly important. Never sand, water or soda blast it. Damp in the brick work will result in the mortar and tuck pointing falling out, which can be seen near the base of the building especially near the down pipes. Refer to section 7 below for practical advice on how to prevent damage from damp.

- 5.4. Remove any dark grey patches to the mortar joints - this is cement mortar which will damage the bricks, as noted above, and reduce the longevity of the walls. Repoint those joints with lime mortar. The mortar is not the problem it is the messenger, altering you to a damp problem (also see Water Damage and Damp)
