**Locality:** YARRAM  
**Place address:** 109-113 COMMERCIAL RD  
**Citation date** 2016  
**Place type (when built):** Church, Hall  
**Recommended heritage protection:** Local government level  
Local Planning Scheme: Yes  
Vic Heritage Register: No  
Heritage Inventory (Archaeological): No

**Place name:** St Andrews Uniting Church and Hall

Project: Wellington Shire Stage 2 Heritage Study  
Client: Wellington Shire Council  
Author: Heritage Intelligence Pty Ltd  
Date: 12/2/16

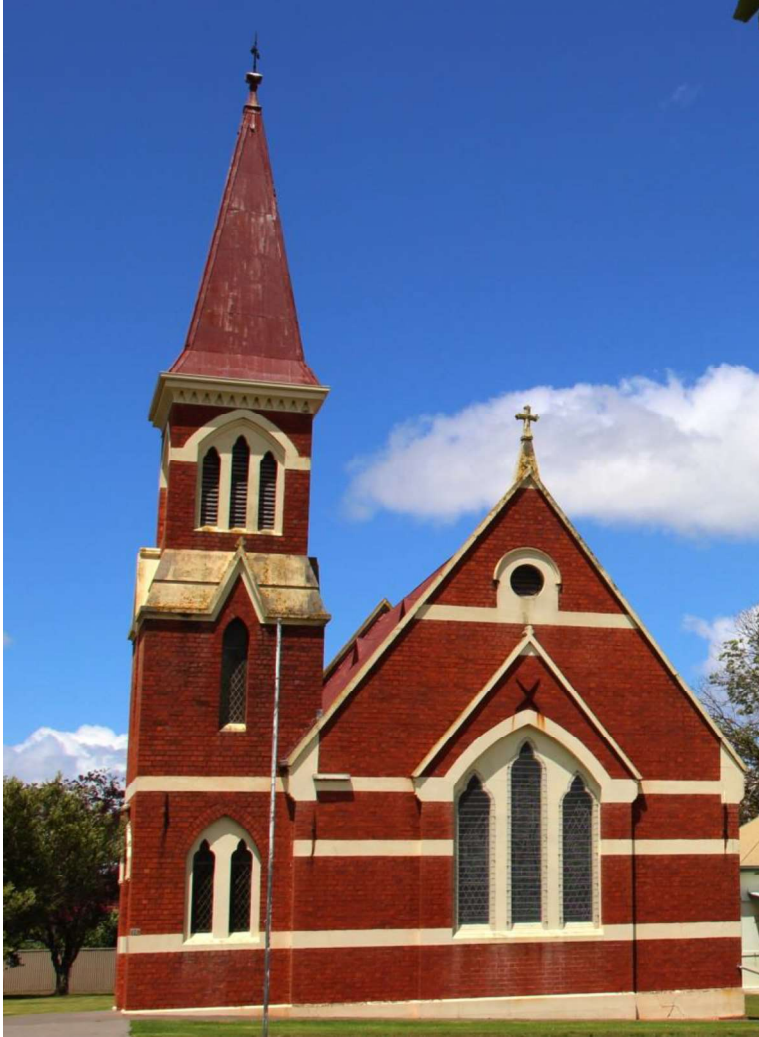
**Figure D1.** The church is constructed of handmade, tuck pointed red bricks, with a rendered plinth and gabled roof clad with galvanised corrugated iron (overpainted). Four small triangular vents are located near the ridge line. Four horizontal bands of decorative render run across the facade, creating strong horizontality across the face-brick. Decorative render is also applied to some window surrounds. The rendered parapeted gable to the facade has a cross to the apex and a round vent to the gabled-end. A smaller bay projects slightly from the facade, with a peaked moulding that imitates the profile of the parapeted gable. The bay contains three pictorial leadlight windows, which finish at the top in a trefoil motif. These windows are recessed in a section with a wide pointed-arch. To the left of the facade is a tall tower and spire with a pyramidal roof clad in narrow-gauge galvanised corrugated ripple iron (overpainted).

**Figure D1.** The church is constructed of handmade, tuck pointed red bricks, with a rendered plinth and gabled roof clad with corrugated iron. Four horizontal bands of decorative render (overpainted) run across the facade, creating dominant lines across the face-brick.

5.1. The finish on these walls has been damaged and shows that there are a lot of patch repairs in many parts of it. Most of the fine and very expensive tuck-pointed finish has come off. It may be due to damp, or perhaps it was water blasted at some time, but this matter needs to be investigated by an expert in heritage building construction. David Young or similarly experienced and qualified person would be suitable – see the reference on Salt Attack and Rising Damp, noted below.

5.4.2. Cream coloured paint removal on the church. It is strongly recommended that the paint be removed chemically from all the rendered decorative elements (never sand, water or soda blast the building as this will permanently damage the bricks, mortar and render and never seal the bricks or render as that will create perpetual damp problems.) Removal of the paint will not only restore the elegance of the architecture, see Figures H1 and H2, but it will remove the ongoing costs of repainting it every 10 or so years.

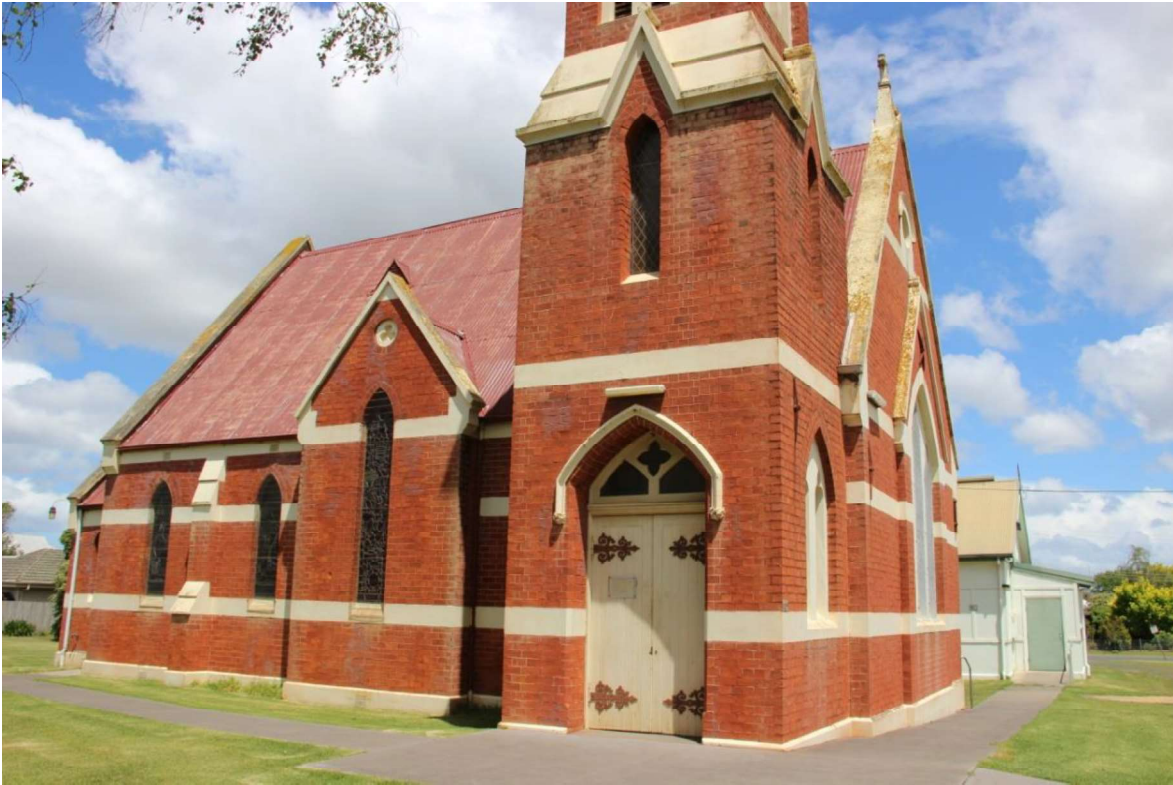
**Figures D2 & D3.** The north elevation contains the entrance on the north side of the tower. The pointed-arch opening has a label moulding stopped by rosettes, and recessed entrance with double timber ledged and framed doors (with ornate metal hinges) and a highlight with a quatrefoil motif.

**Figure D2.** The north elevation contains the entrance on the north side of the tower. The pointed-arch opening has a label moulding stopped by rosettes, and recessed entrance with double timber ledged and framed doors (with ornate metal hinges) and a highlight with a quatrefoil motif.

- 3.1. The ground level and concrete path has been built up to be flush with the top step of the tower entry. This is likely to cause damp in the walls. If this starts to occur, it is very important to remove the concrete, lower the ground level as instructed below, and construct a ramp as described in 3.2.

- 3.2. Ramps
  - 3.2.1. Removable ramp construction
    - 3.2.1.1. A metal framed ramp which allows air to flow under it, to ensure the subfloor vents of the building are not obstructing good airflow under the floor which will allow the wall structure to evaporate moisture and reduce termite and rot attack to the subfloor structure and rising damp in brick/stone walls.

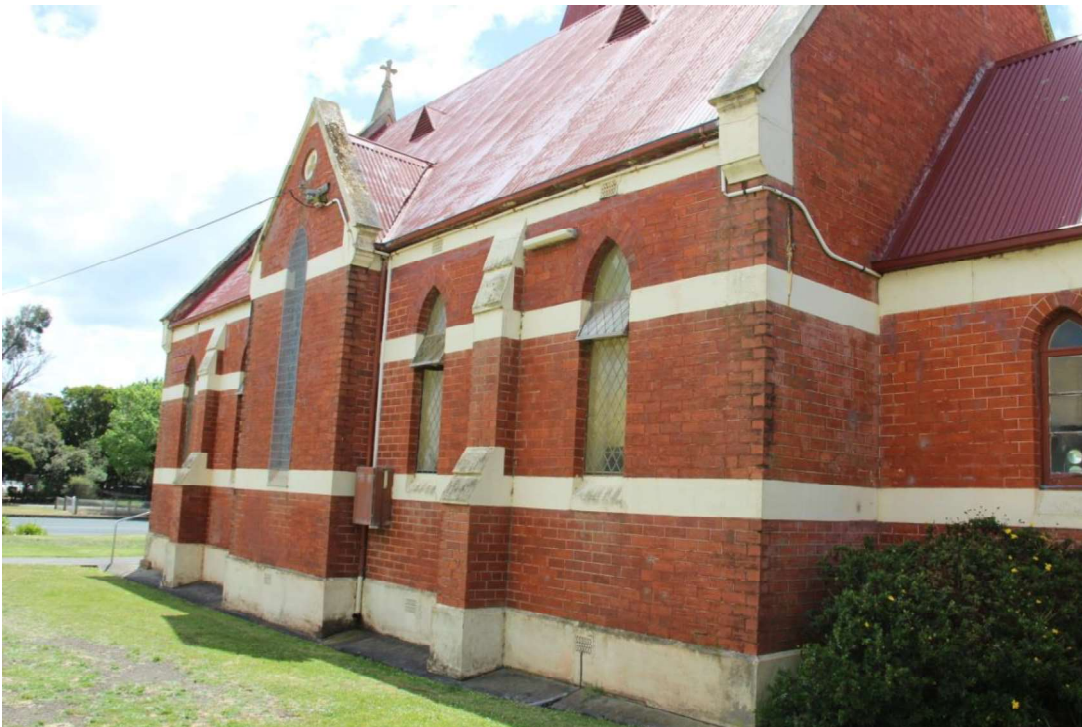
**Figure D3.** The south elevation. The side elevations of the nave are divided into five bays by buttresses with rendered coping. The central bay of each elevation has a (slightly projecting) gabled bay with a very tall pointed-arch window with leadlight. On both elevations, bands of decorative render (overpainted) run across the walls at sill level and impost level, (near the tops of the windows).

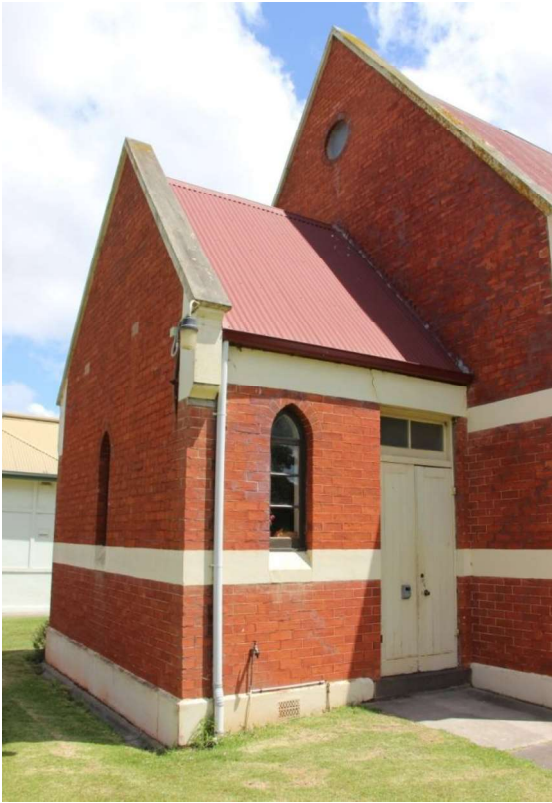
**Figure D4.** The gabled-end of the rear (east) elevation of the church has a round opening, above a chancel with a rendered parapeted gable. Timber doors with a highlight provide access off the north elevation. Small pointed-arch windows with three-paned casement windows (with clear glass) appear on each side.

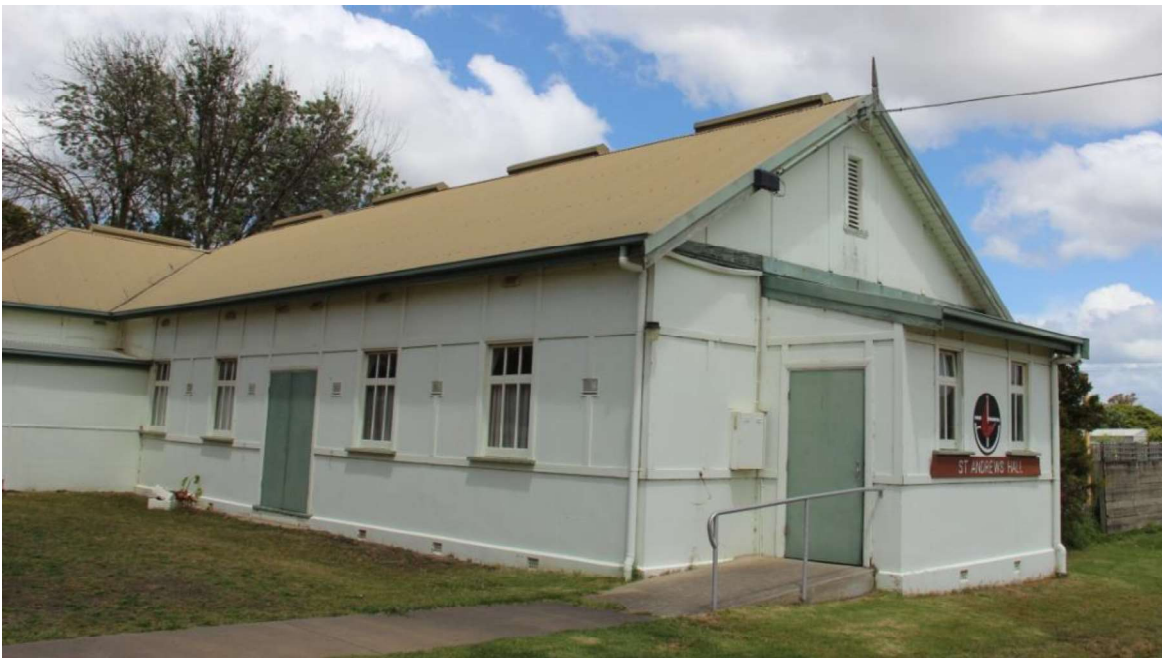
**Figure D5.** To the south of the church is the 1929 hall which underwent extensions in 1955, which comprised the hipped section to the rear with one-over-one sash windows. The Interwar hall and its Postwar addition are in very good condition and retain a very high level of integrity.

**Figure D5.** To the south of the church is the 1929 hall which underwent extensions in 1955, which comprised the hipped section to the rear with one-over-one sash windows. Both sections of the hall have a rendered plinth and are constructed of rendered brick to the bottom third of the wall, which is incised with ruled lines to create an ashlar effect. The top 2/3 of the wall and gabled-ends are clad with fibro-cement sheets and strapping (all overpainted).

5.4.1. It is recommended to paint the exterior of the hall building using original colours (paint scrapes may reveal the colours) to enhance the historic architecture and character.

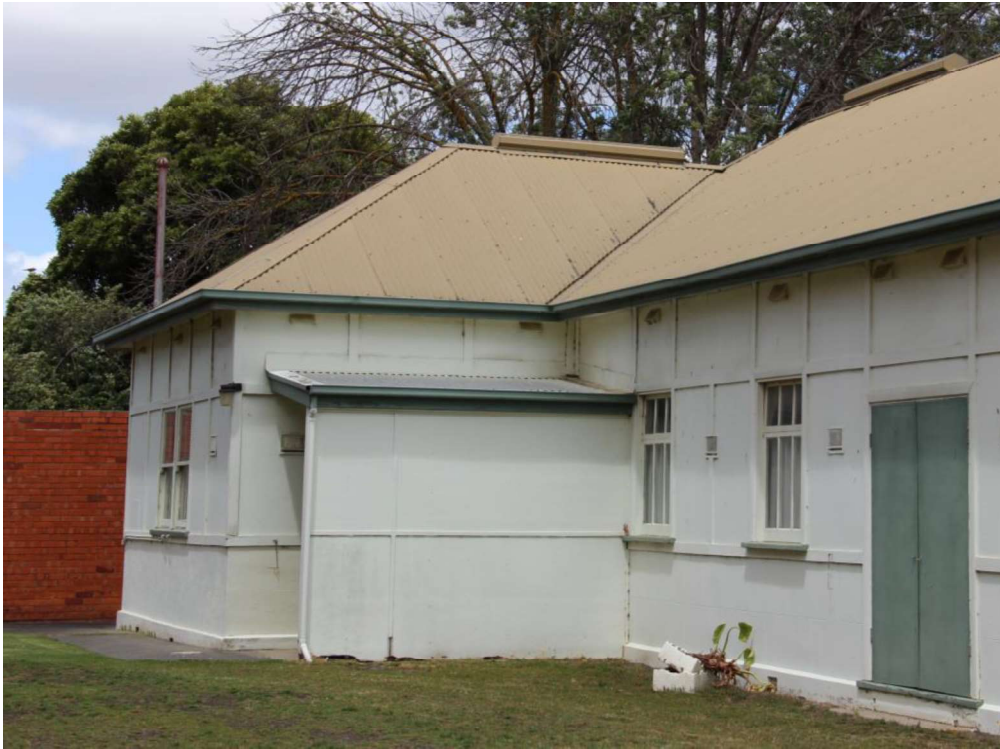
The 1955 hipped-roof addition to the rear imitates the architectural details of the 1929 section, but has one-over-one sash windows. A small skillioned-roof section is enclosed with one wall, located on the west side of the 1955 section.

**Figure D6.** The 1955 hipped-roof addition to the rear imitates the architectural details of the 1929 section, but has one-over-one sash windows. A small skillion-roof section is enclosed with one wall, located on the west side of the 1955 section.

4.1.2. Don't use Zincolume or Colorbond. It appears that Colorbond has recently been put on the small extension at the rear. It is preferable that this be removed (it has already started growing lichen which will get worse as it is a common problem with Colorbond and will look terrible on the main roof), or at least painted light grey to match unpainted galvanised corrugated iron, so that when the galvanised corrugated iron roof on the nave (which is has faded red paint on it) is replaced they will match. The original design was never intended to have a red roof.
