# Rosedale Flood Study – Data Review (R01)

**May 2016**

| Project Name | Rosedale Flood Study |
| Report Number | R01 |

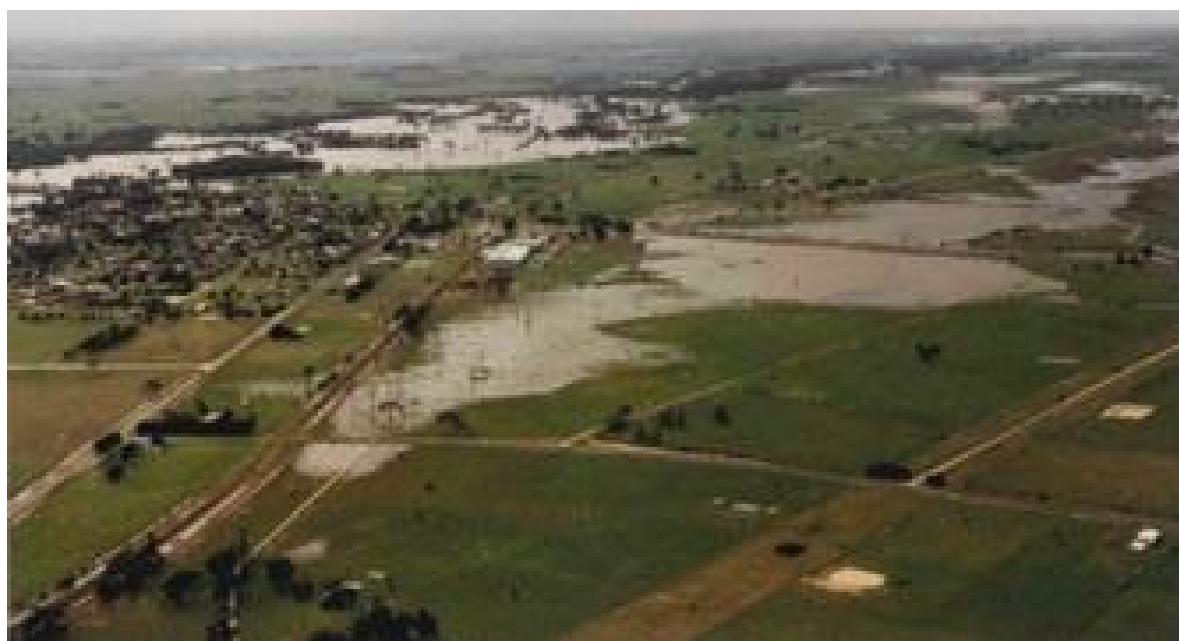
**Figure 5-4 September 1993 oblique flood image**

Oblique flood aerial photography was available for the June 1978 event in black and white and colour for 1993, 2011 and 2012. An example is shown in Figure 5-4 below. Aerial photography was also available for the aftermath of the 1993 event (28 September 1993) in the Hydrotechnology (1995) flood review. Table 5-1 gives a summary of flood imagery available by event.

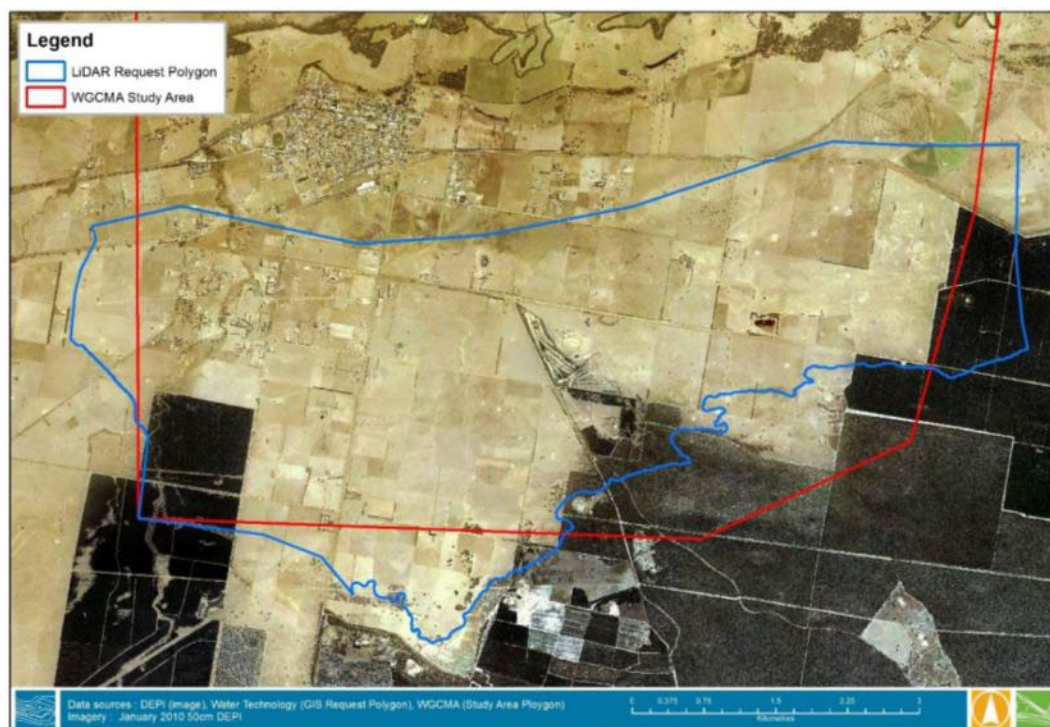
**Figure 6-4** LiDAR survey request area

It was identified in the WGCMA project brief that there was insufficient LiDAR to flood map the southern portion of the study area. To inform what infill LiDAR was required, Water Technology created a preliminary rain-on-grid hydraulic model of the Blind Joes Creek and its adjacent catchments to the east. This modelling was undertaken using the VicMap 10 x 10 m DEM which is only vertically accurate to 5 m. The purpose of this modelling was to identify key inflow points and help understand where flow paths are. Using this information, Water Technology provided a recommended survey area to WGCMA, this area was then further refined by WGCMA. The area adopted for infill survey is shown in Figure 6-4.

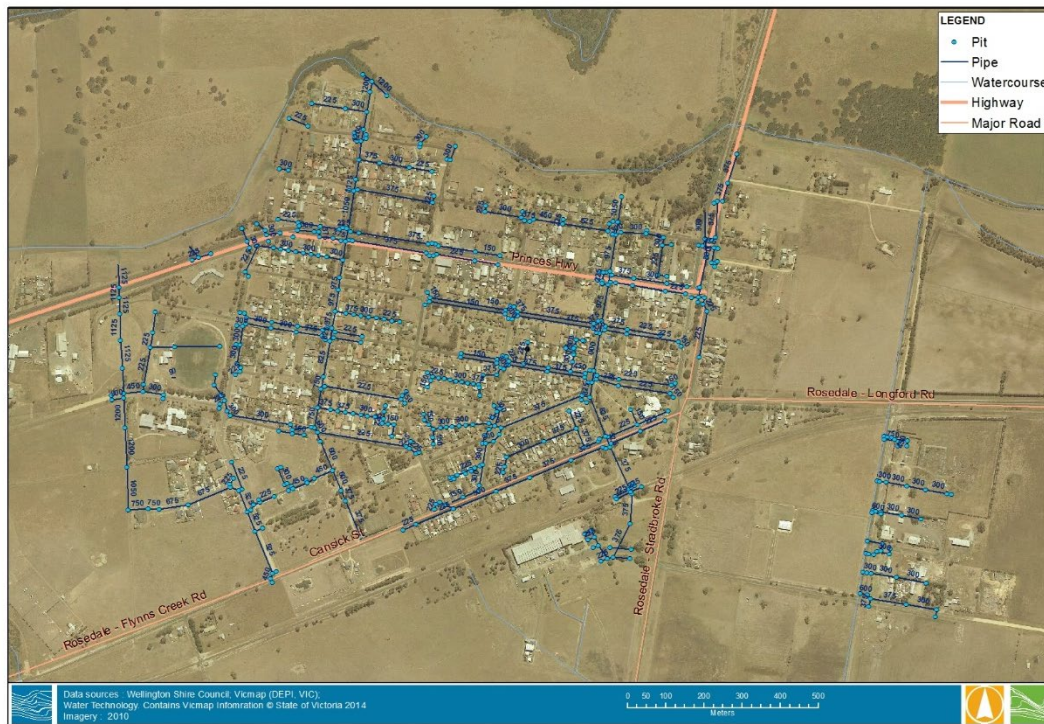
**Figure 6-6 Drainage GIS layers (Wellington Shire Council)**

GIS layers of local pits and pipes were provided by Wellington Shire (Figure 6-6). [REDACTED] from Wellington Shire provided advice on the reliability of the pipe layer and additional/altered pipes. Broadly, the township is drained via three main drainage systems. A fourth system is found on the eastern edge of the township and forms part of the Holy Plains Drainage Scheme. A review of the data showed it is suitable for use in the hydraulic model of the township.

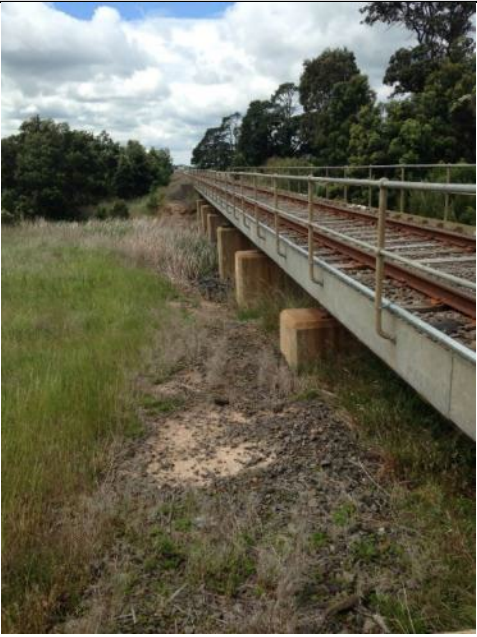
| Location/Notes | Photo |
|---|---|
| <p>Railway bridge (Blind Joes Creek);</p> <ul style="list-style-type: none"> <li>• Capacity of railway bridge was significantly greater than the Flynns Creek Road bridge;</li> <li>• It appeared the waterway upstream of the railway bridge had been fenced and re-vegetated, possibly by the local Landcare group;</li> <li>• Currently modelling shows the creek breaking out upstream of the railway bridge and flowing east (sitting behind the railway embankment); and,</li> <li>• A number of the railway openings were partially blocked with sediment, potential to increase capacity by excavating out material from under bridge with transition upstream and downstream.</li> </ul> | |

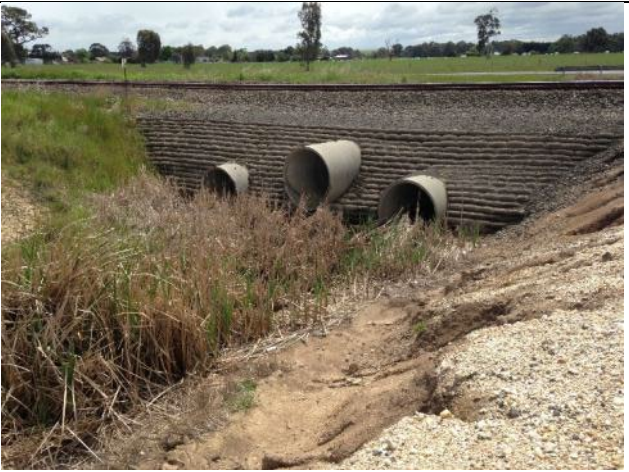
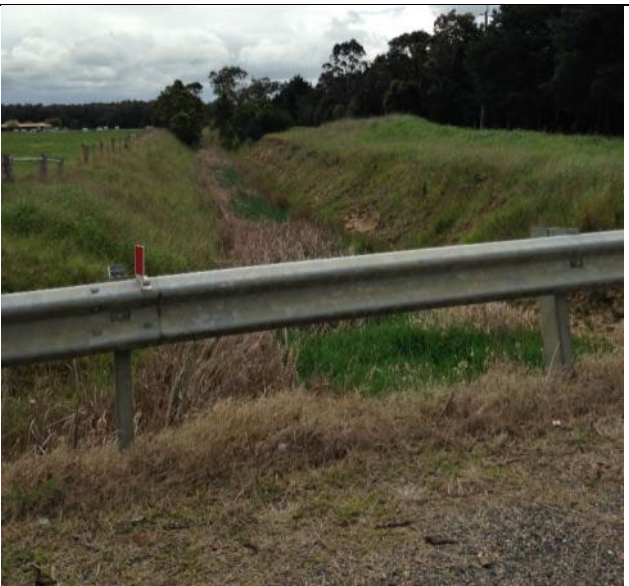
| Location/Notes | Photo |
|---|---|
| <p>Old drainage scheme works;<br/>Mill Lane (Railway line culvert and channel downstream of Mill Lane);</p> <ul style="list-style-type: none"> <li>• Significant northerly flowing drain feature;</li> <li>• Rosedale-Longford Road culvert 3.00 x 1.95 m RCP's;</li> <li>• Railway line culvert 3 x 1.5 m RCPs; and</li> <li>• Huffers Road 3x 1.2x1.2 box culverts.</li> </ul> | <br> |

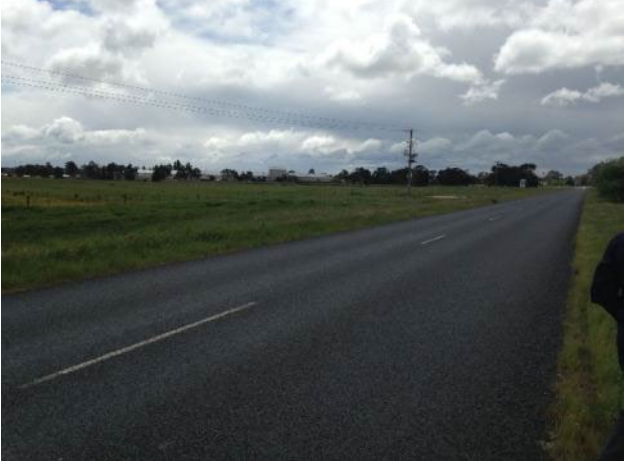
| Location/Notes | Photo |
|---|---|
| <p>Eastern Breakout - Rosedale floodway;<br/>Friends Road;</p> <ul style="list-style-type: none"> <li>• Current modelling shows flood water ponding behind Friends Road controlled by a single 0.9 x 0.6 m box culvert;</li> <li>• Current modelling shows breakout flows crossing the railway crossing (with Friends Road) and flowing into the vacant land proposed for R1Z development; and,</li> <li>• Adam Dunn (WGCMA) posed the question could more floodwater flow east, could this protect the land proposed for development.</li> </ul> <p>Willung Road;</p> <ul style="list-style-type: none"> <li>• Overland flow appears shallow and broad;</li> <li>• Willung Road inundated in June 2012, Adam Dunn (WGCMA) was pretty sure this was not from Blind Joes Creek - but more from local runoff;</li> <li>• 3 x 750 mm RCPs convey water under Willung Road; and</li> <li>• Minimal development on the floodplain, tannery or timber mill sits on a fill pad on the northern boundary of the floodplain.</li> </ul> | |

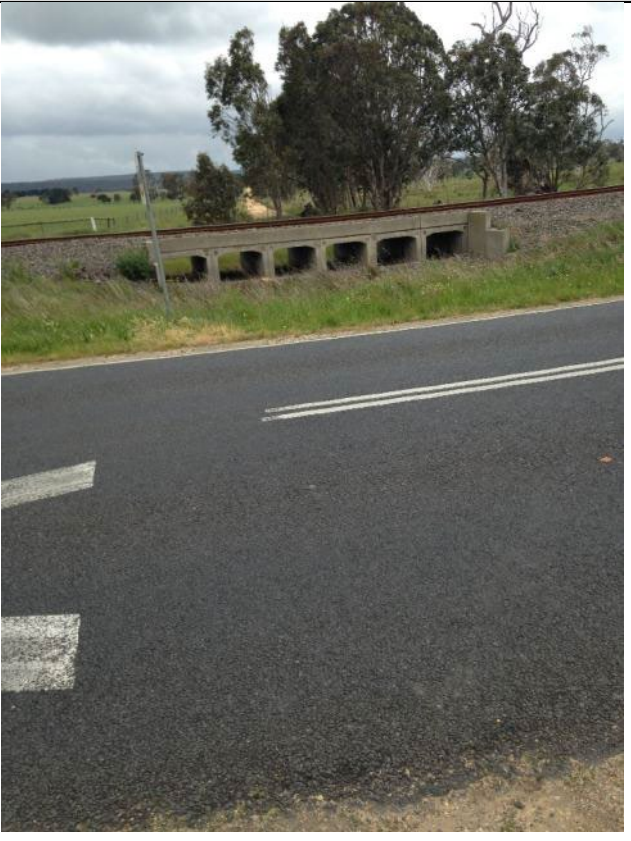
| Location/Notes | Photo |
|---|---|
| <p>Rosedale-Longford Road (Railway crossing);</p> <ul style="list-style-type: none"> <li>• Flows from the Rosedale Floodway (and other catchments) connect back to the Latrobe River floodplain near Mullocky Lane - 2 crossings under Rosedale-Longford Road and the railway; and,</li> <li>• Cut off drain observed on Mullocky Lane moving flow back to Rosedale-Longford Road.</li> </ul> | |
