# Rosedale Flood Study – Hydrology & Hydraulics (R02)

| Project Name | Rosedale Flood Study |
| Client | West Gippsland Catchment Management Authority |
| Report Number | R02 |

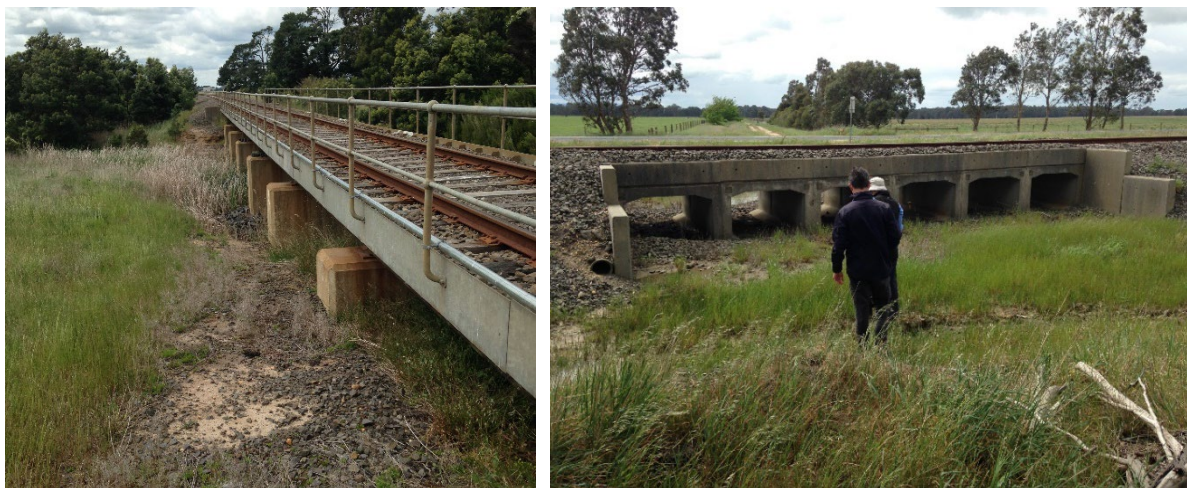
**Figure 4-6 Blind Joes Creek – Railway Crossings (West LHS & East RHS)**

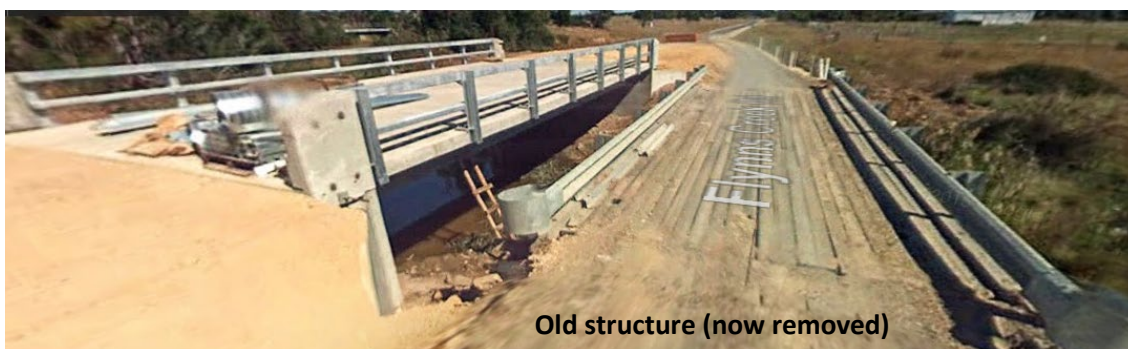
**Figure 4-7 Blind Joes Creek – Cansick Street Bridge(s) – April 2008 - Source: Google Maps**

In two instances, major changes have occurred with the structures found in the catchment now to that found in the system during 1993 and 2012. After the 1993 flood, but prior to 2012 (suspected to be in 2008), significant works were completed on the Cansick Street (Flynn's Creek Road) bridge over Blind Joes Creek. These works included replacing the existing bridge and increasing waterway capacity upstream of the new bridge. No details were available of the old bridge or the land form prior to the works being completed. Water Technology worked with Wellington Shire council to establish the likely conditions at this time. The new bridge feature (surveyed by Beveridge Williams) is included in the 2012 and design flood modelling. Figure 4-7 (a screen shot from google maps) shows the two structures, the downstream (lower feature) was removed when the new bridge became operational.

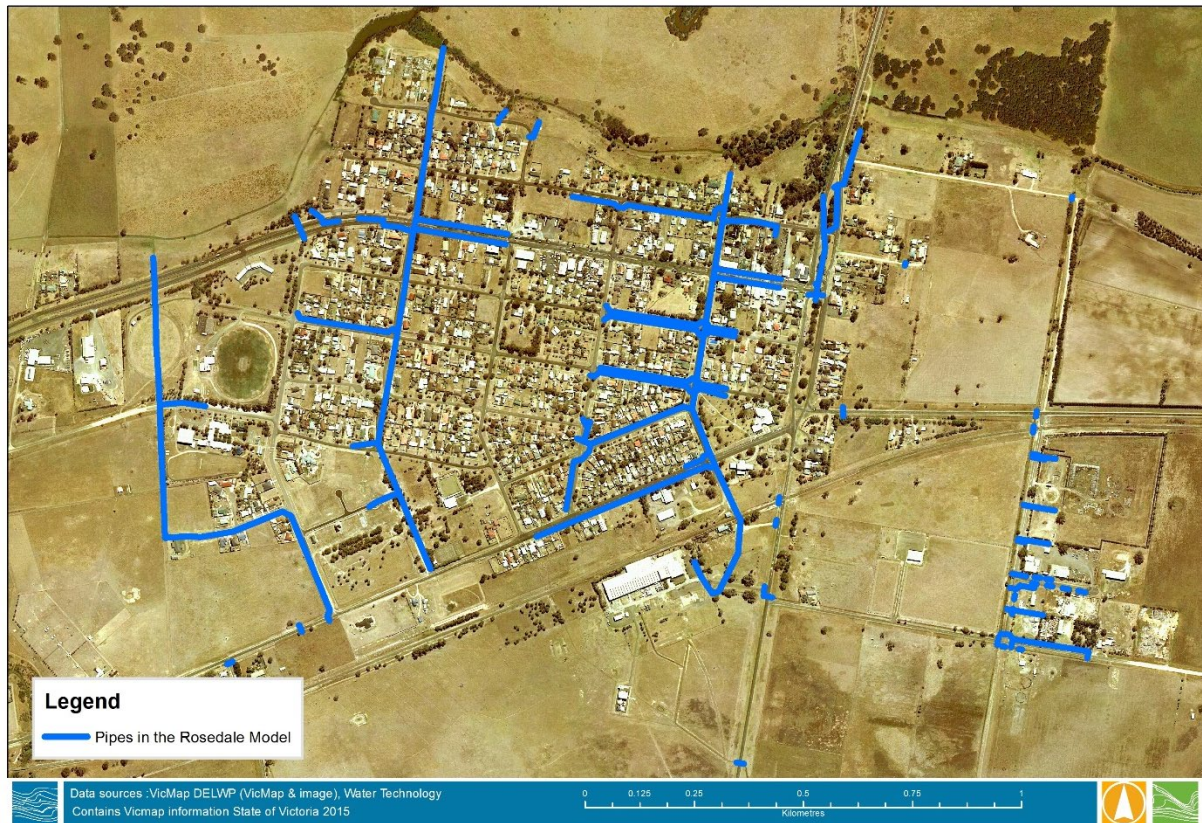
**Figure 4-9 Rosedale Flood Study Drainage Network Information**

Wellington Shire Council drainage assets were provided in GIS format. The quality of the drainage asset data varied from high quality detail including pipe and pit size, location and invert, while other areas lacked sufficient data for use in the hydraulic model. Where the accuracy of the locations and attributes is unknown, Wellington Shire Council [REDACTED] advised that errors in the data are common. A thorough review of the drainage network identified areas of data which were suitable for use within the hydraulic modelling. In areas where the dimensions of the pipes were missing, a pipe diameter was assumed based on available information upstream and downstream. For pipe and pit inverts, the available information on pit depths was used in combination with the LiDAR surface at the pit location, and an assumed minimum cover. These changes were noted within a MapInfo table database. The drainage information assessed for the hydraulic model is shown in Figure 4-9.

Following a data review, modification of the drainage dataset was undertaken to fill the missing gaps and further checks were undertaken to ensure the pit and pipe network placed into the model was functioning as expected. Much of this involved engineering judgement to schematise the drainage network slope throughout the catchment to ensure water is running downhill towards the outfall, as it was designed to do. This information was provided back to Wellington Shire Council in the final deliverables to help provide additional information in their database.

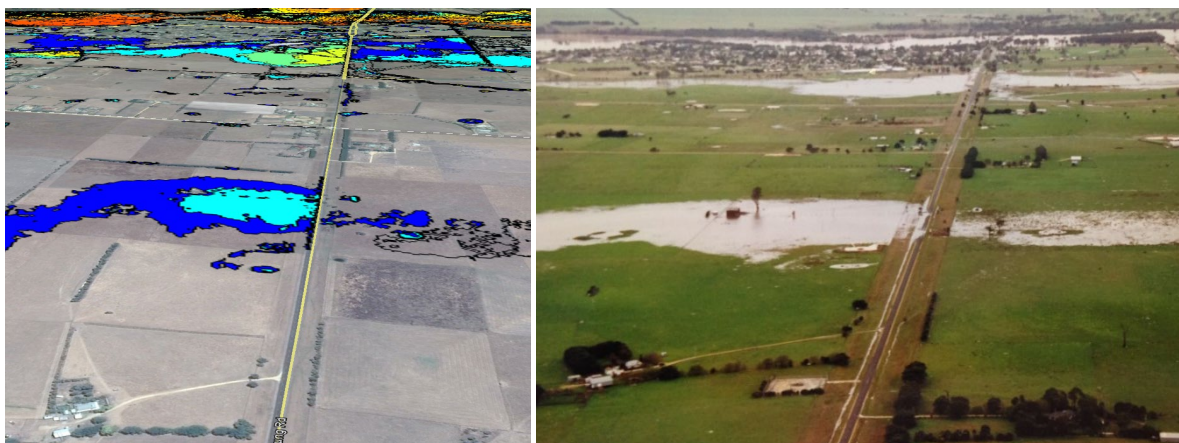
**Figure 5-16** September 1993 hydraulic model results compared with oblique aerial photographic record – Willung Road south of town

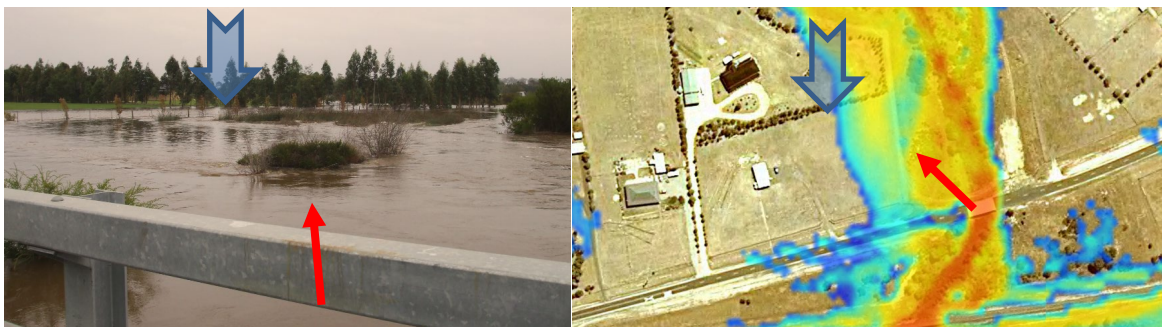
**Figure 5-24** June 2012 hydraulic model results compared to photograph from the WSC Rosedale-Cansick Street Bridge - 5<sup>th</sup> June 2012

| Figure 5-23 | June 2012 hydraulic model results compared to photograph from the WSC Rosedale-Willung Road 5 <sup>th</sup> June 2012 ..... | 45 |
| Figure 5-24 | June 2012 hydraulic model results compared to photograph from the WSC Rosedale-Cansick Street Bridge - 5 <sup>th</sup> June 2012 ..... | 45 |

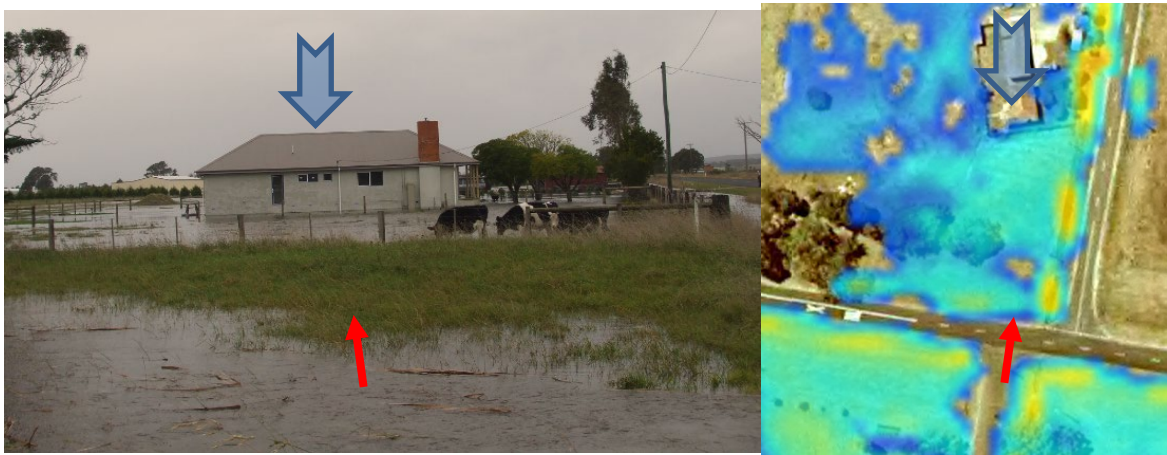
**Figure 5-27** June 2012 hydraulic model results compared to photograph from the WSC Rosedale-Corner of Huffers Lane and Willung Road - 5<sup>th</sup> June 2012

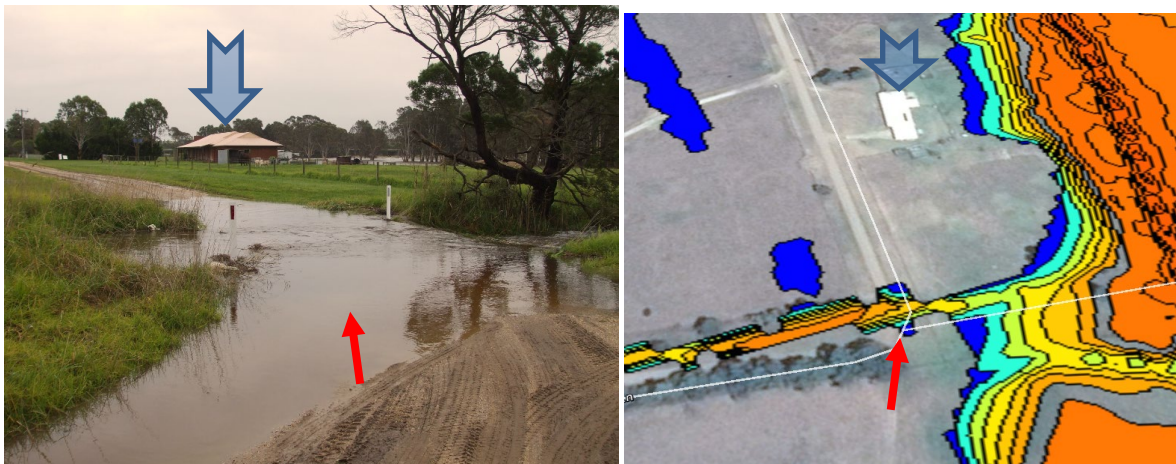
**Figure 5-28** June 2012 hydraulic model results compared to photograph from the WSC Rosedale-Mill Lane - 5<sup>th</sup> June 2012
