# Seaspray Flood Study – Data Review (R01)

**March 2016**

| Project Name | 3369-03 Seaspray Flood Study |
| Report Number | R01 |

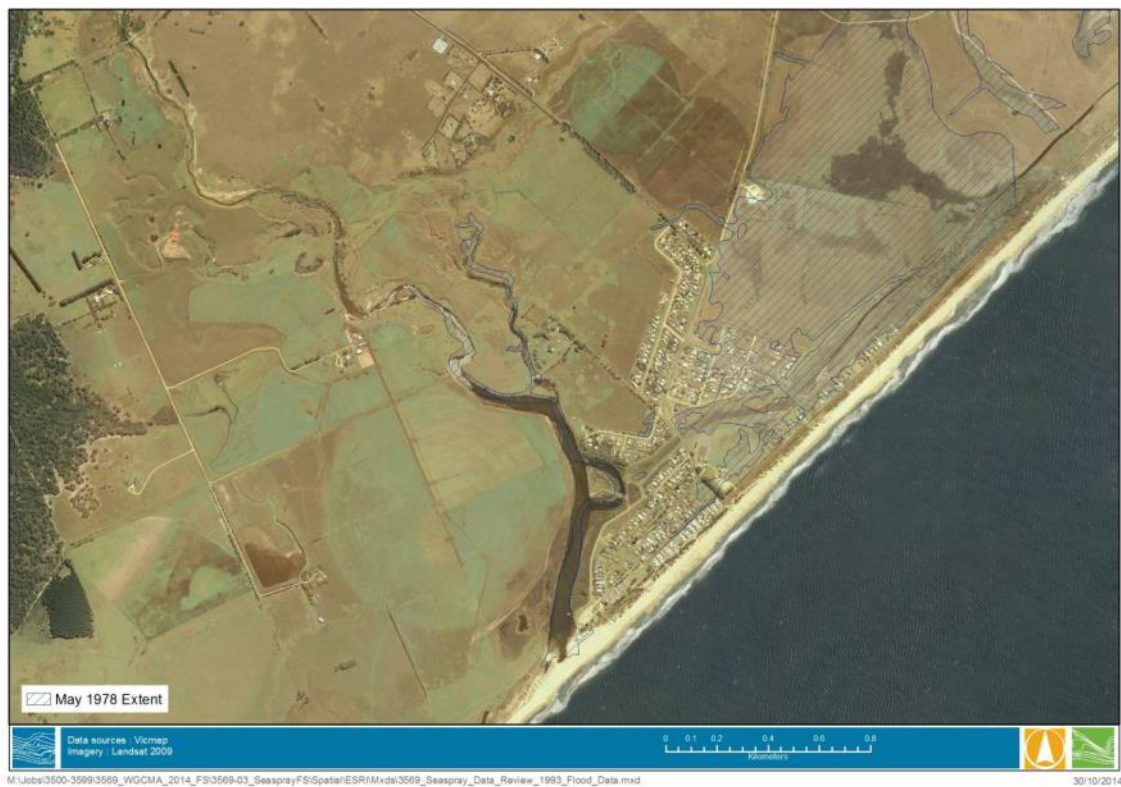
Historic flood data recorded in the Victorian Flood Database (VFD) is summarised in Figure 5-1, Figure 5-2 and Figure 5-3 below. Note that flood heights for the May 1978 flood are not recorded in the VFD but are available in the 1978 Flood Report (SRWSC 1978). Some inconsistencies have been noted between the VFD data and the original data recorded in the 1978 and 1993.

**Figure 5-1 May 1978 flood information in VFD**

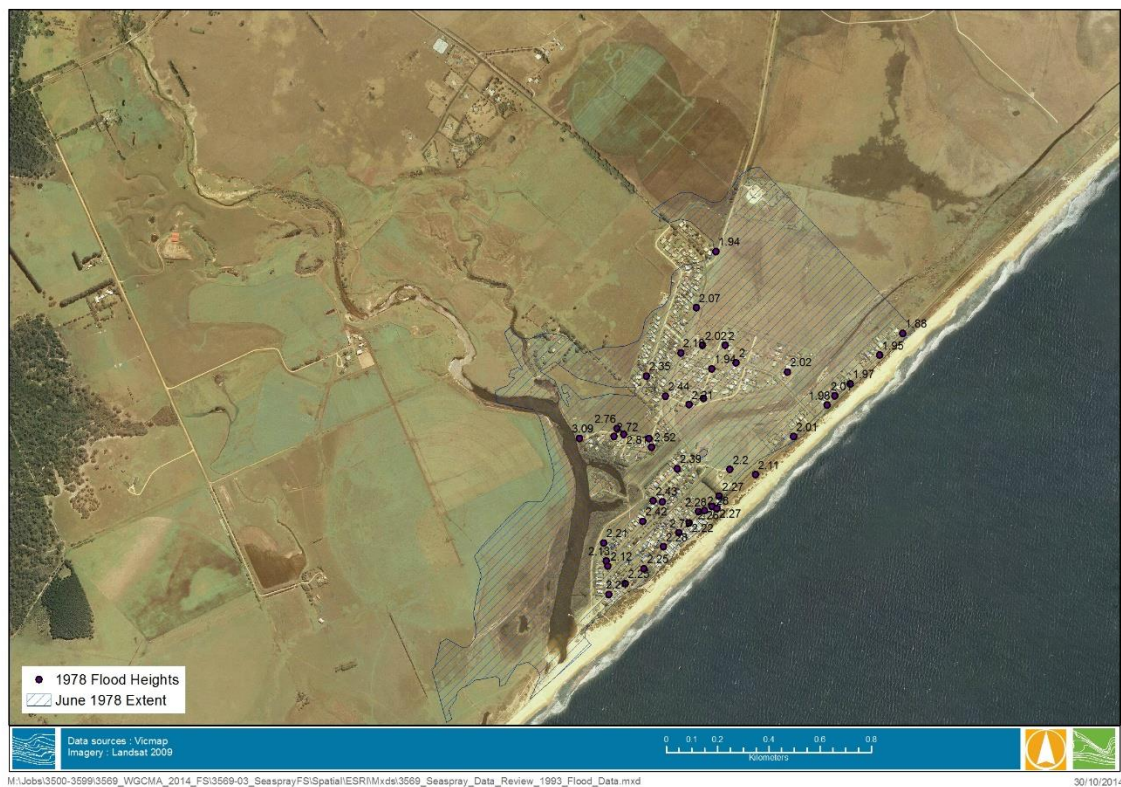
**Figure 5-2 June 1978 flood information in VFD**

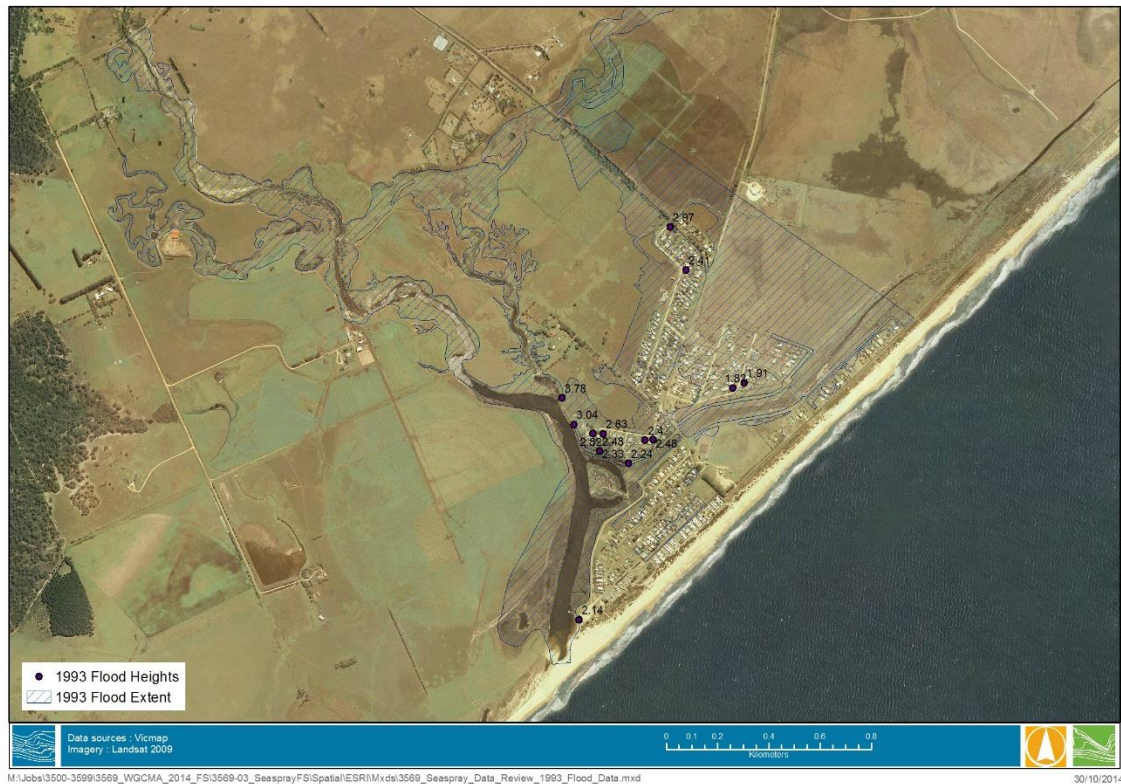
**Figure 5-3 1993 flood information in VFD**

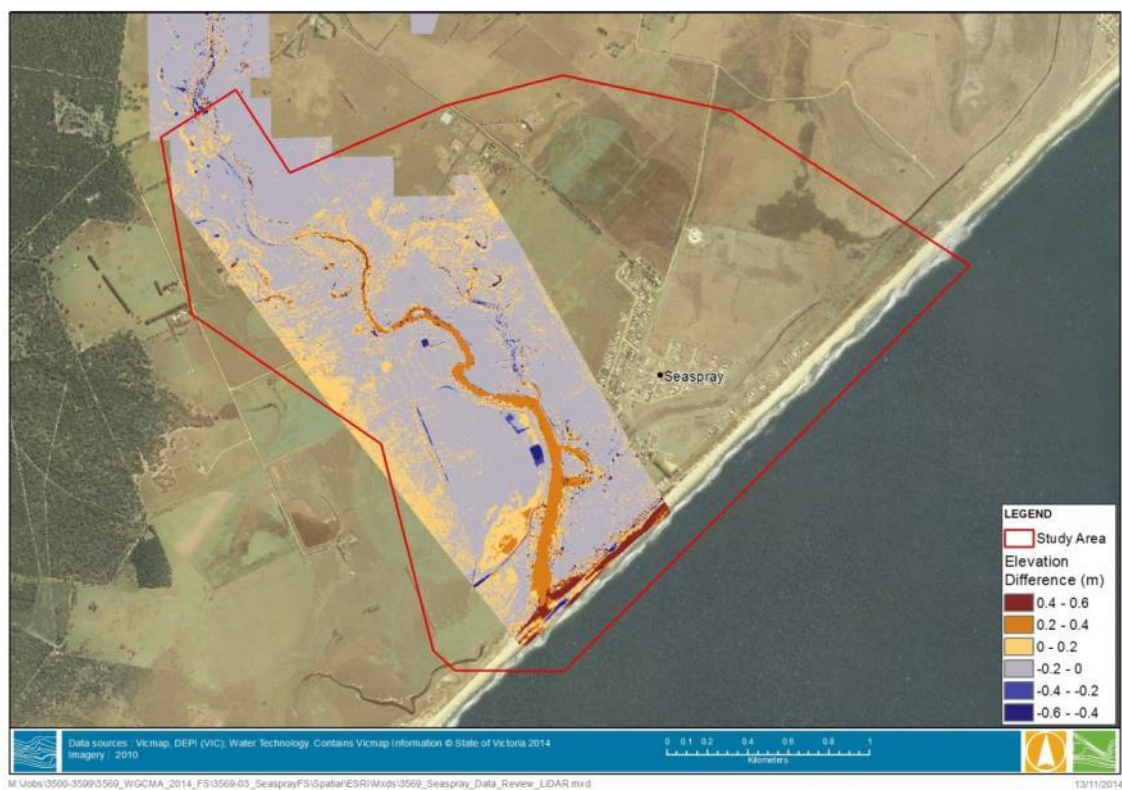
**Figure 6-2 LiDAR comparison - Rivers LiDAR DEM minus Coastal DEM**

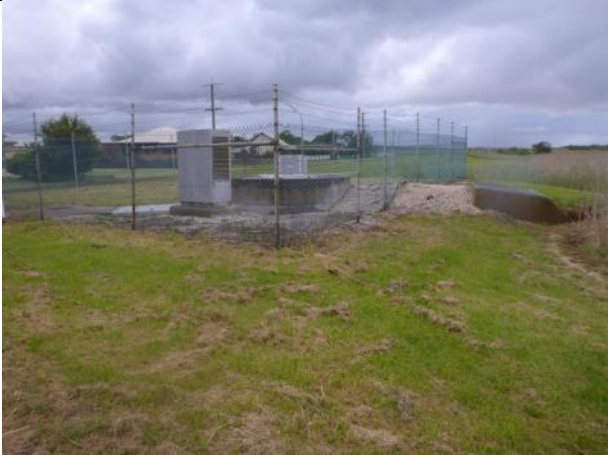
| Location/Notes | Photo |
|---|---|
| <p>Centre Road Pump Station</p> <ul style="list-style-type: none"> <li>All stormwater drains to 2 pump stations. Some stormwater from the northern levee area drains to the southern area via pipes under the floodway.</li> </ul> | |

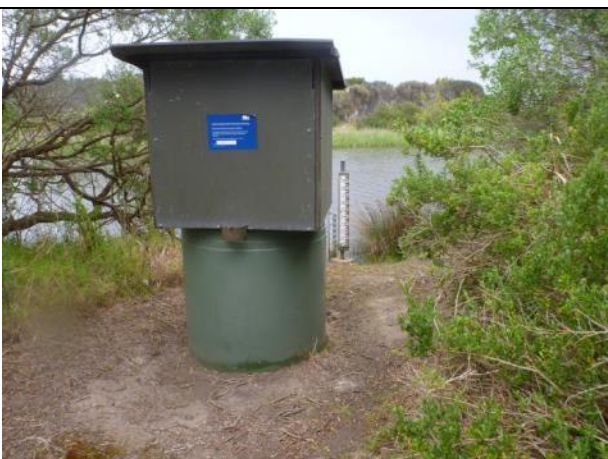
| Location/Notes | Photo |
|---|---|
| <p>Water Level Gauge</p> <ul style="list-style-type: none"> <li>Lagoon quite high, 1.3 m on gauge</li> </ul> | |

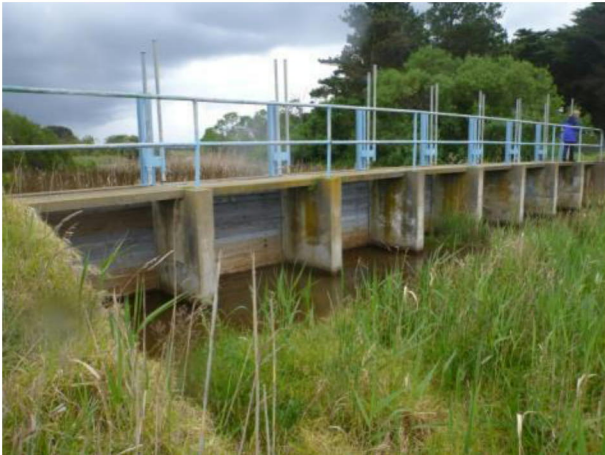
| Location/Notes | Photo |
|---|---|
| <p><b>Regulator</b></p> <ul style="list-style-type: none"> <li>All boards were in. Boards come up to top of concrete walkway.</li> <li>(Wellington Shire Council) advised that current practice is to leave all boards in at all times, which deviates from the operating procedure. The rationale behind this is that the priority during a flood is to get the entrance open, and if the floodway is open it can create conditions where the entrance is less likely to scour out properly when opened. The regulator would only be opened if water was required to top up Lake Reeve. In a typical flood it can be assumed to remain closed.</li> </ul> | |

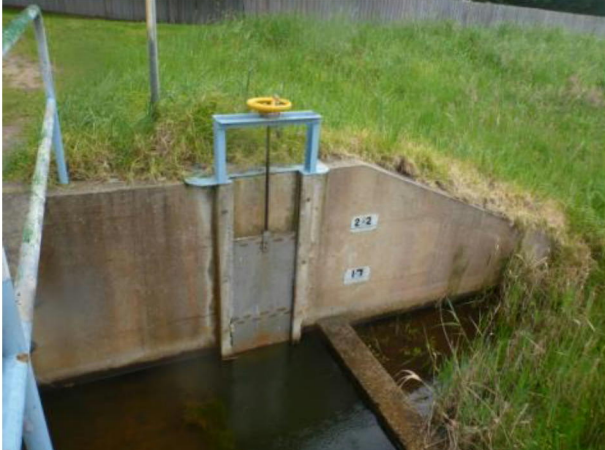
| Location/Notes | Photo |
|---|---|
| <p><b>Low flow gate at Regulator (closed)</b></p> <ul style="list-style-type: none"> <li>Small regulators on each side of the regulator are intended to allow low flow through to Lake Reeve. The floodway side should be kept open but is currently closed and cannot be operated. The lagoon side was also closed. The low flow pipe runs to an outlet at the Centre Road crossing of the floodway.</li> </ul> | |

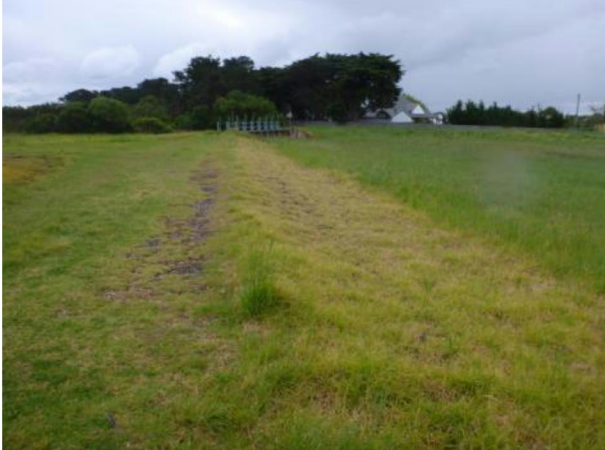
| Location/Notes | Photo |
|---|---|
| <p><b>Spillway beside regulator</b></p> <ul style="list-style-type: none"> <li>Next to the regulator is a wide spillway at a lower level than the top of the boards. The weir is constructed of rock gabions or rock covered with mesh)</li> </ul> | |

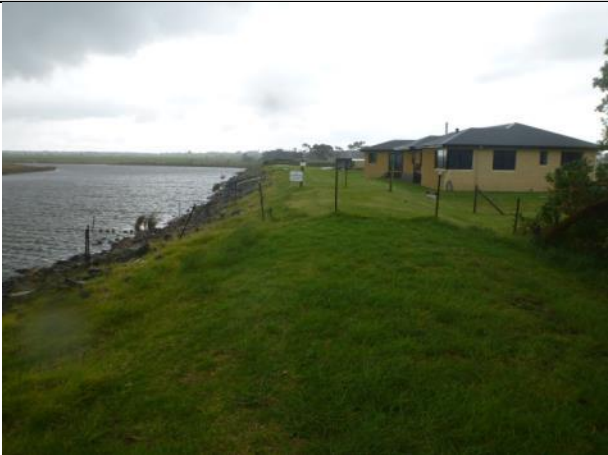
| Location/Notes | Photo |
|---|---|
| <p>Levee north of The Island</p> <ul style="list-style-type: none"> <li>Levees have recently been surveyed by SKM. A section north of The Island was missed.</li> <li>All levees appeared in good condition</li> </ul> | |

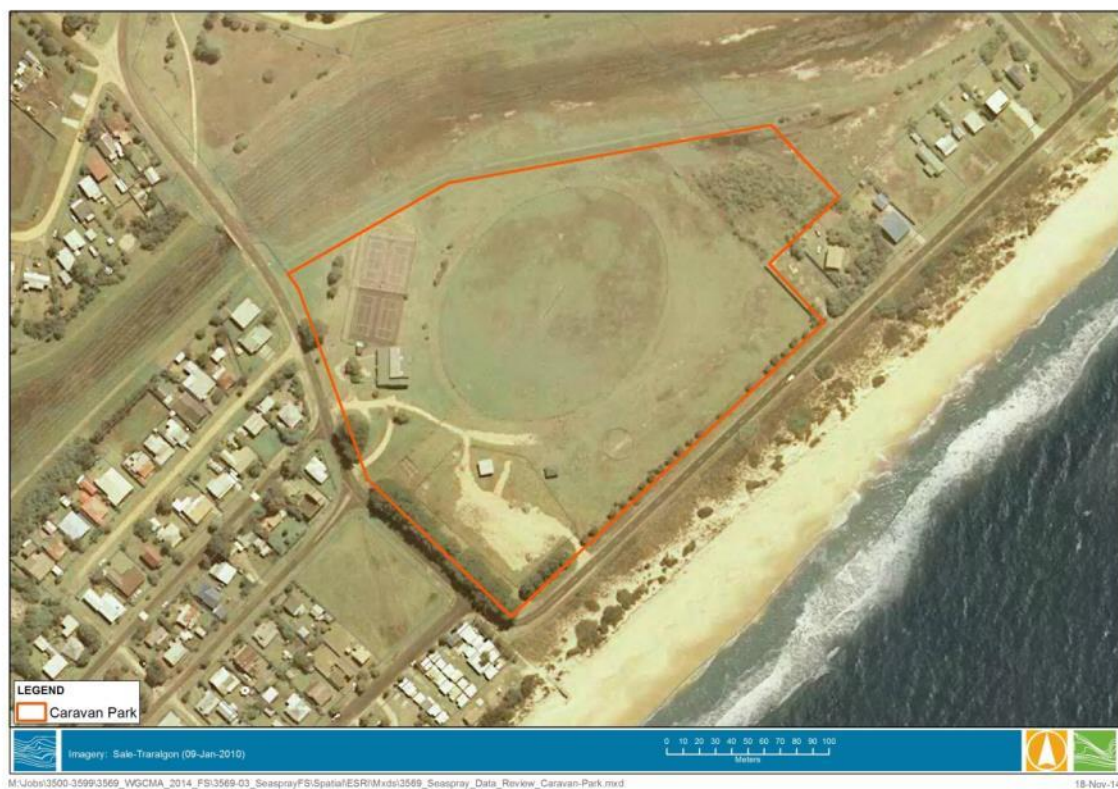
Since the collection of the various LiDAR datasets the Seaspray caravan park has been relocated to an area that was formally the football oval, as shown in Figure 11-1. The ground surface levels in this area have been raised and significant drainage infrastructure has been installed. Information was requested from the Seaspray Foreshore Committee for any “as-built” survey or drainage plans, however no information was available. Wellington Shire Council provided design information including ground levels and drainage layout and this information has been adopted for the study.

**Figure 11-1**      **Location of Seaspray Caravan Park**
