# Seaspray Flood Study - Summary Report (R05)

**May 2016**

| Project Name | 3569-03 Seaspray Flood Study |
| Report Number | R05 |

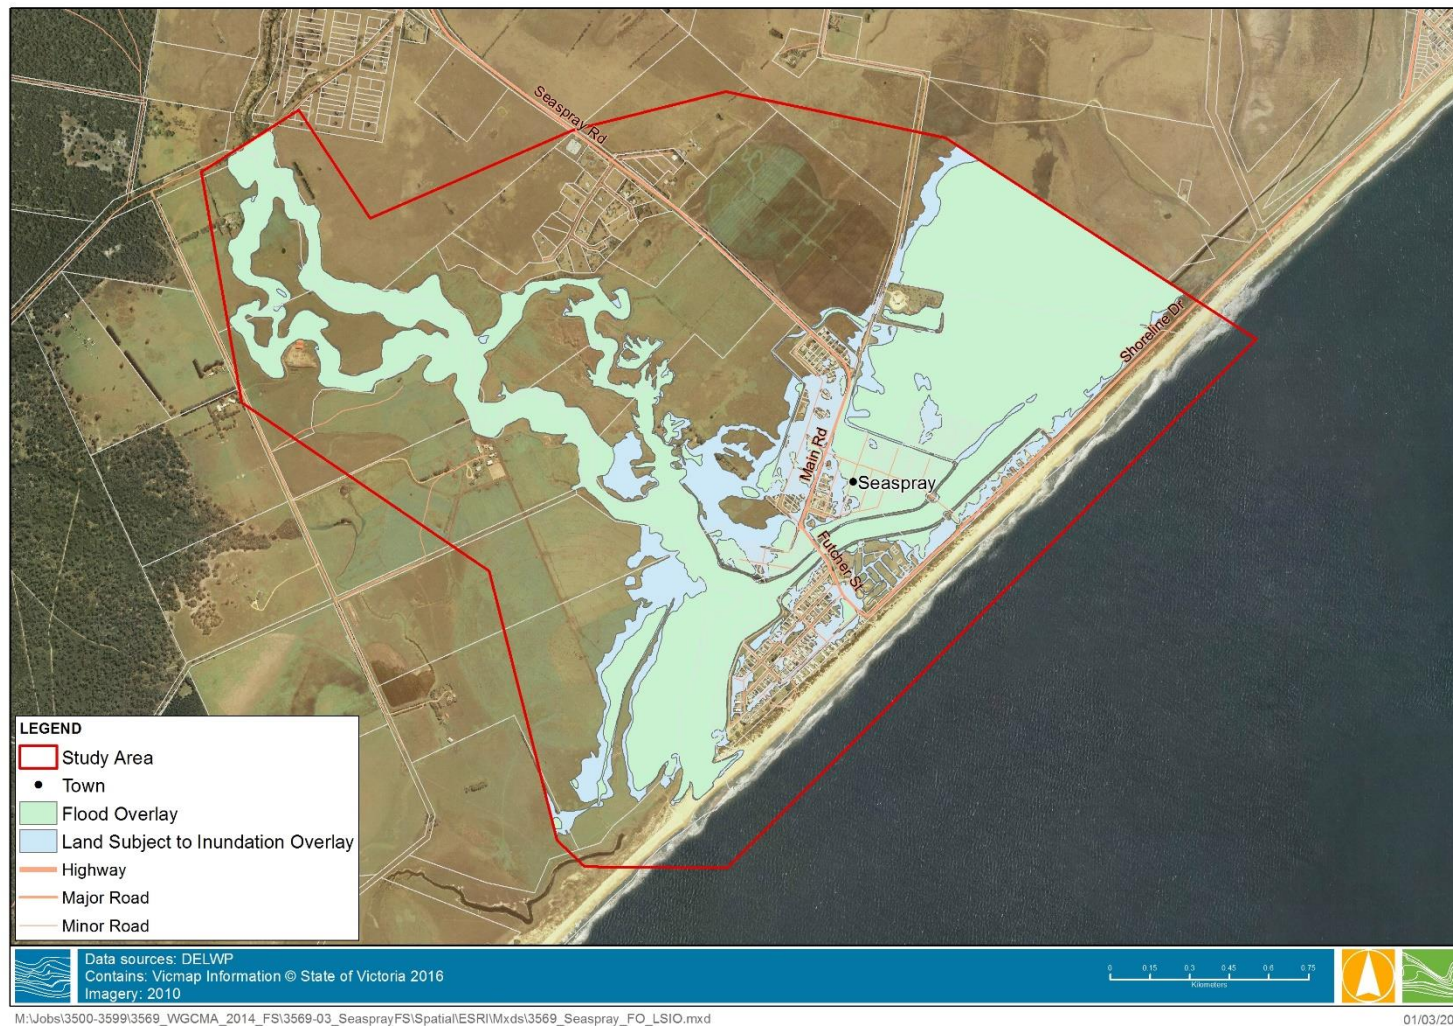
Figure 5-2 Draft LSI0 and FO Map for Existing Conditions

For the study area, FO and LSIO overlays have been developed based on accepted safety criteria (refer Report 4 for details). The resultant draft FO and LSIO maps are provided in Figure 5-2.
