# Rosedale Flood Study – Data Review (R01)

| Project Name | Rosedale Flood Study |
| Report Number | R01 |

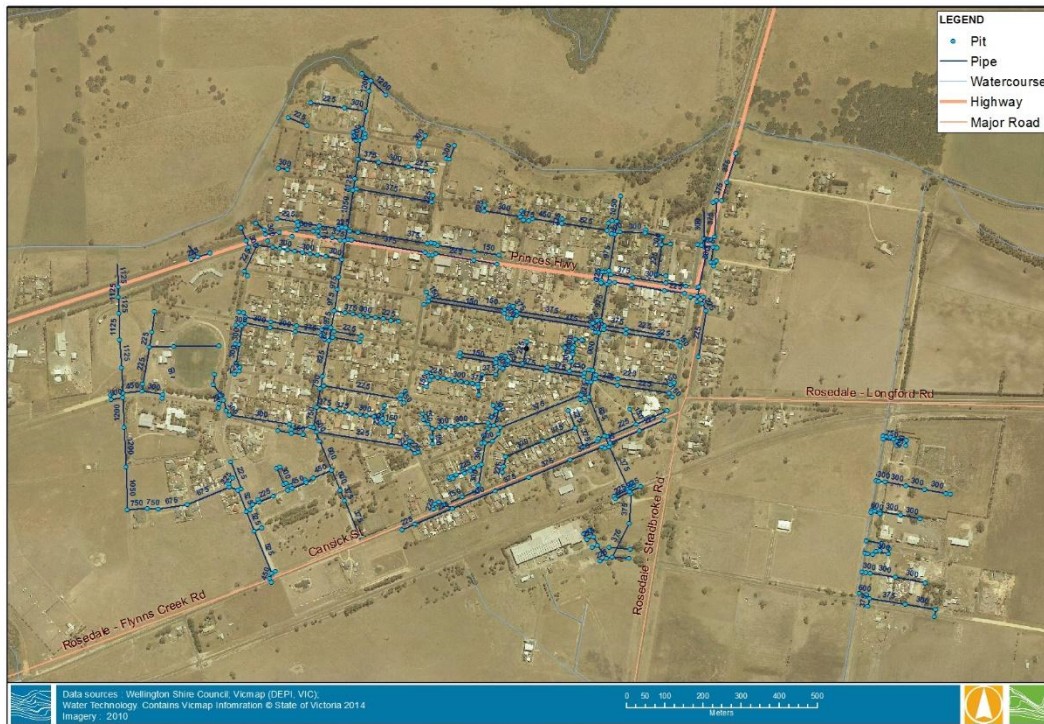
GIS layers of local pits and pipes were provided by Wellington Shire (Figure 6-6). [REDACTED] from Wellington Shire provided advice on the reliability of the pipe layer and additional/altered pipes. Broadly, the township is drained via three main drainage systems. A fourth system is found on the eastern edge of the township and forms part of the Holy Plains Drainage Scheme. A review of the data showed it is suitable for use in the hydraulic model of the township.

**Figure 6-6 Drainage GIS layers (Wellington Shire Council)**

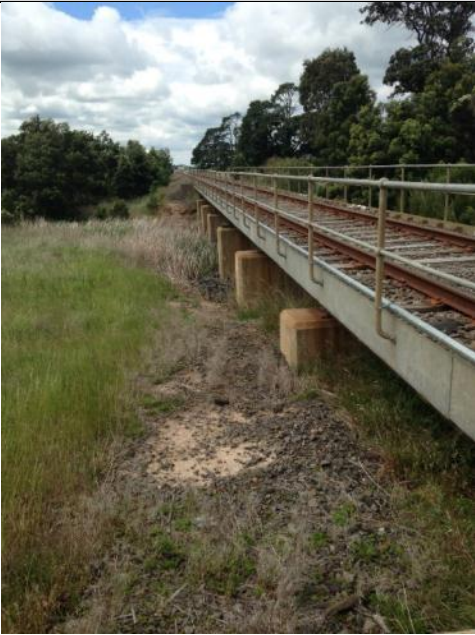
| Location/Notes | Photo |
|---|---|
| <p>Railway bridge (Blind Joes Creek);</p> <ul style="list-style-type: none"> <li>• Capacity of railway bridge was significantly greater than the Flynns Creek Road bridge;</li> <li>• It appeared the waterway upstream of the railway bridge had been fenced and re-vegetated, possibly by the local Landcare group;</li> <li>• Currently modelling shows the creek breaking out upstream of the railway bridge and flowing east (sitting behind the railway embankment); and,</li> <li>• A number of the railway openings were partially blocked with sediment, potential to increase capacity by excavating out material from under bridge with transition upstream and downstream.</li> </ul> | |

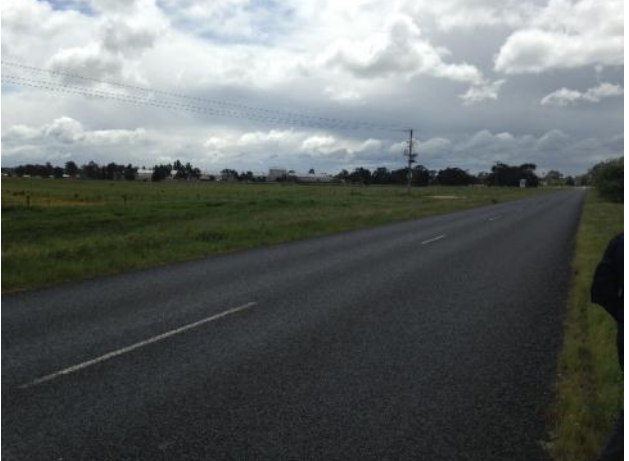
| Location/Notes | Photo |
|---|---|
| <p>Eastern Breakout - Rosedale floodway;<br/>Friends Road;</p> <ul style="list-style-type: none"> <li>• Current modelling shows flood water ponding behind Friends Road controlled by a single 0.9 x 0.6 m box culvert;</li> <li>• Current modelling shows breakout flows crossing the railway crossing (with Friends Road) and flowing into the vacant land proposed for R1Z development; and,</li> <li>• Adam Dunn (WGCMA) posed the question could more floodwater flow east, could this protect the land proposed for development.</li> </ul> <p>Willung Road;</p> <ul style="list-style-type: none"> <li>• Overland flow appears shallow and broad;</li> <li>• Willung Road inundated in June 2012, Adam Dunn (WGCMA) was pretty sure this was not from Blind Joes Creek - but more from local runoff;</li> <li>• 3 x 750 mm RCPs convey water under Willung Road; and</li> <li>• Minimal development on the floodplain, tannery or timber mill sits on a fill pad on the northern boundary of the floodplain.</li> </ul> | |

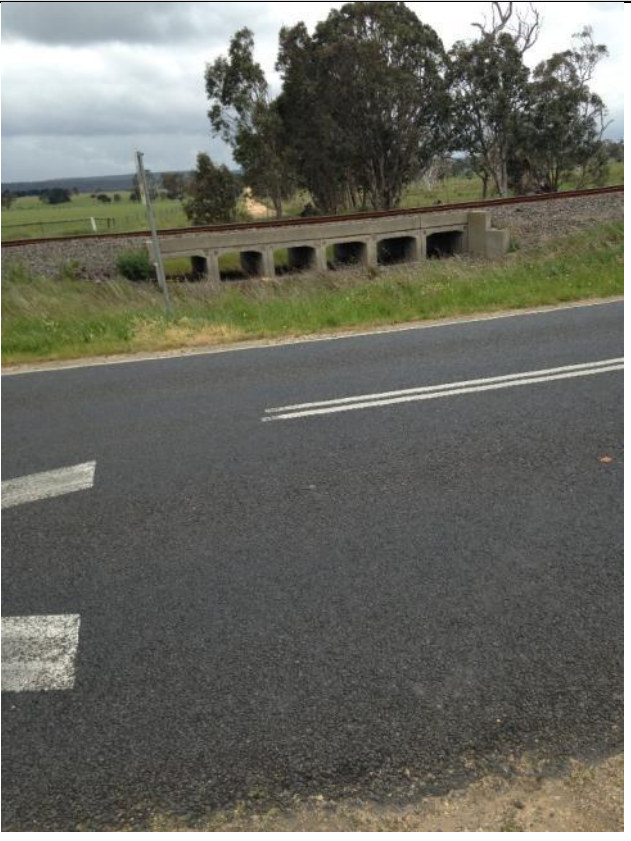
| Location/Notes | Photo |
|---|---|
| <p>Rosedale-Longford Road (Railway crossing);</p> <ul style="list-style-type: none"> <li>• Flows from the Rosedale Floodway (and other catchments) connect back to the Latrobe River floodplain near Mullocky Lane - 2 crossings under Rosedale-Longford Road and the railway; and,</li> <li>• Cut off drain observed on Mullocky Lane moving flow back to Rosedale-Longford Road.</li> </ul> | |

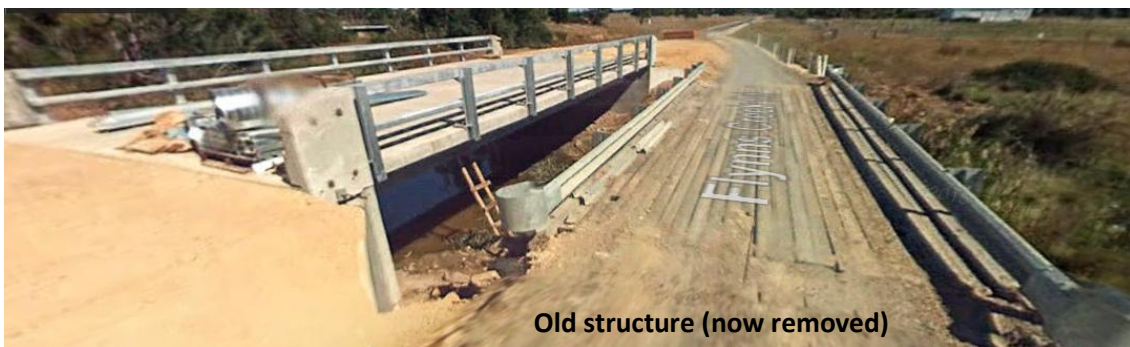
In two instances, major changes have occurred with the structures found in the catchment now to that found in the system during 1993 and 2012. After the 1993 flood, but prior to 2012 (suspected to be in 2008), significant works were completed on the Cansick Street (Flynn's Creek Road) bridge over Blind Joes Creek. These works included replacing the existing bridge and increasing waterway capacity upstream of the new bridge. No details were available of the old bridge or the land form prior to the works being completed. Water Technology worked with Wellington Shire council to establish the likely conditions at this time. The new bridge feature (surveyed by Beveridge Williams) is included in the 2012 and design flood modelling. Figure 4-7 (a screen shot from google maps) shows the two structures, the downstream (lower feature) was removed when the new bridge became operational.

**Figure 4-7 Blind Joes Creek – Cansick Street Bridge(s) – April 2008 - Source: Google Maps**

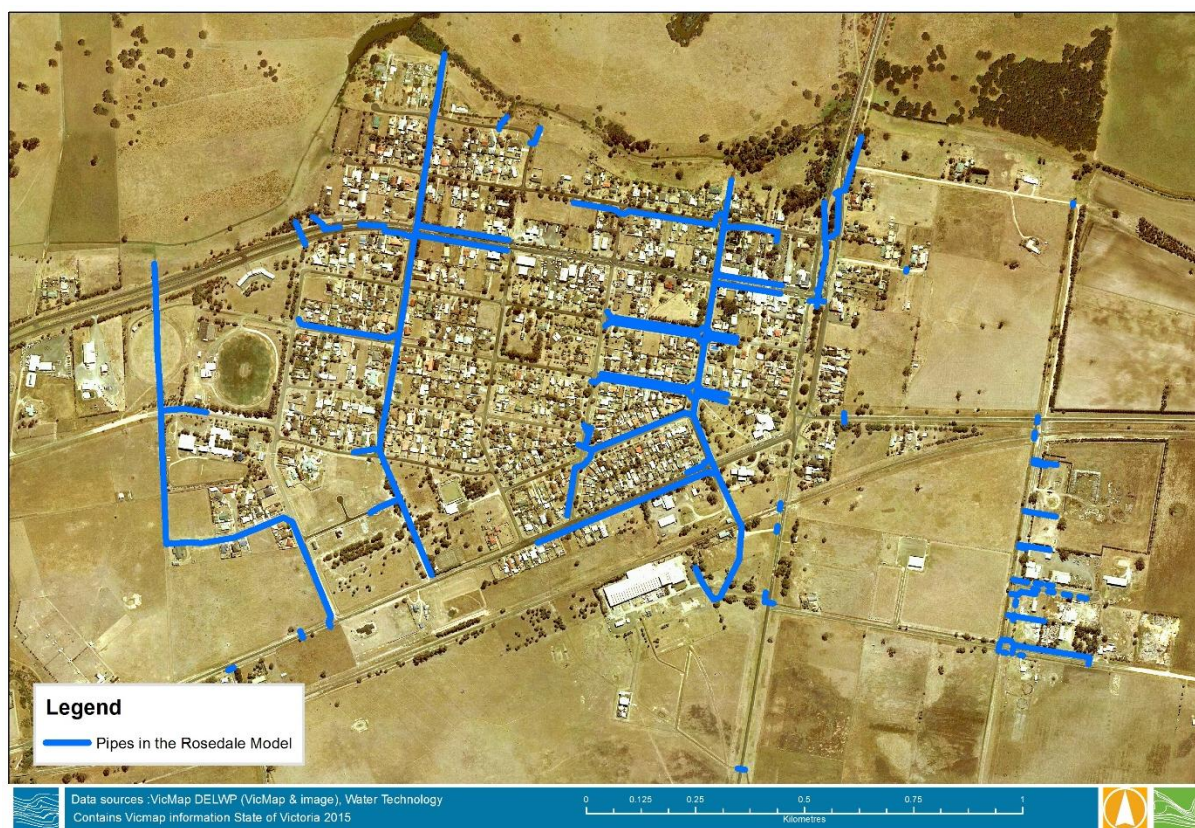
Following a data review, modification of the drainage dataset was undertaken to fill the missing gaps and further checks were undertaken to ensure the pit and pipe network placed into the model was functioning as expected. Much of this involved engineering judgement to schematise the drainage network slope throughout the catchment to ensure water is running downhill towards the outfall, as it was designed to do. This information was provided back to Wellington Shire Council in the final deliverables to help provide additional information in their database.

**Figure 4-9 Rosedale Flood Study Drainage Network Information**

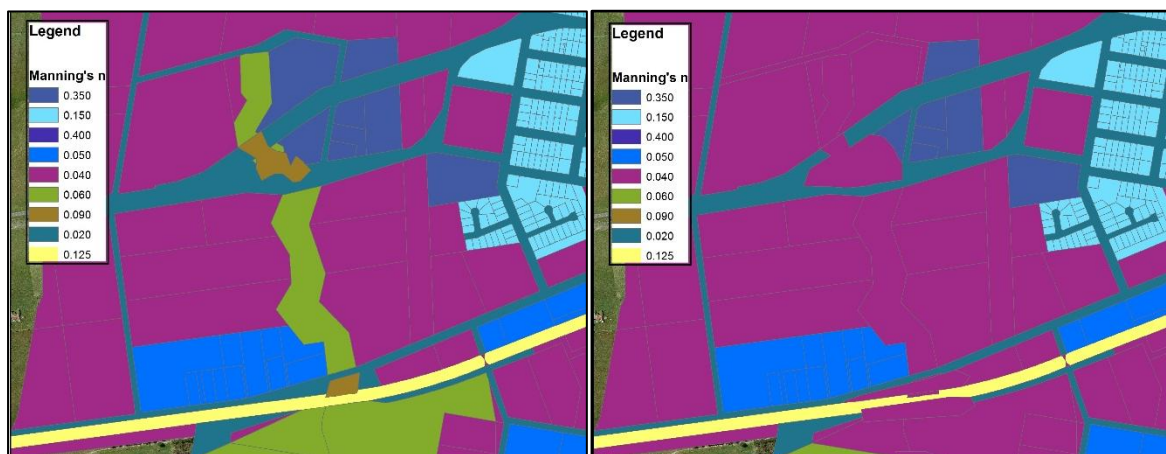
**Figure 9-2** Manning’s roughness applied inside the Blind Joes Creek LHS design modelling RHS roughness tested.
