# Seaspray Flood Study – Data Review (R01)

**March 2016**

| Project Name | 3369-03 Seaspray Flood Study |
| Client | West Gippsland Catchment Management Authority |

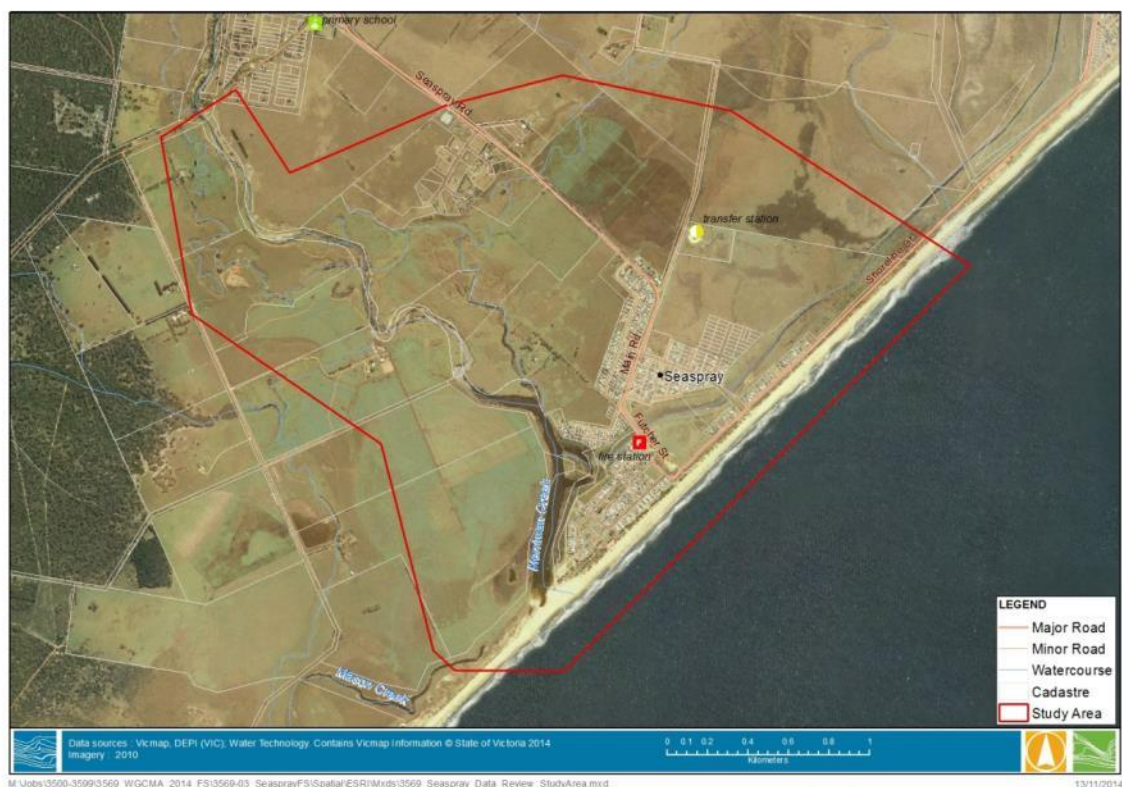
**Figure 2-1 Seaspray Study Area**

The town is located at the downstream end of the Merriman Creek catchment, with the creek flowing along the western boundary of the township, before it passes through the 90 Mile Beach coastal dunes system and enters the ocean. The study area and significant watercourses or flood related influences are shown in Figure 2-1.

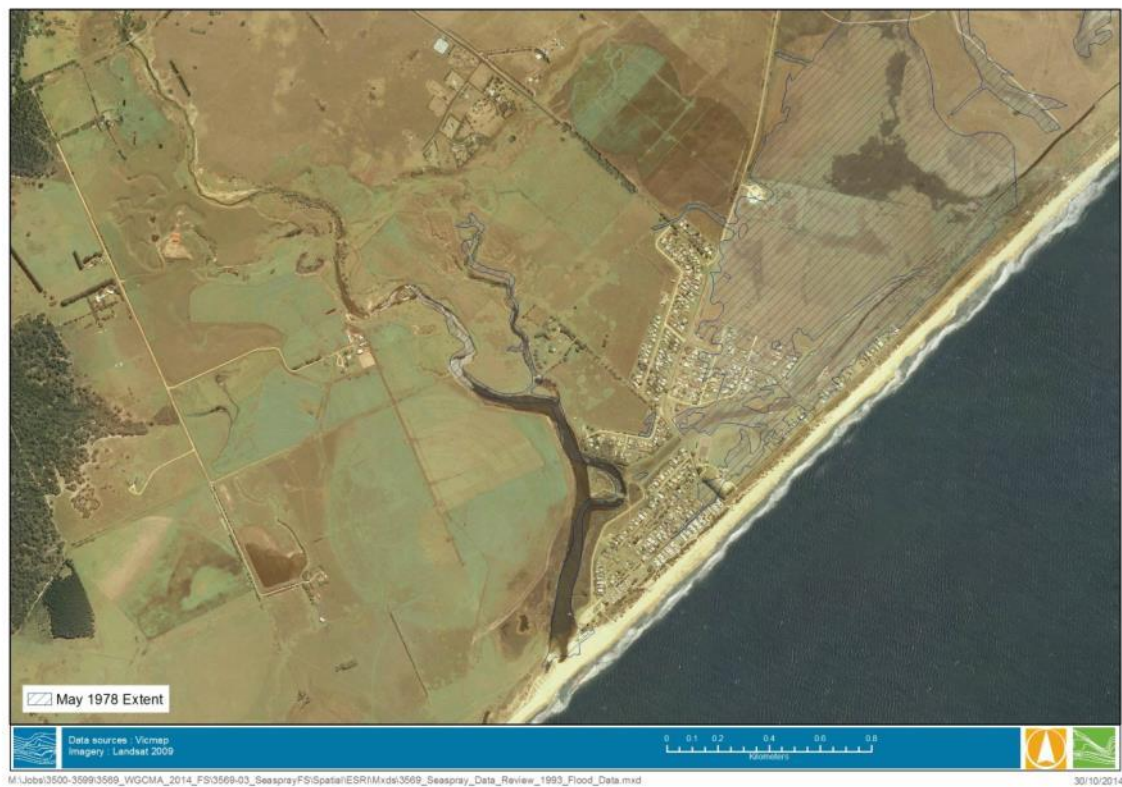
**Figure 5-1 May 1978 flood information in VFD**

Historic flood data recorded in the Victorian Flood Database (VFD) is summarised in Figure 5-1, Figure 5-2 and Figure 5-3 below. Note that flood heights for the May 1978 flood are not recorded in the VFD but are available in the 1978 Flood Report (SRWSC 1978). Some inconsistencies have been noted between the VFD data and the original data recorded in the 1978 and 1993.

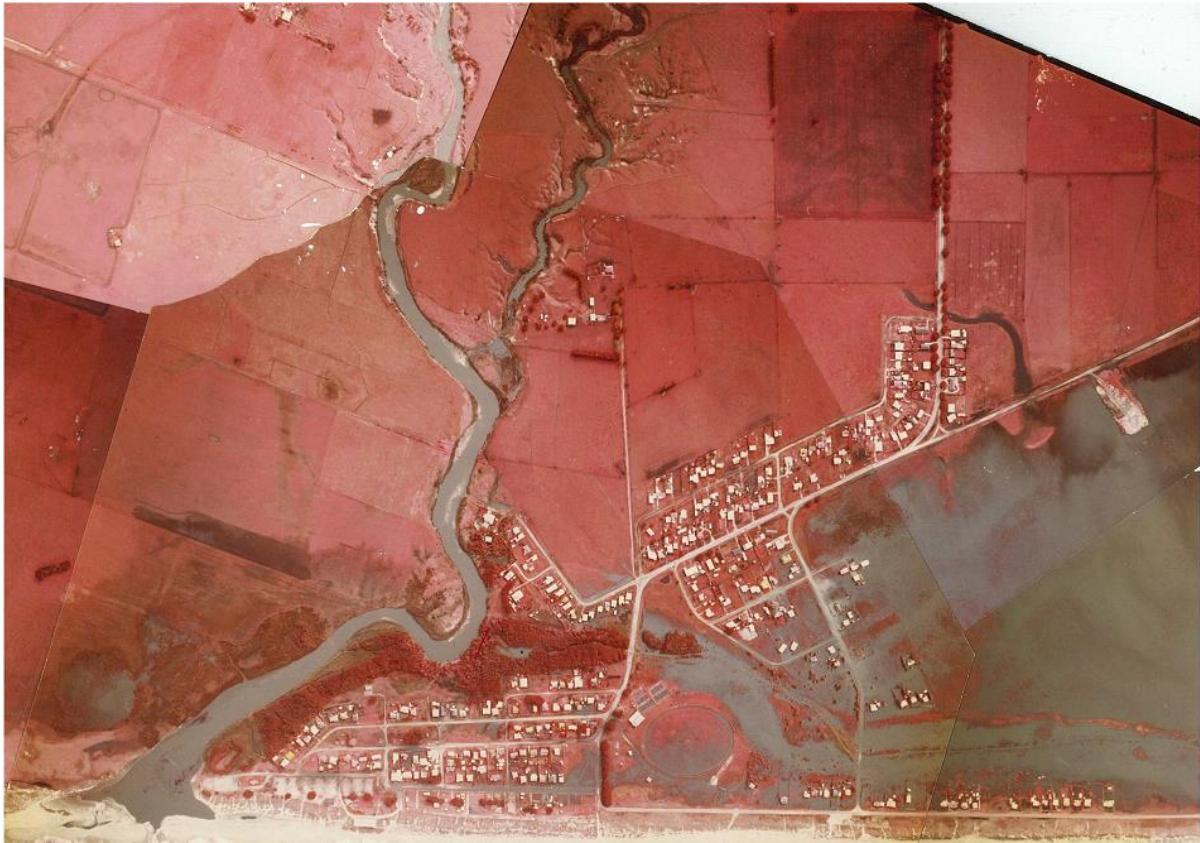
**Figure 5-4**      **CIR Imagery of May 1978 event**

Flood aerial photography is available for the May 1978 event in Colour and Colour Infrared (CIR) and the June 1978 event in CIR only. An example is shown in Figure 5-4 below. Aerial photography is also available for the aftermath of the 1993 event (28 September 1993) in the Hydrotechnology (1995) flood review.

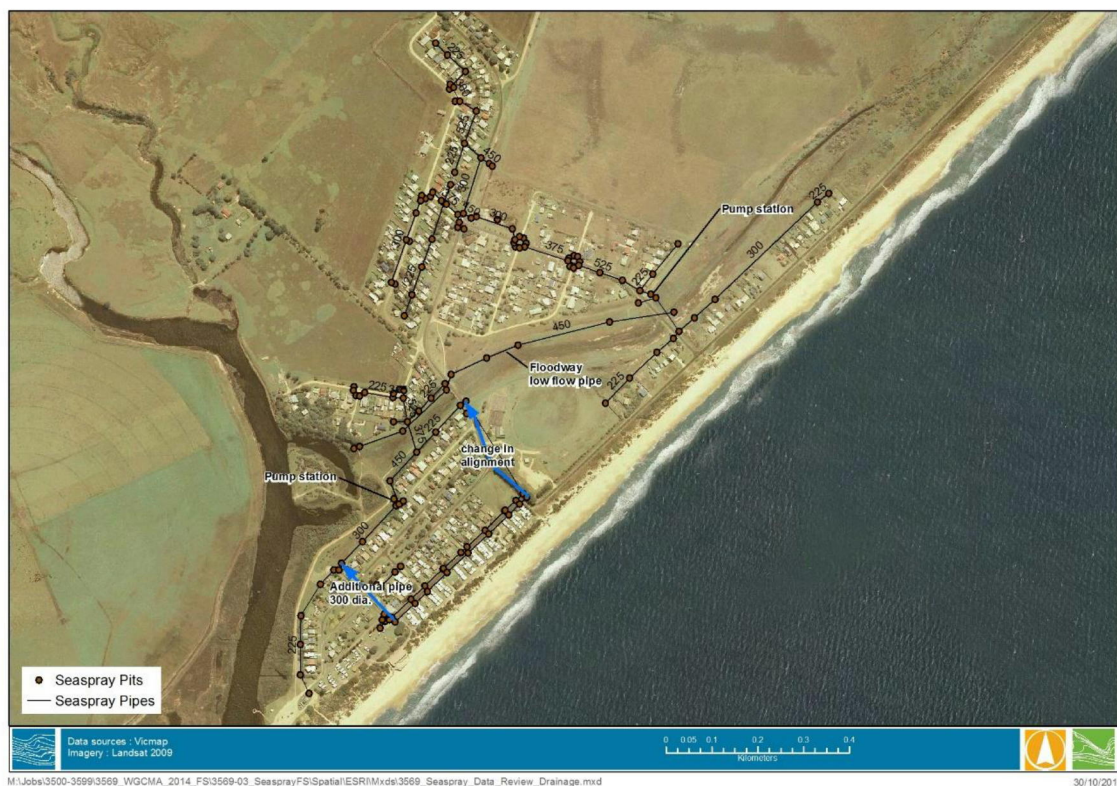
**Figure 6-4** Drainage GIS layers (Wellington Shire Council) and additional/alterd pipes as advised by

GIS layers of local pits and pipes were provided by Wellington Shire (Figure 6-4). from Wellington Shire provided advice on the reliability of the pipe layer and additional/altered pipes. The town of Seaspray is divided into two separate drainage areas. The area east of Futcher Road drains to a pump station on Centre Road on the northern side of the floodway, which pumps stormwater out to the floodway. The area west of Futcher Road drains to a pump station on Irving Street, which pumps to Merriman Creek. Each pump station has two pumps which have a maximum capacity of 170 L/s each. During a high rainfall event both pumps can be operated together giving a maximum discharge rate from each pump station of 340 L/s.

The caravan park has been constructed recently on the site of the former oval and has significant internal drainage infrastructure, including grated pits and pipes running along internal roads, and two retarding basins.

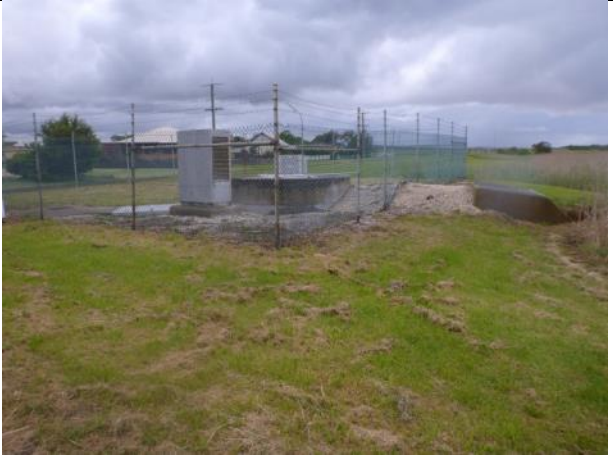
| Location/Notes | Photo |
|---|---|
| <p>Centre Road Pump Station</p> <ul style="list-style-type: none"> <li>All stormwater drains to 2 pump stations. Some stormwater from the northern levee area drains to the southern area via pipes under the floodway.</li> </ul> | |

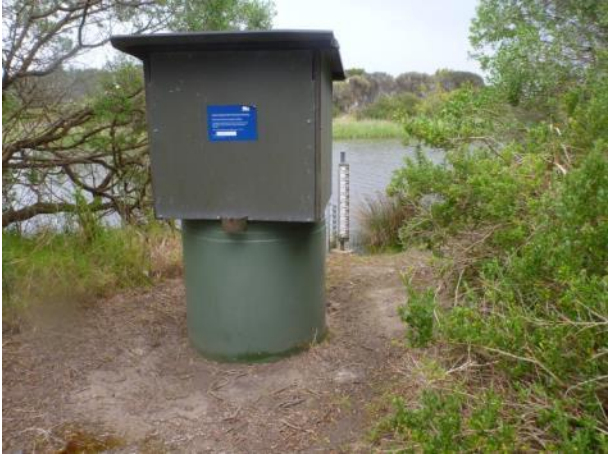
| Location/Notes | Photo |
|---|---|
| <p>Water Level Gauge</p> <ul style="list-style-type: none"> <li>Lagoon quite high, 1.3 m on gauge</li> </ul> | |

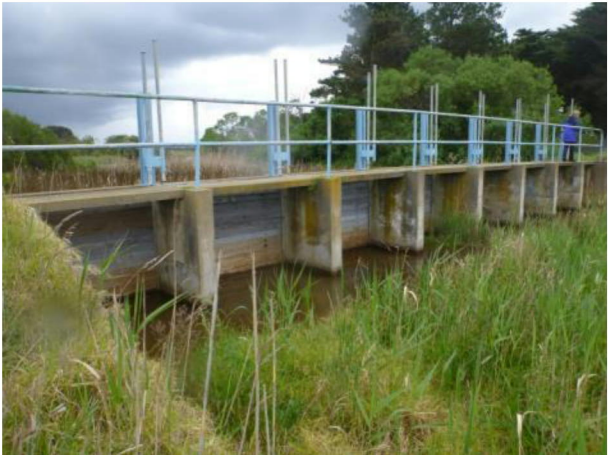
| Location/Notes | Photo |
|---|---|
| <p><b>Regulator</b></p> <ul style="list-style-type: none"> <li>All boards were in. Boards come up to top of concrete walkway.</li> <li>(Wellington Shire Council) advised that current practice is to leave all boards in at all times, which deviates from the operating procedure. The rationale behind this is that the priority during a flood is to get the entrance open, and if the floodway is open it can create conditions where the entrance is less likely to scour out properly when opened. The regulator would only be opened if water was required to top up Lake Reeve. In a typical flood it can be assumed to remain closed.</li> </ul> | |

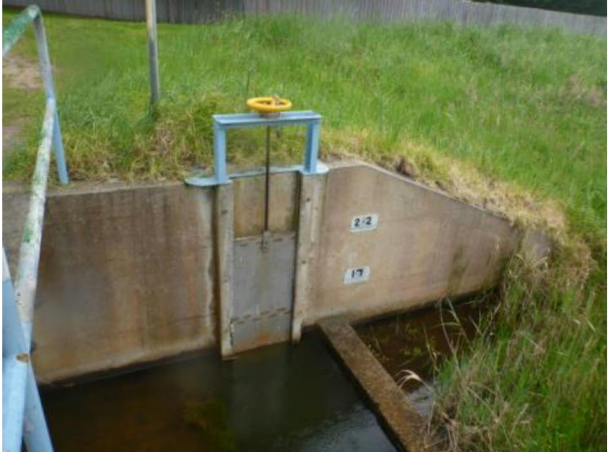
| Location/Notes | Photo |
|---|---|
| <p><b>Low flow gate at Regulator (closed)</b></p> <ul style="list-style-type: none"> <li>Small regulators on each side of the regulator are intended to allow low flow through to Lake Reeve. The floodway side should be kept open but is currently closed and cannot be operated. The lagoon side was also closed. The low flow pipe runs to an outlet at the Centre Road crossing of the floodway.</li> </ul> | |

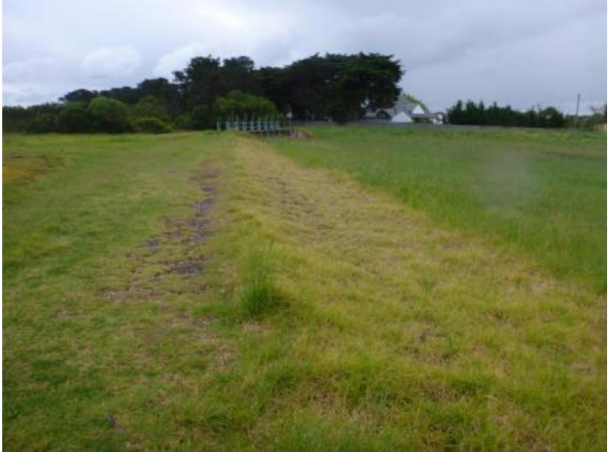
| Location/Notes | Photo |
|---|---|
| <p><b>Spillway beside regulator</b></p> <ul style="list-style-type: none"> <li>Next to the regulator is a wide spillway at a lower level than the top of the boards. The weir is constructed of rock gabions or rock covered with mesh)</li> </ul> | |

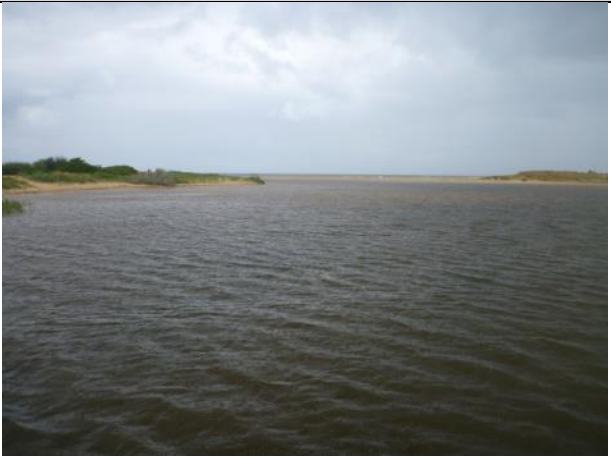
| Location/Notes | Photo |
|---|---|
| <p>Merriman Creek Lagoon</p> <ul style="list-style-type: none"> <li>Entrance closed</li> <li>Large lagoon on ocean side of dunes, stretching toward surf club</li> <li>Phragmites along fringes of lagoon, some swamp paperbark around The Island</li> </ul> | |

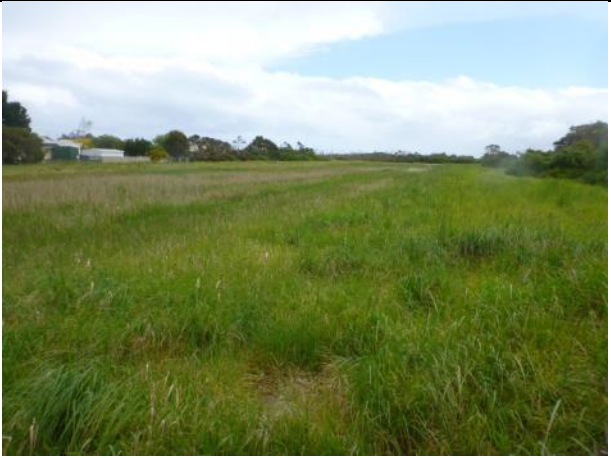
| Location/Notes | Photo |
|---|---|
| <p>Floodway (looking west from Futcher Road)</p> <ul style="list-style-type: none"> <li>High grass in Floodway</li> </ul> | |

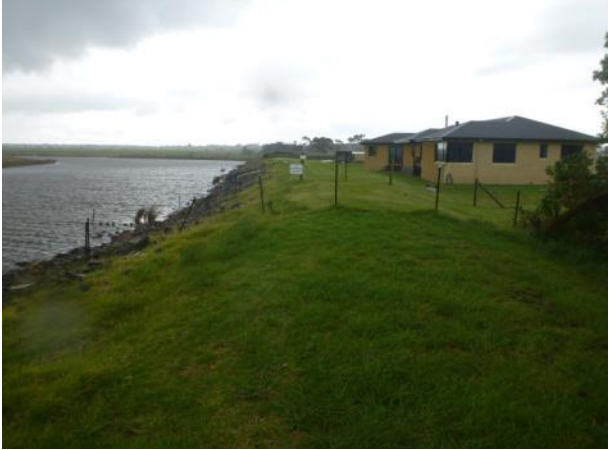
| Location/Notes | Photo |
|---|---|
| <p>Levee north of The Island</p> <ul style="list-style-type: none"> <li>Levees have recently been surveyed by SKM. A section north of The Island was missed.</li> <li>All levees appeared in good condition</li> </ul> | |

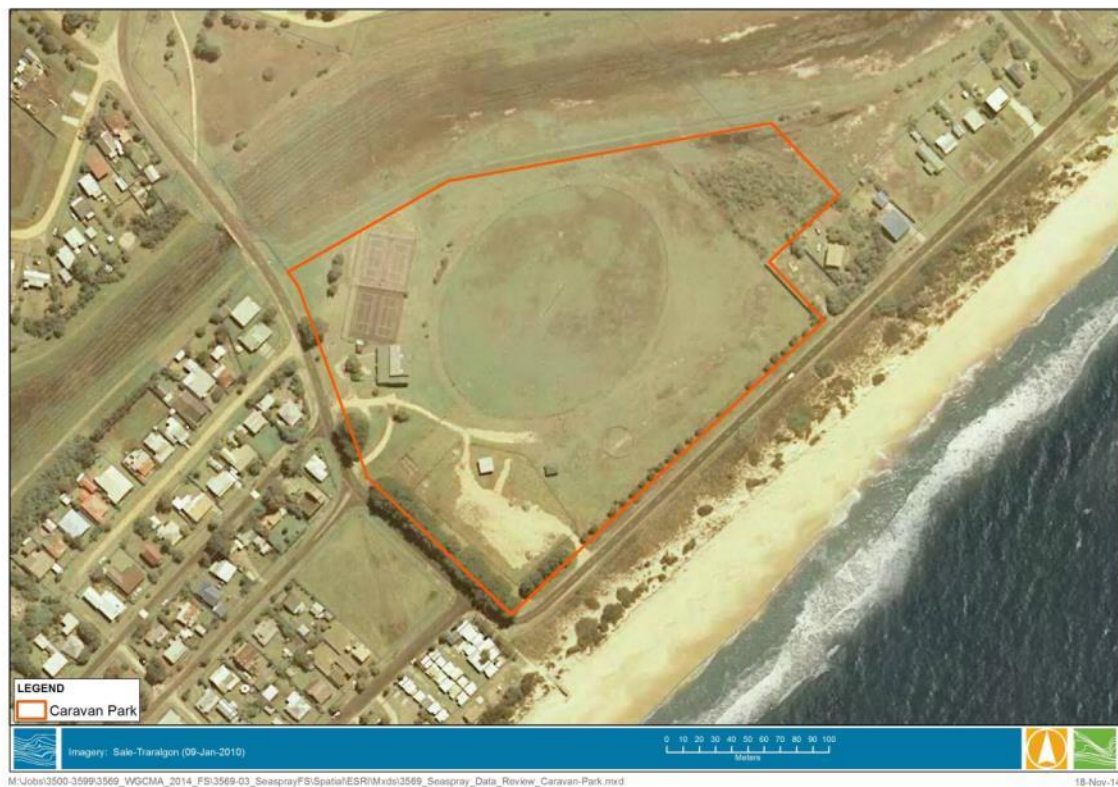
**Figure 11-1**      **Location of Seaspray Caravan Park**

Since the collection of the various LiDAR datasets the Seaspray caravan park has been relocated to an area that was formally the football oval, as shown in Figure 11-1. The ground surface levels in this area have been raised and significant drainage infrastructure has been installed. Information was requested from the Seaspray Foreshore Committee for any “as-built” survey or drainage plans, however no information was available. Wellington Shire Council provided design information including ground levels and drainage layout and this information has been adopted for the study.

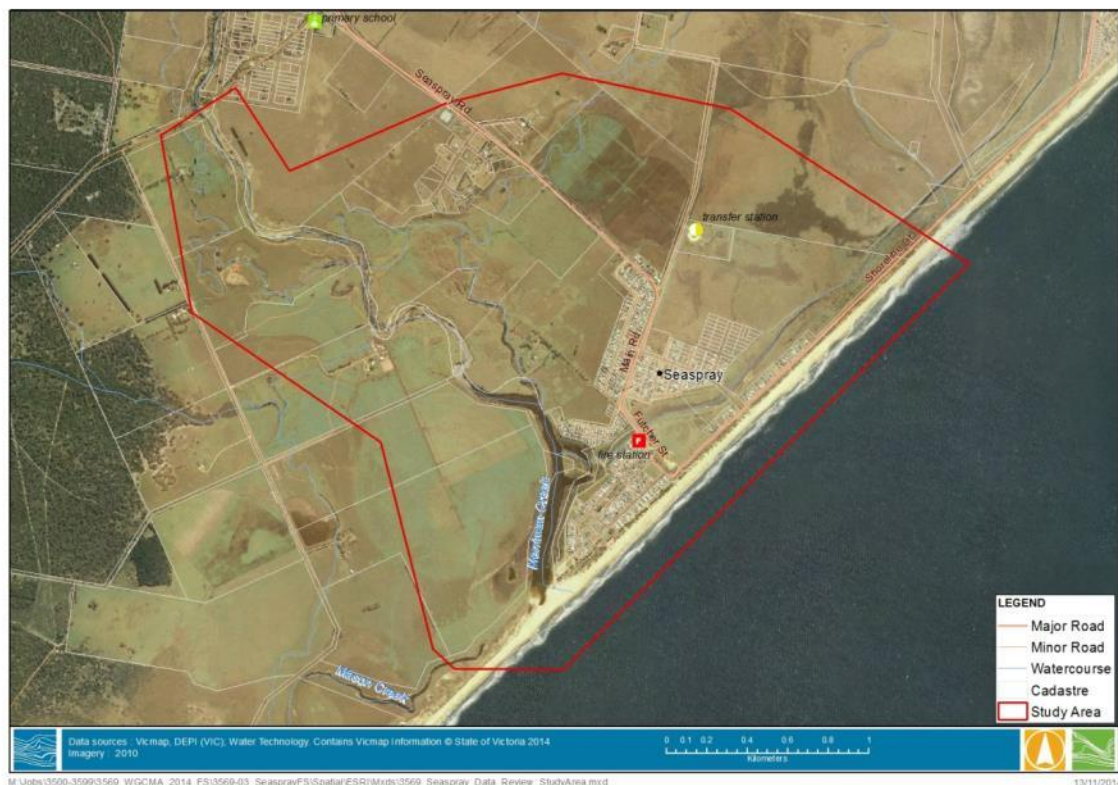
**Figure 2-1 Seaspray Study Area**

The town is located at the downstream end of the Merriman Creek catchment, with the creek flowing along the western boundary of the township, before it passes through the 90 Mile Beach coastal dune system and enters the ocean. The study area is shown in Figure 2-1.

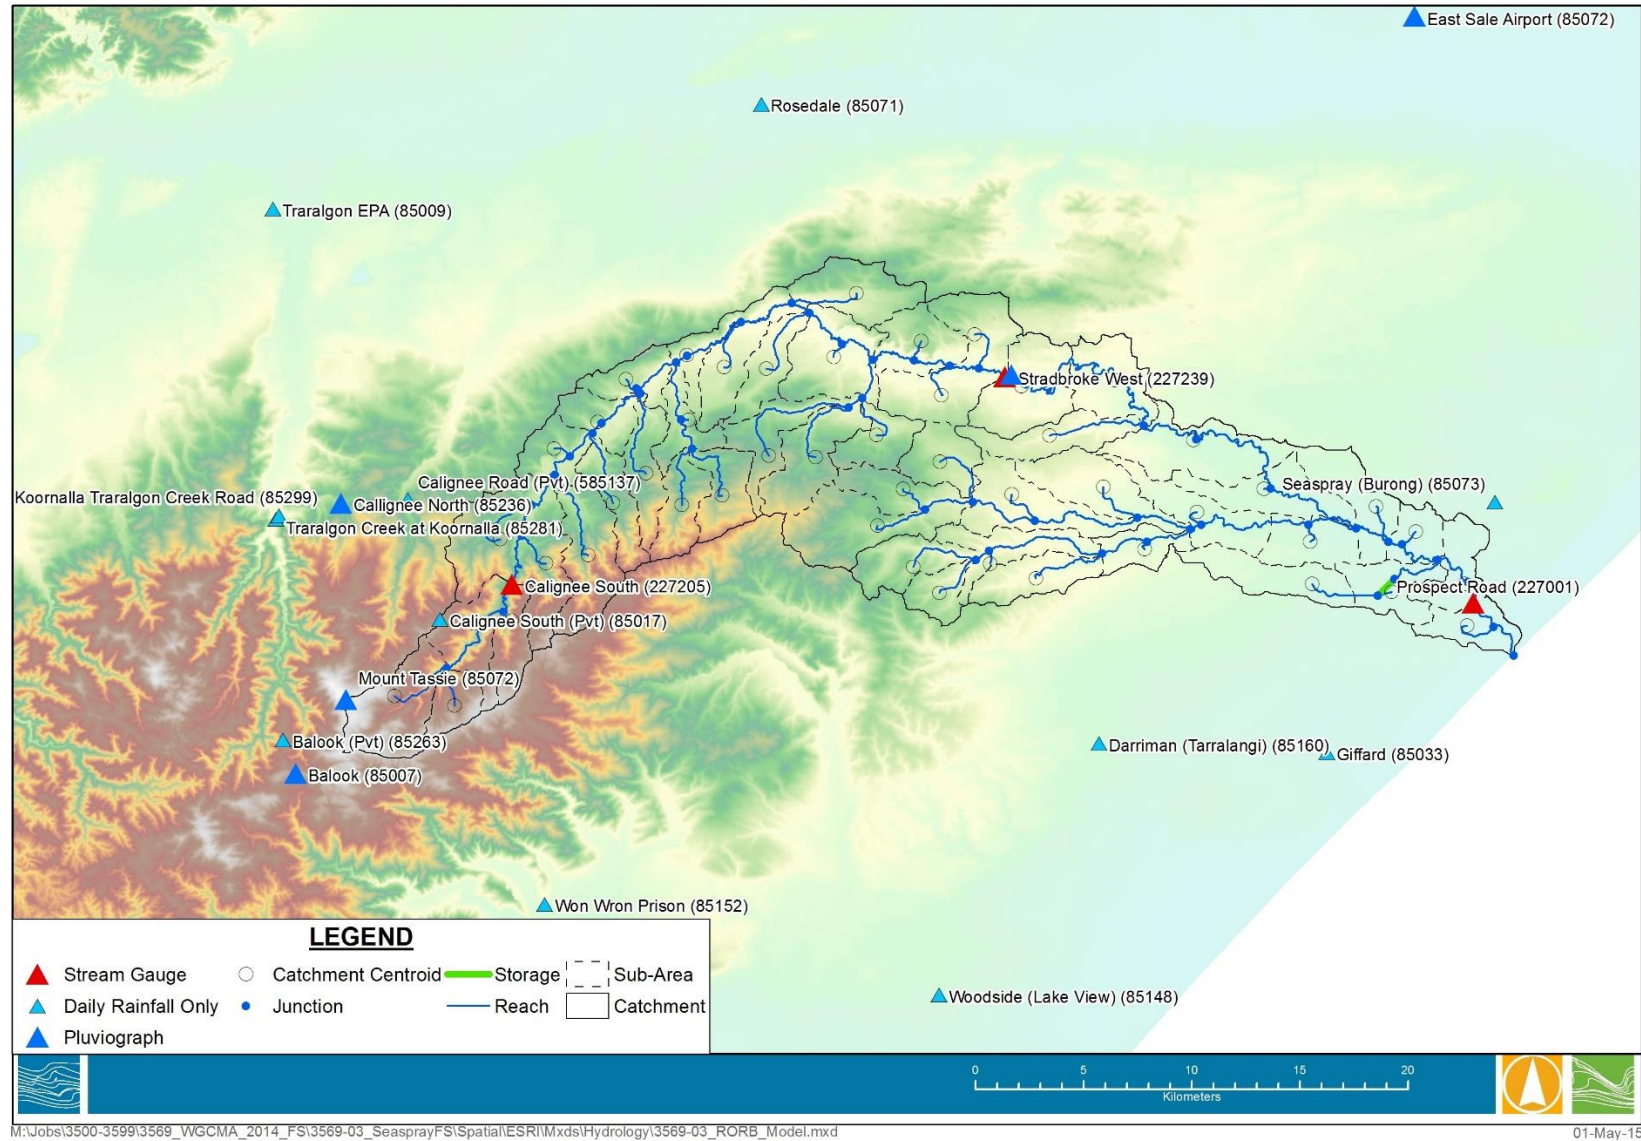
**Figure 3-12 RORB model structure**

The RORB model was at a resolution adequate to resolve the main drainage paths and sub-catchments, and to provide smooth hydrographs for the hydraulic model.

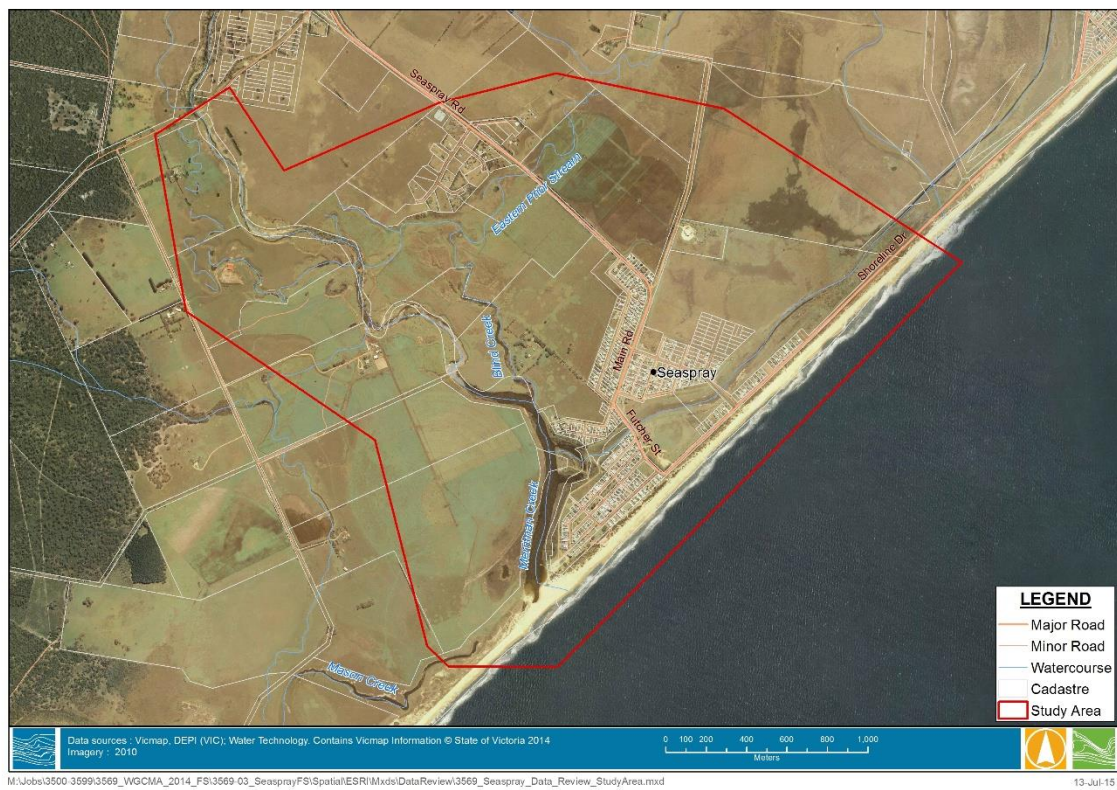
**Figure 2-1 Seaspray Hydraulic Model Area**

- Overbank flows from Merriman Creek,
- Coastal inundation due to elevated ocean levels,
- Flooding from the Gippsland Lakes via Lake Reeve,
- Localised stormwater flooding.

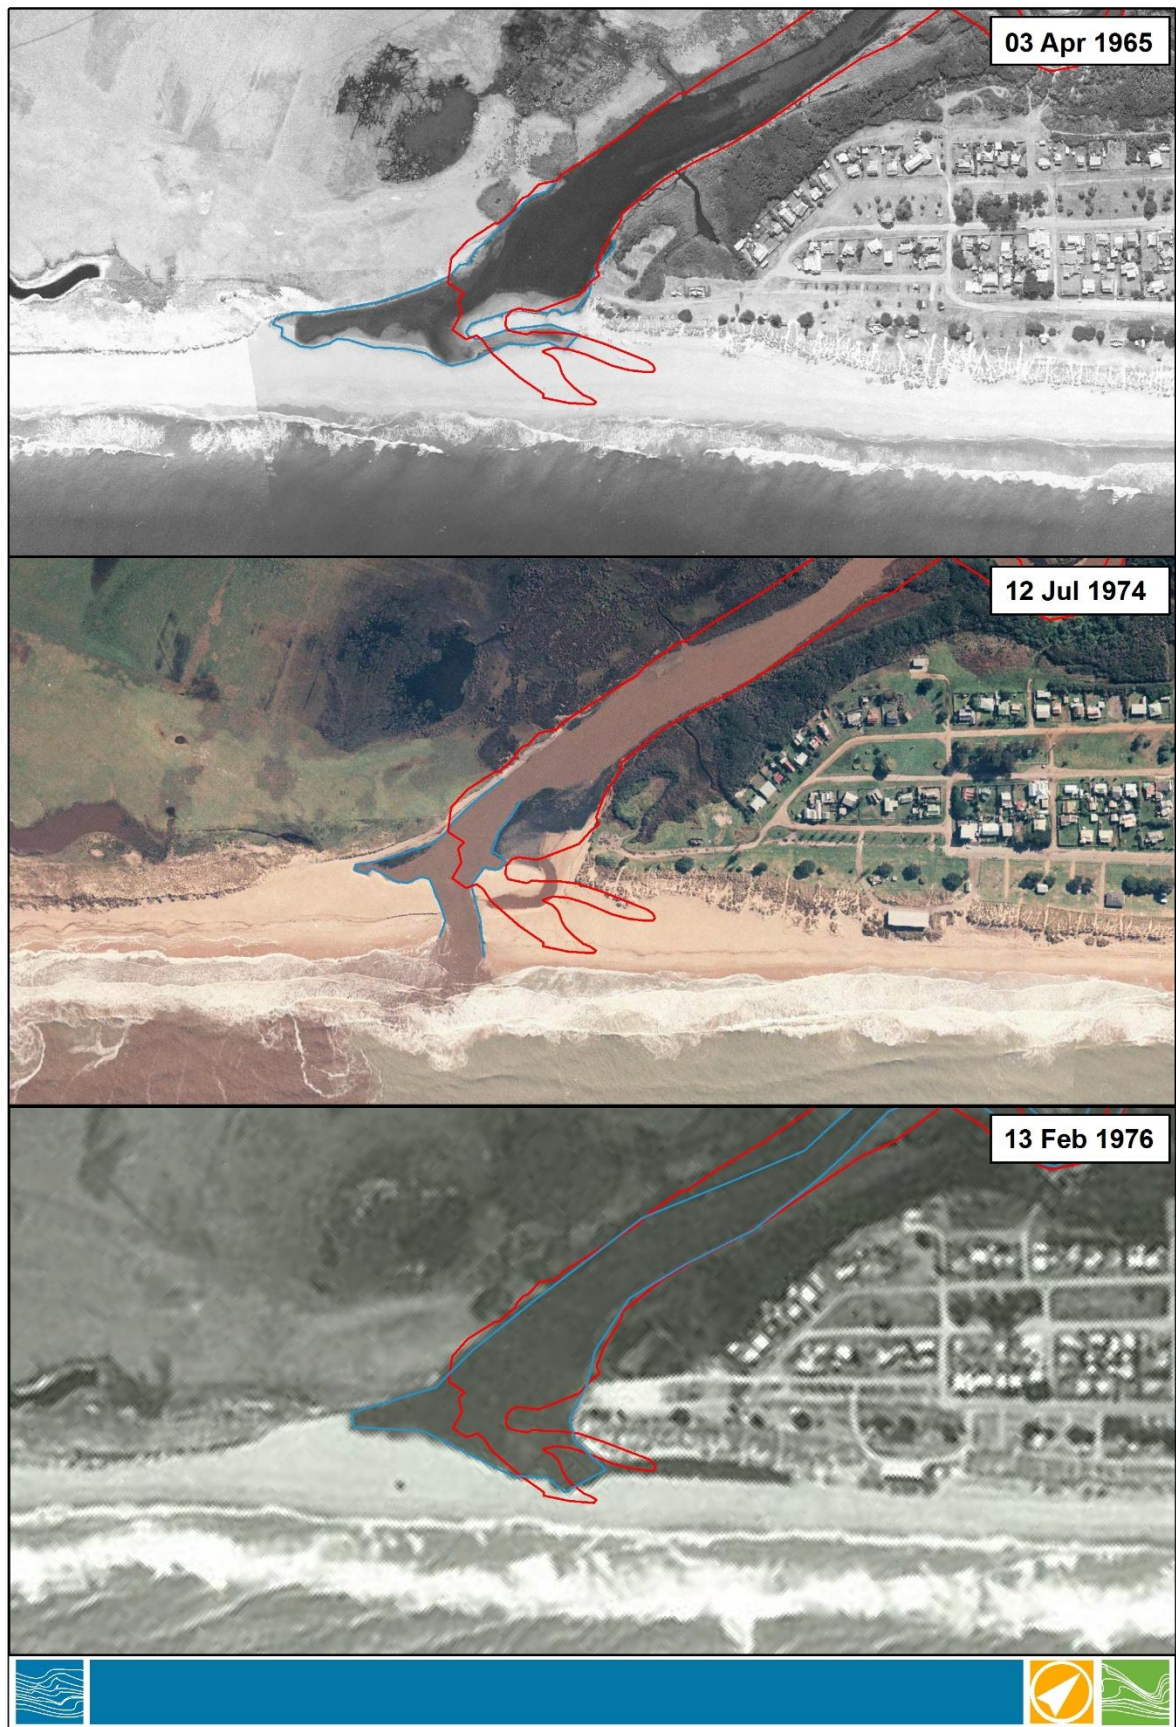
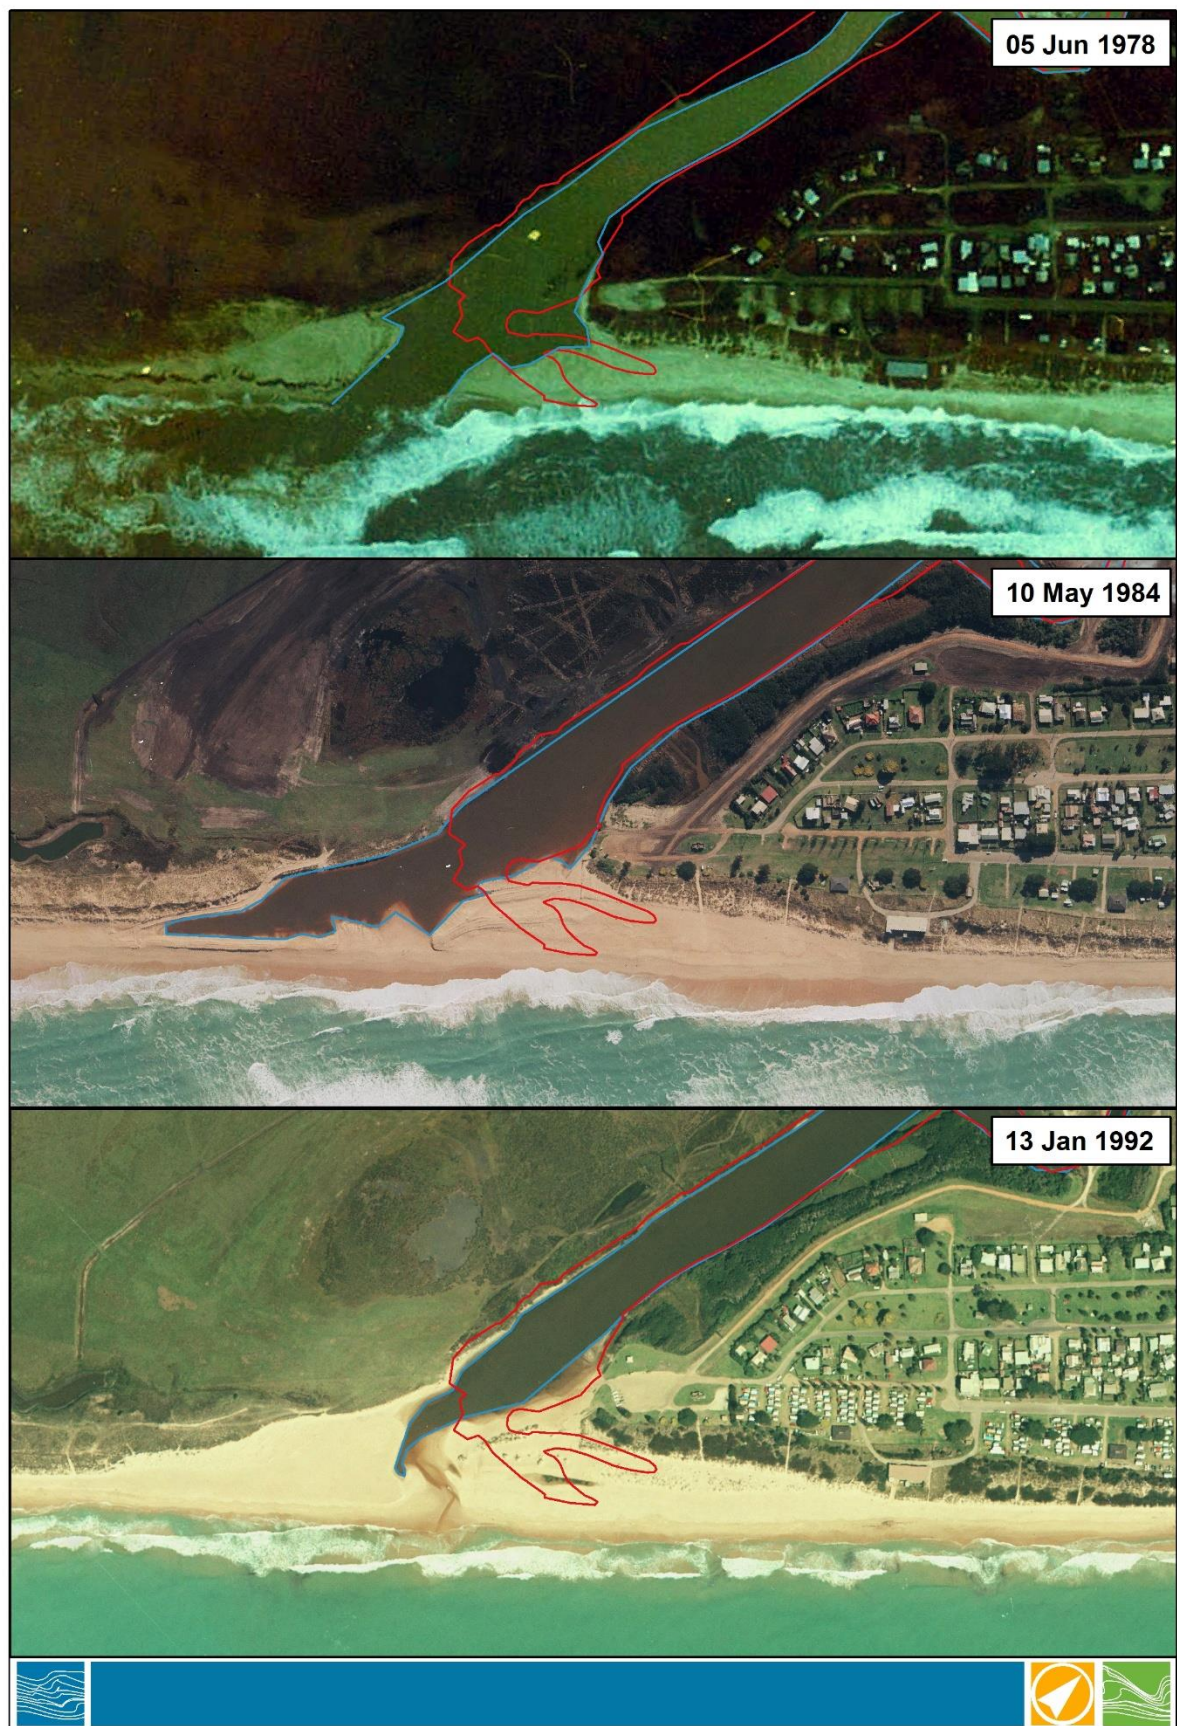
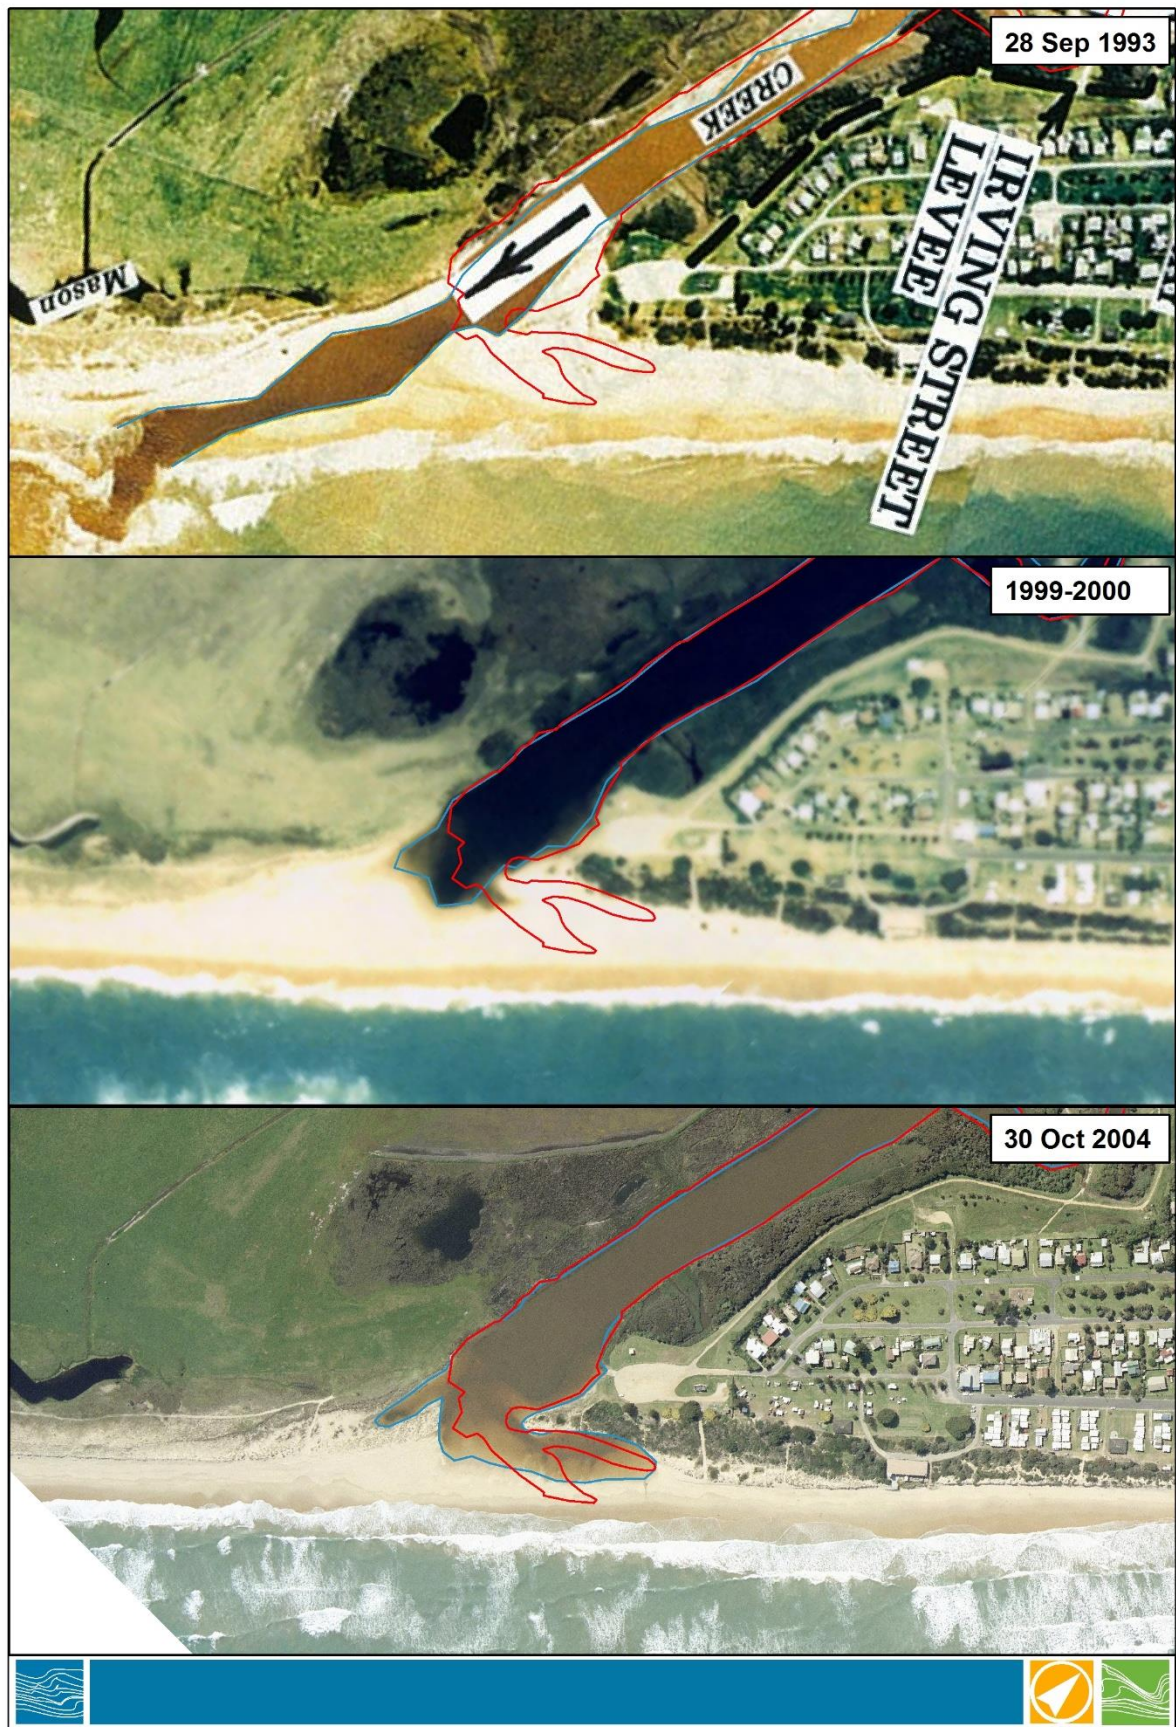
A selection of aerial photographs has been collated showing various open and closed configurations of the entrance between 1965 and 2011. Each of the photographs are overlaid by a red polygon showing the most recent March 2011 condition of the entrance to allow a comparison to the range of historical conditions. Throughout the historical photographs, the lagoon can be seen migrating

east and west behind the accumulated sand berm. However, the photographs also suggest that when a break-out flow occurs, the berm is breached either directly straight out into the sea, or to the west, in alignment with the lower reach of Merriman Creek.

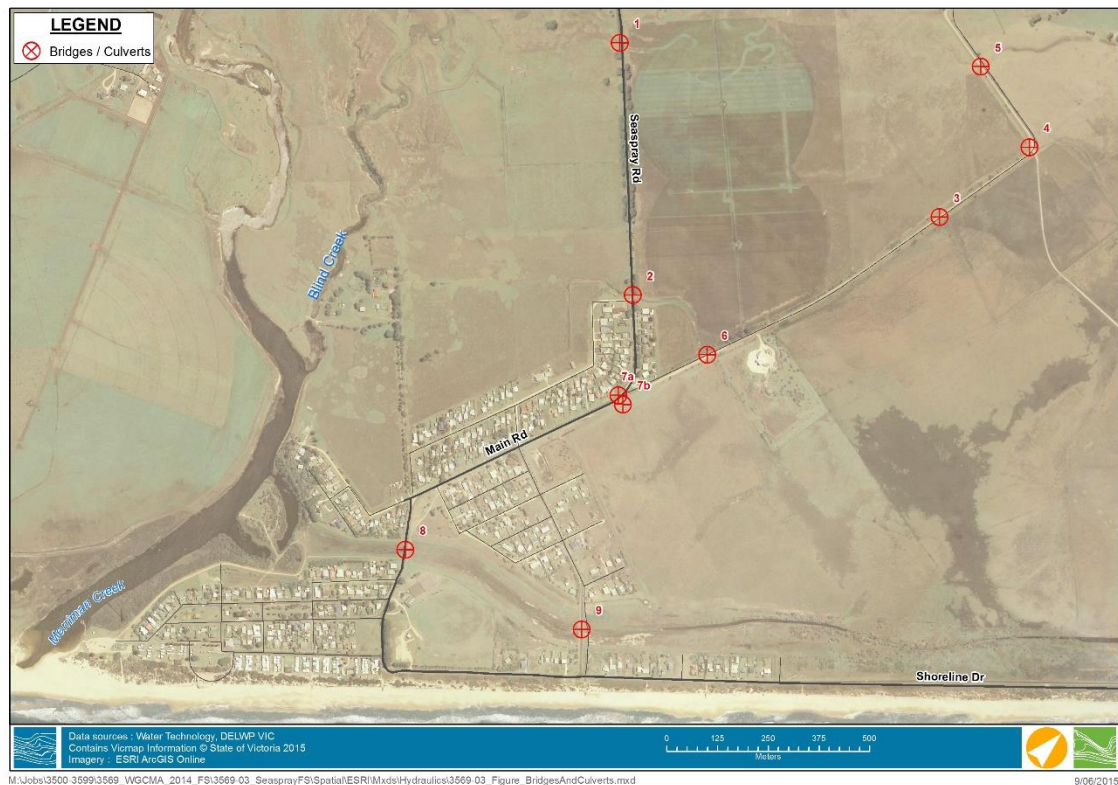
**Figure 3-10 Surveved Bridges and Culverts**

The main bridges and culverts were included in the model as structures defined by their dimensions. The dimensions for the bridges and culverts were determined during a site visit as listed in the Data Review Report (R01).

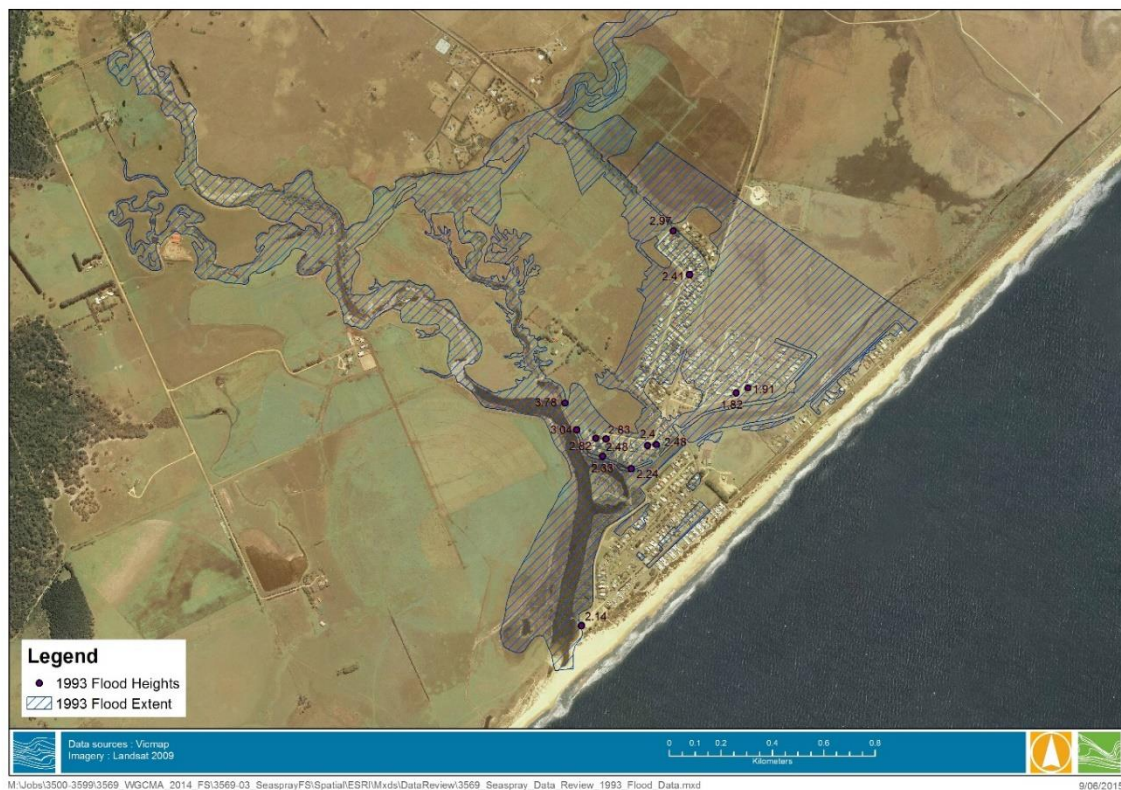
**Figure 5-1 1993 Flood Information in VFD**

In September 1993 an intense low off the east coast generated south-easterly winds blowing across eastern Victoria resulting in heavy rainfall. The catchment of Merriman Creek received the highest precipitation on record and as the flow reached the coast, it caused extensive flooding of the township of Seaspray (HydroTechnology, 1995). The Flood Summary Report prepared by HydroTechnology (1995) provides details of the 1993 flood including inundation extents, spot flood levels, and impacts in Seaspray. A hydraulic model was simulated for the 5 day period from 15 September 1993 to 20 September 1993.

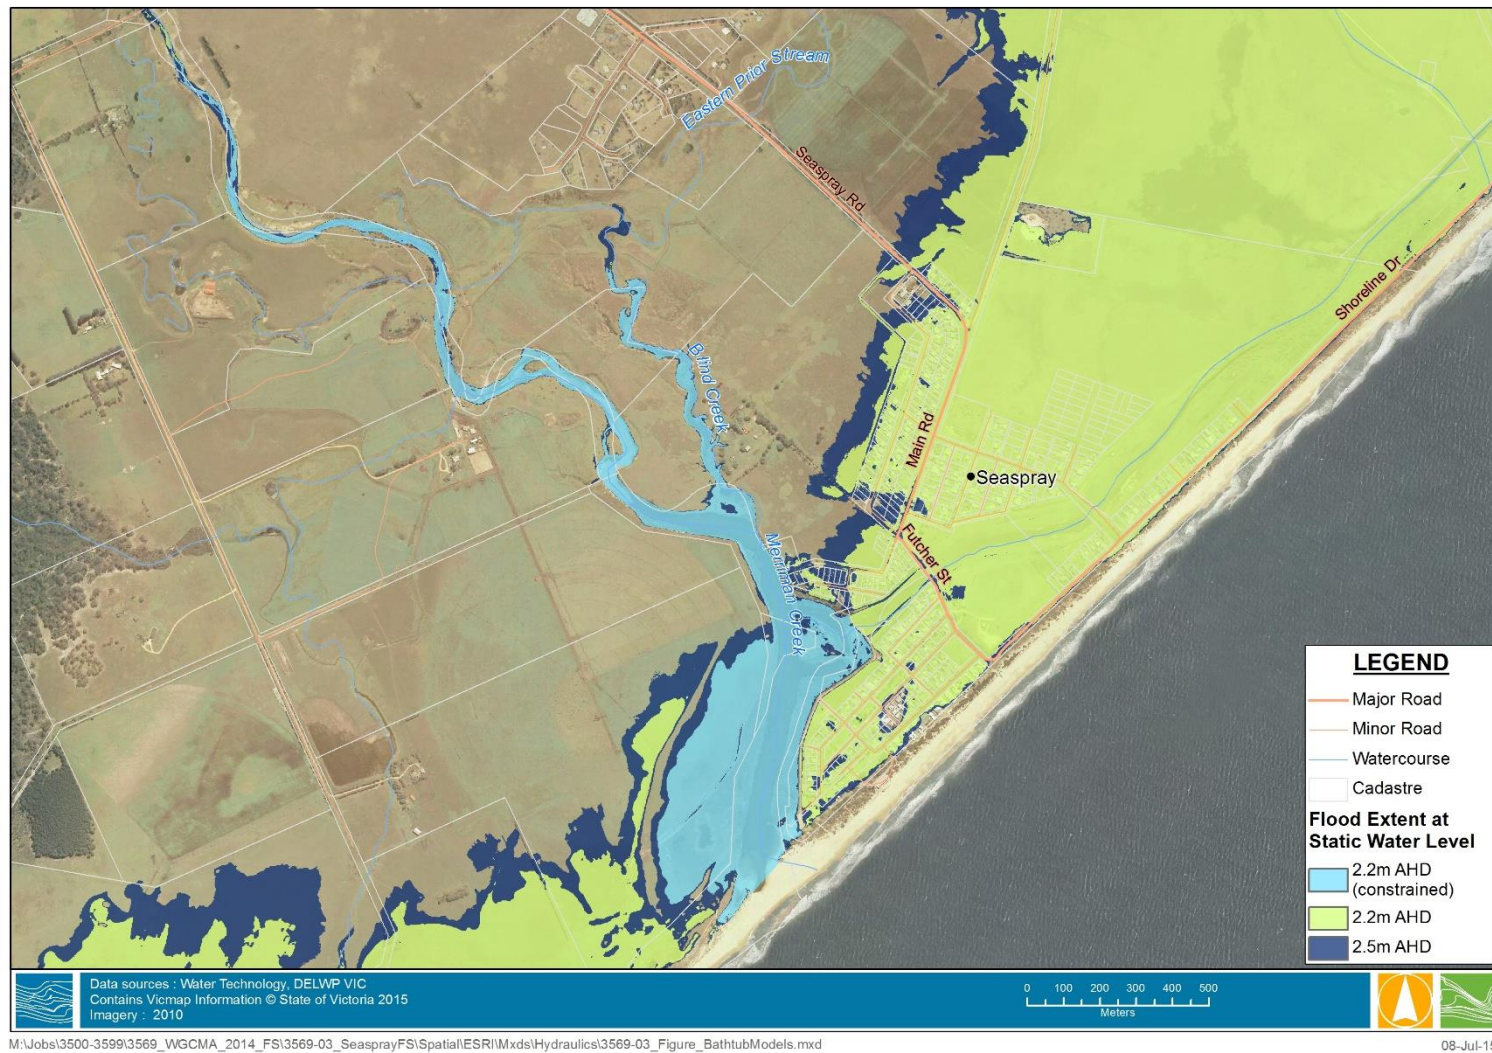
**Figure 6-2 Bathtub Inundation Extents at Seaspray for Berm Heights of 2.2 m and 2.5 m AHD**

The limitation of this approach is that the modelled extents only take into account a single water level and do not take into account the dynamics and volume of the flood event. It is unlikely that a flood event in Merriman Creek would be of sufficient volume to inundate all of the areas shown. Additionally, the effect of levees on preventing inundation of certain areas is not explicitly taken into account. For example, if the crest elevations of the levees along Merriman Creek are taken into account, the flood extent to the east of the creek is significantly limited for a water level of 2.2 m AHD, as shown in Figure 6-2 (labelled 2.2 m AHD constrained).
