# Seaspray Flood Study – Data Review (R01)

**March 2016**

| Project Name | 3369-03 Seaspray Flood Study |
| Client | West Gippsland Catchment Management Authority |

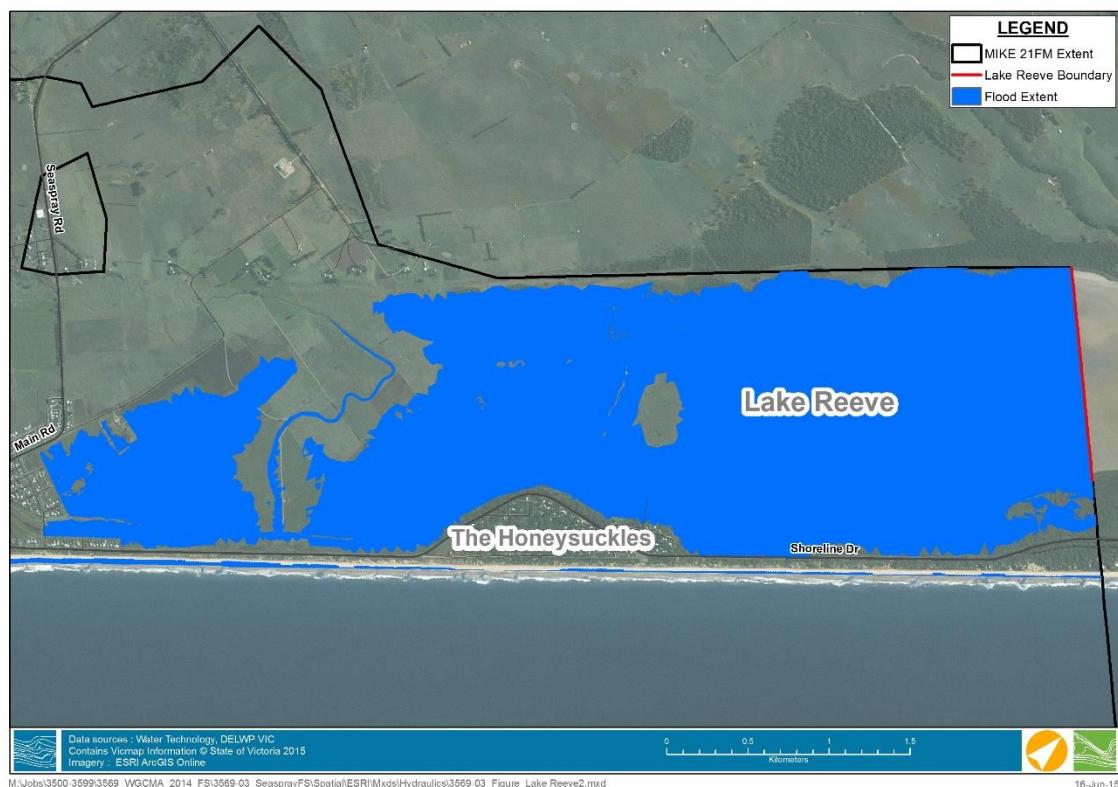
**Figure 6-9 Flood Extent with water levels at Lake Reeve raised to 1.37 m AHD**

For the present assessment this previous work was reassessed using the more detailed model of Lake Reeve and Seaspray that has been developed. The level in Lake Reeve was set to 1.37 m, based on the 2014 results for the 10% AEP flood with +0.8m sea level rise, and water from the lake was allowed to flow towards Seaspray.

The resultant flood extent is shown in Figure 6-9, with water reaching the levees at the eastern end of the floodway but no overtopping of the levees occurred. It is therefore unlikely that flooding from Lake Reeve is a mechanism for flooding of the township of Seaspray.

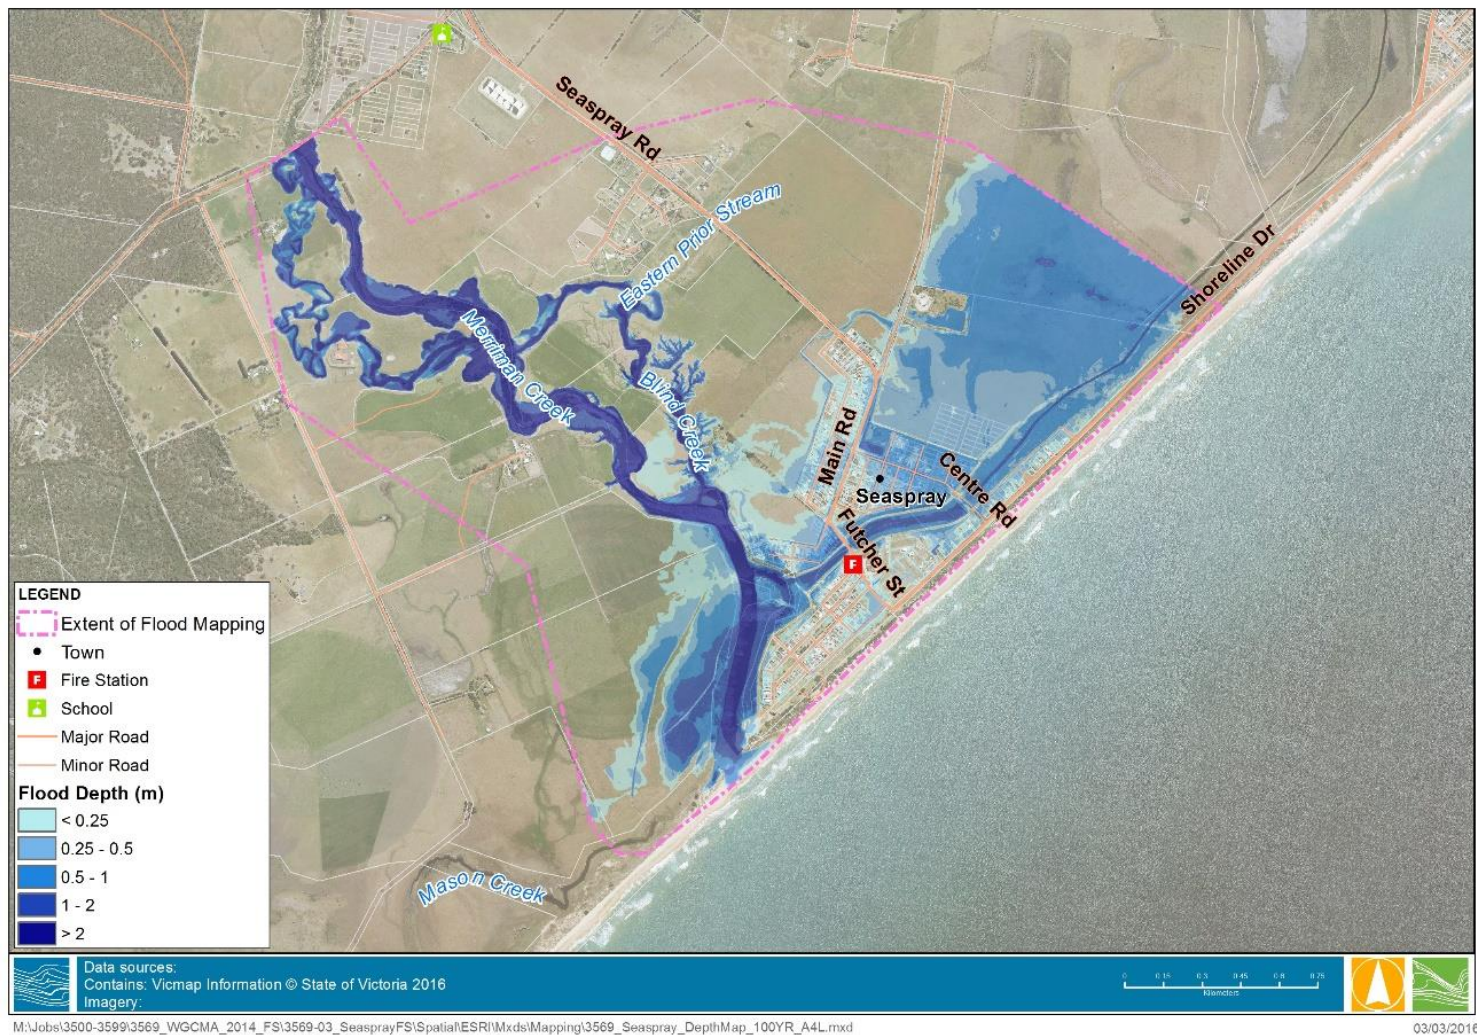
**Figure 7-1 Design 1% Flood Depth Map**

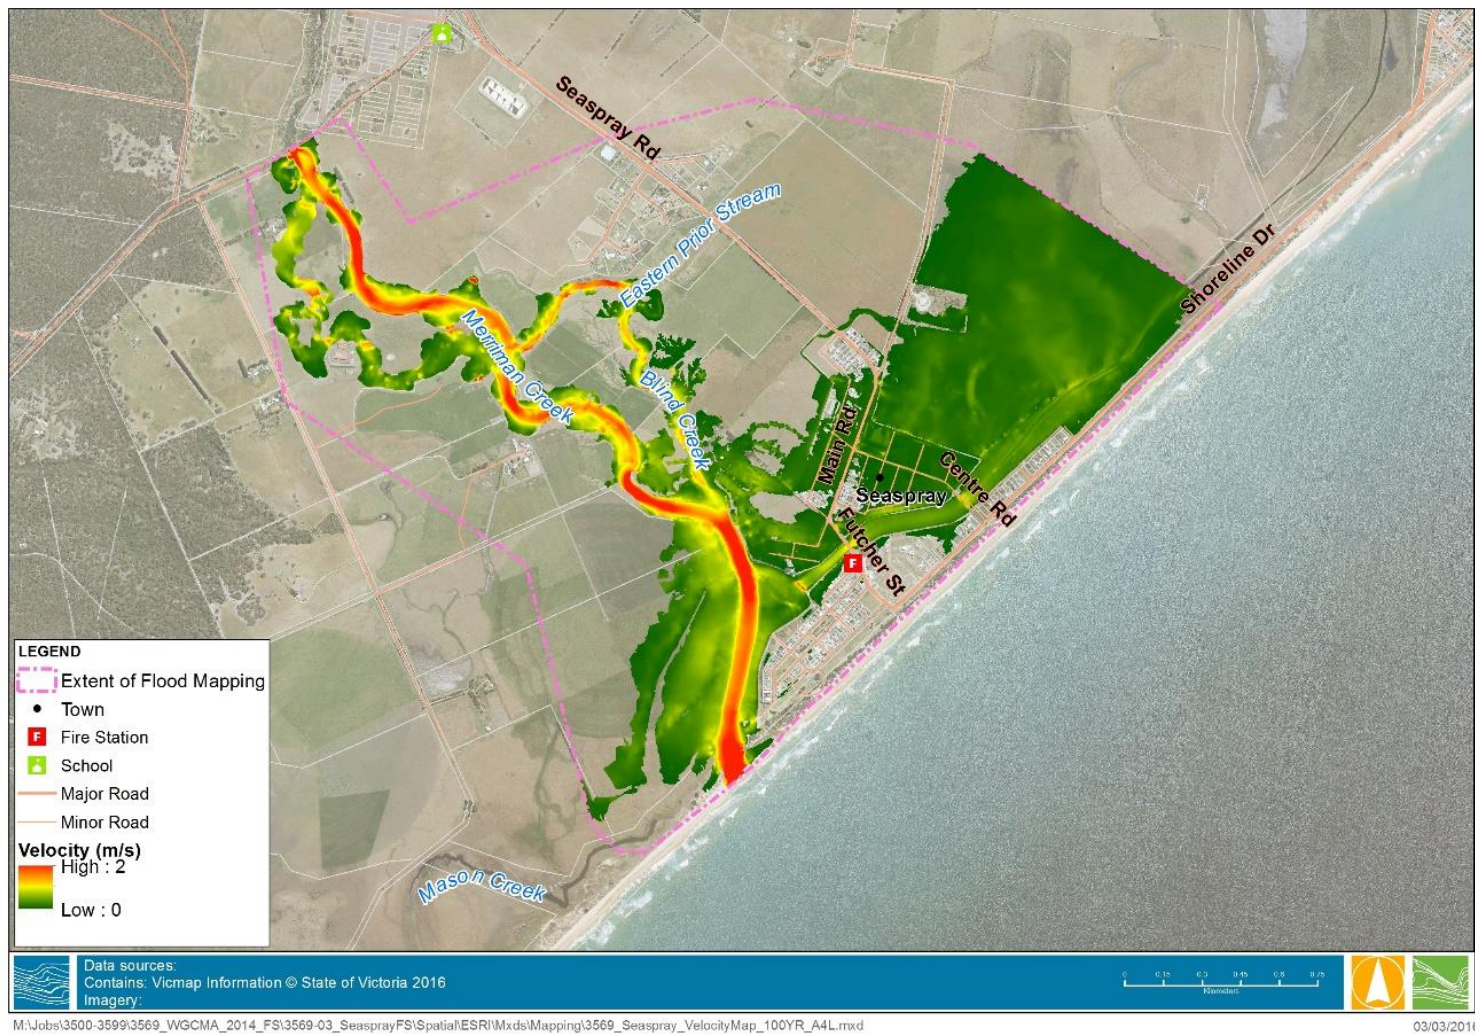
**Figure 7-2 Design 1% AEP Peak Flood Velocity Map**

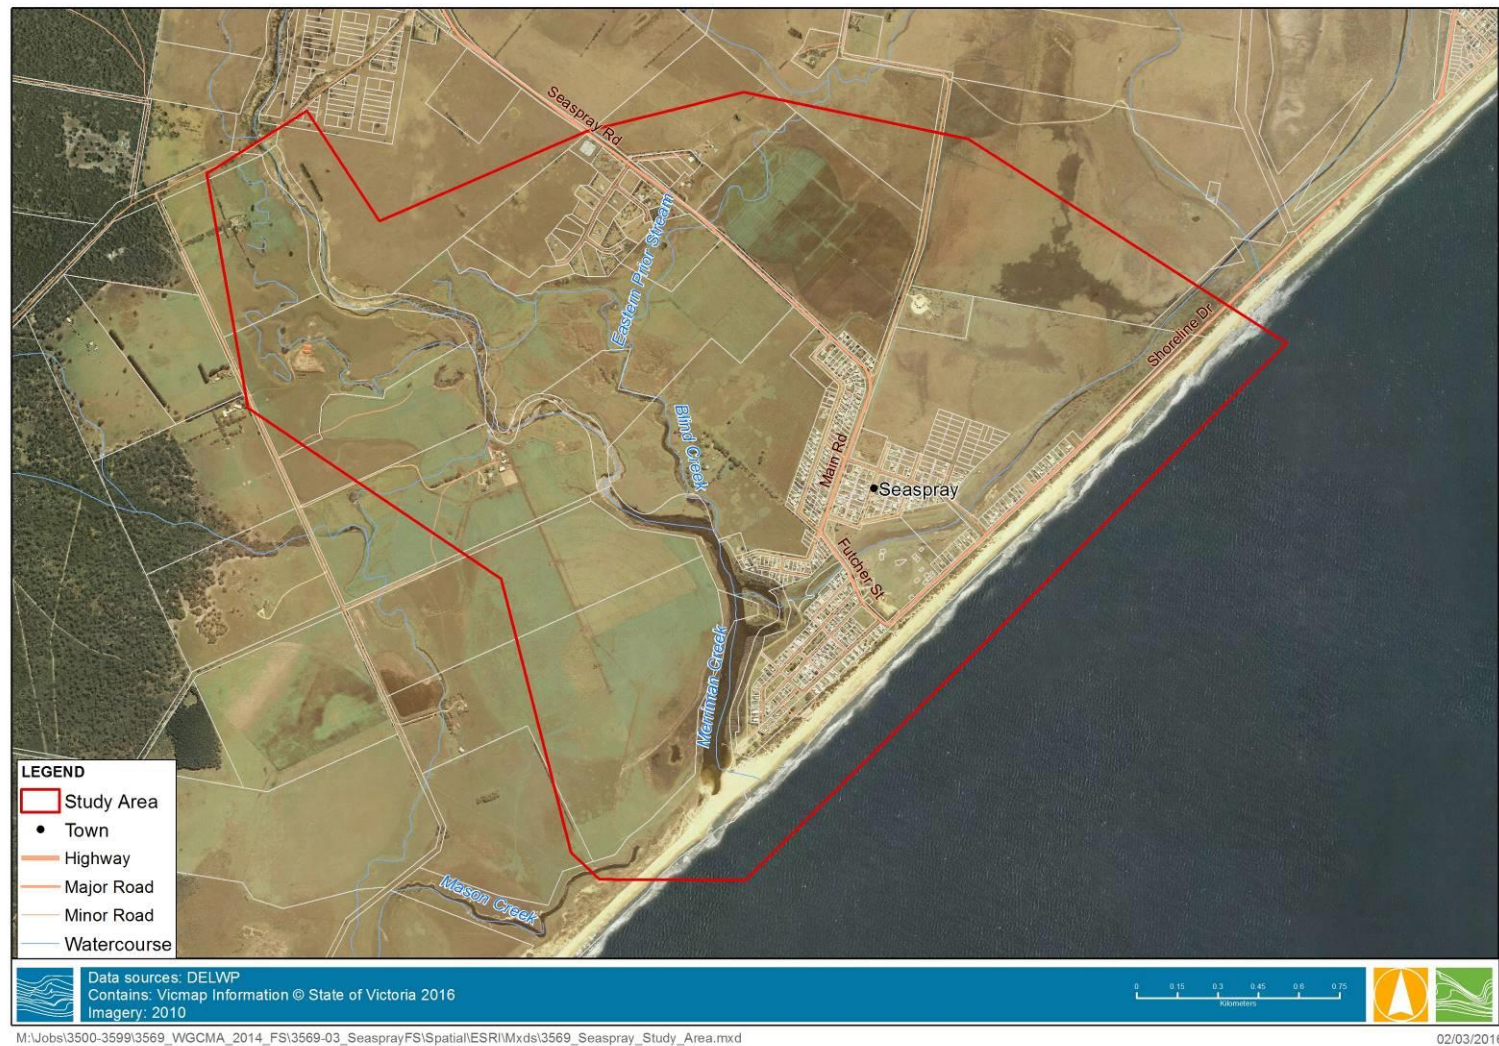
**Figure 2-1 Seaspray Flood Study Model Area**

- Overbank flows from Merriman Creek,
- Coastal inundation due to elevated ocean levels,
- Flooding from the Gippsland Lakes via Lake Reeve,
- Localised stormwater flooding.

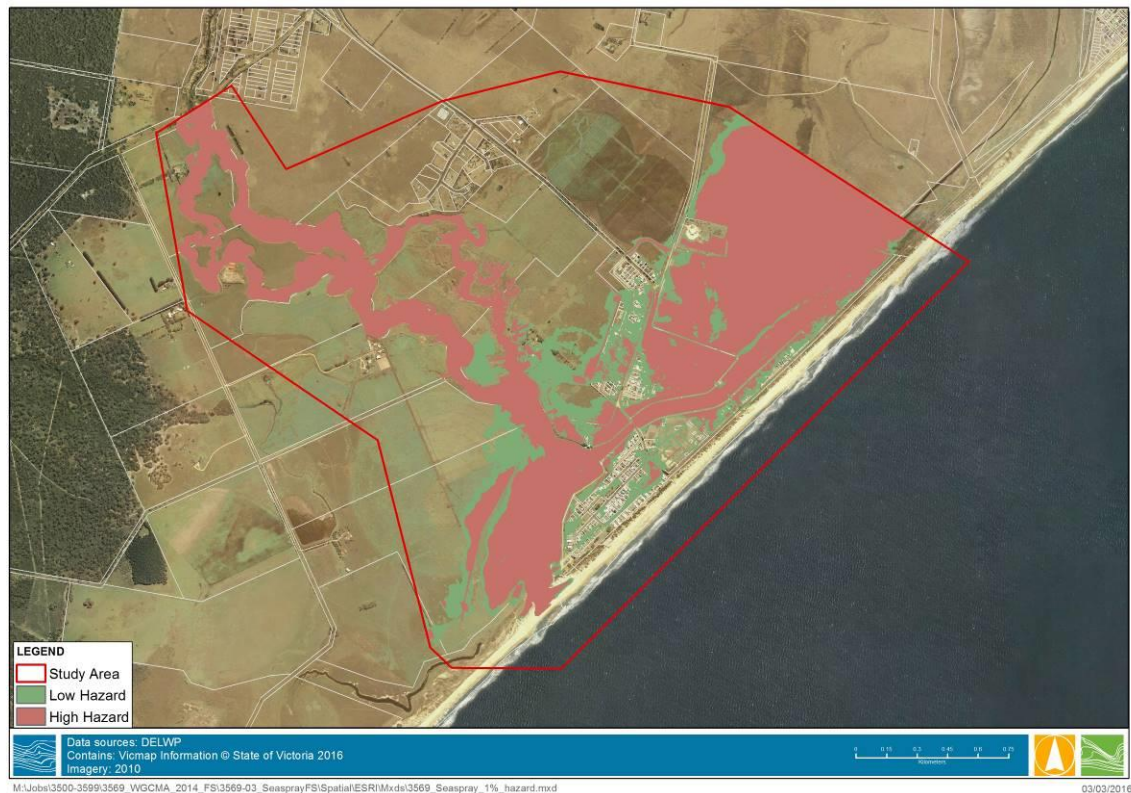
**Figure 3-1 High and Low Hazard Areas in the 1% AEP flood event**

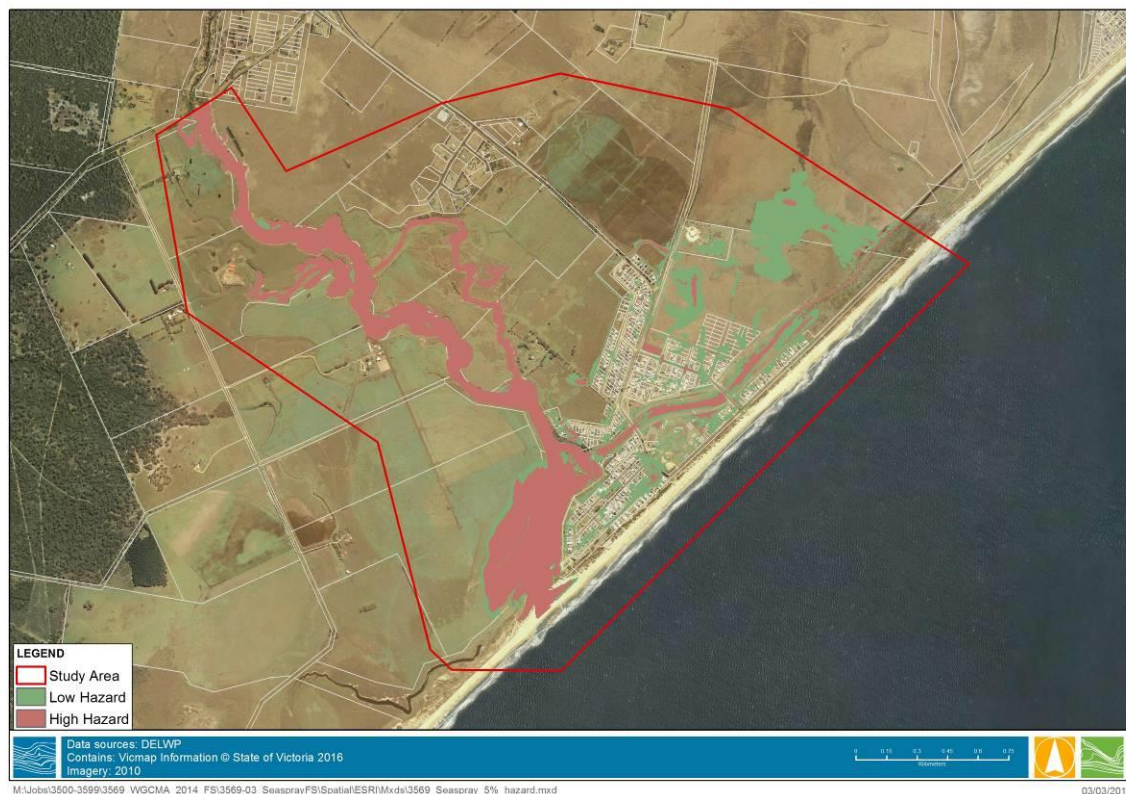
**Figure 3-2 High and Low Hazard Areas in the 5% AEP flood event**

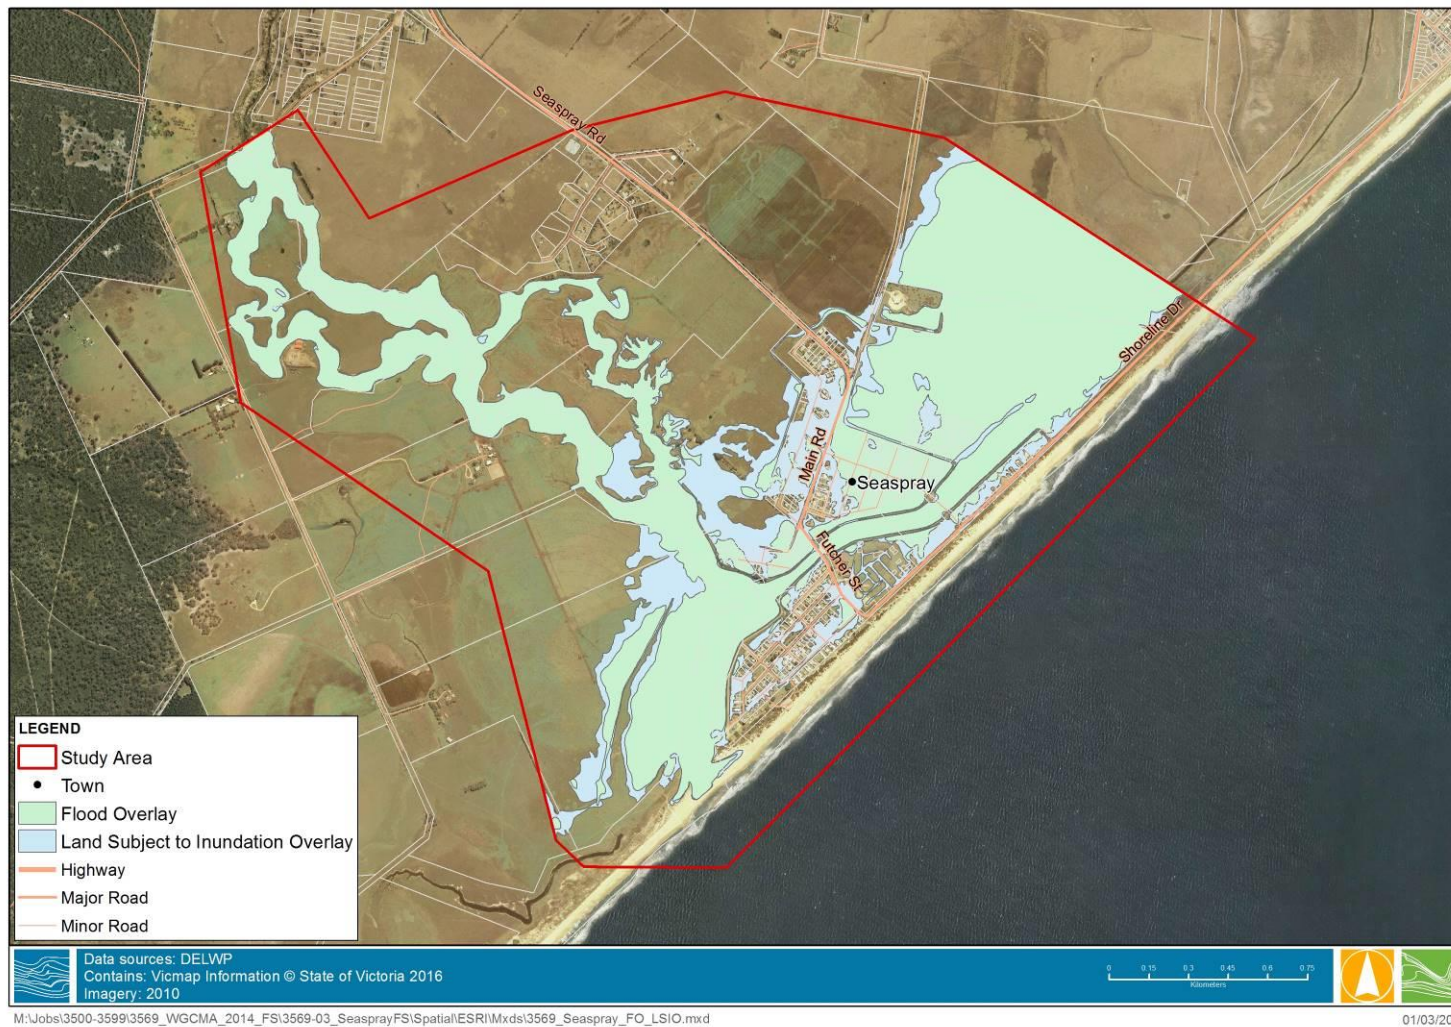
**Figure 3-4      Draft                      LSI0                      and                      FO                      Map                      for                      Existing                      Conditions**

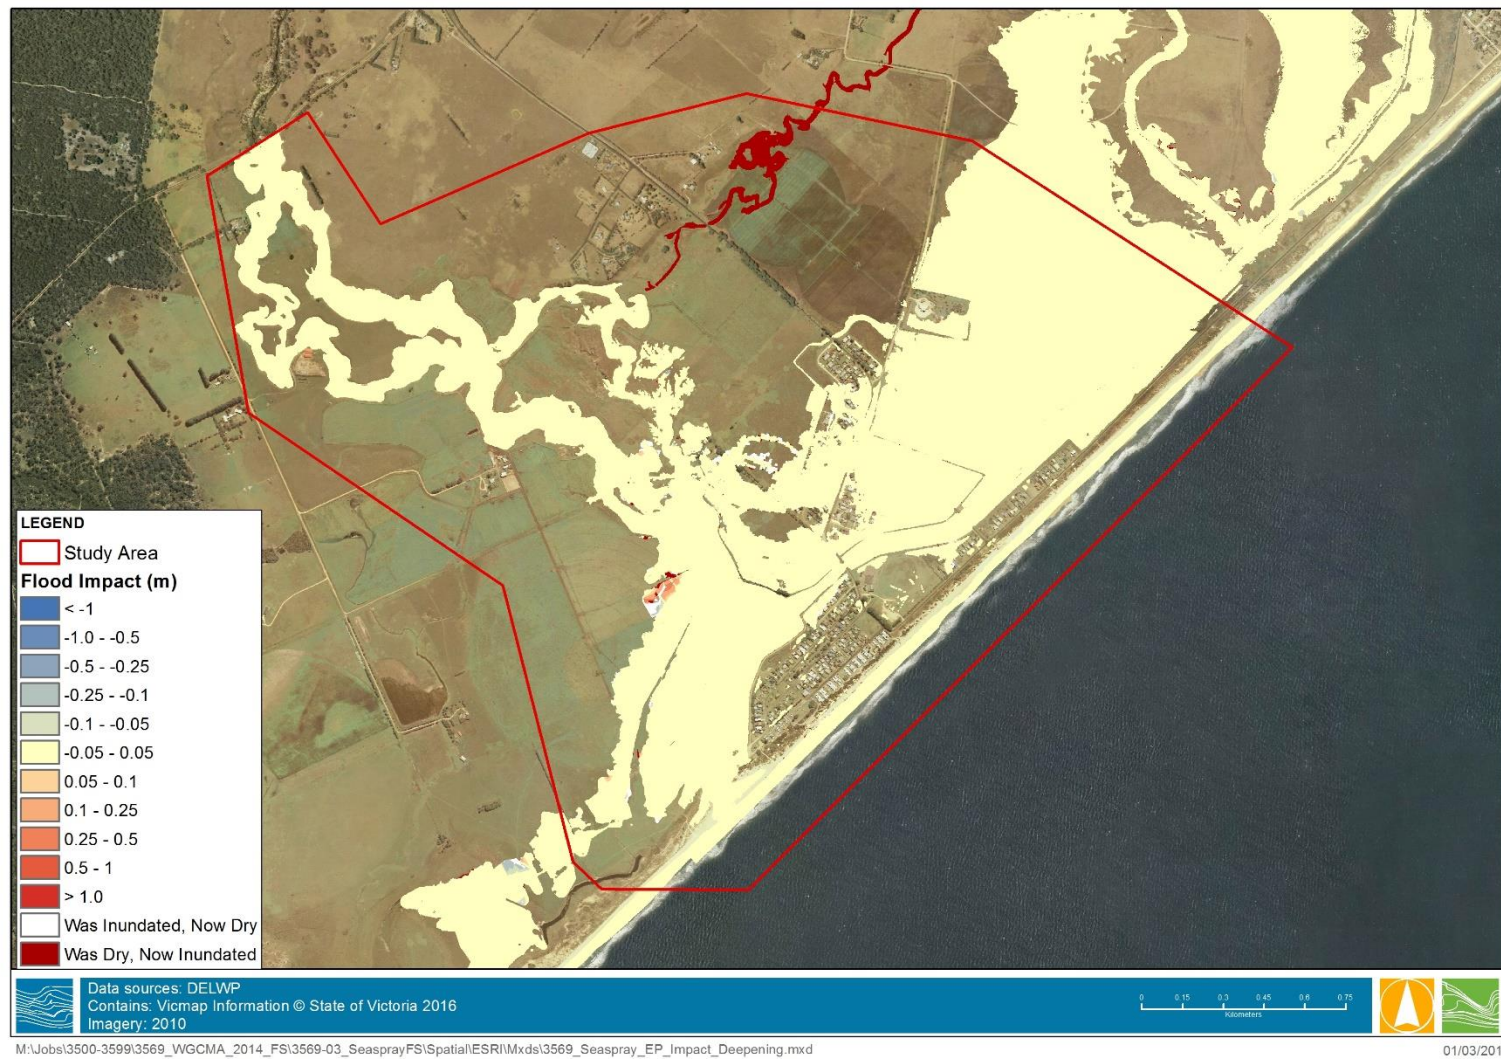
**Figure 4-2 Flood Impact of Deepening Easter Prior Stream**

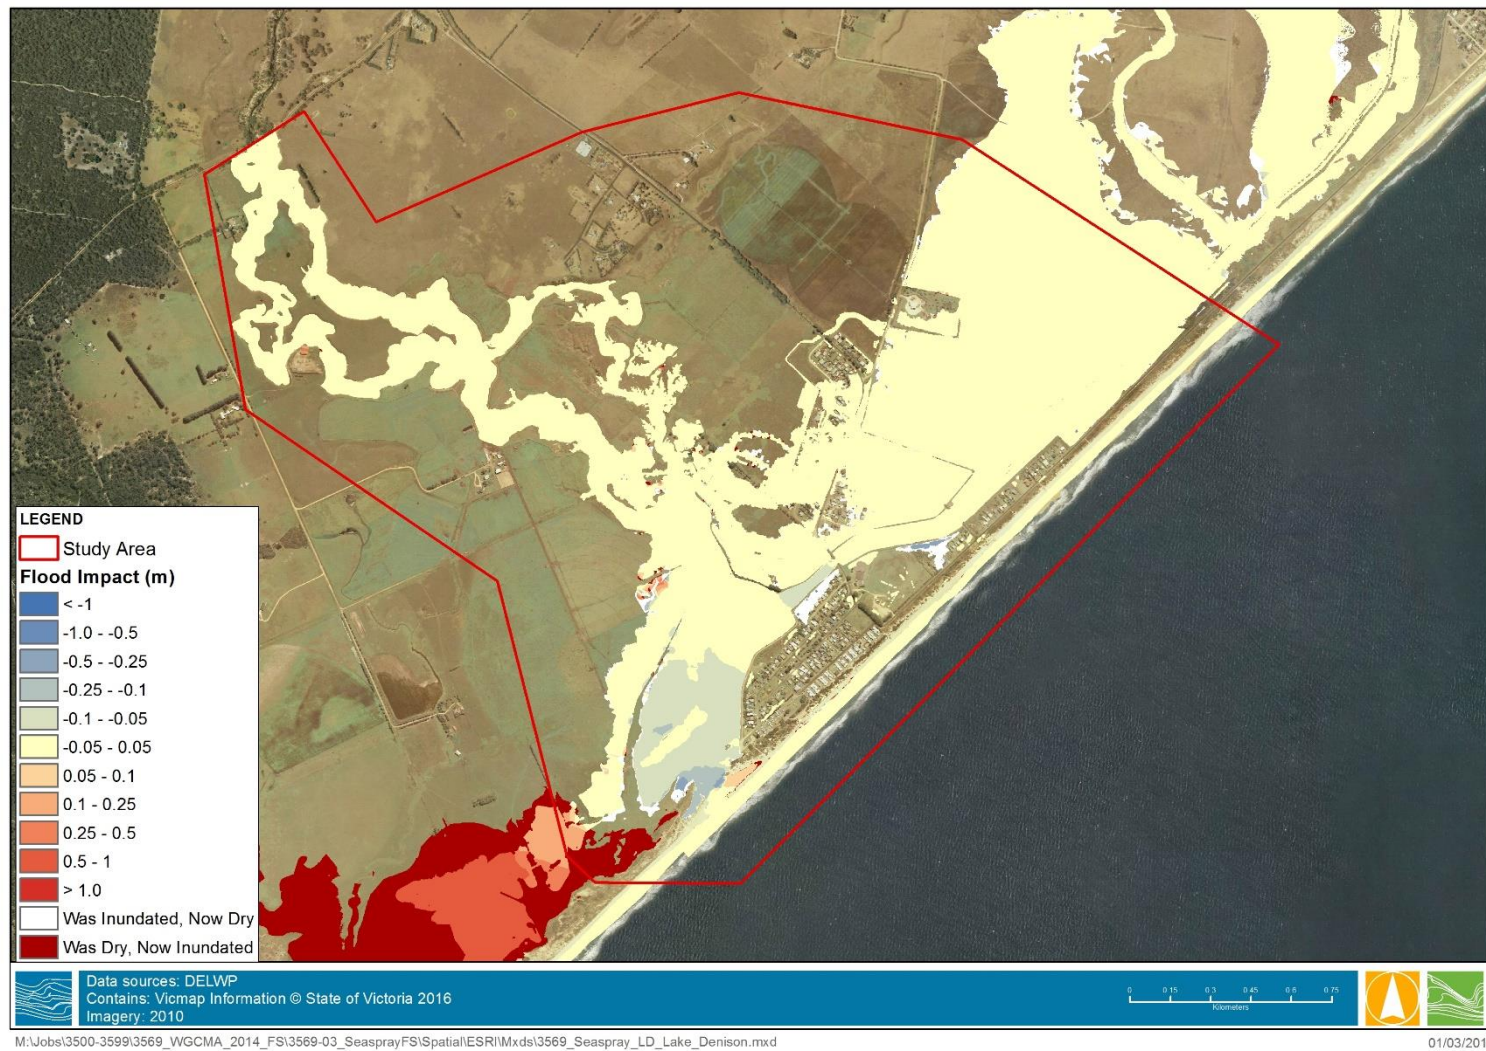
**Figure 4-4 Flood Impact of Increased Water Storage in Mason Creek, towards Lake Denison**

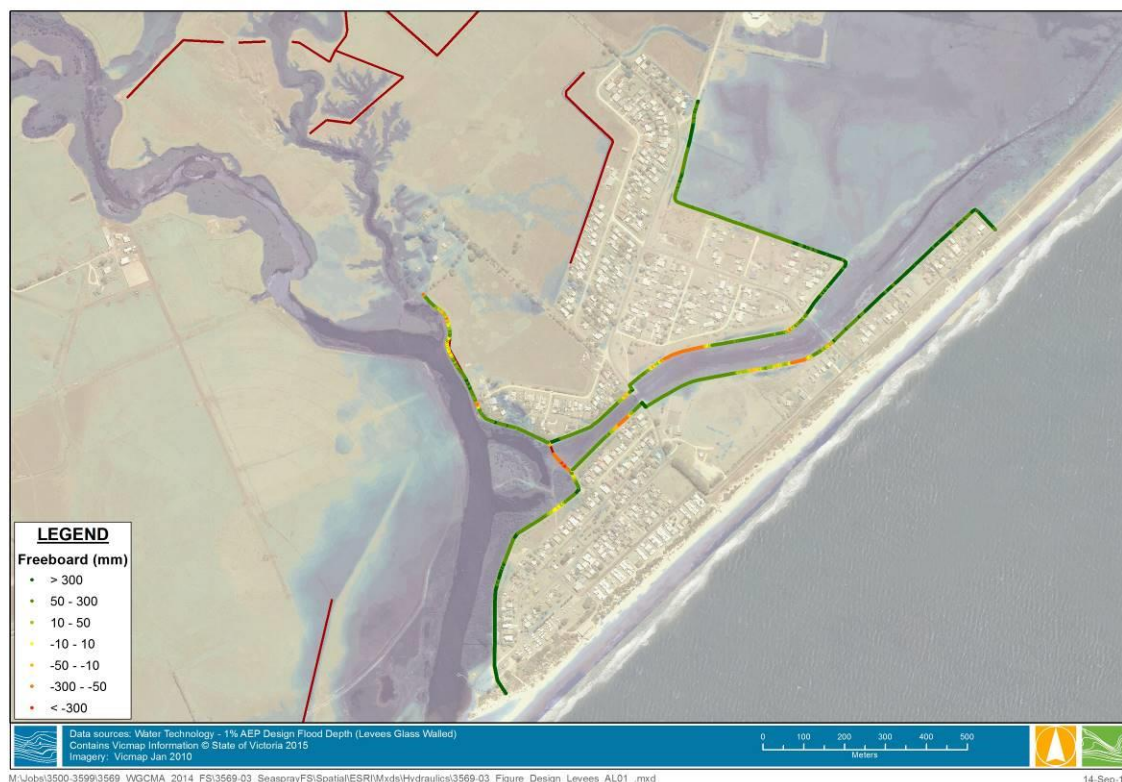
**Figure 4-5 Vulnerability of existing levees in the 1% AEP flood event**

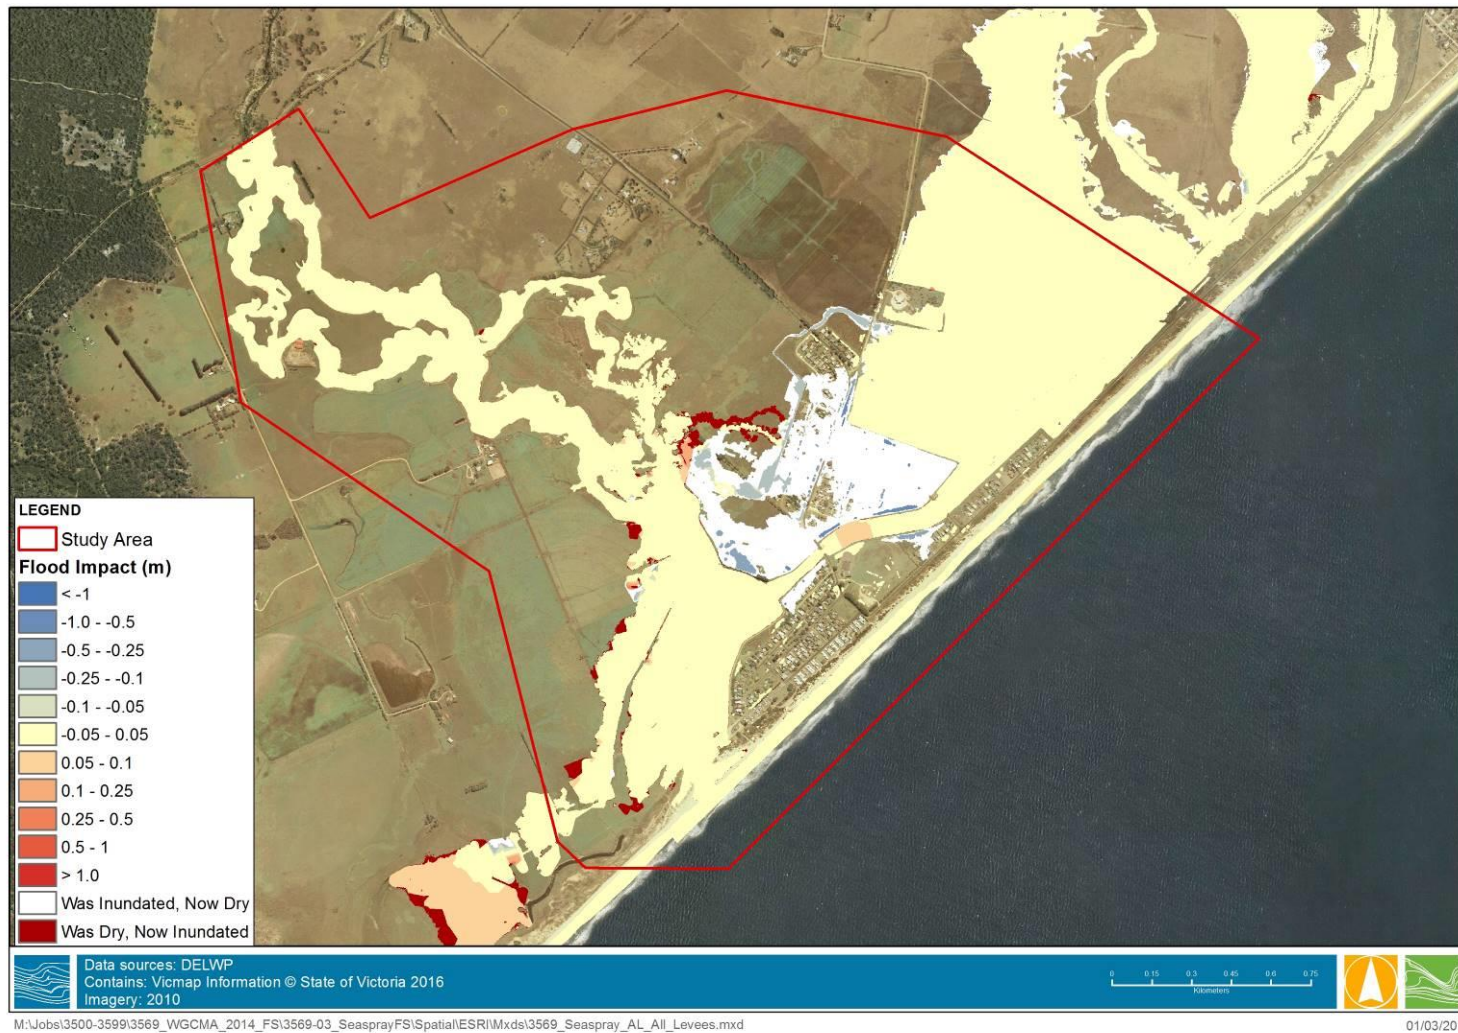
**Figure 4-7 Flood Impact of raising all levees about 1% AEP flood level**

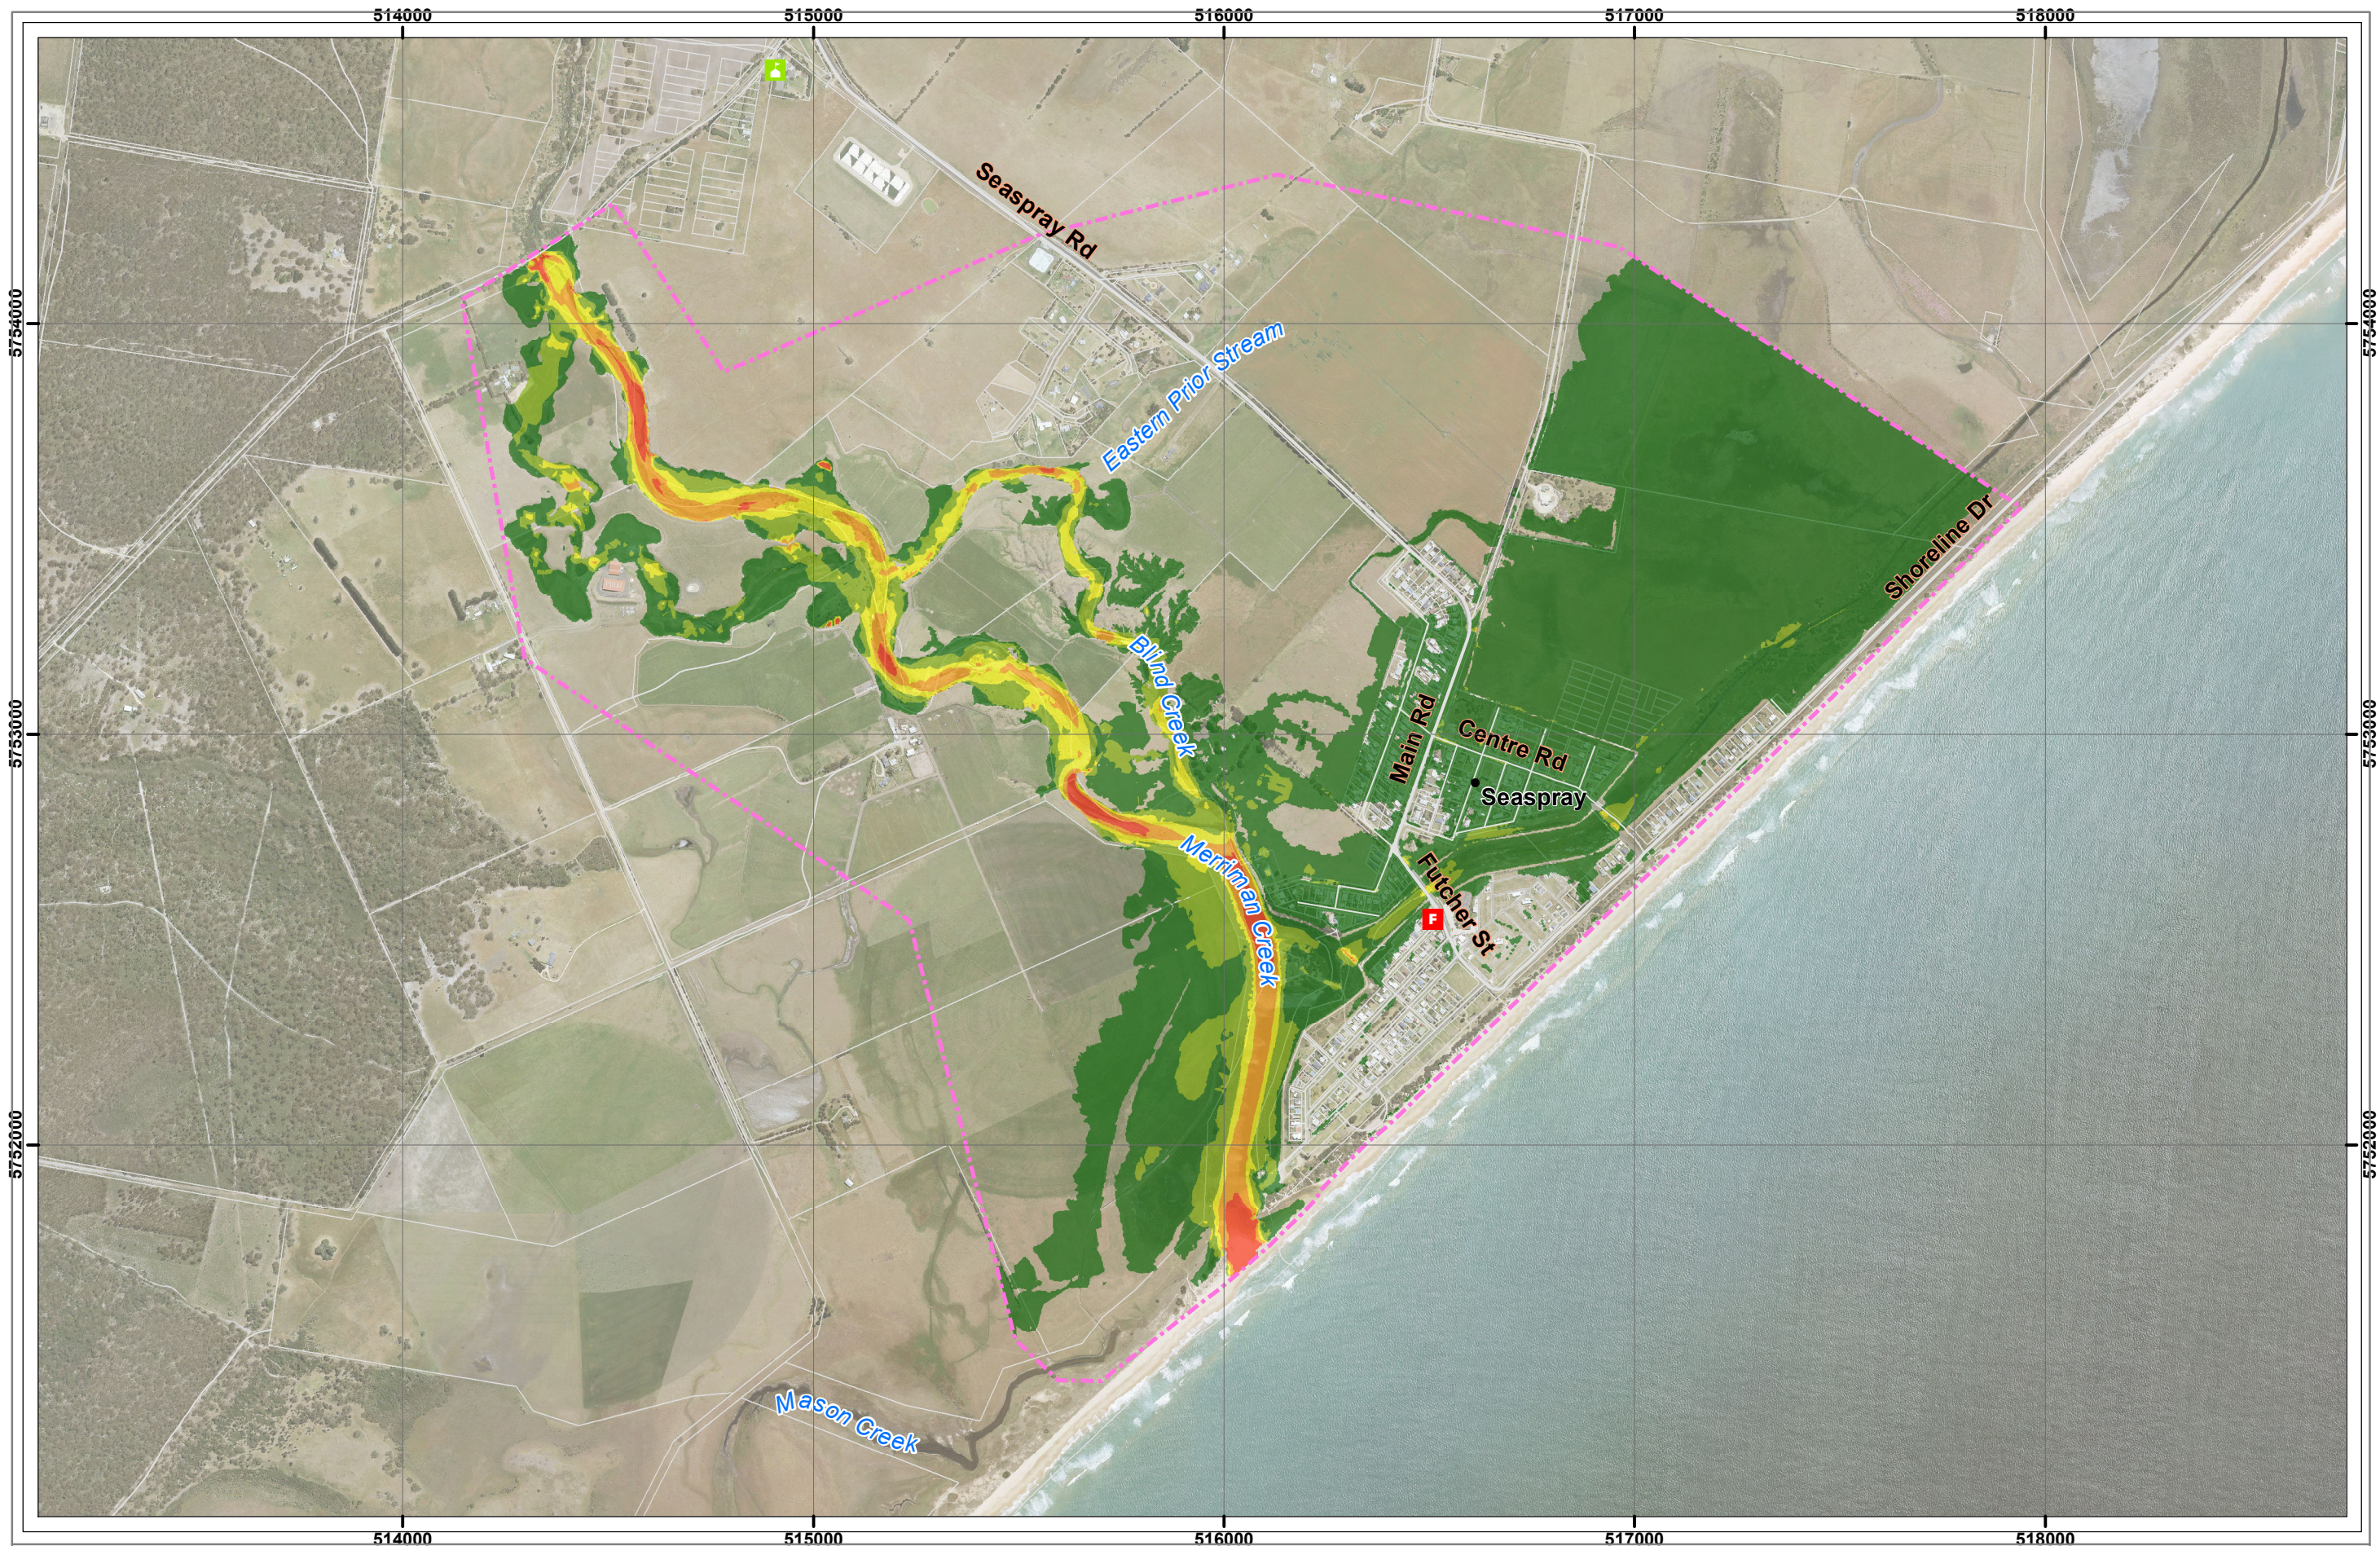
**Maximum Depth**  
S04: 1% AEP Flow + 0.8 m SLR + 1% AEP Storm Tide

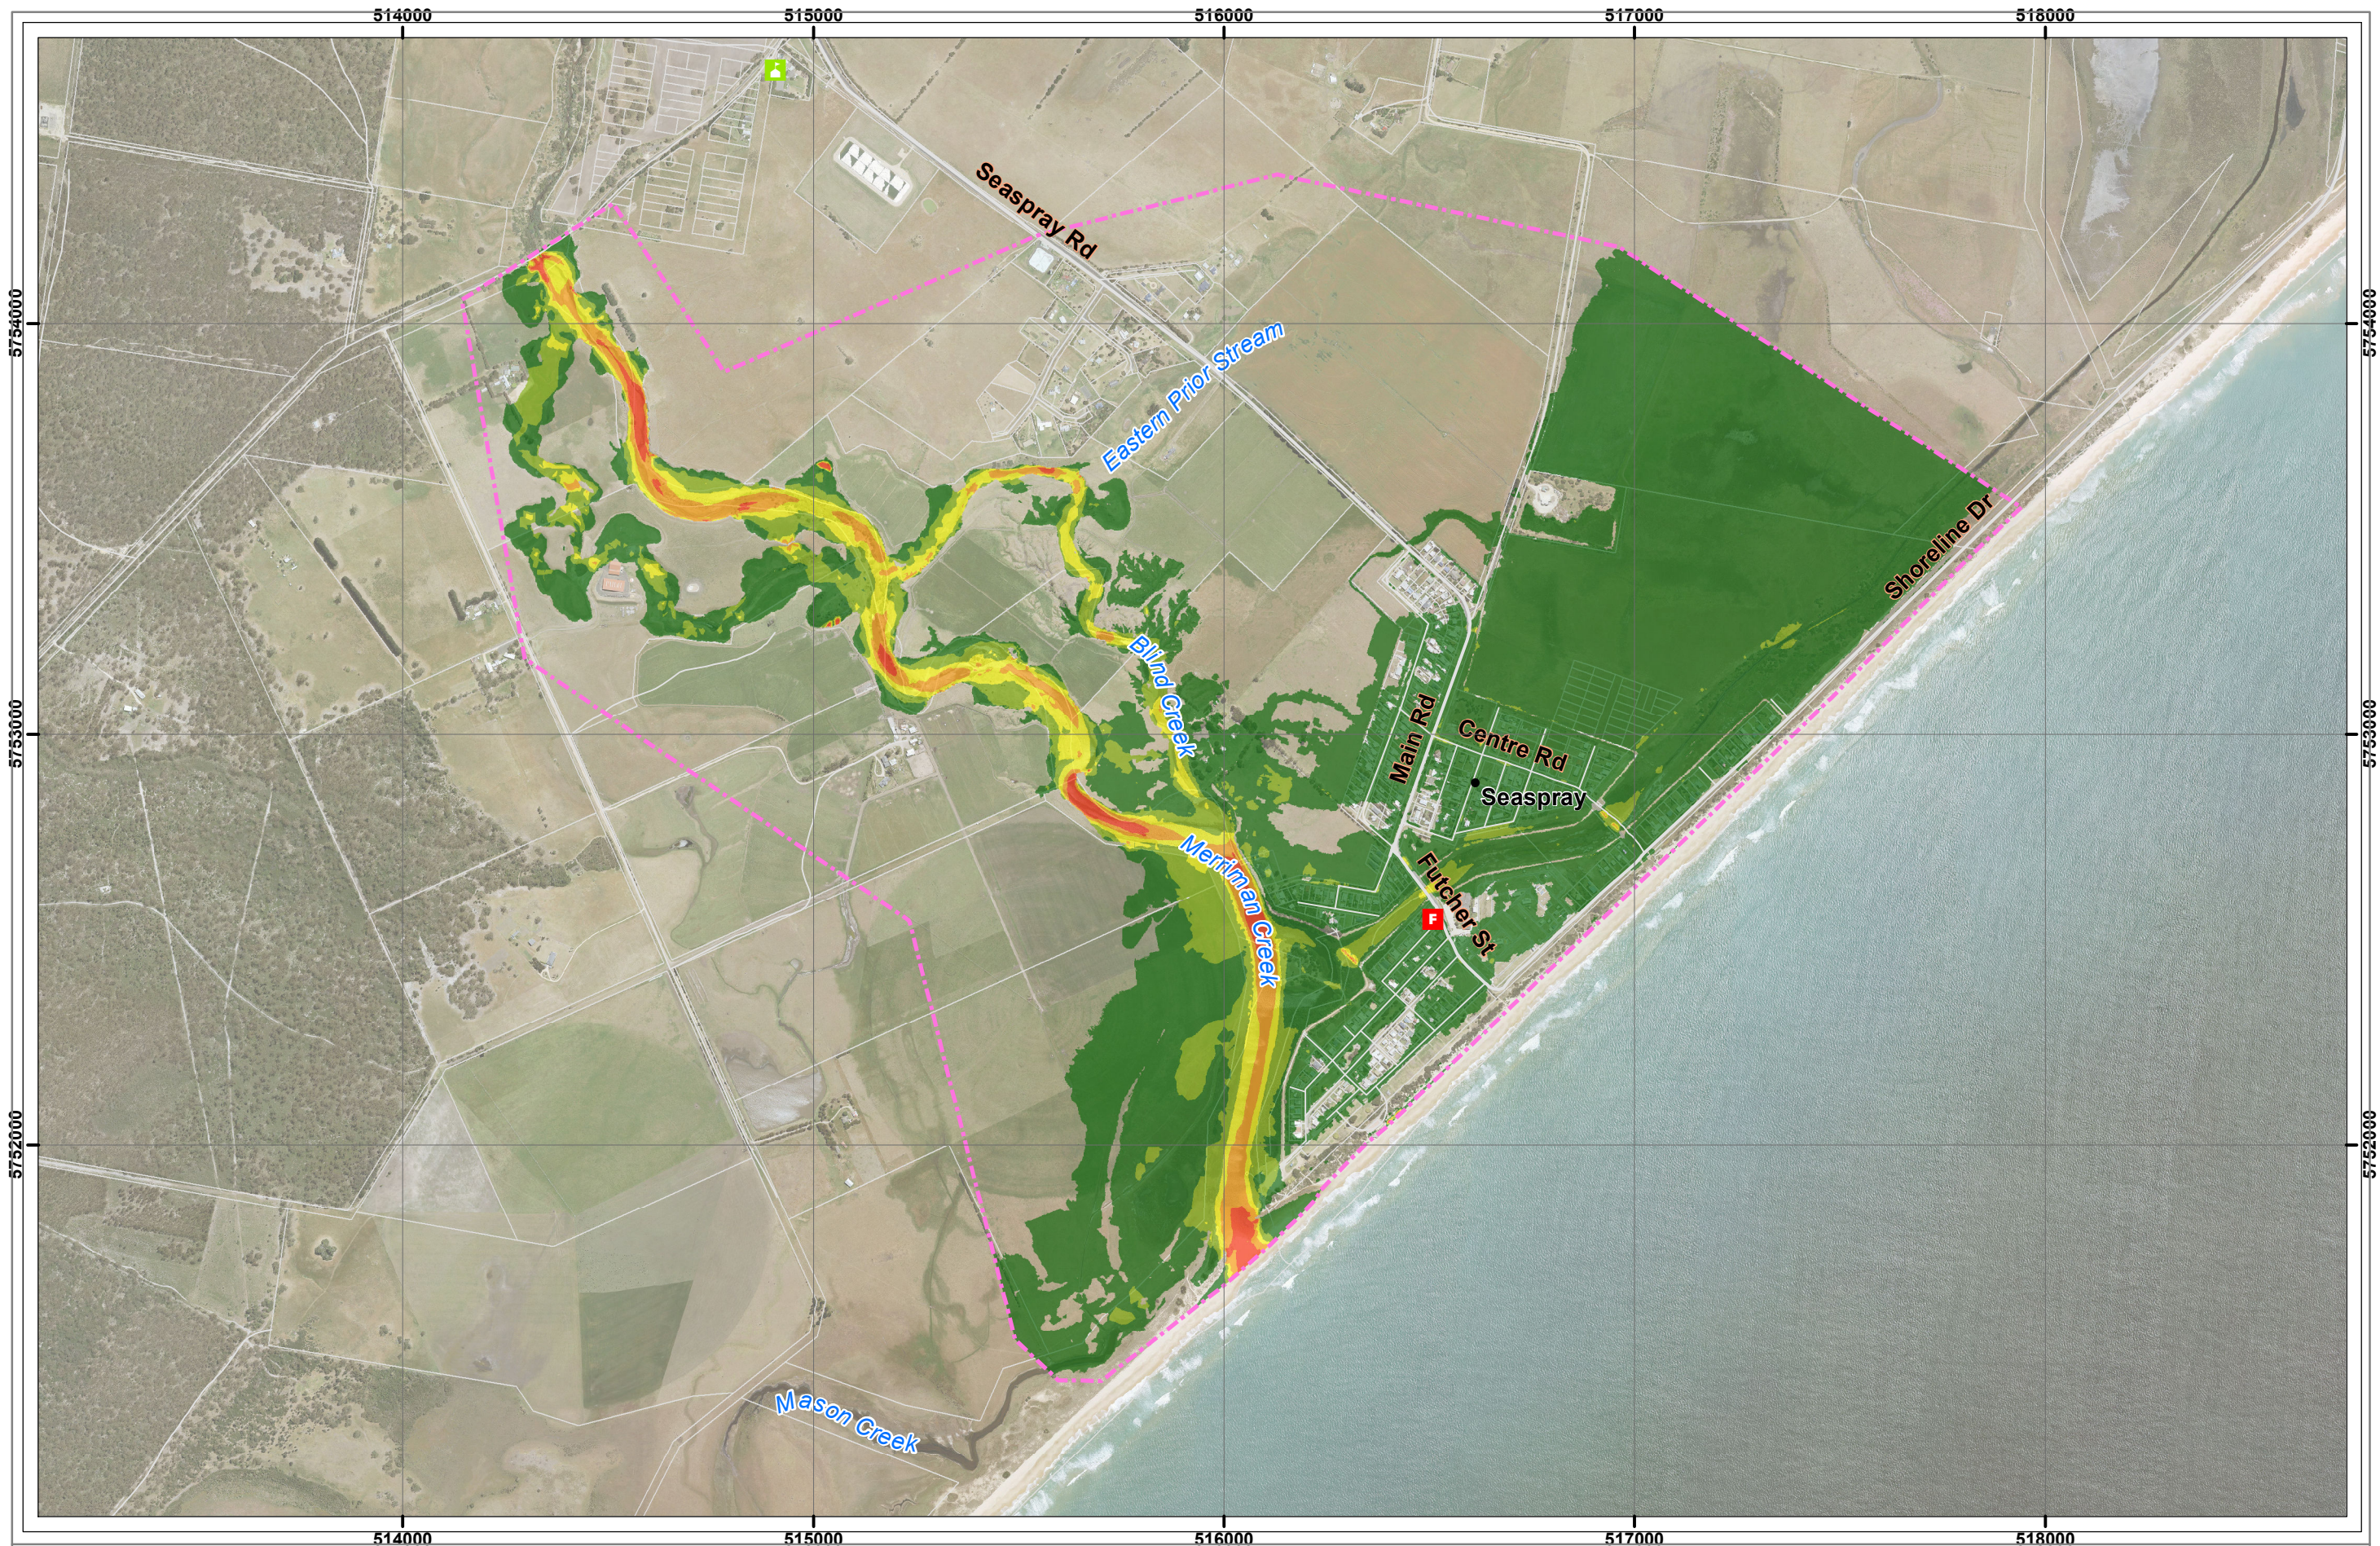
**Maximum Velocity**  
S02: 1% AEP Flow + 10% AEP Storm Tide
