Locality:	YARRAM
Place address:	40 Commercial Road
Citation date	2017
Place type (when built):	Butter factory
Recommended heritage protection:	Local Planning Scheme: Listed HO27 Vic Heritage Register: Not Recommended 600810 File only. Heritage Inventory (Archaeological): Not Recommended National Trust Register Listed B5060 Register of the National Estate. Listed 018433
Place name:	Former Yarram Butter Factory (South Gippsland Creamery and Butter Factory Company Ltd)

Architectural Style:	Federation Anglo-Dutch
Designer / Architect:	J W Crawley and W P Knights
Construction Date:	1908 - 1909 (two storey section)
Builder	Rose & Wales

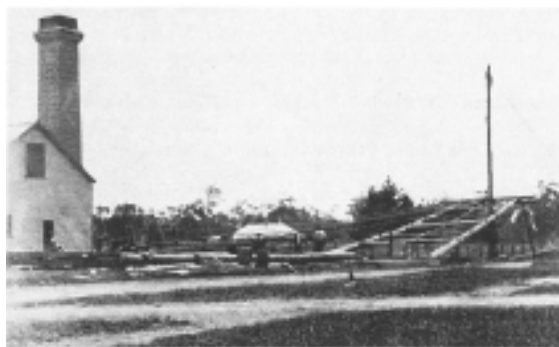
Figure H4. Water tank being erected at Yarram Butter Factory incorrectly dated as 1891 but stack built in 1901. Aylesbury homestead visible in the background. Source. Nicoll, 2008, p. 3

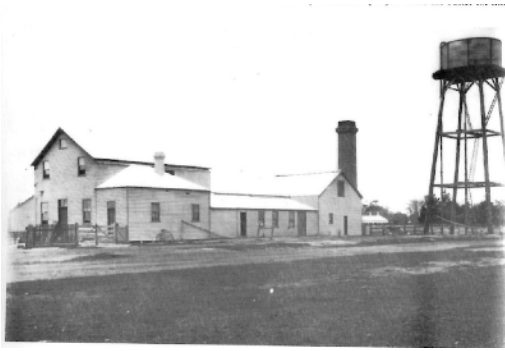
Figure H5. Yarram Butter Factory in 1909 following 1901 additions. Source. Abraham, 1990, 132

The addition of cheese manufacturing to the Yarram Butter Factory was suggested in 1894 (Gippsland Times, 19 January 1894) and by 1901 productivity had grown so that substantial alterations were made to the Yarram Butter Factory complex which changed the building from a "bungalowed edifice (to a) lofty and commodious building" (Adams, 1990, p. 136) (Figure 5 and Figure 6). The chief alterations were reported in The Gippsland Standard 31 July 1901 as;

So extensive were the continual changes to the Yarram Butter Factory that by 1905 there was "only one little portion of the original factory left...in the middle of the complex..." (McAlpine in West Gippsland Gazette, 18 April 1905) (Figure 5 and Figure 6) and it was reported that the condition of the old Yarram Butter Factory and its many additions was so poor as to put it at risk of being condemned (Gippsland Standard, 1st September 1909 in Nicoll, 2008, p. 15)

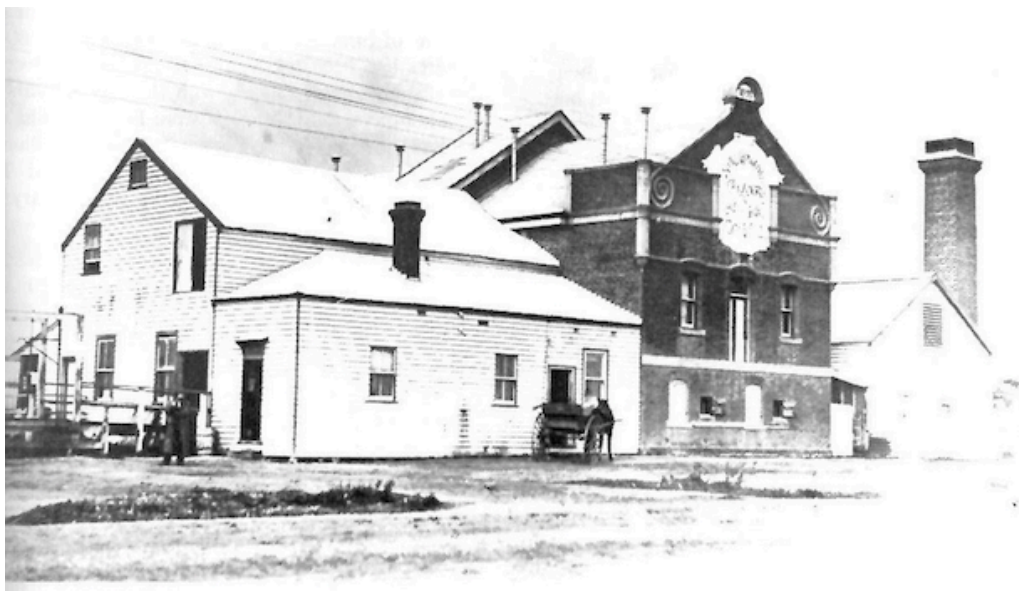
Figure H7. Yarram Butter Factory described as 'second stage' n.d. showing works done in 1908/1909. Source. Adams, 1990, p. 133

Comprehensive details of the new Yarram Butter Factory (Figure 7, Figure 8 and Figure 9) were published in the Gippsland Standard 1st September 1909 (Nicoll, 2008, p. 15). The chief features are described as cleanliness, imperviousness, drainage, lighting and ventilation and some of the built elements described include;

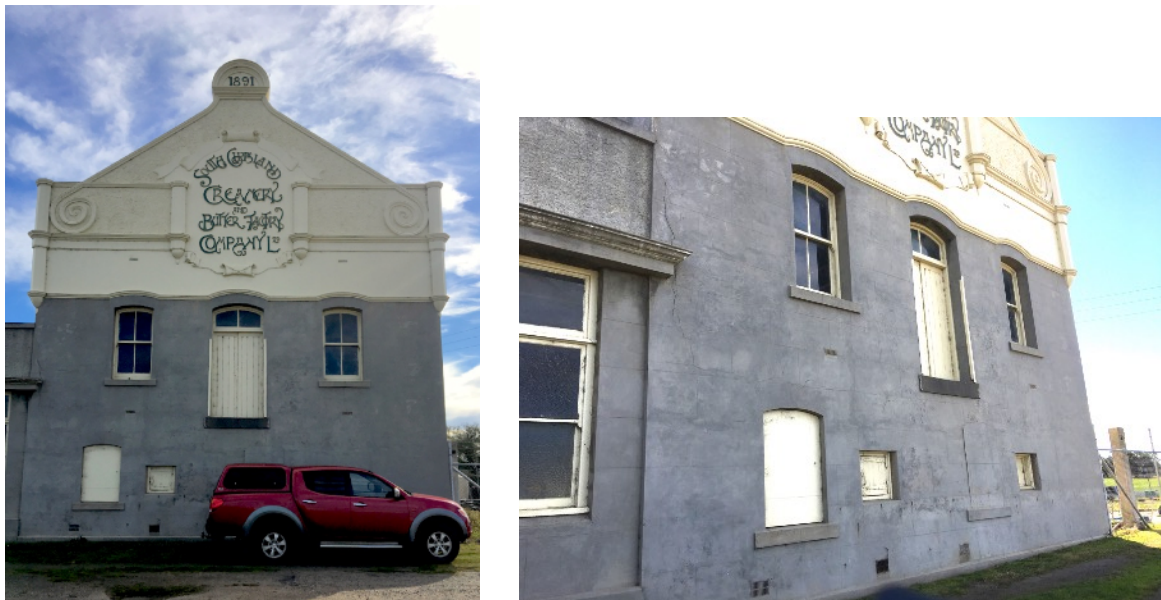
Figure D1. Blue Areas A, B, C, H, I, J. The 1908-9 former Yarram Butter Factory building south (front) elevation. The 1891 date refers to the date the Yarram Dairy Company commenced, not the date of this building. The front facade has a high degree of integrity as a fine example of the Federation Anglo-Dutch style applied to an industrial building. The original tuck pointed red brick walls (now rendered) contrasting with the elaborate rendered gable end were typical finishes in the Federation period. The elaborate gable end with Art Nouveau style writing is rare on surviving industrial buildings in Victoria. Changes that have occurred include painting the decorative gable end, rendering and scoring over the former tuck pointed red brickwork on the lower section to appear like stone (probably at the time of the 1931 extensions), and bricking-in a ground floor opening. The segmentally arched openings with projecting sills and four pane windows are typical of the Federation period.

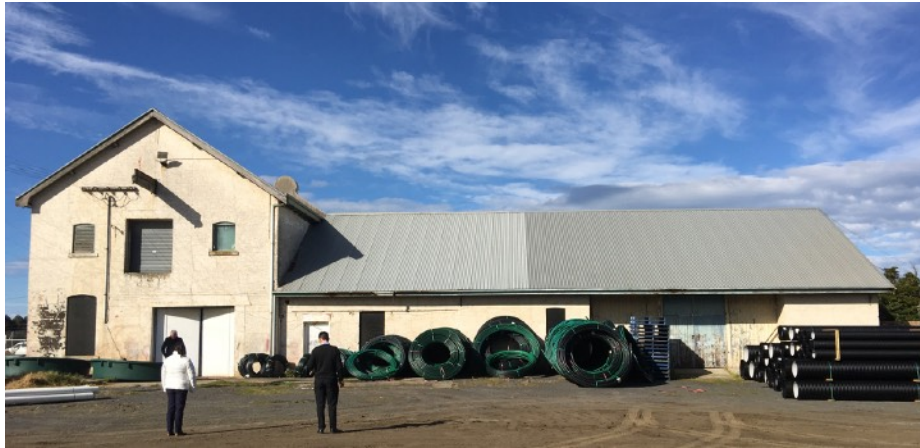
Figure D2. Two storey blue areas A, H. Single storey areas F, G, K. The northern elevation of the existing two storey 1908-09 butter factory (on the left in Figure D2) in which there are three segmentally arched openings with projecting sills dating from 1908-09. Alterations to the two storey section include 'bagging' the red brick wall, enlarging the first floor doorway and inserting a roller door. On the ground floor the double doorway has been enlarged c1931 and double doors inserted. The single storey extension (on the right in Figure D2) is c1931 (and later) is not significant. .

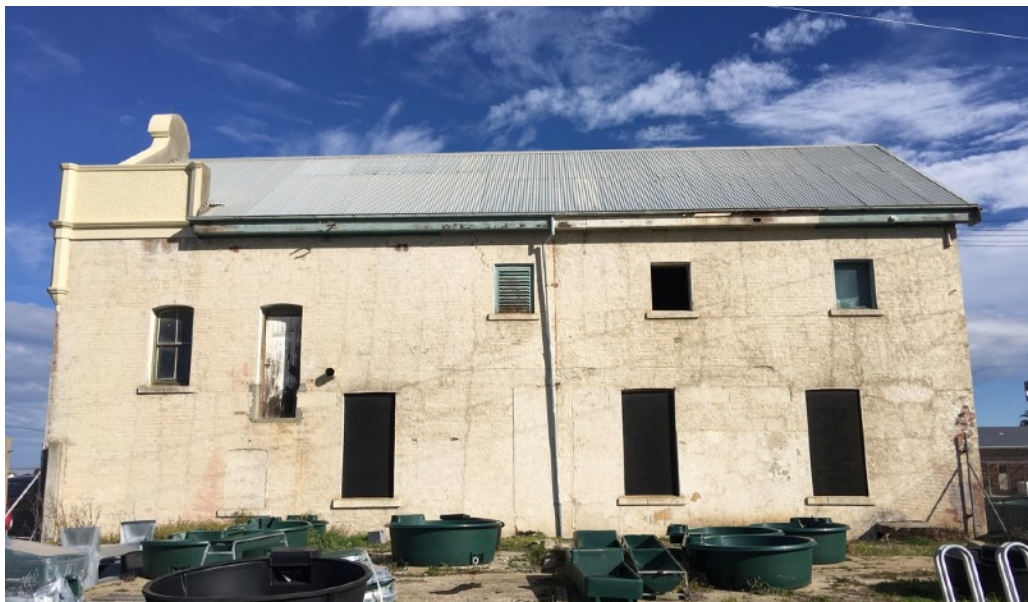
Figure D3. Blue areas A, B, H, I, J. The east elevation has a good degree of integrity. Figure D3 shows the gabled roof clad in galvanized iron and the red brick wall 'bagged'. Segmentally arched openings are located towards the front section. The first floor left hand window is original, the next one has been altered to be a doorway. Two small windows have been bricked up. Towards the northern end of the wall, at first floor level, are three square openings with flat arches, one of which has timber louvres and it is likely that they all had louvres. At ground level are three large flat arched window openings which have been temporarily blocked up on the inside and one that has been infilled. All the openings, except the altered doorway, have projecting sills as seen on the south facade and all of these openings date from 1908-09. The spouting has corroded and is allowing water to soak around the base of the building, most likely contributing to the uneven settling and minor cracking.

- 4.3. Landscaping
- 4.3.1. To minimise damage to the building by rising damp, it is recommended that impervious/ concrete paths, garden beds, bushes, or trees etc, are not placed within 1 meter of the walls, and the ground lowered so that the ground level is a minimum of 250mm lower than the ground level inside the building and slope it away from the building, and the gap can be backfilled with very coarse gravel up to the level of the path. The coarse gravel will have air gaps between the stones which serves the function of allowing moisture at the base of the wall to evaporate.

- 4.3.2. It is recommended that a path of crushed granitic sand one metre wide is placed along the south and east elevations to facilitate evaporation of moisture in the footings of the walls and reduce the incidence of rising damp.

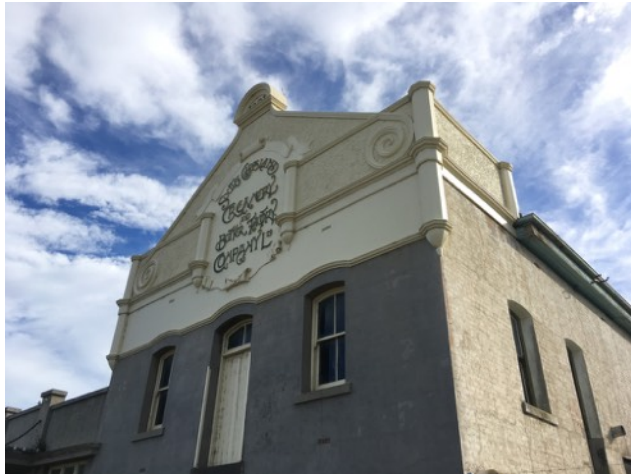
Figure D4. Blue area J. The upper level of the south elevation of the 1908-09 building. Note the skilled craftsmanship of the highly ornamental decorative gable end and parapet which wraps around the corner of the east and west elevations. The original joinery of the doors and windows is intact. The Federation Anglo-Dutch design with Art Nouveau writing is a unique, fine and intact example as there are no other known examples on butter factories in Victoria. The architects designed Art Nouveau writing on plaques on other buildings but these are mainly in the Western District and arguably this is the best example.

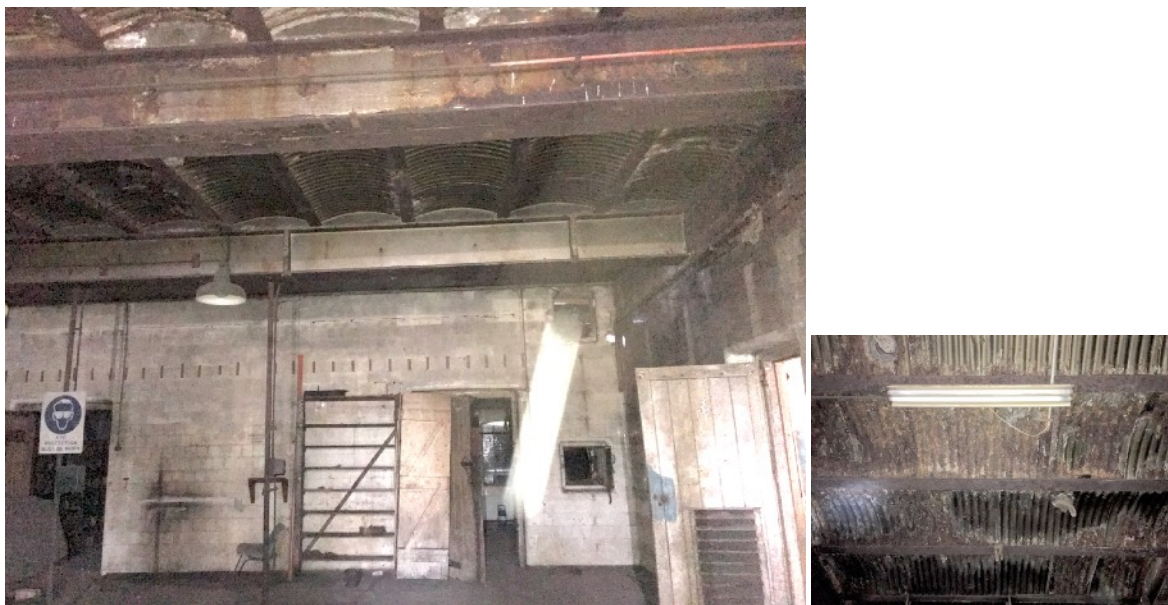
Figure D5. Blue Area A. View looking south towards the doorways into Areas B and C. The door on the right goes into Area F. Note all the walls are lined with glazed white tiles (now dirty) as are the architraves and reveals, the floor is lined with matt finish hexagon shaped brown-red tiles and the ceiling appears to be comprised of wrought iron joists supporting arched, deep-gauge (?) corrugated iron. The roof appears to be supporting a concrete floor. The method of construction is now rare, and appears to be similar to that used in the Queens Warehouse, Melbourne and described by Miles Lewis as 'Lysaght's Galvanized Tinned Iron 20 Gauge [sic]'; 'Heavy Weight ... equal to sample'; and 'Traegerwellblech'. "In 1902 Lysaght's *Metal Trades Referee* listed 'weight-bearing' Lysaght Orb iron of four inch [102 mm] pitch and $2\frac{1}{2}$ inch [38 mm] depth." (Structural Corrugation: February 2017 8.05.29. The roof was most likely used in this case to assist with keeping the building cool. It is also noted that the girders and corrugated iron are corroding. It is recommended that a forensic and heritage structural engineer investigate the actual method of structure and recommendations for repair.

- 3.3.5. Engage a heritage and forensic structural engineer to determine the exact nature and condition of the corrugated structural system, and methods to protect it as well as alternative methods to safely support the floor above.

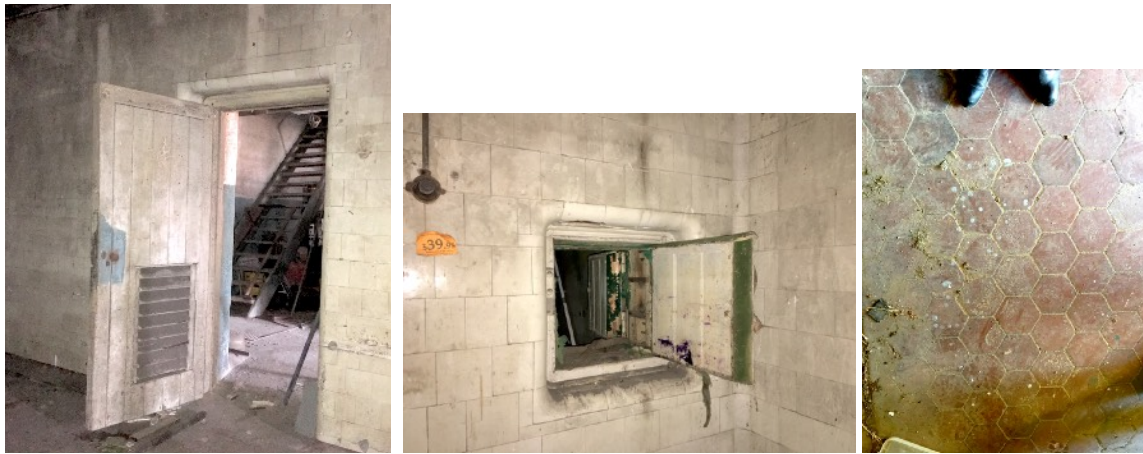
Figure D6. Area A. Detail of door to Area E/F, small hatch and door to Area C, and floor tiles,. Note the white glazed tiles with specially curved ones used to cover the edges of the openings and the thick doors on both sides of the small opening.

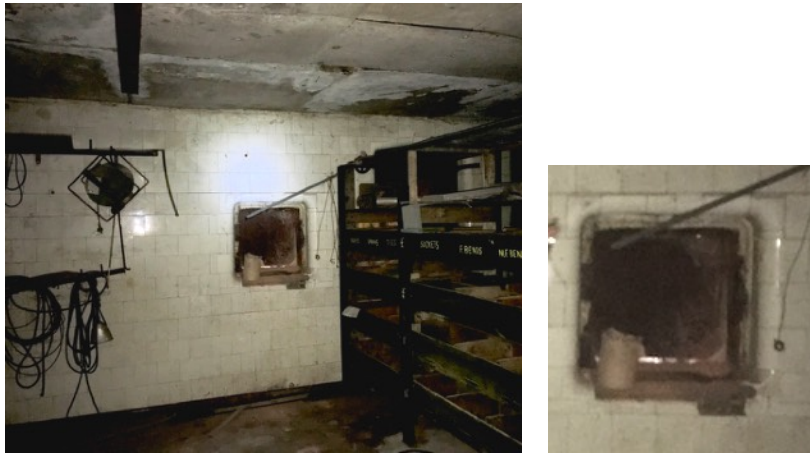
Figure D7. Area B. Note the white glazed tiles on the walls, red-brown hexagon tiles on the floor and concrete roof and detail of hatch which opens out to the front (south elevation) of the building.

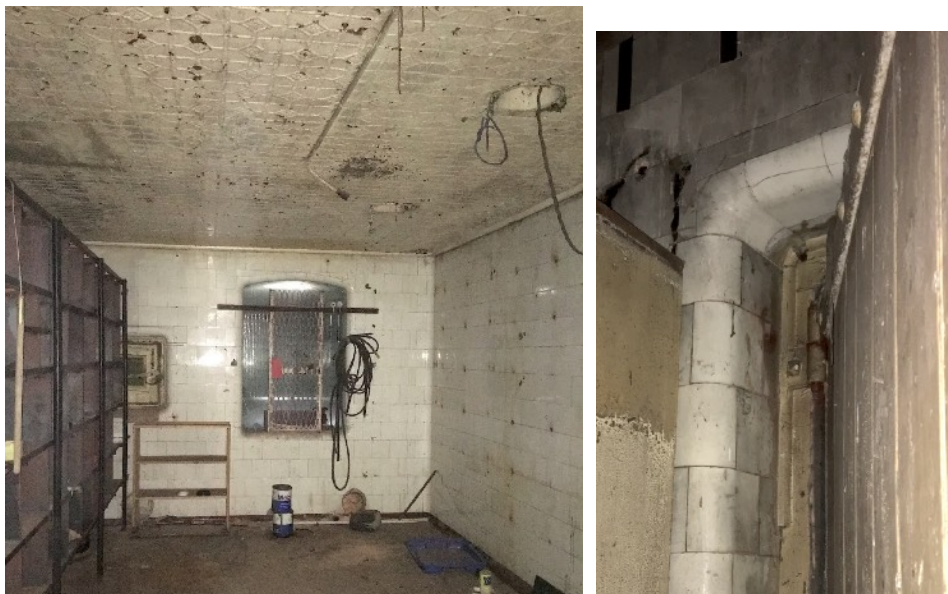
Figure D8. Area C. Looking south to the intact white glazed wall tiles, red-brown hexagon floor tiles, pressed metal ceiling, small hatch, and window and the door opening lined with curved tiles.

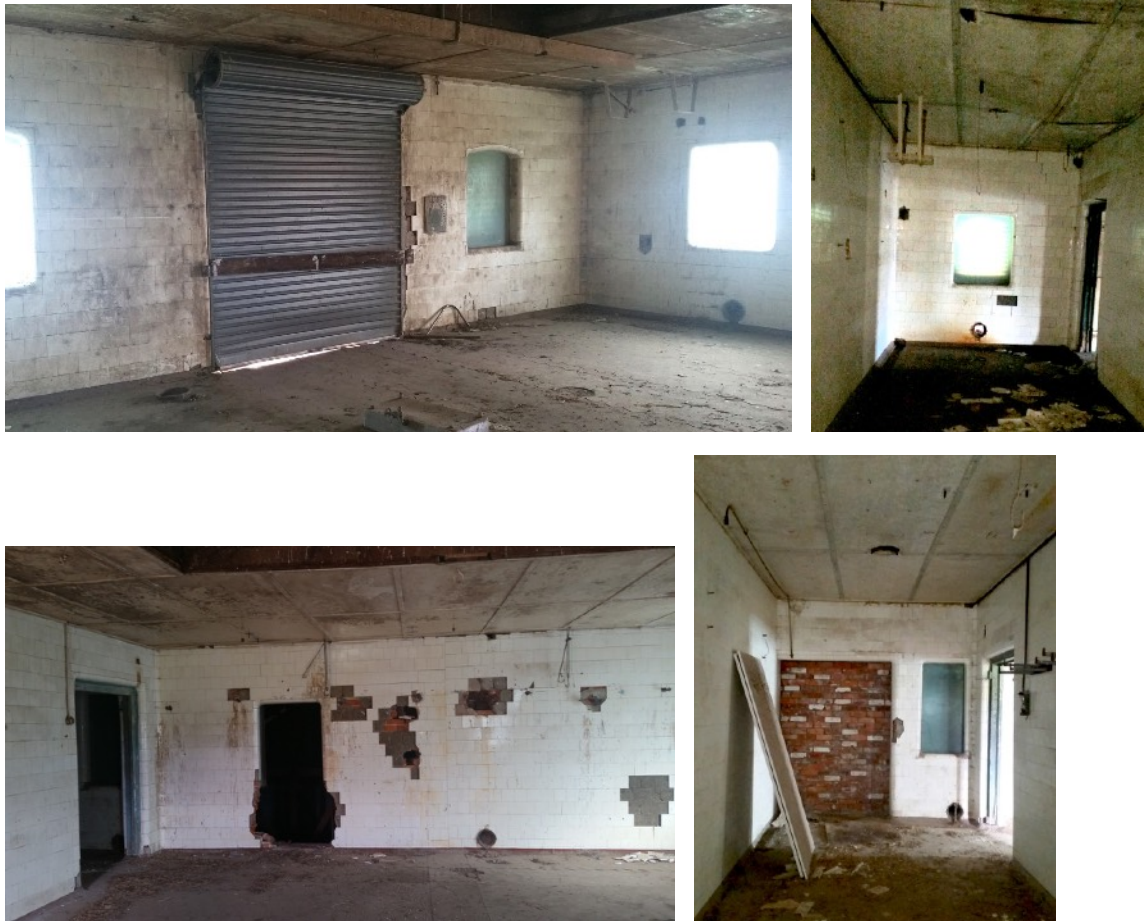
Figure D9. Area H (left) Looking north. Showing the original segmental arched window openings in the north elevation and the square window opening in the east elevation, all with architraves of curved white glazed tiles and white glazed tiles on the walls, and red-brown hexagon tiles on the floor. The roller door is a later alteration. **Area I (right)**. Looking east to the square window opening, and west to the bricked up opening, with walls clad in white glazed tiles. Note the ceilings may be asbestos cement sheeting. Source. Andrew Martin 2017.

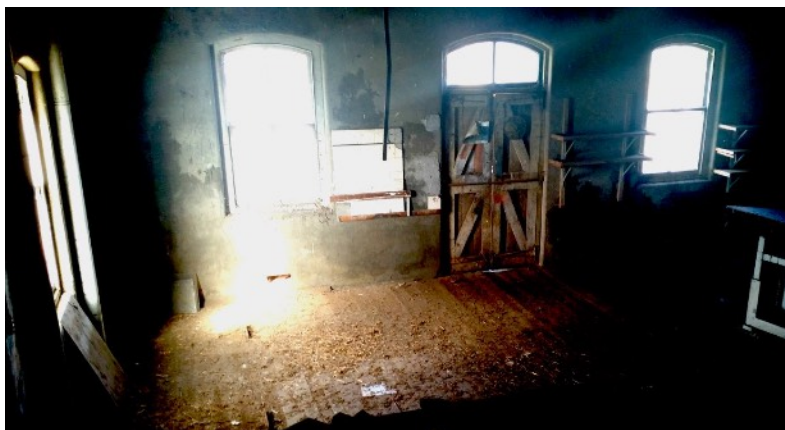
Figure D10. Area J. Looking north, from the loft over area J. Note the intact segmental arched windows, doorway and intact doors. The floor is timber. Source. Andrew Martin 2017.

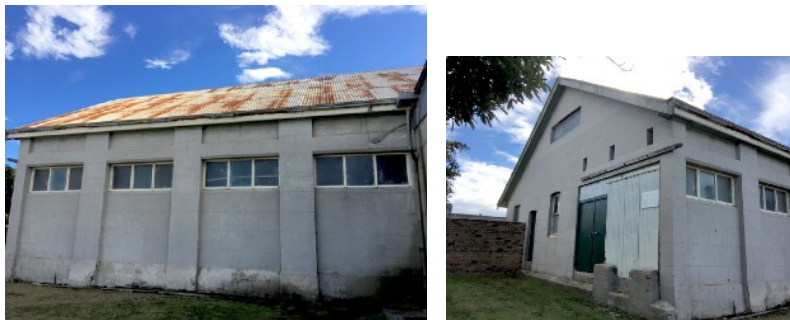
Figure D11. Area G. Left: South elevation of the c1931 factory extension, divided into four bays by pilasters, with highlight windows, and rendered to match the 1931 office building adjacent. Right: The rendered gable end of the single storey extension. The north elevation walls are built of brick with some corrugated iron cladding See Figure D2.

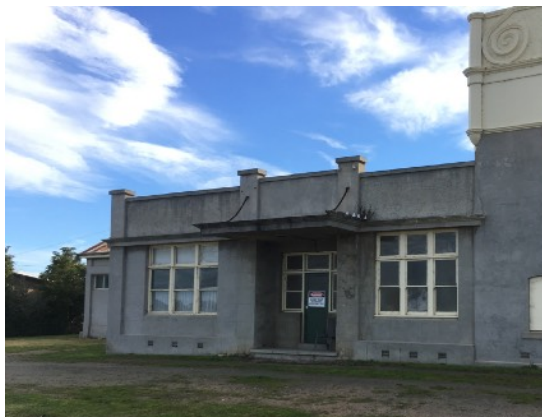
Figure D12. Area D. The south elevation of the 1931 office building. Constructed of brick and rendered, it is divided into three bays with banks of three windows either side of a centrally recessed front door accentuated by the cantilevered porch ‘supported’ by chains attached to the high parapet. The integrity is high however the architectural design is unremarkable compared with the 1908-09 building.

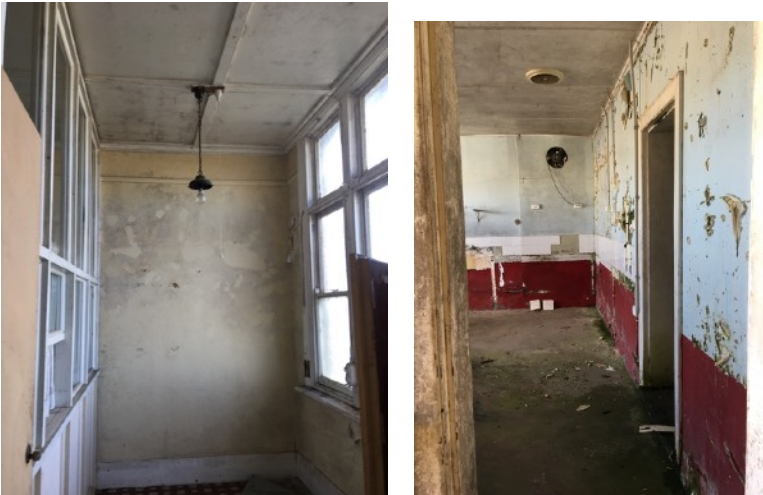
Figure D13. Area D. Typical views of the asbestos clad ceiling and walls of the interior of the 1931 offices.

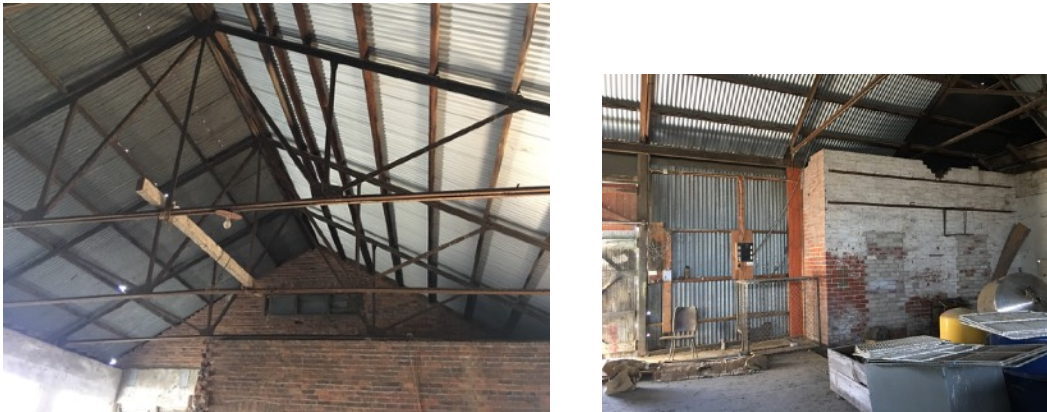
Figure D14. Area G. Left Typical view of the gabled roof of the single storey c1931 factory, with metal roof trusses and galvanized corrugated iron cladding and brown brickwork. Right. View showing red brickwork and corrugated iron walls. The brown brick sections may be earlier remnants of pre 1931 structures.

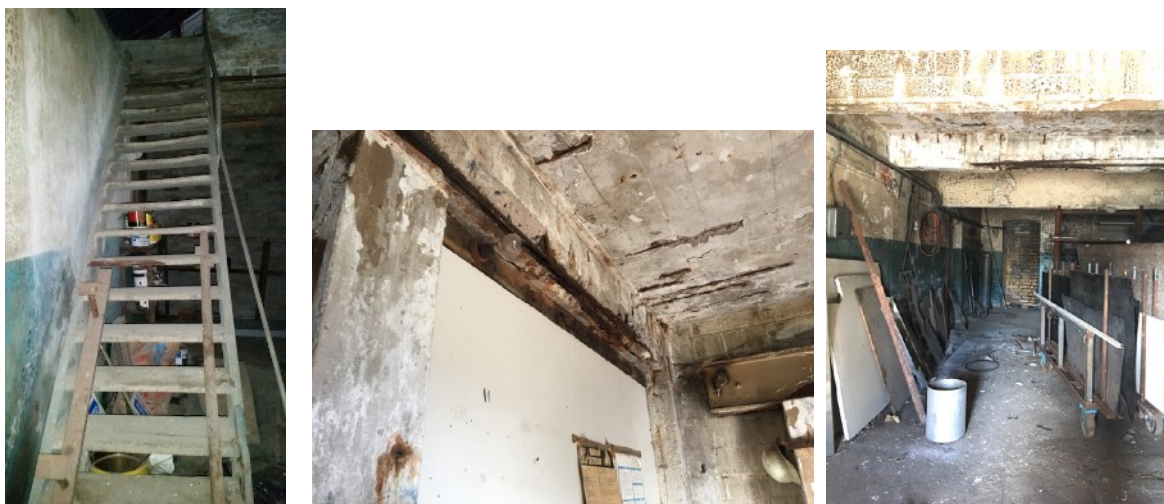
Figure D15. Areas E and F. c1931 building located behind the 1931 office building. The timber staircase, located in AREA E goes to the first floor in AREA K. The other two views are of AREA F.

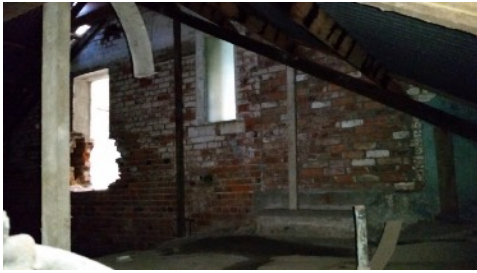
Figure D16, Area K. View towards a former window which has been crudely made into a doorway from Area K into Area H. Source. Andrew Martin 2017.

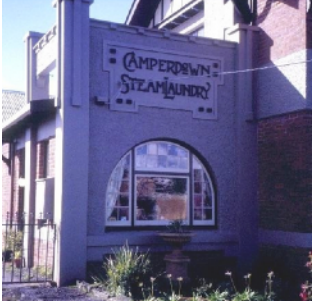
<p>Figure 7</p> <p>Image from Flickr, photographer Jeff Boyd <http://farm6.static.flickr.com/5109/5678879104_4065109462.jpg></p>	<p>Detail of cement facings on Glenormiston Butter and Cheese Factory Company</p>

In common with the old factory in the Yarram Butter Factory historic precinct, the Glenormiston Butter Factory and Camperdown Steam Laundry features a decorative written plaque (Figure 5; Figure 6) and the Glenormiston building includes similar decorative cement facings to the old factory in the Yarram Butter Factory historic precinct (Figure 5; Figure 7).

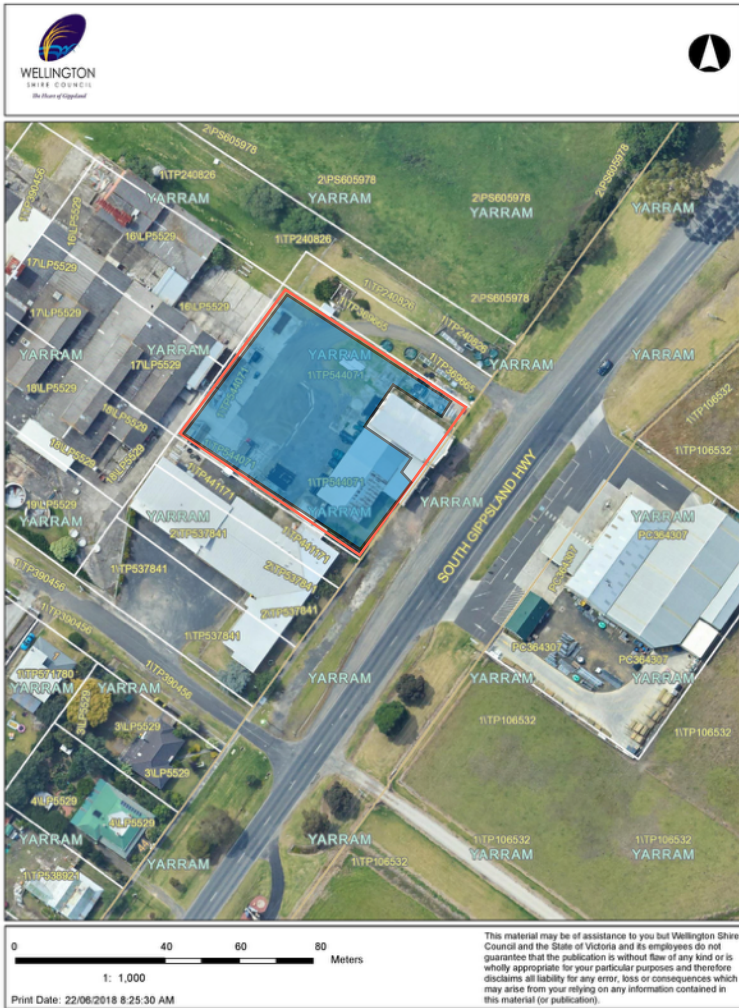
Boundary of HO in Red.

Blue shaded area indicates area suitable for demolition and new works.
