Locality: BRIAGOLONG
Place address: 1 AVON STREET
Citation date 2016
Place type (when built): Church
Recommended heritage protection: Local government level
Local Planning Scheme: Yes
Vic Heritage Register: No
Heritage Inventory (Archaeological): No

Place name: St Patrick's Catholic Church

Architectural Style: Federation Gothic
Designer / Architect: T. A. Payne
Construction Date: 1905

Project: Wellington Shire Stage 2 Heritage Study
Client: Wellington Shire Council
Author: Heritage Intelligence Pty Ltd
Date: 12/2/16

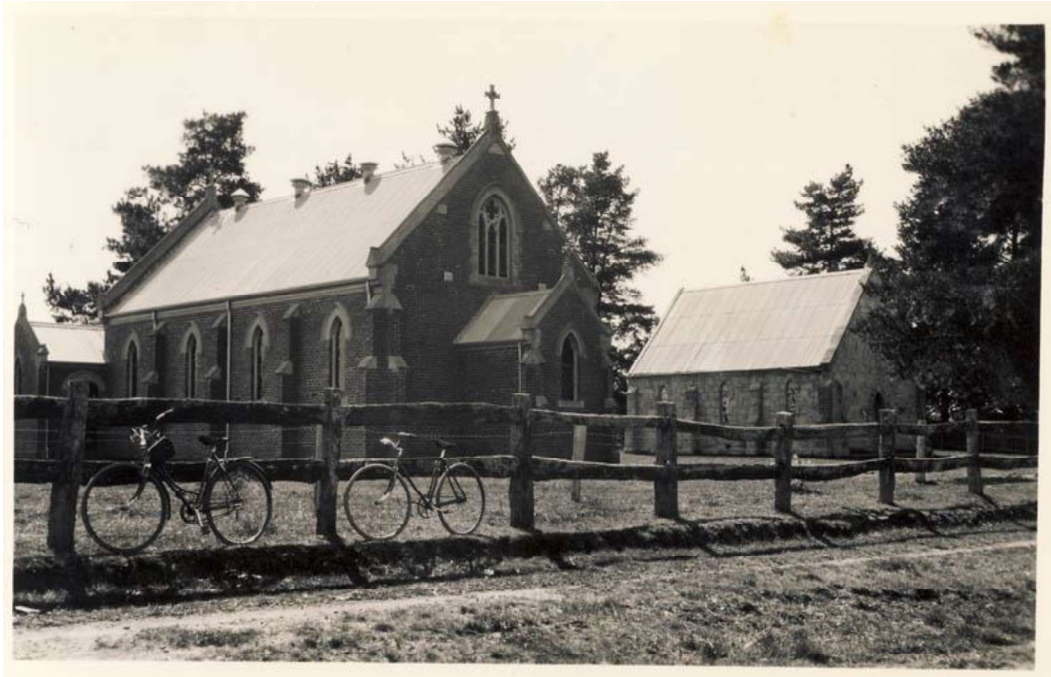
Figure H1. A photo dating to 1918 that showed the existing brick church and the original 1878 Catholic Church constructed of stone, since removed. Mature exotic trees were evident in the background (since removed), and a post and rail fence ran along the front boundary (since removed) (MDHS, ID. P03789VMFF 1918).

The photo dating to 1918 (MDHS) showed the first Catholic church to the east of the existing brick church (demolished in 1948) (Figure H1). The facade and west elevation of the existing church were evident. The roof was clad with galvanised corrugated iron and had four round vents projecting from the ridge (removed, presumably when the roof was reclad recently in Colorbond). The church appeared it does today, but the decorative render appeared to be unpainted at this date. The entrance porch was evident at the front, and the vestry projected westward off the apse. Mature exotic trees were evident in the background (since removed), and a post and rail fence (of non-uniform slabs) ran along the front boundary (since removed).

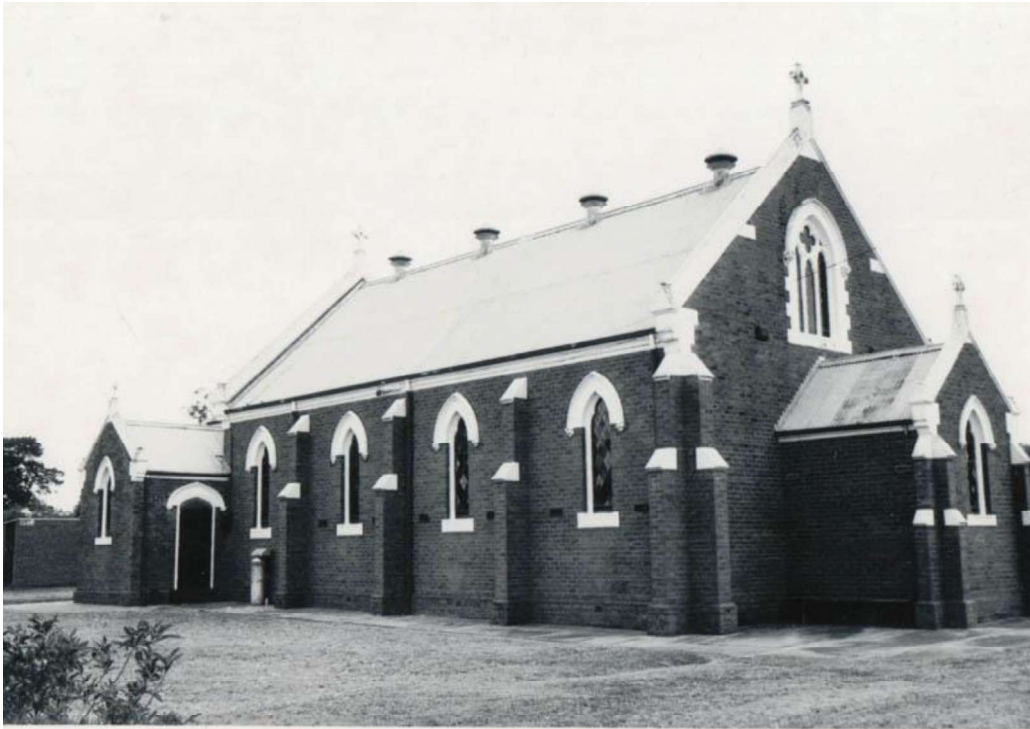
Figure H2. Photo dating to 1976, showed the vents along the ridge of the roof remained at this date and the rendered decoration had been overpainted (MDHS, ID. P02790VMFF 1976).

A photo dating to 1976 (MDHS) showed that the vents along the ridge of the roof remained at this date and the rendered decoration had been overpainted (Figure H2). The toilet block at the rear boundary had been constructed.

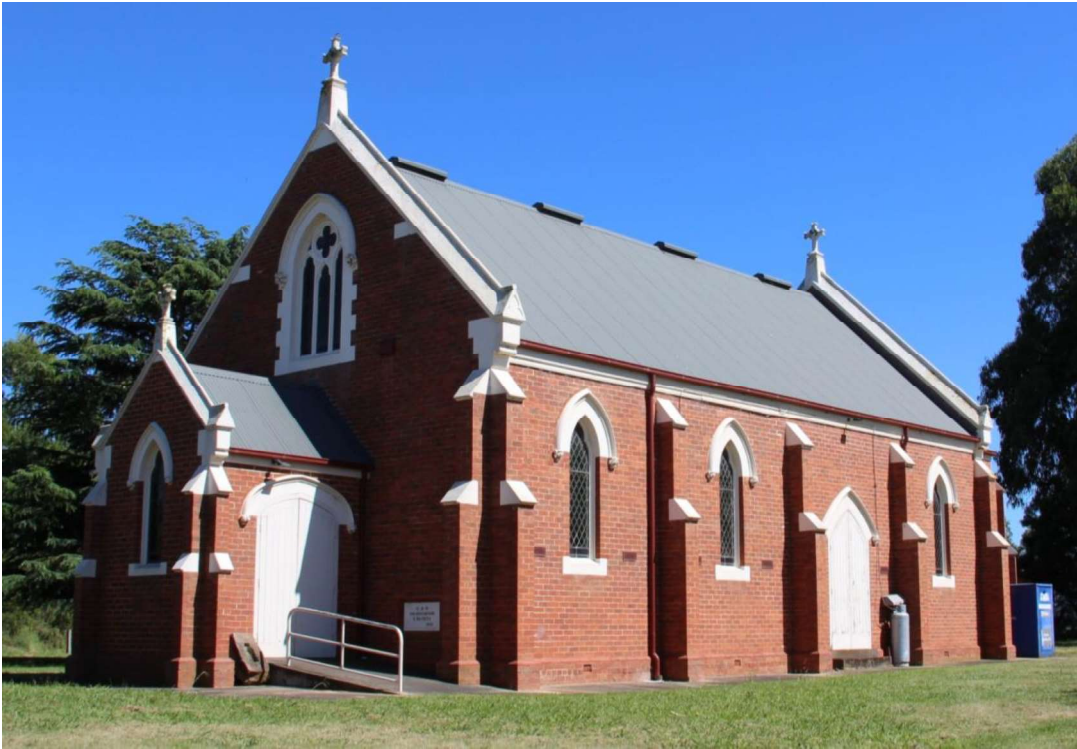
Figure D1. The church is constructed of handmade red bricks on a brick plinth, and has a gabled roof clad with (recent) grey Colorbond (with introduced flat ridge vents). The parapeted gables have a cross at the apex. Decorative render and coping (overpainted) is a decorative element of the red-brick building. The gabled end to the facade has a large pointed-arch window with a label moulding stopped by rosettes; recessed within is a three-part window with a quatrefoil at the peak. Central to the facade is the entrance porch which mimics the design of the nave behind, with its parapeted gable and corner buttresses. Double ledged and framed timber doors enter off the east side of the porch (accessed by a modern concrete ramp with a metal handrail).

Figure D1. The church constructed of handmade red bricks, with its gabled roof and central entrance porch. Decorative render and coping is a decorative element of the Federation Gothic design, overemphasised by the recent white paint.

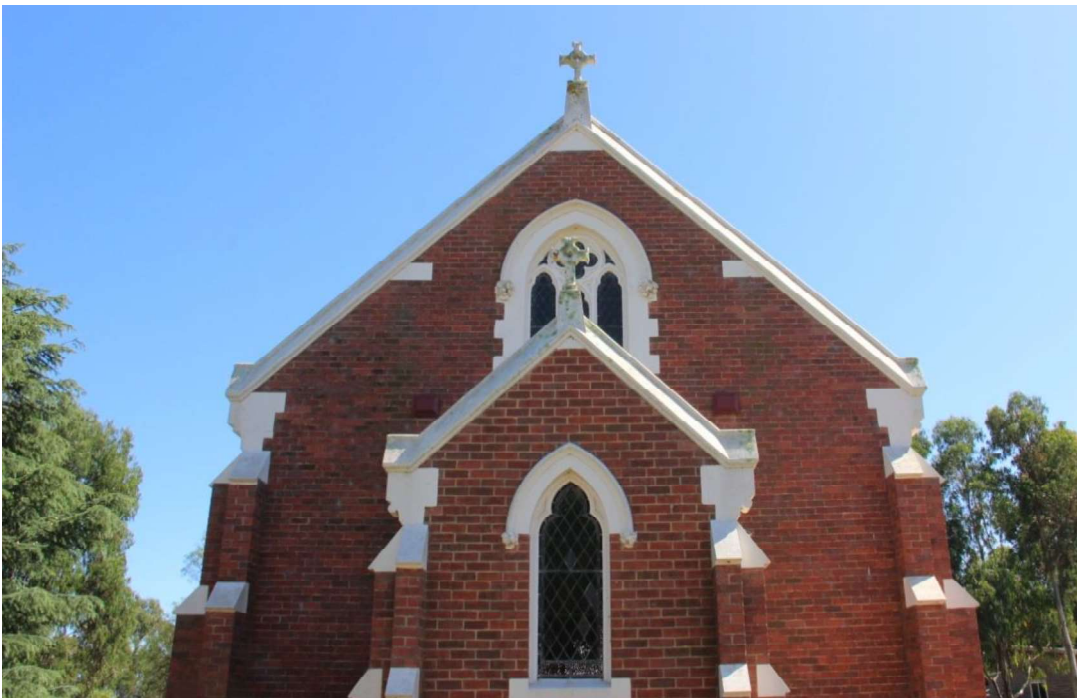
Figure D2 & D3. The church has pointed-arch window openings with a label moulding stopped by rosettes and a rendered sill. Recessed within each opening is a leadlight window (of coloured glass in a diaper pattern) which finishes at the top in a trefoil motif.

Figure D2. The church has pointed-arch window openings with a label moulding stopped by rosettes and a rendered sill. Recessed within each opening is a leadlight window (of coloured glass in a diaper pattern) which finishes at the top in a trefoil motif.

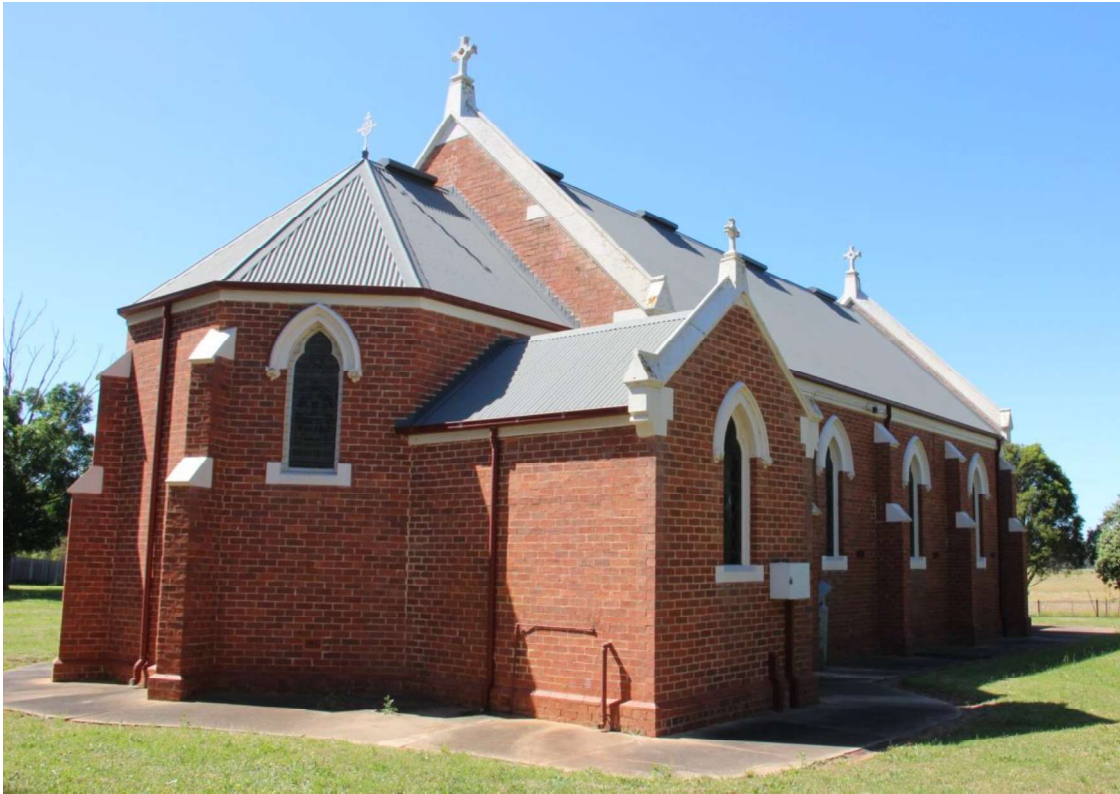
Figure D3. The side elevations form four bays, divided by five buttresses (all with rendered coping). The east elevation has double timber doors in the third bay, accessed by bluestone steps, while the other bays have windows (Figure D1). The west elevation has four windows.

At the (rear) chancel end of the church is a faceted bay with smaller windows at a raised height. Projecting off the west of this is a small vestry with a gabled roof. The vestry has a timber entrance door off its south side.

Figure D3. The side elevations form four bays, divided by five buttresses (all with rendered coping). At the (rear) chancel end of the church is a faceted bay with smaller windows at a raised height. Projecting off the west of this is a small vestry with a gabled roof.

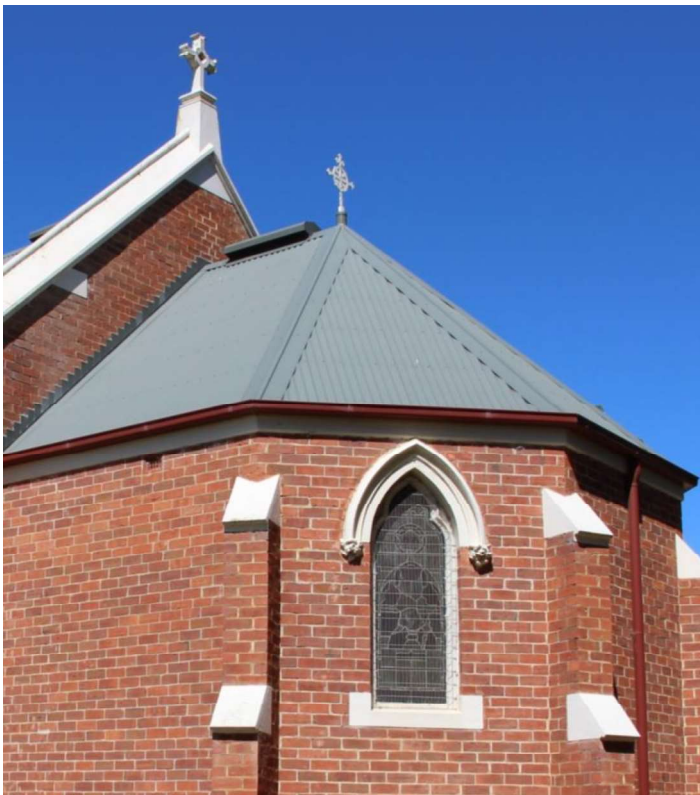
Figure D4. The windows to the bay at the chancel end have ornate leadlight, in comparison to the nave of the church.

Figure D4. The windows to the bay at the chancel end have ornate leadlight.

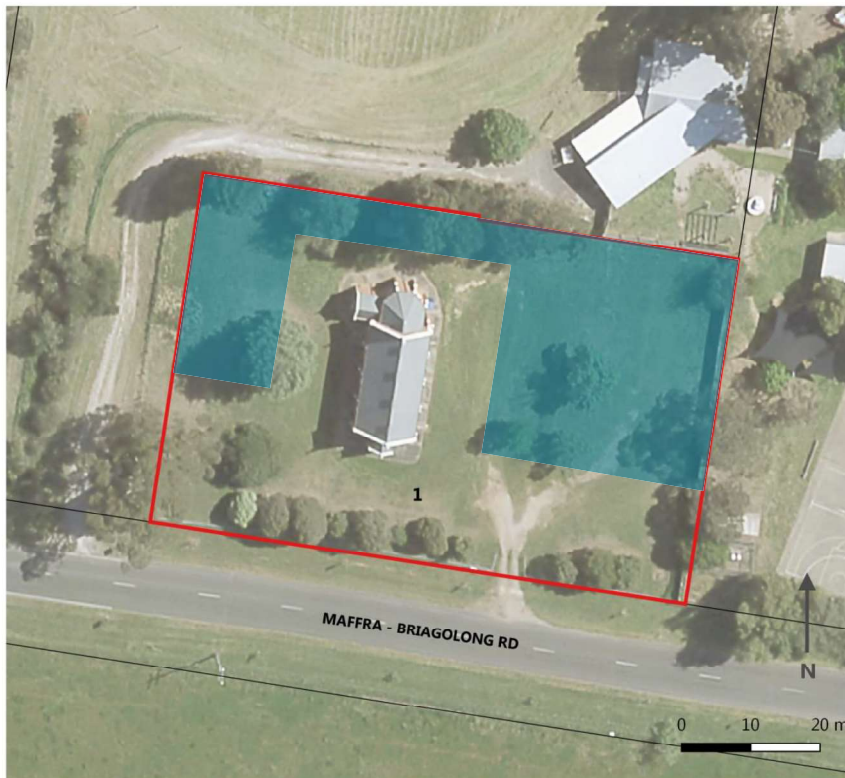
NOTE: The blue shaded area is the preferred location for additions and new development.

2.1. New structures should be restricted to the rear of the property as shown in the blue polygon on the aerial map below.
