Locality: HEYFIELD
Place address: 7 TEMPLE STREET
Citation date 2016
Place type (when built): Post office
Recommended heritage protection: Local government level
Local Planning Scheme: Yes
Vic Heritage Register: No
Heritage Inventory (Archaeological): No

Place name: Post Office (former)

Project: Wellington Shire Stage 2 Heritage Study
Client: Wellington Shire Council
Author: Heritage Intelligence Pty Ltd
Date: 12/2/16

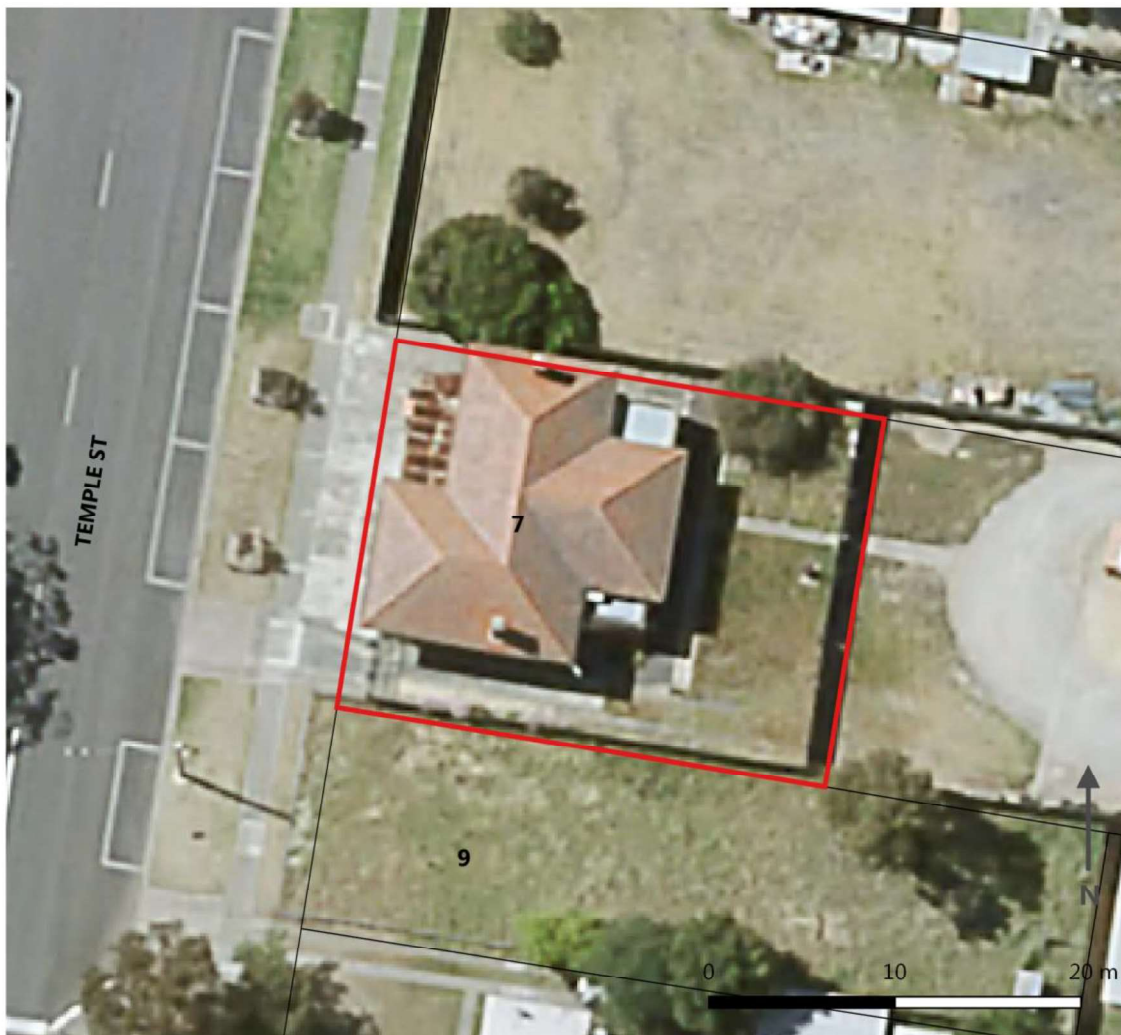
Map of recommended boundary for Heritage Overlay

This place is recommended for inclusion in the Schedule to the Heritage Overlay of the Wellington Shire Planning Scheme to the extent of the title boundary as shown on the map.

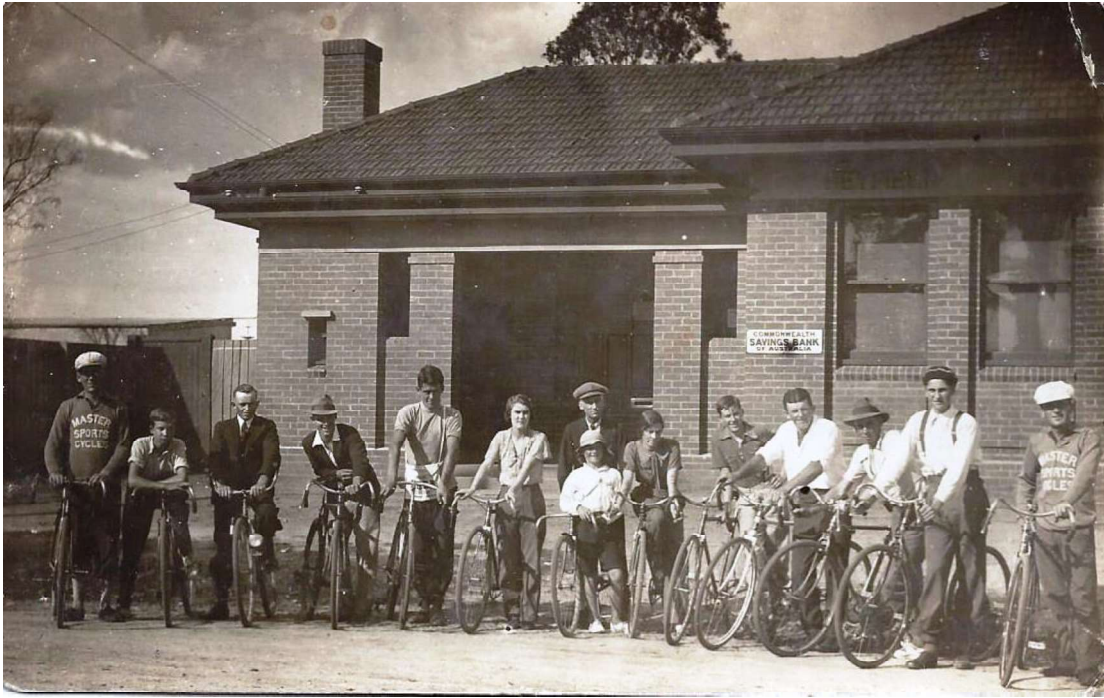
A photo dating to c1927 (HDHS), soon after it was completed, showed a group of cyclists parked in front of the building (Figure H1). The facade of the post office appeared as it does in 2015, with a tiled hipped roof, simple brick chimney and face-brick walls. The words 'Heyfield Post [Office]' appeared under the eaves of the projecting bay. A small sign on the facade reads 'Commonwealth Savings Bank of Australia' which suggests the building also served as a branch.

Figure H1. Photo of the post office taken c1927, soon after the post office was built, illustrating the original colour scheme of unpainted render and dark-tone timber joinery. (HDHS).

- 3.3. The rendered band under the eaves, around the building, and entry porch has been painted, however, these architectural features were not designed to be painted, see Fig H1 for original

colour scheme. They were a light coloured unpainted rendered. It is strongly recommended that the next time the cost of a repaint is considered, remove the paint chemically (never sand, water or soda-blast the building as this will permanently damage the bricks, mortar and render and never seal the bricks or render as that will create perpetual damp problems). Removal of the paint will not only restore the architecture, but it will remove the ongoing costs of repainting it every 10 or so years. However, if it is decided to repaint the render, it should be one colour only, similar to white Portland cement.

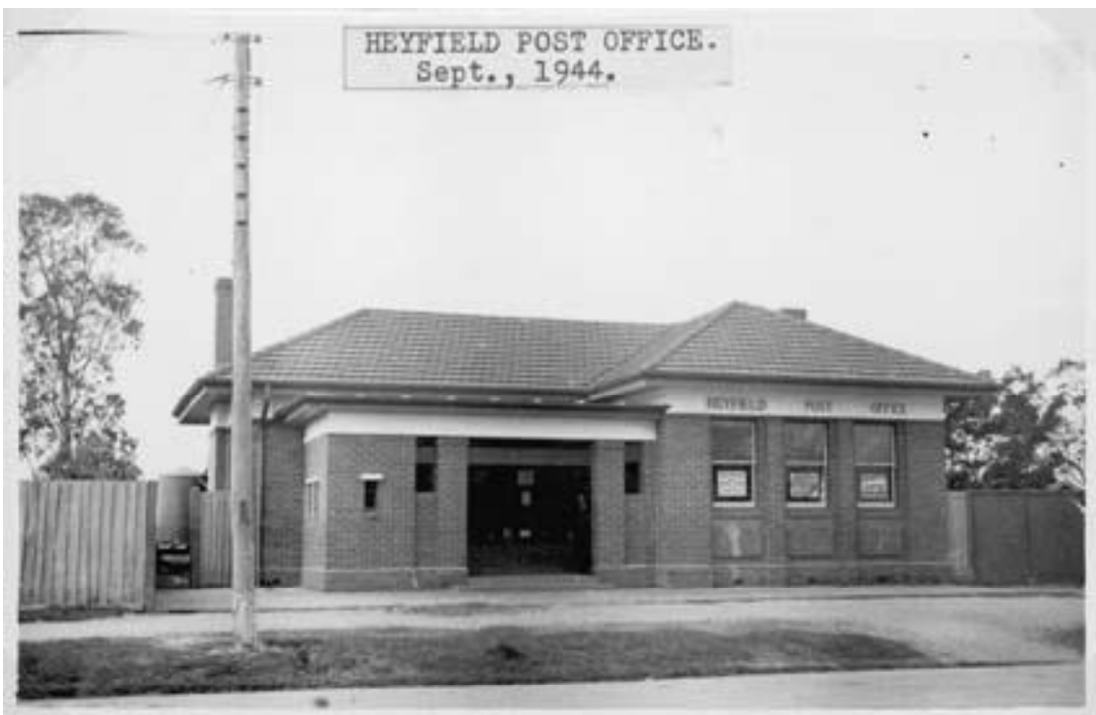
Figure H2. The facade and part of the north elevation of the post office in 1944 (NAA).

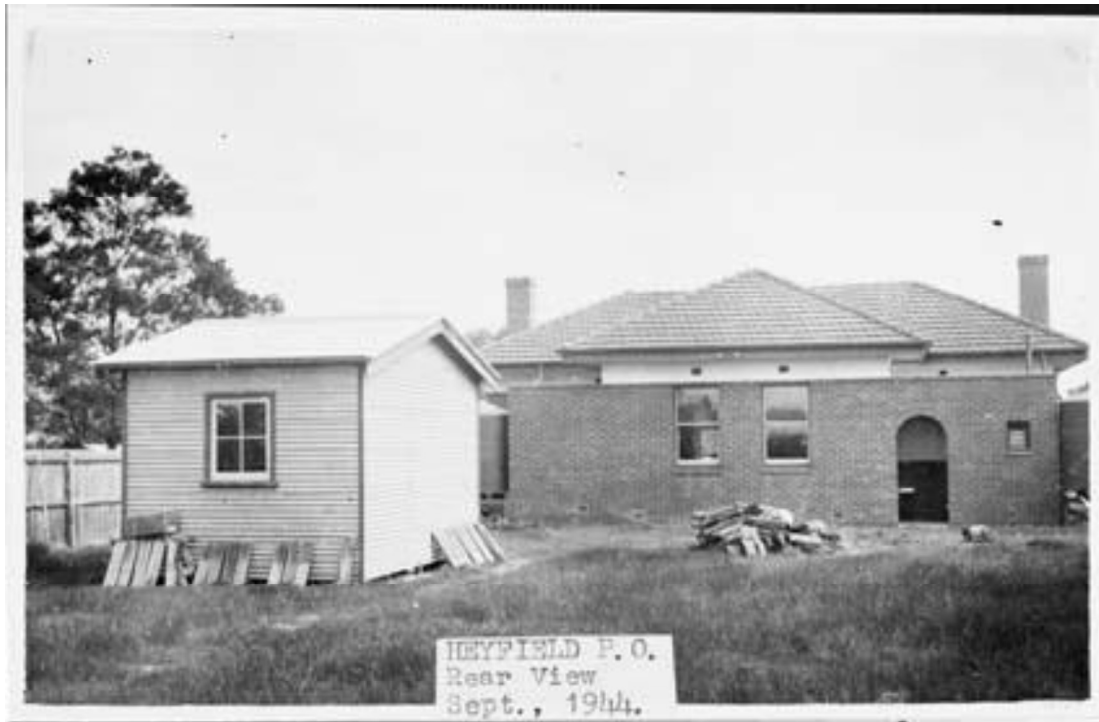
Figure H3. The rear elevation in 1944, with a round arched doorway and a small timber outbuilding to the rear of the post office (NAA).

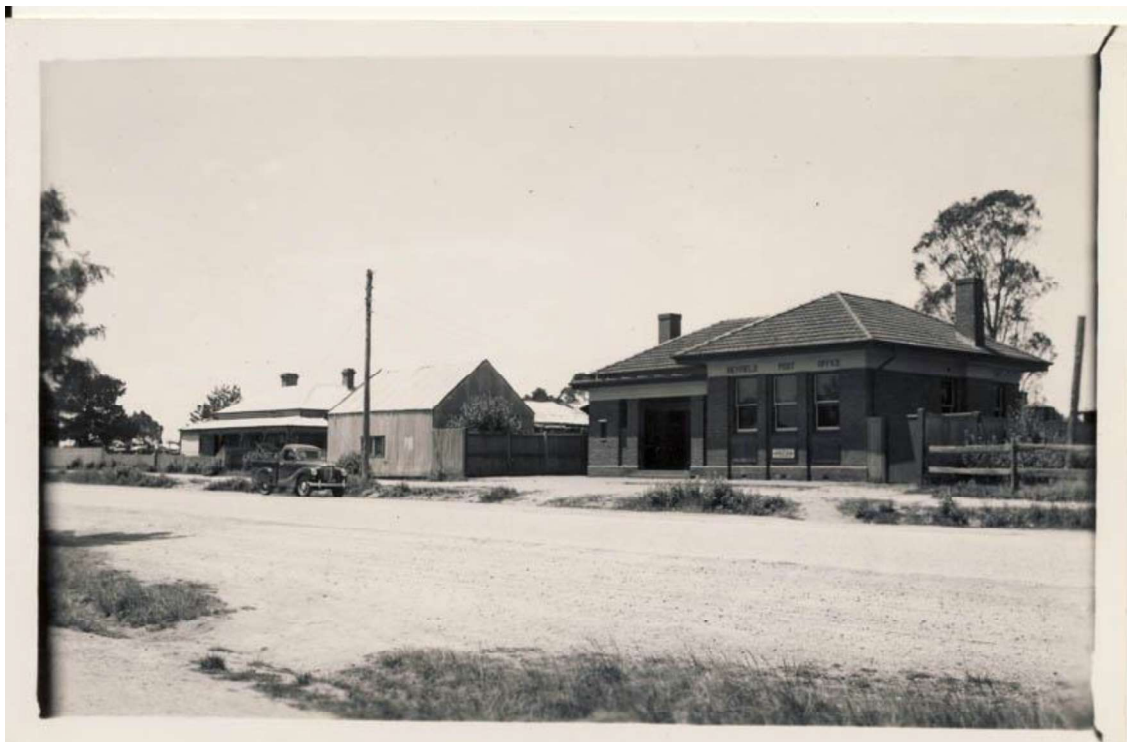
Figure H4. The facade and south elevation, photo dates to post-1948 (HDHS).

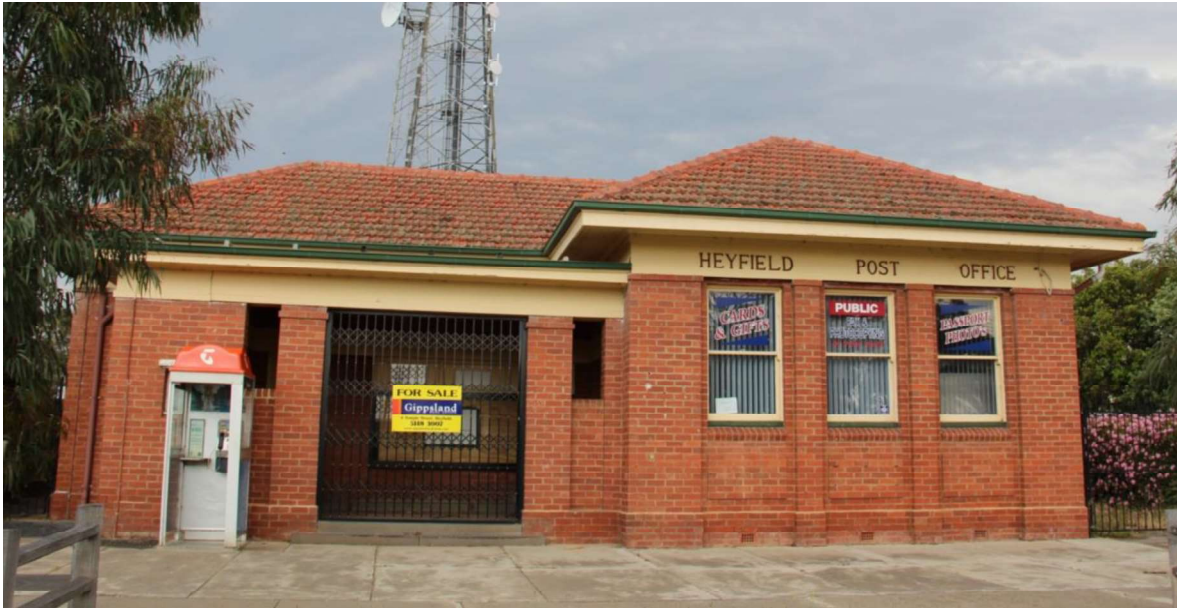
Figure D1. The single-storey face-red brick building is domestic in scale and has a low-pitched hipped roof clad with orange-coloured terracotta tiles. The roof form comprises a projecting bay at the right side of the facade and at the left side of the rear (east) elevation (as evident in the aerial of the map). Two red brick chimneys remain at the north and south ends of the building. Engaged brick pilasters with capitals and bases break up the facade into vertical bays, appearing between the windows of the projecting bay to the right of the facade, and repeated either side of the entrance, forming piers with entablature above, representing a classical trabeated facade.

Figure D1. The façade of the post office. The two chimneys are out of view in this photo.

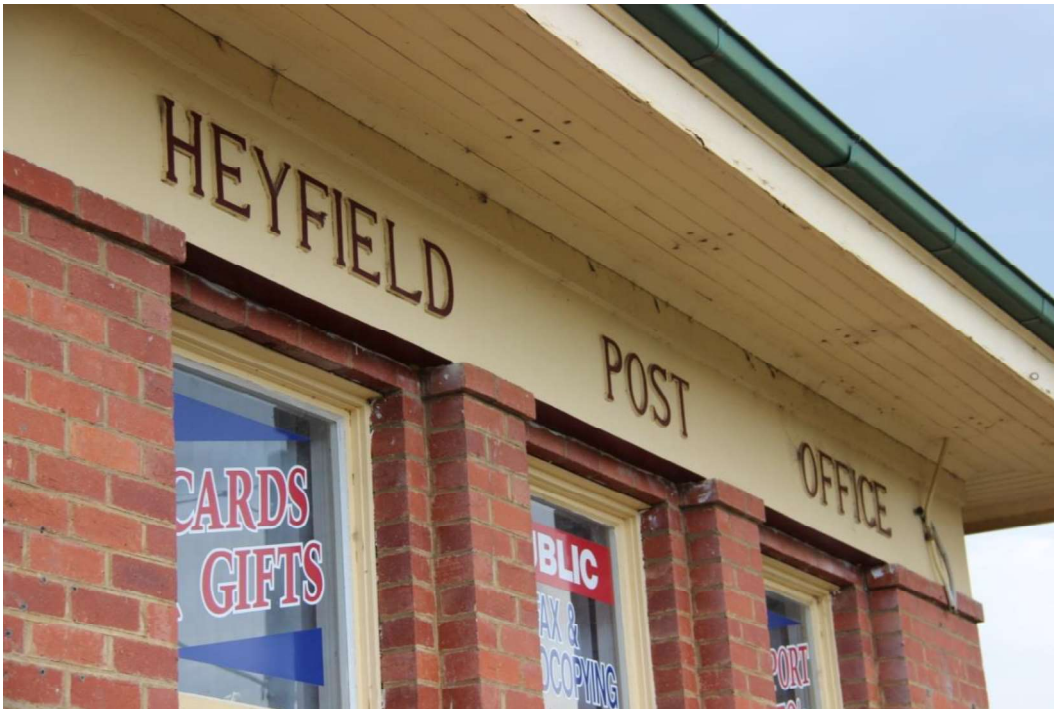
Figure D2. The wide eaves of the roof are timber lined, under which is a band of smooth render that runs around the entire building. Upon the decorative render is the name 'Heyfield Post Office', under the eaves of the projecting bay to the facade.

Figure D2. The wide eaves which are timber lined, and the name of the post office on the smooth band of decorative render.

- 5.1. Ensure all signage is designed to fit around the significant architectural design features, not over them.
- 5.2. Retain the Heyfield Post Office signage. If the place is not used as a post office in the future, do not remove the sign, if necessary, remove the paint so that the sign is not a feature, and if necessary, place a removable sign over the writing in such a way that the original writing will not be damaged.

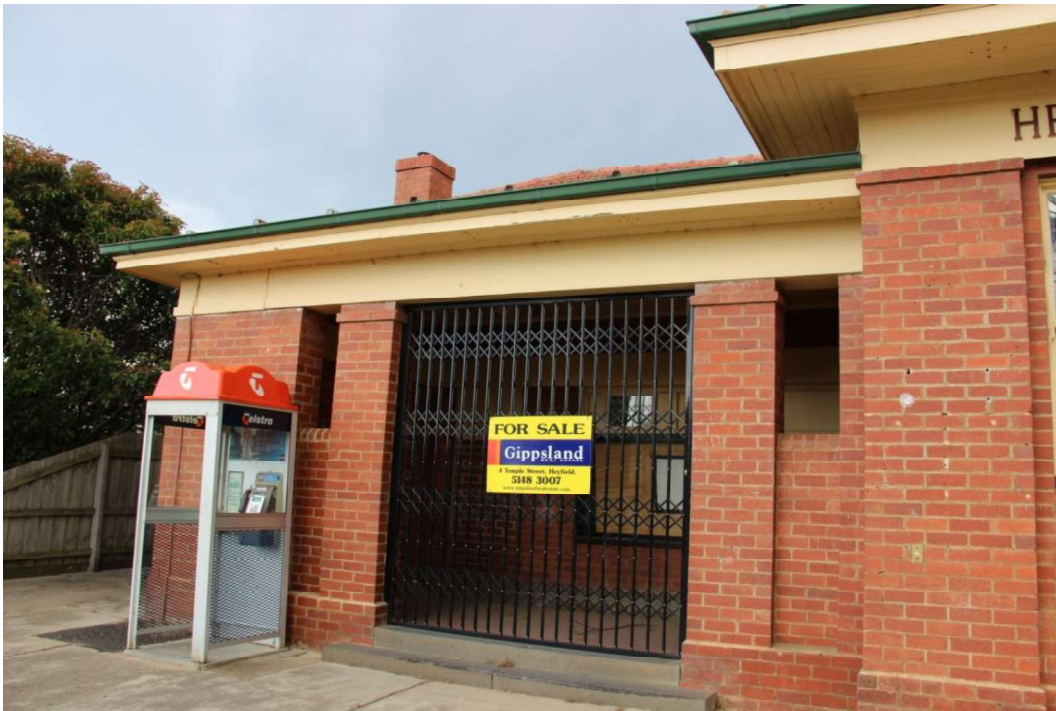
Figure D3. To the left of the facade is a partly enclosed porch with a separate roofline, under which is the entrance to the interior of the post office, (one entrance is bricked up, with another entrance open to the right of the porch).. The porch is entered by two bluestone steps to a flat floor clad in original pavers. The porch opening is enclosed by a modern retracting security gate. A modern telephone box is located in front of the entrance porch.

Figure D3. The entrance porch to the left of the facade, which is under a separate roofline.

- 3.4. It is recommended that a heritage specialist industrial cleaner be engaged to remove the paint, but Haymes Peelaway may be used. The former bank at Rosedale was recently cleaned of paint using an approved chemical method. If an opportunity arises, consider relocating the telephone booth to the side or rear, and away from the front of the building.
- 3.5. Remove items such as the oil tank when no longer required.
- 3.6. Remove the Victorian era spears from the top of the metal gates, as they are out of character with the inter war design of this building. This is recommended but not a requirement.

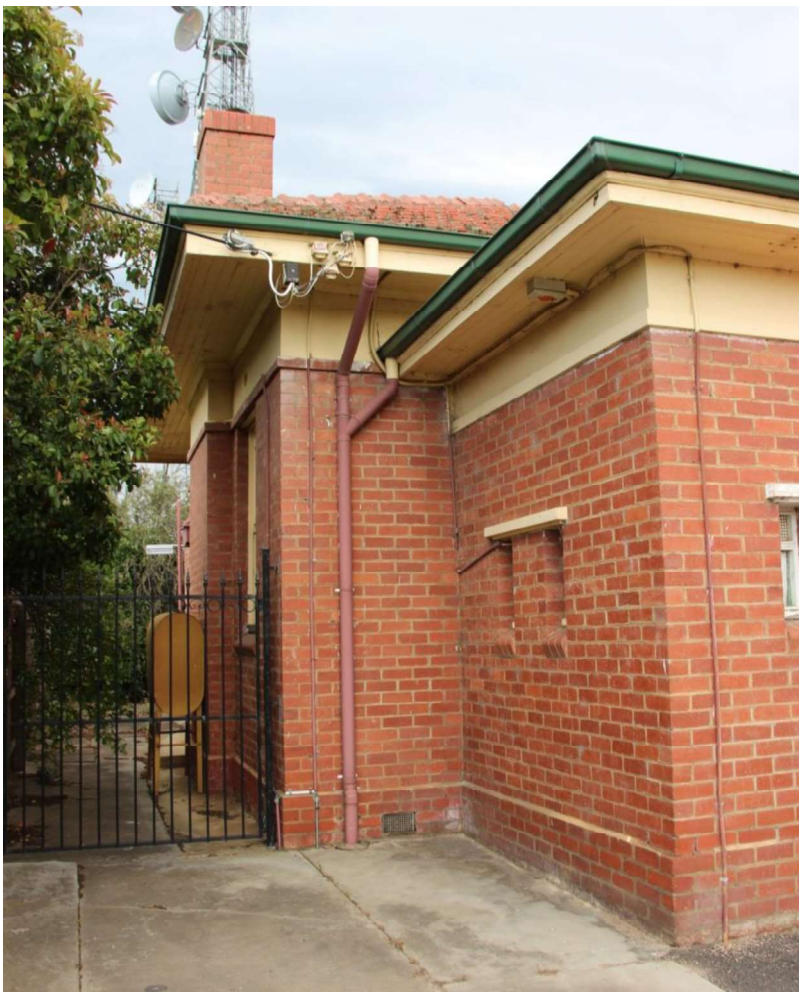
Figure D4. The red brick chimney stack stands externally on the north elevation. The wide eaves and band of smooth decorative render continue under the eaves on both the outside and inside porch and main portion of the building. Two small windows, with one narrow decorative lintel, are located on the north wall of the entrance porch and one on the left side of the porch which may indicate early telephone booths.

Figure D4. The chimney stack stands on the exterior of the elevation. Three small windows are

located on the entrance porch.

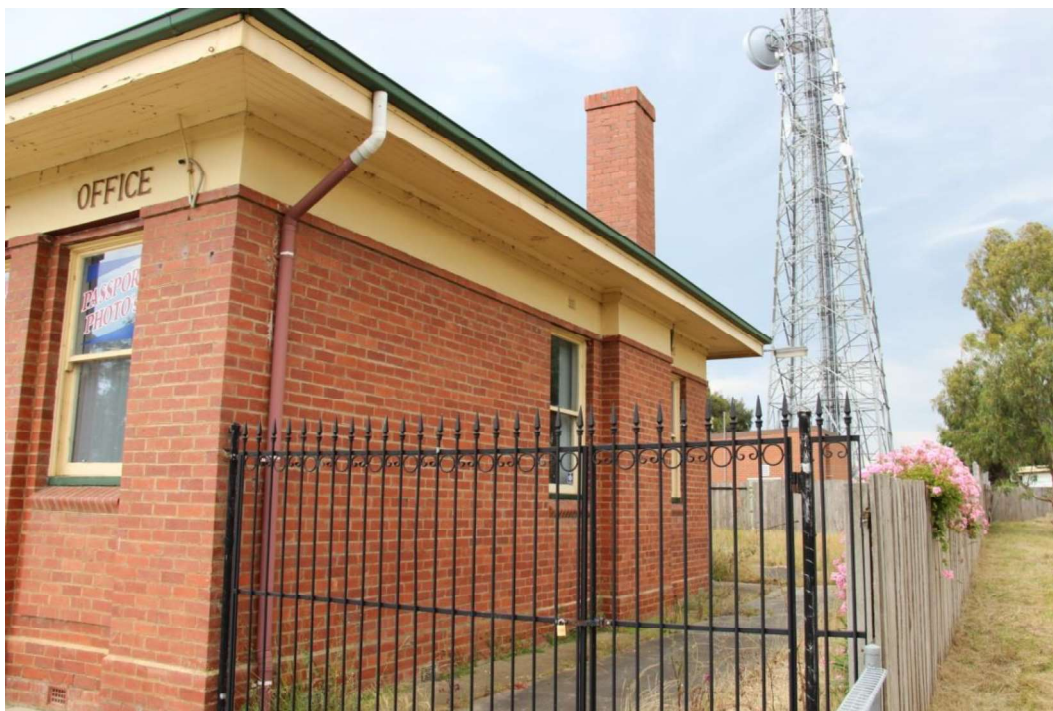
Figure D5. The south elevation comprises the external chimney breast of the second chimney. This is flanked by one-over-one timber sash windows. The smooth band of render continues beneath the wide eaves.

Figure D5. The southern elevation with the external chimney stack flanked by one-over-one sash windows.

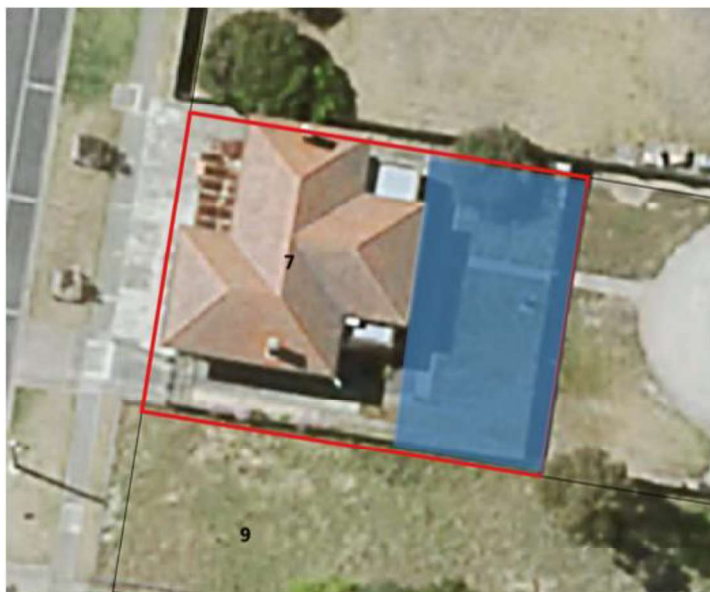
NOTE. The blue shaded area is the preferred location for additions and new development.

- 1.1. Retain clear views of the front elevation.
- 1.2. New structures should be restricted to the rear of the property and concealed behind the heritage fabric when viewed from Temple Street. The aerial image below shows the area recommended for new structures shaded in blue. It is preferable that they are not identical in design, so that the original building fabric is discernable, but sympathetic in scale, roof form, colours and materials.
