Locality: MAFFRA
Place address: APEX PARK, MCMAHON DRIVE
Citation date 2016
Place type (when built): Factory office, weighbridge
Recommended heritage protection: Local government level
Local Planning Scheme: Yes
Vic Heritage Register: No
Heritage Inventory (Archaeological): No

Place name: Beet Sugar Factory Office (former) and Weighbridge

Project: Wellington Shire Stage 2 Heritage Study
Client: Wellington Shire Council
Author: Heritage Intelligence Pty Ltd
Date: 12/2/16

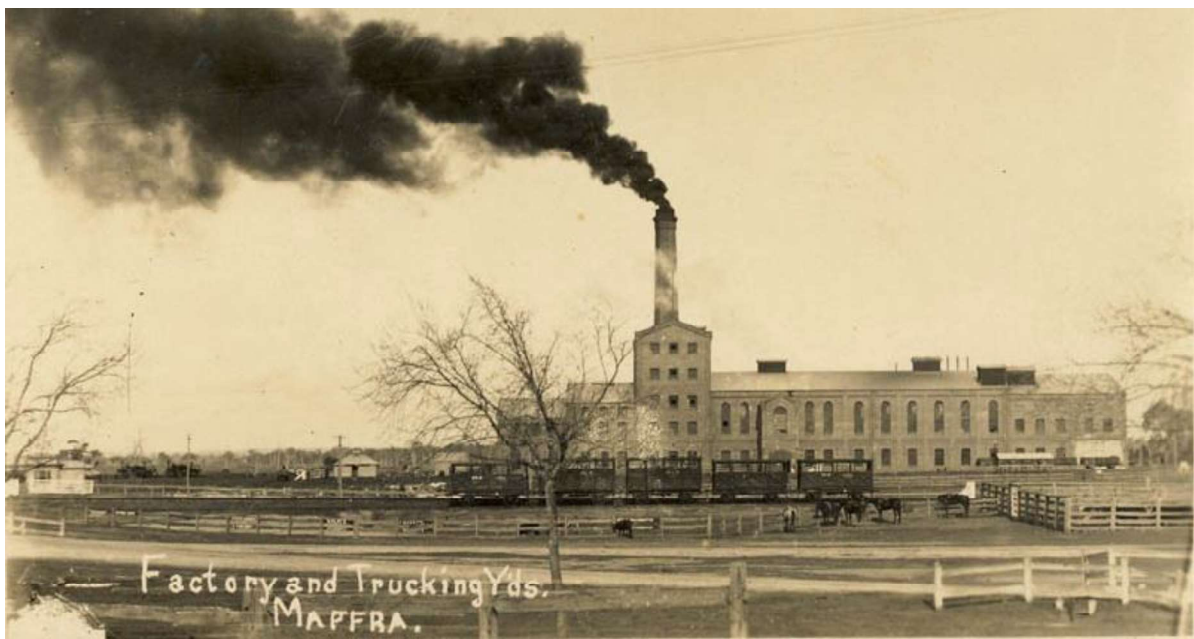
Early photos showed the factory office in its original context (Figure H1). The office was built near Sale Road (east of the remaining brick store building), facing Railway Place. Other early photos showed office's facade and elevation to the right. What is probably the earliest photo showed the facade of the office, with the parapet reading '1896, Maffra Beet Sugar Company Limited' (Figure H2). The hipped roof was clad in corrugated iron, with a brick chimney to the left of the facade. A flagpole stood at the peak of the parapet and below was a three part window (remains in 2015). To the left was the small hipped roof section of the office, with the entrance and three part window. The entrance had simple timber brackets (remain in 2015) and a sign above that read 'office' (since removed).

Figure H1. The office in its original context at the factory site, at far left (MDHS, ID. P02179VMFF). The photo dates to pre-1926, when the new brick store building was constructed.

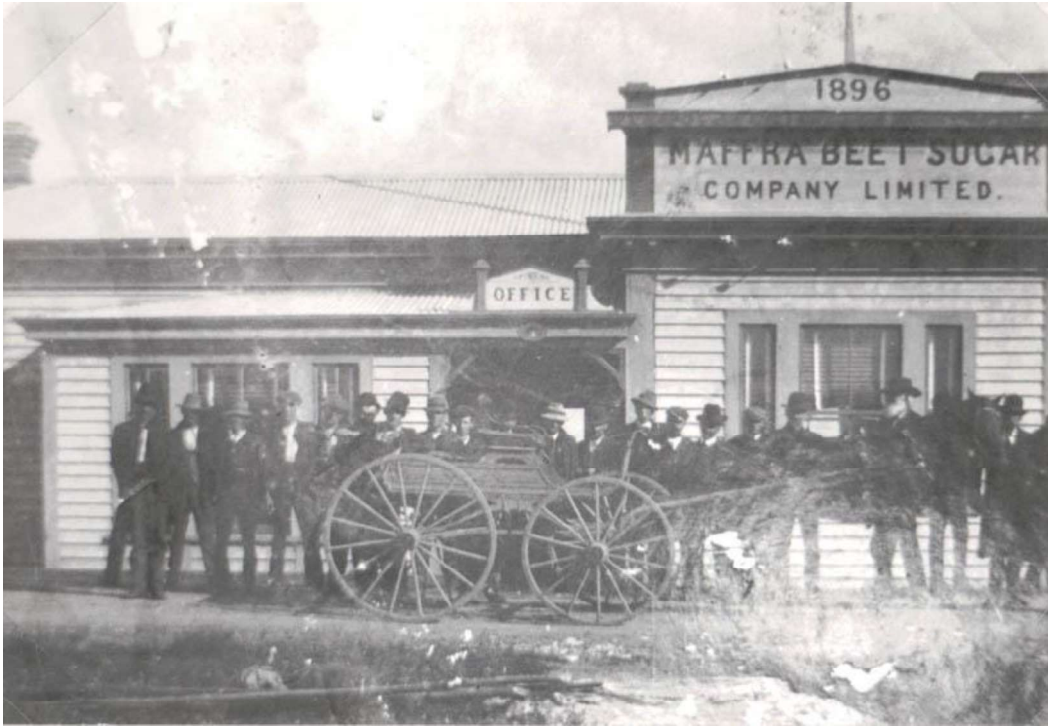
Figure H2. An early photo (date not known) of the office at its original location. The parapet reads 'Maffra Beet Sugar Company Limited' (MDHS, ID. P02172VMFF).

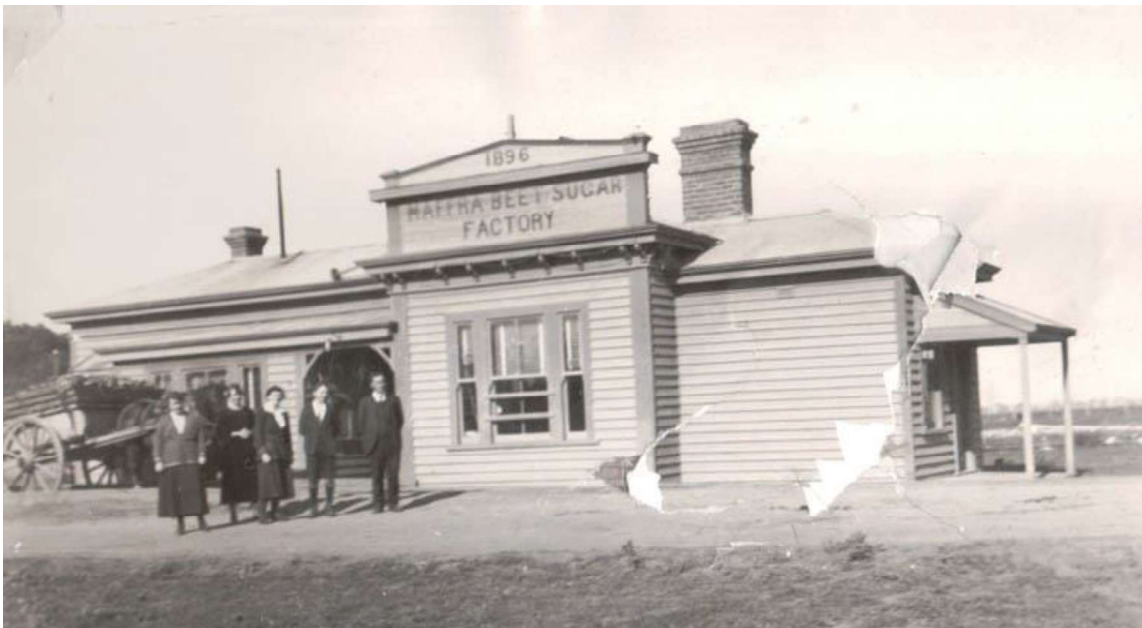
Other early photos showed the office, behind people and carts of beets, however, the weighbridge was not apparent in front of the building in this photo (Figures H3 & H4). In these photos the parapet read '1896, Maffra Beet Sugar Factory'. The sign 'office' had been removed from above the entrance (or not yet added, depending on the date of these photos, which could not be confirmed). Timber brackets were located at the cornice, below the parapet (remain in 2015). A wide corbelled-brick chimney was located on the right section of the building. The right hand side of the building comprised a skillion-roofed verandah (since removed) covering an entrance door and window.

Figure H3. An early photo of the office (date not known), showing the verandah on the elevation to the right (since removed) and chimneys (MDHS, ID. P02174VMFF).

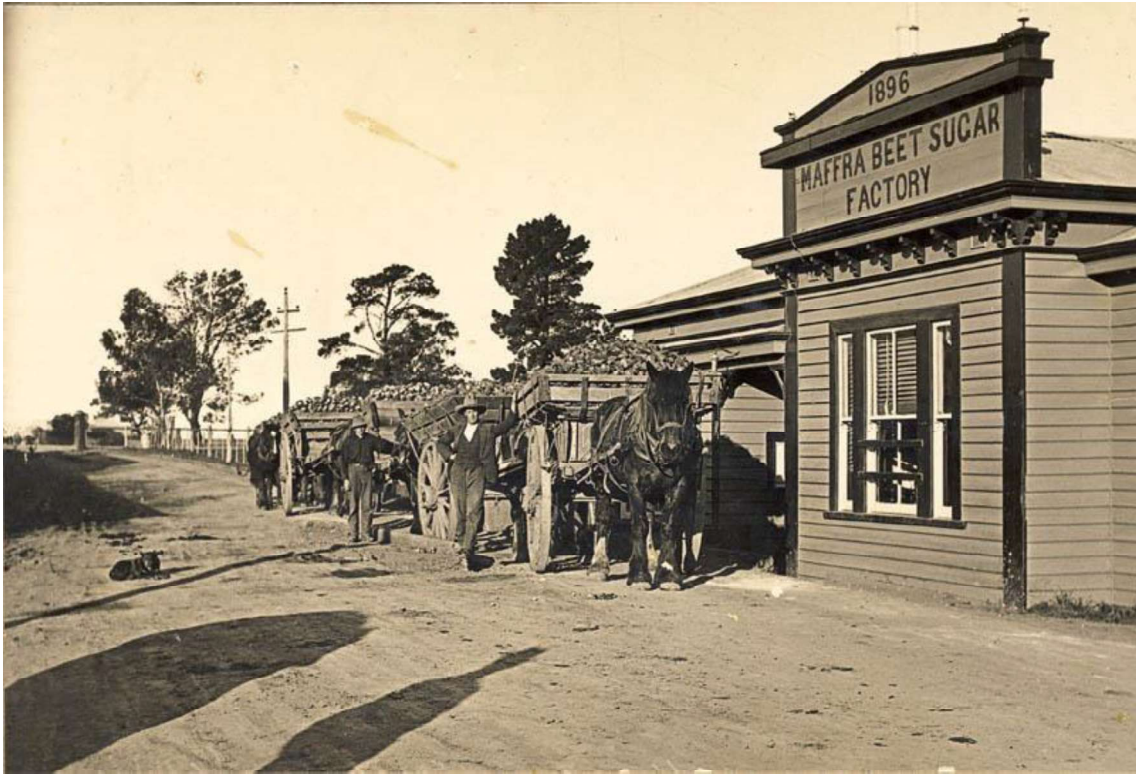
Figure H4. An early photo (date not known) of the office (MDHS, ID. P02176VMFF).

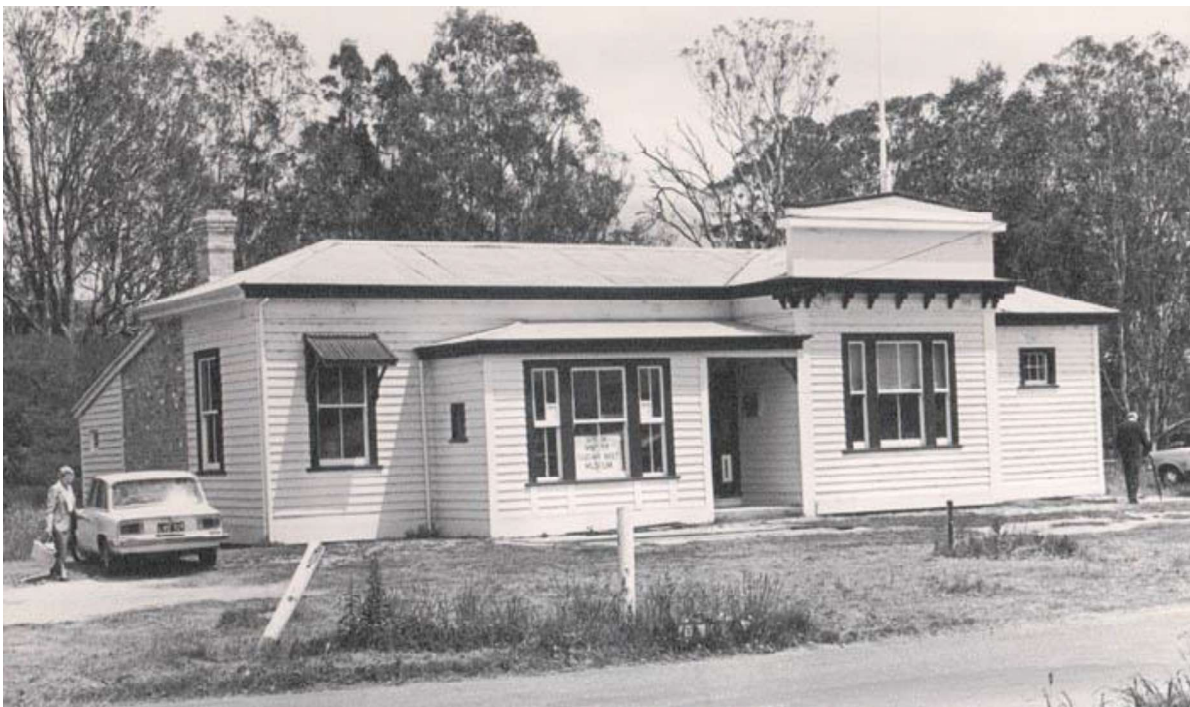
In 1978, the former factory office opened as the Maffra Sugar Beet Museum (Hitchins 2014). A photo of the office in its new location on McMahon Street (MDHS) showed the facade and elevation to the left (Figure H5). The parapet was over-painted and a window hood covered the single window to the left of the facade. The elevation to the left showed the timber portion and two skillion-roofed portions, the first of brick, the second of timber. The photos showed that by this date, a small window had been inserted on the right hand side of the facade.

Figure H5. The office after its relocation to its current site (date of photo not known). The parapet was void of a name (MDHS, ID. P02175VMFF).

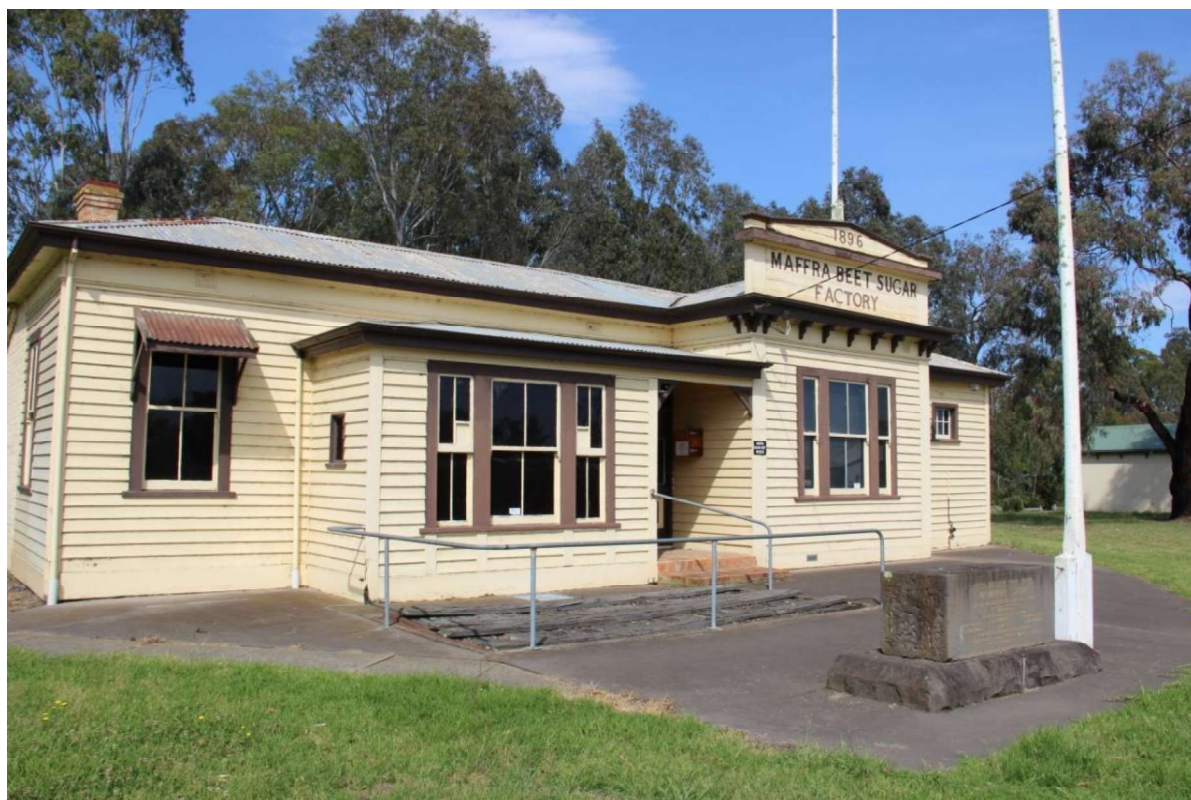
Figure D1. The c1897 building is a commercial purpose-designed goods-receiving weighbridge office in the Federation Free Classical. The former office is a single-storey asymmetrical weatherboard building with a hipped roof clad in corrugated iron. Two corbelled red brick chimneys remain on the southern and northern ends of the building (probably reconstructed to their original design following the building's relocation in 1975). A projecting bay at the right of the façade is the dominating element of the façade, with a tall timber parapet. The parapet reads '1896 Maffra Beet Sugar Factory' (replicating an earlier appearance that was removed). The parapet has a flagpole at the peak and is supported below with timber brackets at the cornice. Below is a three part window with a one-over-one double hung sash window flanked by two in narrower proportions. To the left of the projecting bay is a small room with a lower roofline, comprising a three part window of the same design and a recessed entrance. At the left of the façade is a two-over-two double-hung sash window with a windowhood (not known if original). At the far right of the façade is a small timber framed window (does not appear in early photos, existed by c1975). The c1897 office building is in good condition and retains a high level of integrity.

In front of the c1897 building is the contemporary weighbridge, an early flagpole and the foundation stone of what was likely a major Beet Sugar Factory building.

Figure D1. The facade of the former office, comprising the parapet to the projecting bay, and entrance in the section to the left. In front of the office is the original weighbridge, a foundation stone for the Beet Sugar Factory and early flagpole.

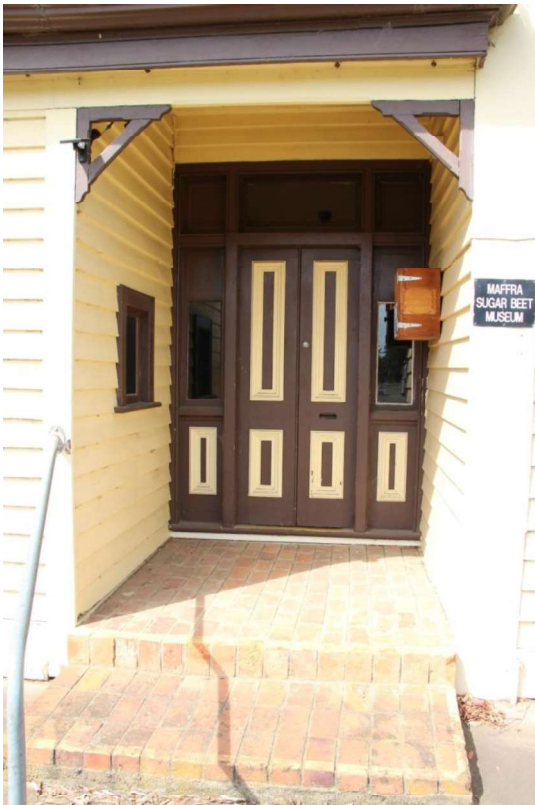
Figure D2. The entrance has a pair of original simple timber brackets. In the recessed portion is a small timber-framed window on the left wall. A pair of paneled doors with bolection moulds has highlights, and sidelights above a timber panel.

Figure D2. The recessed entrance to the office, with its simple timber brackets and the pair of panelled timber doors, with highlights and sidelights.

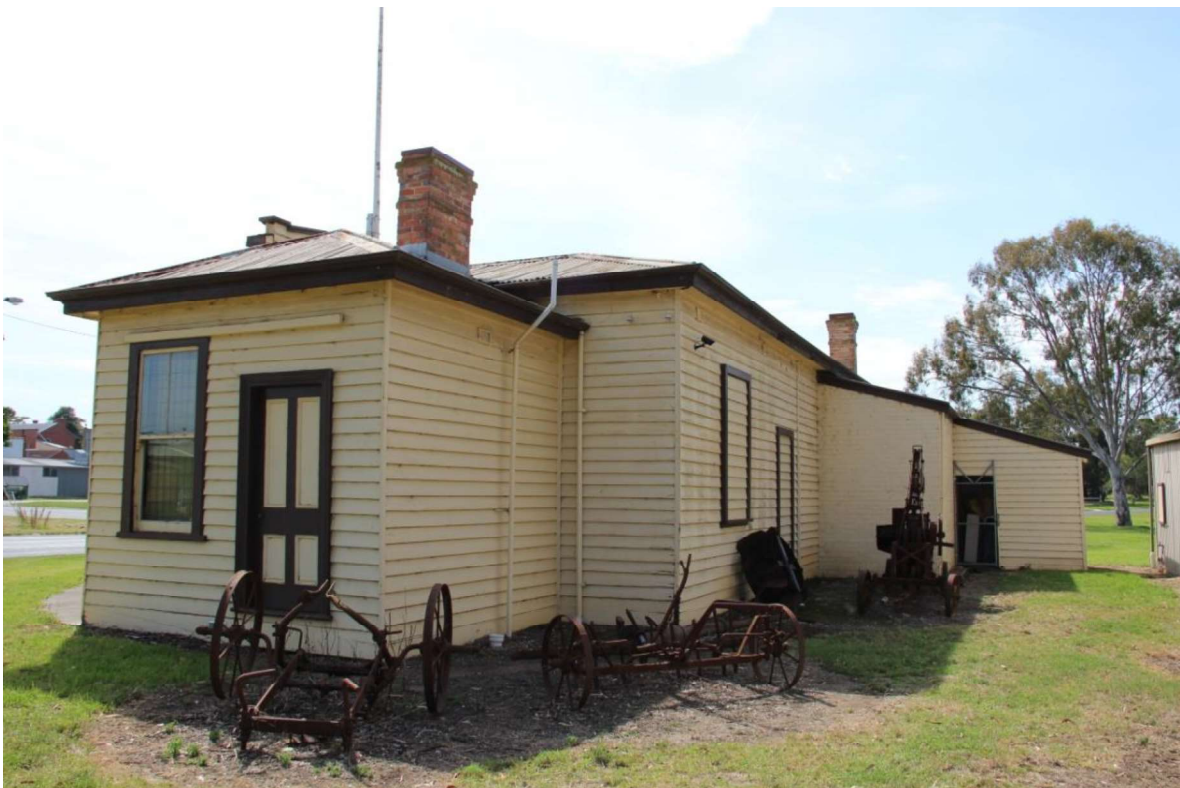
Figure D3. The north-west elevation has four-paneled timber door (above ground level) and one-over-one double-hung sash window, which marked an original entrance to the building (a skillion-profile verandah has been removed). The rear (south-west) elevation has two openings which have been in-filled with weatherboard. To the right are a brick addition with a skillion-profile roof (post-1975), followed by a second timber addition (probably post-1975).

Figure D3. The north-west elevation with its original timber door and window, with the verandah removed. The rear elevation has two openings that have been in-filled with weatherboard, and two later additions to the rear.

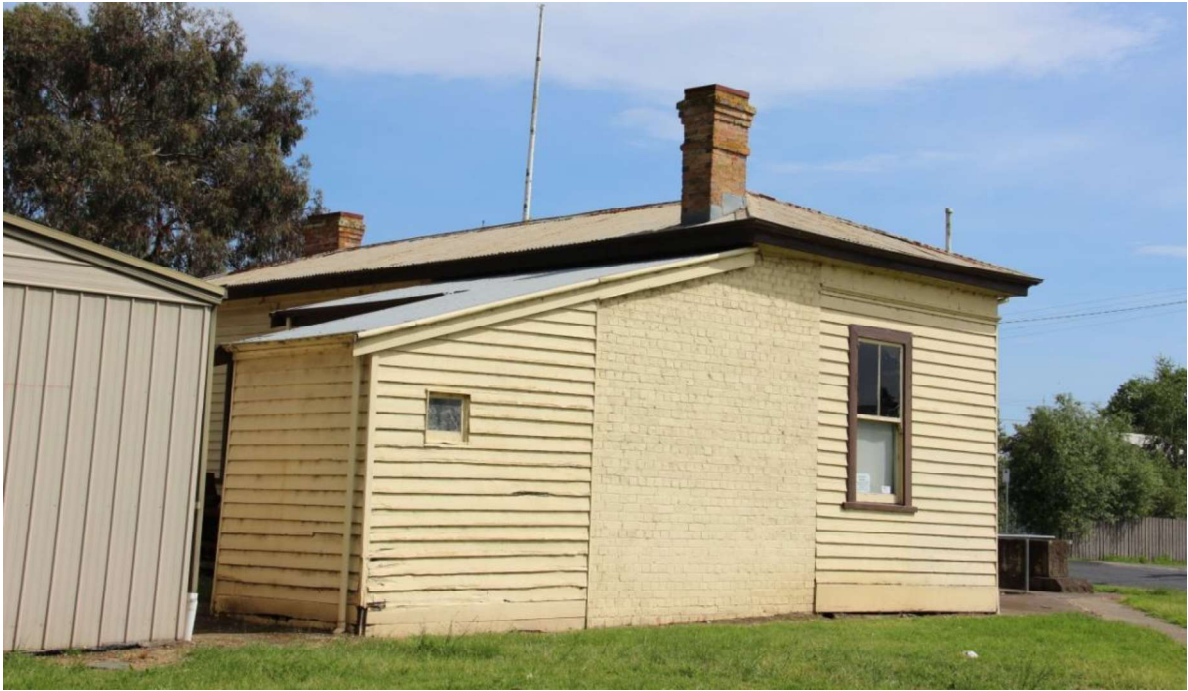
Figure D4. The two later additions with a skillion-profile roof are evident on the south-east elevation. The brick addition appears to also form the base of the chimney (built after its relocation in 1975). The original c1897 portion of the weatherboard building retains a two-over-one double-hung sash window.

Figure D4. The south-east elevation, showing the two later additions with a skillion-profile roof. The brick section appears to form part of the chimney (reconstructed after its relocation in 1975).

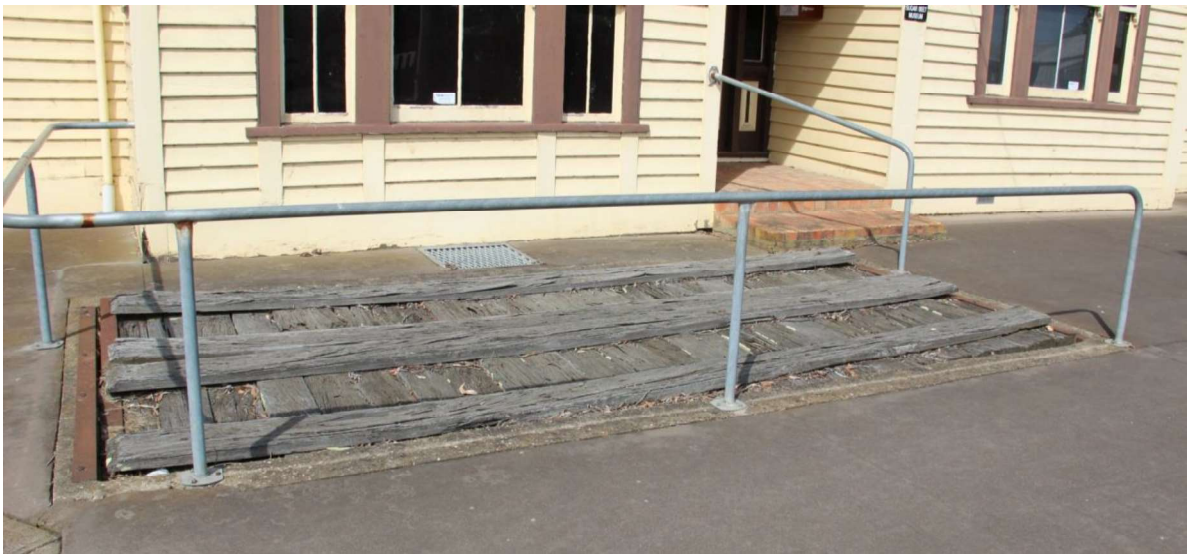
Figure D5. The weighbridge has been located in front of the office on the current site. Made by the Brunswick Machinery Company of Germany, the weighbridge is reportedly a 'Full Capacity Proportional Steelyard Weighbridge with a Boemer weighbridge mechanism that has a capacity of 10,000kgs. The maker was noted as 'Gebr Boemer. Magdeburg. Nevst.' which appears to be a location in Germany. Evident from above are the timber lengths, in a metal frame at the short ends. The weighbridge is in fair condition (the level of integrity from the original design is not known). It is suggested that it is an 'operating weighbridge'; this and its German make is believed to be rare in Victoria, however, this requires further research.

Figure D5. The original weighbridge as evident from above ground.

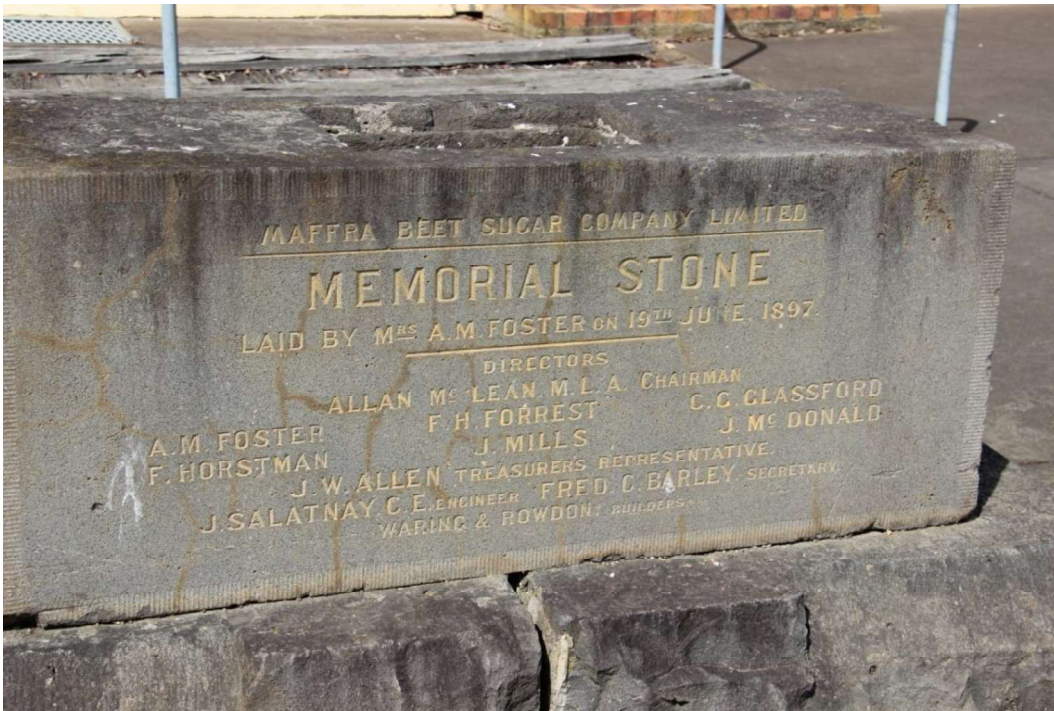
Figure D6. A foundation stone is located in front of the office and weighbridge. It is a large ashlar bluestone with tooled edges and a smooth front with incised lettering.

Figure D6. The large foundation stone in front of the office and weighbridge.

- 1.4.2. Ensure the concrete does not adhere to the monument itself. Insert 10mm x 10mm grey polyurethane seal over a zipped Ableflex joint filler around the stone plinth, to protect the stone from concrete adhering to it and to allow expansion joint movement and prevent water from seeping below the monument.

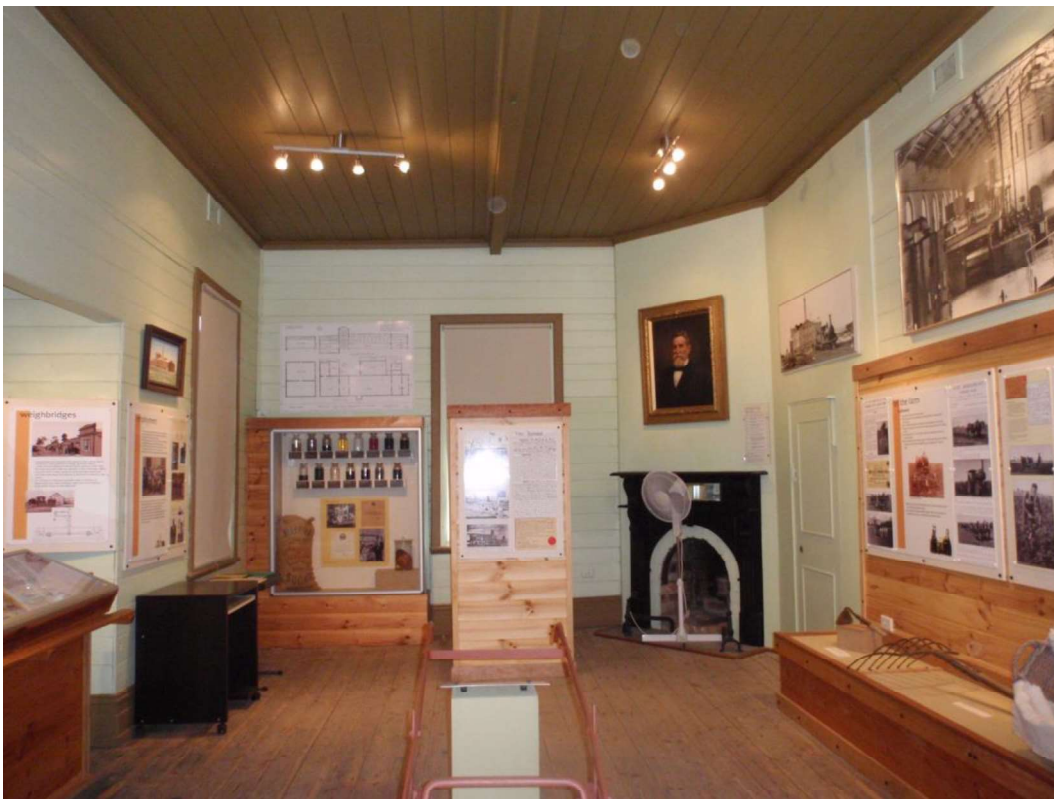
Figure D7. View of the interior of the c1897 office building, showing the timber lined ceiling, walls and floor, and the fireplace.

Figure D7. View of interior showing the timber lined ceiling, walls and floor, and the fireplace.

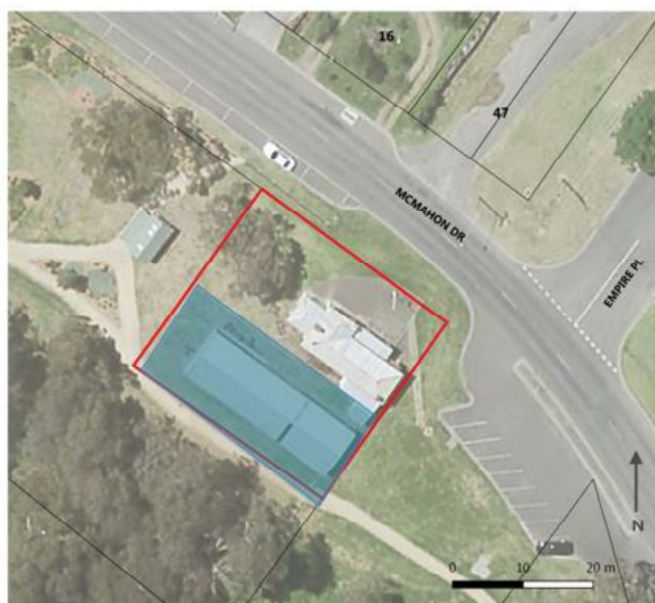
NOTE: The blue shaded area is the preferred location for additions and new development:

2. **Additions And New Structures**
 - 2.1. New structures should be restricted to the rear of the property and concealed behind the heritage fabric when viewed from the Street, as shown on the aerial below.
