**Locality:** MAFFRA  
**Place address:** 122 JOHNSON STREET  
**Citation date** 2016  
**Place type (when built):** Hotel  
**Recommended heritage protection:** Local government level  
Local Planning Scheme: Yes  
Vic Heritage Register: No  
Heritage Inventory (Archaeological): No

**Place name:** Maffra Hotel

Project: Wellington Shire Stage 2 Heritage Study  
Client: Wellington Shire Council  
Author: Heritage Intelligence Pty Ltd  
Date: 12/2/16

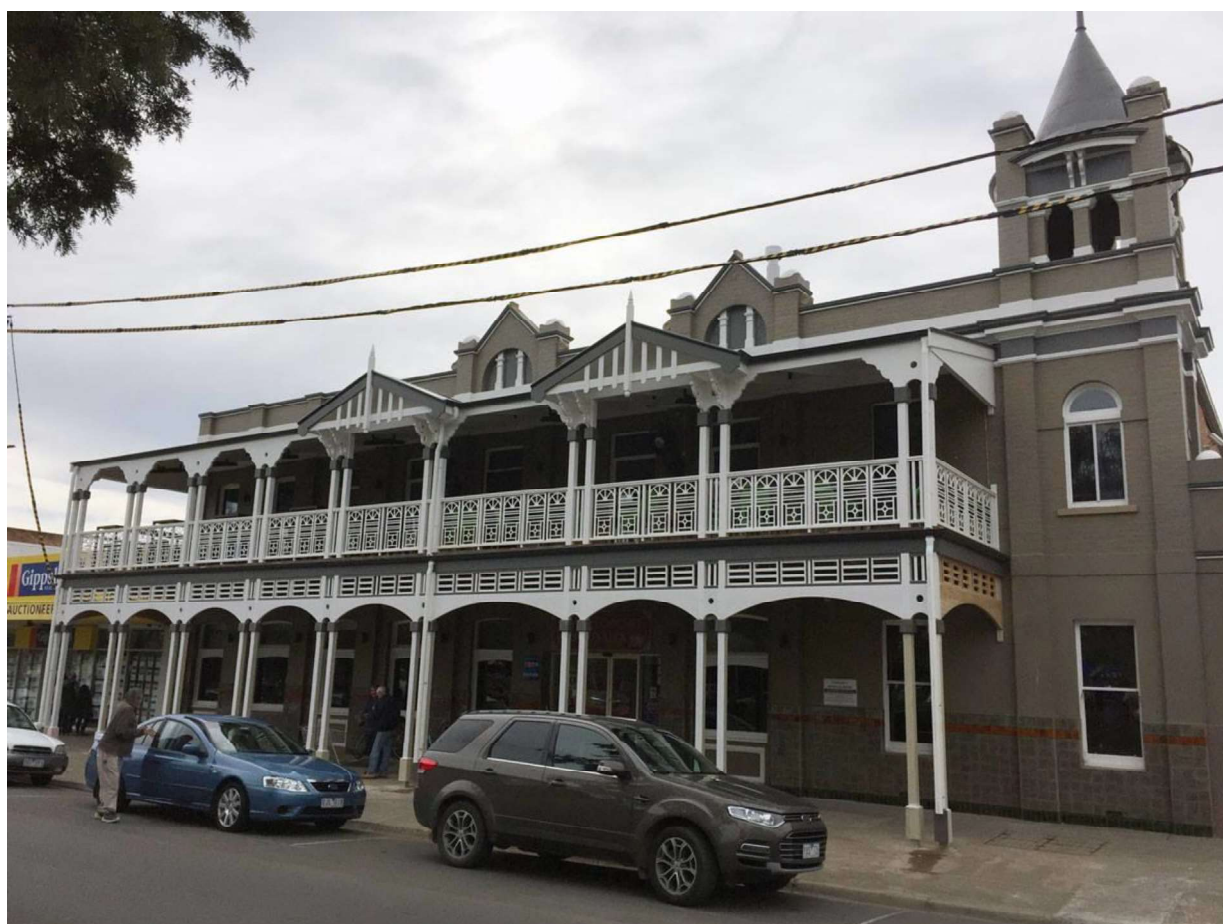
**Architectural Style:** Federation Queen Anne  
**Designer / Architect:** H. W. & T. B. Tompkins  
**Construction Date:** 1900 (and 20<sup>th</sup> century addition)  
Photo above dates to May 2016 (Pauline Hitchins via MDHS facebook page).

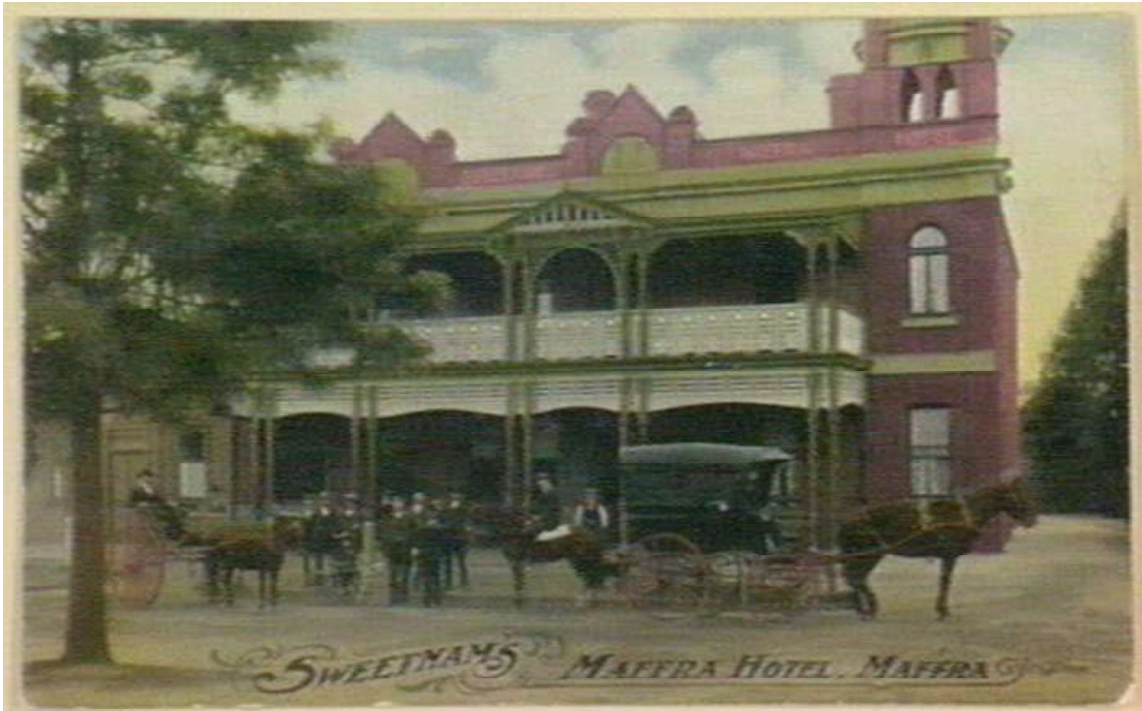
Figure H1. A postcard of 'Sweetnam's Maffra Hotel' that showed a photo (painted in colour) of people, a buggy and carriage posed in front. The facade comprised the two-storey verandah, parapet with two pediments, and corner tower (as they appear in 2015) (SLV).

An early postcard (probably early 1900s) (Figure H1) showed a photo (painted in colour) of 'Sweetnam's Maffra Hotel, Maffra', with people, a buggy and carriage posed in front (SLV). The facade comprised the parapet with two pediments and corner tower (as they appear in 2015). The facade was coloured red (representing red brick; since over-painted), and coloured light colour (possibly representing unpainted render) to the horizontal rendered mouldings. The two-storey verandah (removed in the 1970s but reconstructed in May 2016) appeared a green colour with the cast iron balustrade to the first floor and frieze to the ground floor, painted white/cream. A path led to the right of the hotel (without any gate structures at this date).

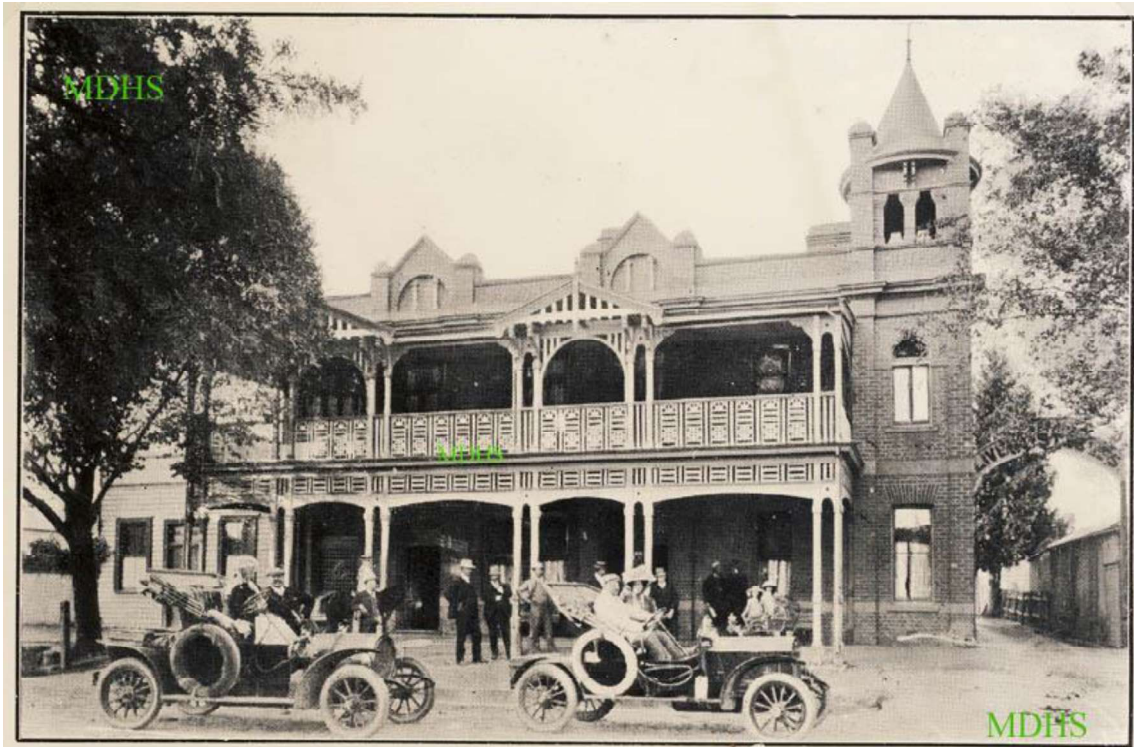
Figure H2. A photo dating to 1915 that showed the facade of the two-storey hotel. To the right of the tower was an arched structure above a side lane (removed) (MDHS web).

A photo dating to 1915 (Figure H2) showed the facade of the two-storey hotel with its parapet (with two pediments) and corner tower (as they appear in 2015) (MDHS). The ornate two-storey verandah had two small gables at the first floor with finials and a vertical timber valence and arched brackets below. There was an ornate iron balustrade to the first floor and frieze to the ground floor. All supports were double posts and the whole verandah structure was painted a light colour. To the left of the verandah was a single storey timber building. To the right of the tower was an arched structure above a side lane (removed). Another photo dating to this period (c1915) (Figure H3) showed the hotel and part of the east elevation with its square-headed windows to the ground floor, and the verandah posts are again a dark colour. (SLV).

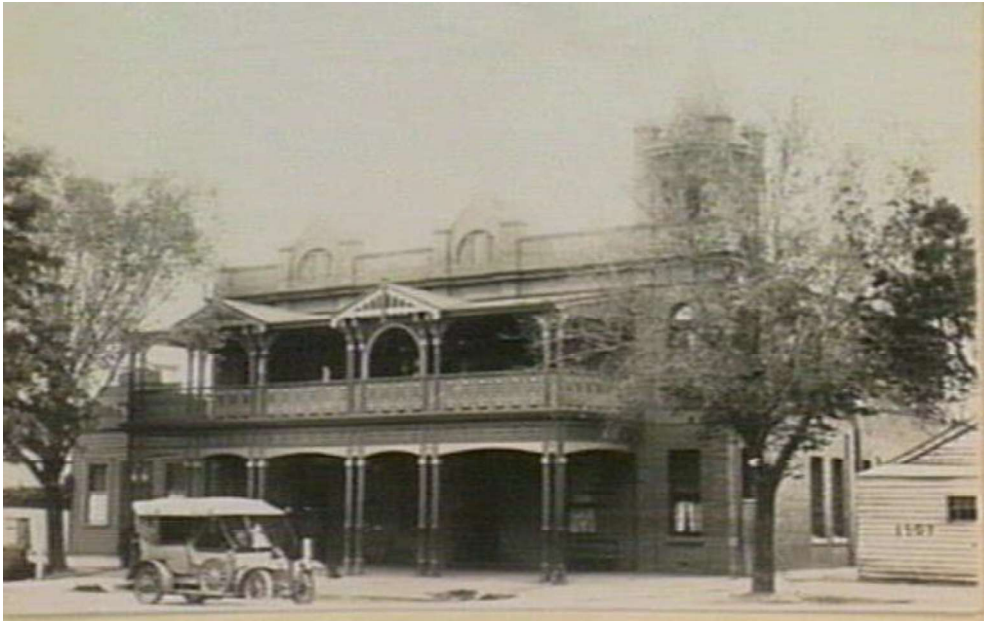
**Figure H3.** A c1915 photo shows the hotel and part of the east elevation. The photo showed the square-headed windows to the ground floor of the side elevation (SLV).

- 4.3. Paint and Colours (also see Paint Colours and Paint Removal)
  - 4.3.1. It is recommended to paint the exterior joinery of the building using original colours (Fig H3; paint scrapes may reveal the colours) to enhance the historic architecture and character.

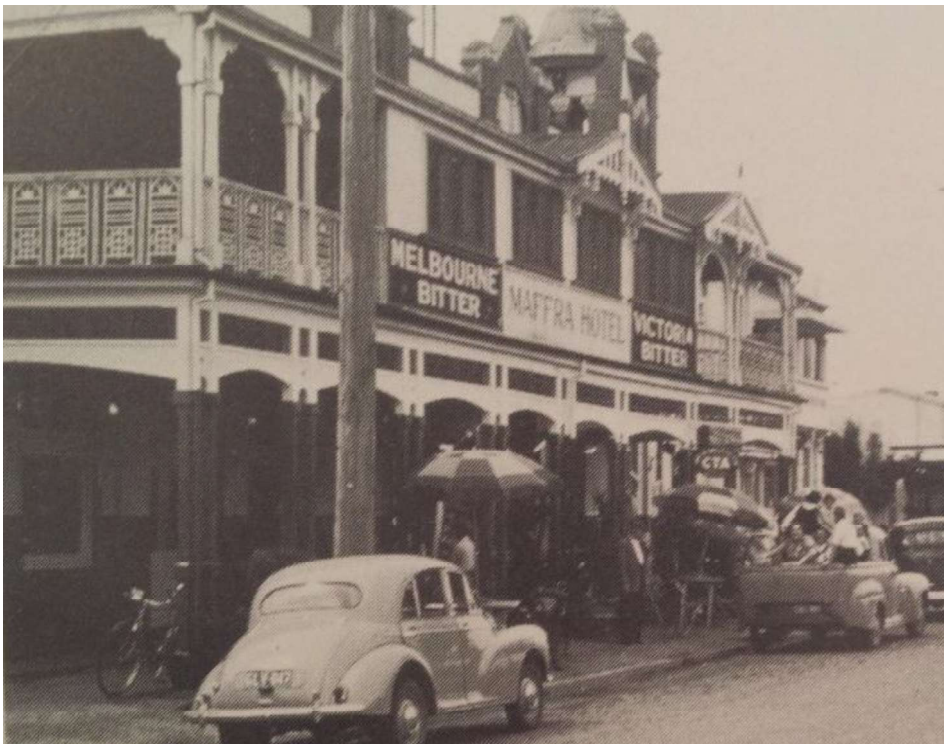
**Figure H4.** This c1940s or 50s photo showed a detail of the original verandah in closer detail. The frieze had been removed from the ground level by this date, but the timber valences that were positioned below remained. The exterior of the ground floor had been tiled (the lower portion) by this date (Pearce 1991:15).

A photo dating to the c1940s or 1950s (Figure H4) showed the original verandah in closer detail (Pearce 1991:15). The exterior of the ground floor had been tiled (the lower portion) by this date. The decorative frieze had been removed from the ground level by this date, but the timber valences that were positioned below remained.

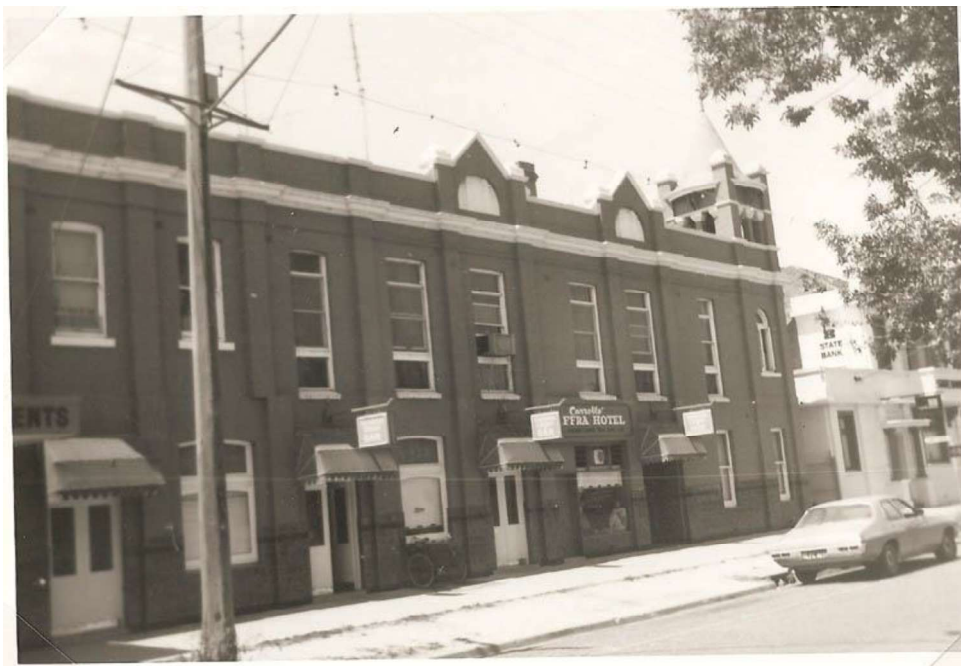
**Figure H5. The hotel without the verandah in the 1970s. The building had four entrance doors with modern doors and hoods (MDHS ID. P02063VMFF 1970s).**

The verandah was completely removed c1970s. Some of the iron lace work is known to have been added to 'Corio', a house on Pearson Street (Pearce 1991:14). A photo dating to the 1970s (Figure H5) showed the hotel without the verandah. The building had four entrance doors with modern doors and hoods. The exterior of the ground floor was still tiled (the lower portion) at this date.

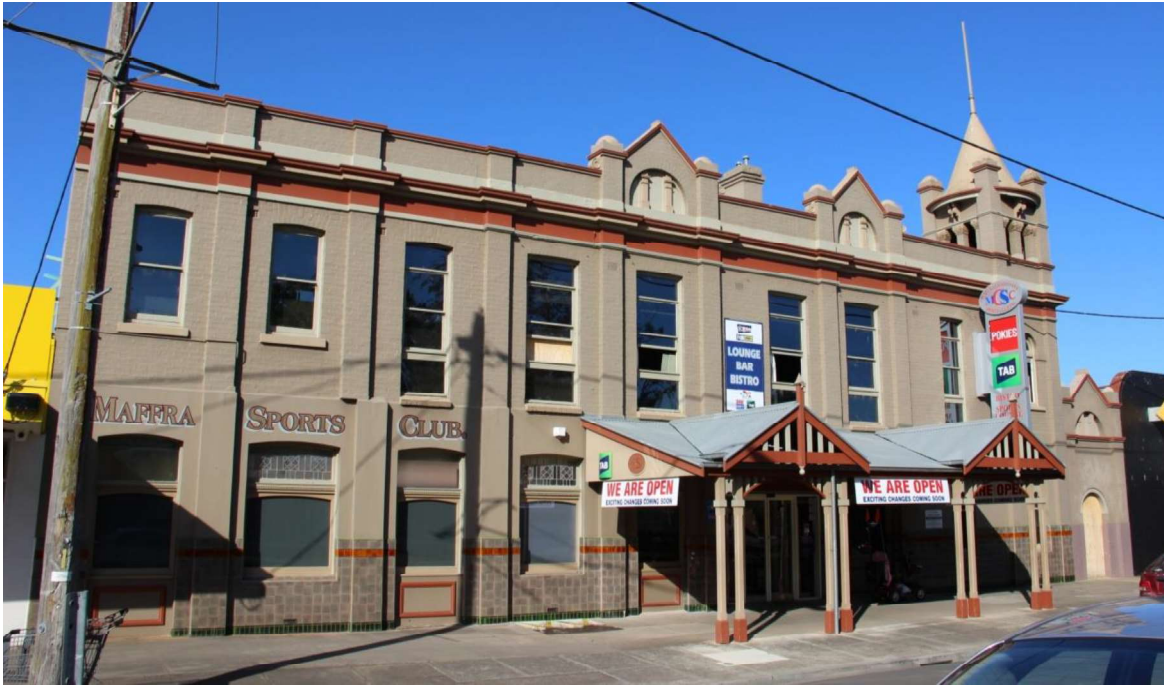
**Figure D1 & Aerial.** The large two-storey building has a hipped roof, clad with (recent) corrugated metal, that is concealed from the Johnson Street elevation by a parapet, but visible from the side. The facade has a smooth render to the ground floor and tuck pointed brick to the first floor and parapet (the entire facade is overpainted; it was all originally face-brick). The ground level has a c1930s tiled dado, in green, grey and orange glazed tiles. The facade is divided into narrow bay by engaged pilasters that extend from ground level to the parapet. The three bays at the north end of the facade were built between c1915 and c1940s (see Figures H3 & H4). Between the engaged piers at parapet level, are two pointed-arch pediments with a round-arch which contains two small piers (which were originally placed centrally to the facade).

**Figure D1 & D2.** The section of the facade built in 1900 retains tall windows to the first floor with one-over-one sash windows, and lowlights and highlights of plain glass (originally would have provided access to the first-floor verandah). The southern end of the ground floor retains two original one-over-one sash windows with segmental-arched heads, while the northern end has wider openings.

Figure D1. The facade has a smooth render to the ground floor and tuck pointed brick to the first floor and parapet (the entire facade is overpainted). The ground level has a c1930s tiled dado, in green, grey and orange glazed tiles. The facade is divided into narrow bay by engaged pilasters that extend from ground level to the parapet.

- 3.1. Remove the render and tiles from the ground floor façade, and the paint from the whole facade. See below for more details.
- 3.2. Repair damaged brickwork with lime mortar.
- 3.3. Roofing, spouting and down pipes
  - 3.3.1. Use galvanised corrugated iron roofing, spouting, down pipes and rain heads.
  - 3.3.2. Don't use Zinalume or Colorbond.
  - 3.3.3. Use Ogee profile spouting, and round diameter down pipes.
- 3.4. Restore the decorative finials, flagpole,
- 3.5. Joinery
  - 3.5.1. Reconstruct the missing 1900 doors, windows, and repair others.

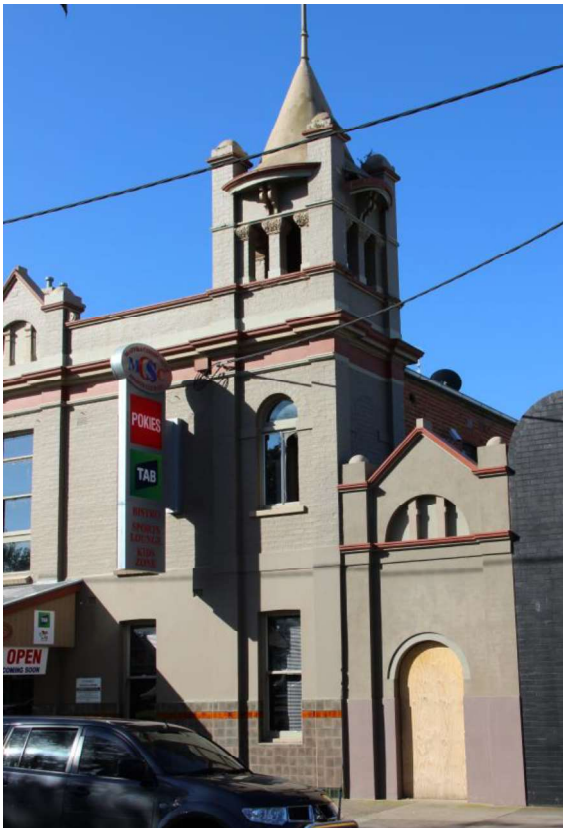
**Figure D2.** At the southern end of the facade is a tower that finishes above the parapet with a candle-snuffer roof (with a flagpole or very tall finial), supported by four corner piers which extend above the roof. The tower also has openings to the side, in which are small piers with ornate capitals. Below the parapet, the tower has a round-arched window (with a later window). At the south end of the hotel is a gateway with a pedimented parapet in the same style as the 1900 building, but is a recent construction.

Figure D2. At the southern end of the facade is a tower that finishes above the parapet with a candle-snuffer roof (with a flagpole or very tall finial), supported by four corner piers which extend above the roof. Below the parapet, the tower has a round-arched window (with a later

window). The southern end of the ground floor retains two original one-over-one sash windows.

1.1. Retain clear views of the front section and rear section, as seen in Figs D2 and D4.

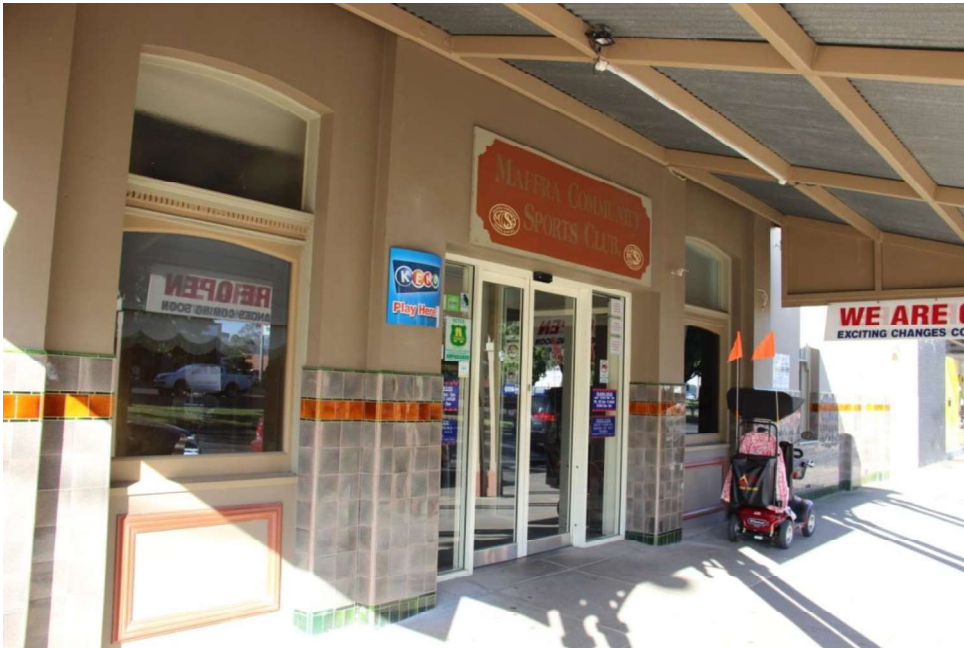
**Figure D3.** Underneath the porch, the entrance doors have been replaced with a modern entrance.

Figure D3. Underneath the porch, the entrance doors have been replaced with a modern entrance.

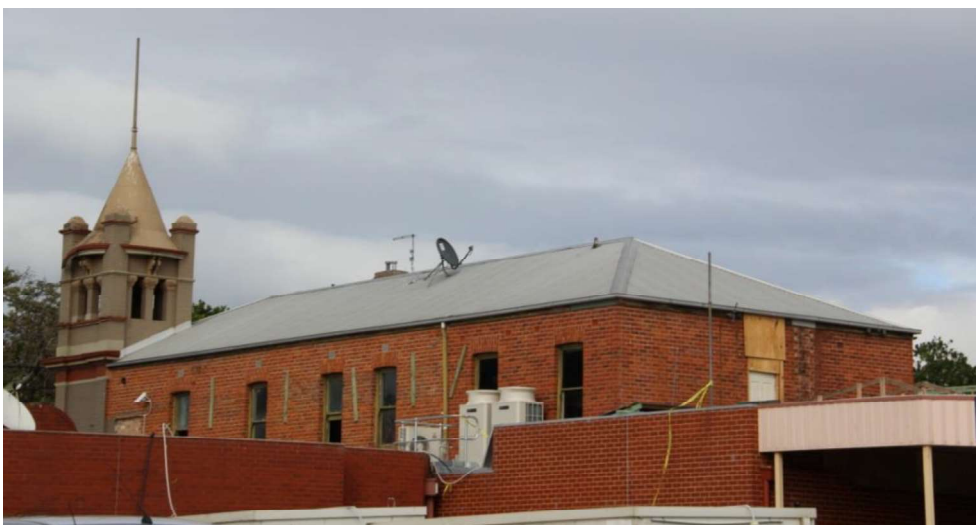
**Figure D4.** The long hipped-roof section of the 1900 building that projects to the rear (north-east) is a red-brick structure with a hipped corrugated metal roof. The south-east elevation has one-over-one double hung sash windows with red brick voussoirs radiating above. It appears to be undergoing restoration in 2015.

Figure D4. The long hipped-roof section of the 1900 building that projects to the rear (north-east) is a red-brick structure.

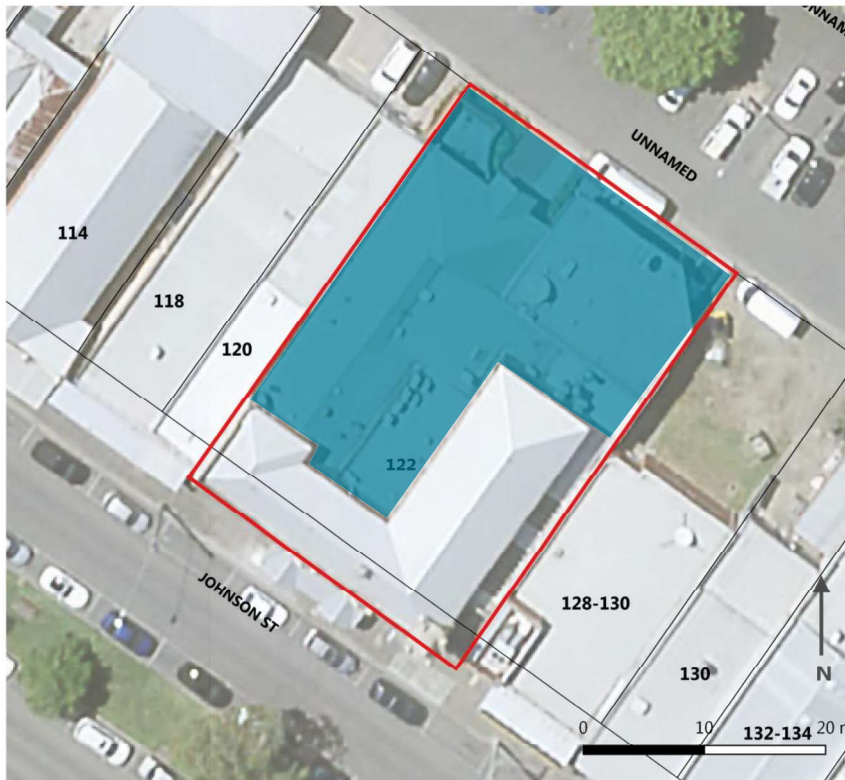
NOTE: The blue shaded area is the preferred location for additions and new development
