Place name: Rosedale Shire Offices (former) & English Elms

Architectural Style: Federation Free Style (altered)
Designer / Architect: Gibbs & Finlay
Builder: William Allen
Construction Date: 1913

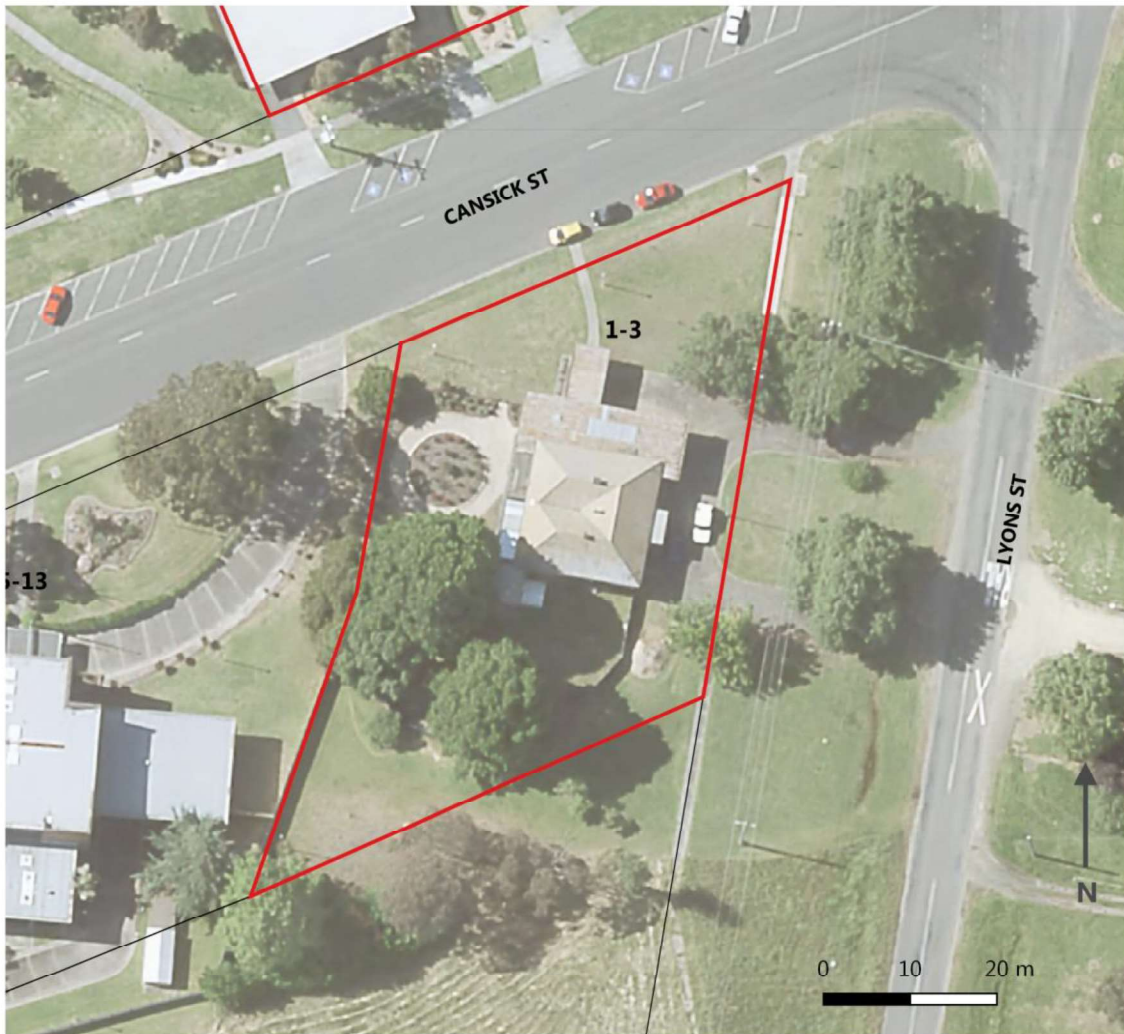
Map of recommended boundary for Heritage Overlay

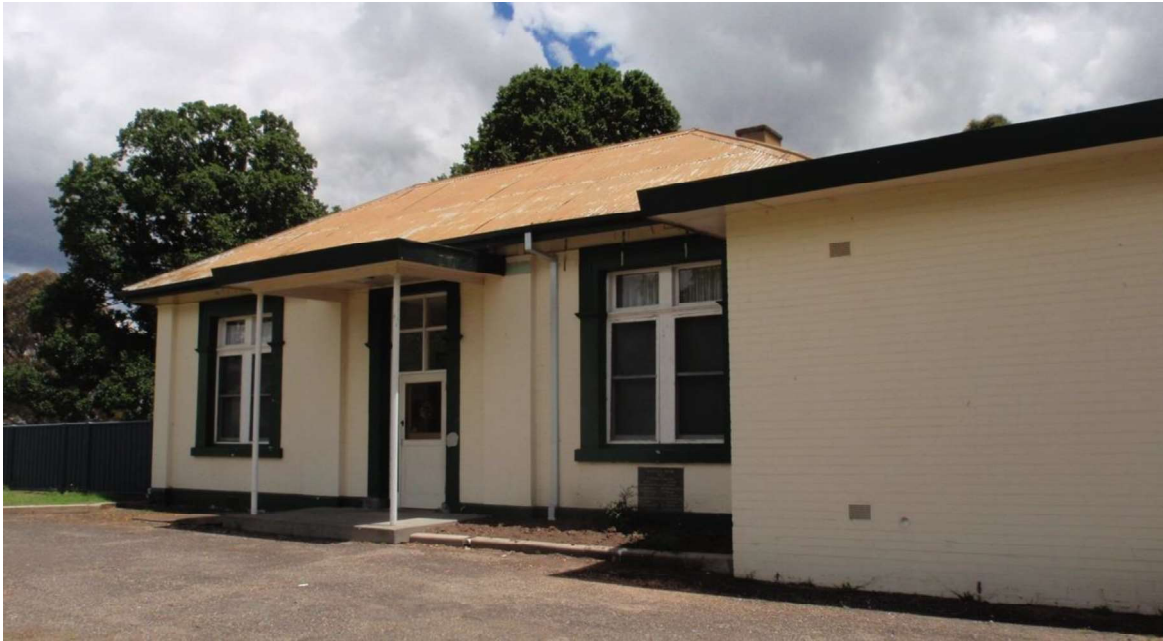
Figure D1. The original 1913 building is red brick with tuck pointing (overpainted), and rendered details, with an M-hip roof clad in corrugated iron and a symmetrical facade. Alterations include the removal of the parapet, eaves, replacement of the entrance door and highlights, addition of an unsympathetic entrance porch and a 1961 addition to the north elevation.

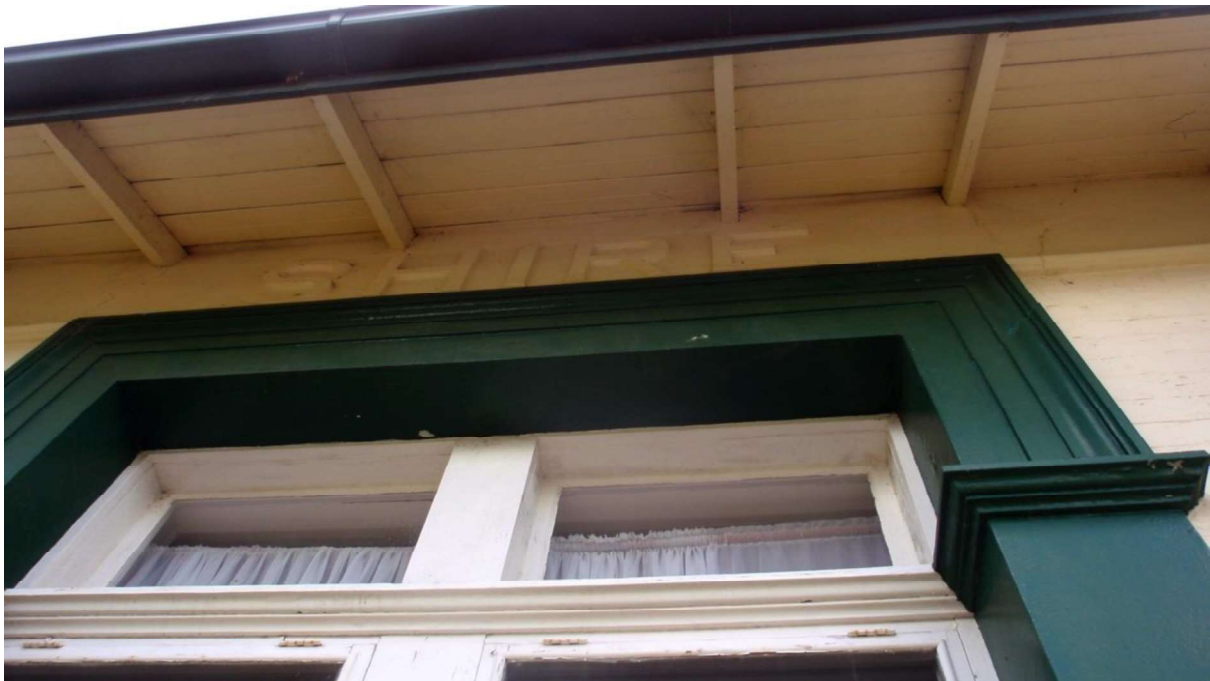
Figure D2. The words 'Shire Hall' and the date '1913' remain in raised letters beneath the 1961 eaves. The entrance and flanking windows are framed with original wide pilasters and sills (all overpainted in a heavy green colour). The eaves are from the 1961 changes, but the windows are original.

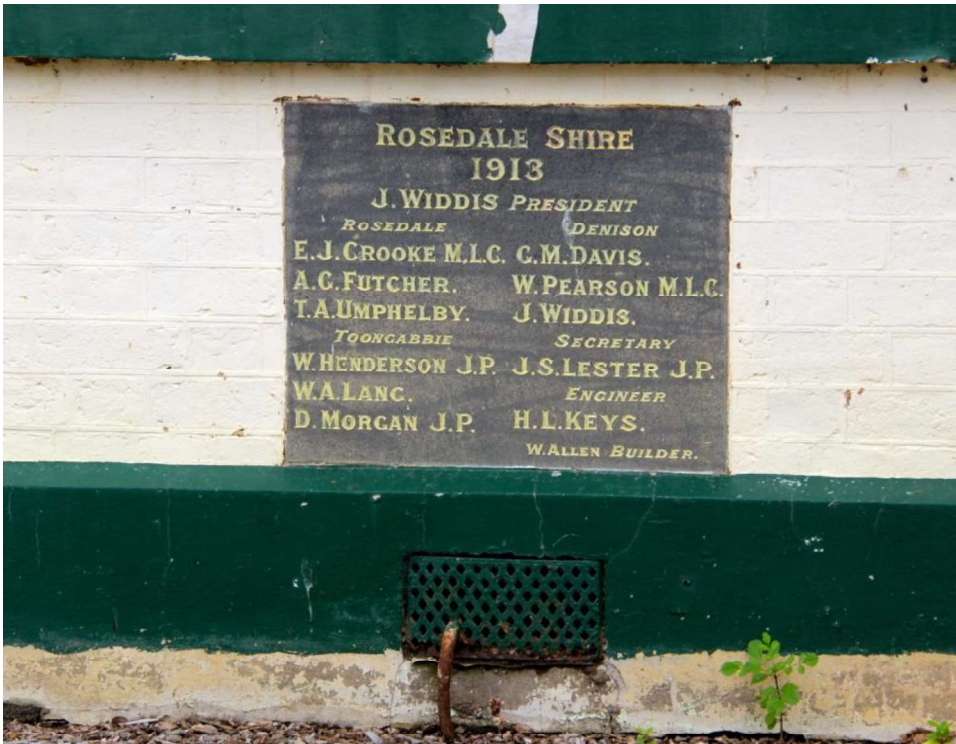
Figure D3. The 1913 Foundation Stone with hand cut incised and gilded lettering has remained intact. The raised lines of the tuck pointed can be seen under the white paint. The dark green coloured render was originally unpainted.

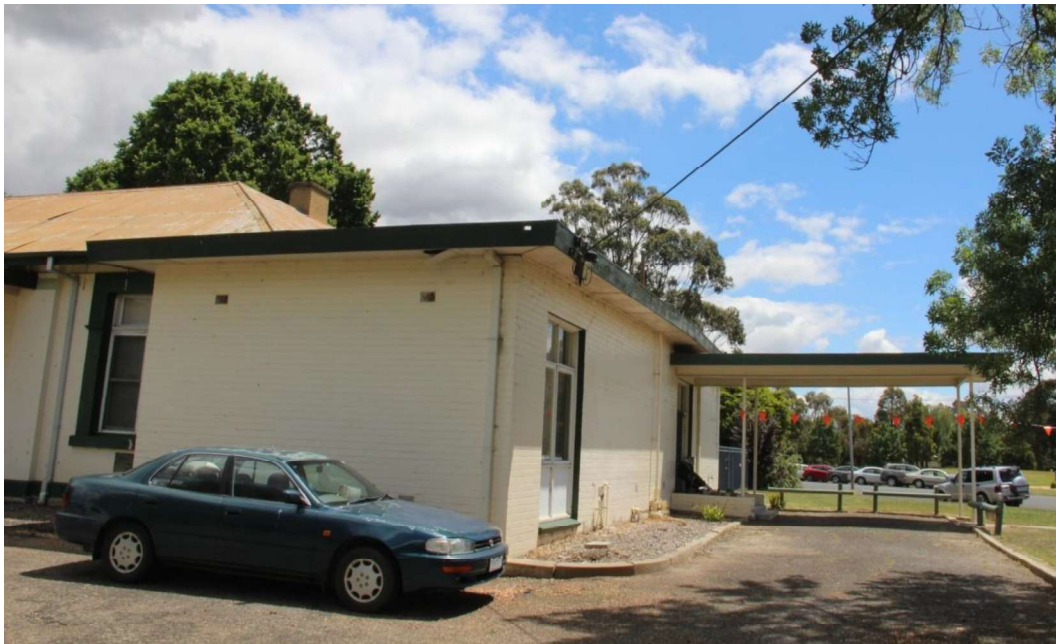
Figure D4. The large unsympathetic addition and carport was added to the north elevation in 1961, this is a cement-brick construction with a flat roof.

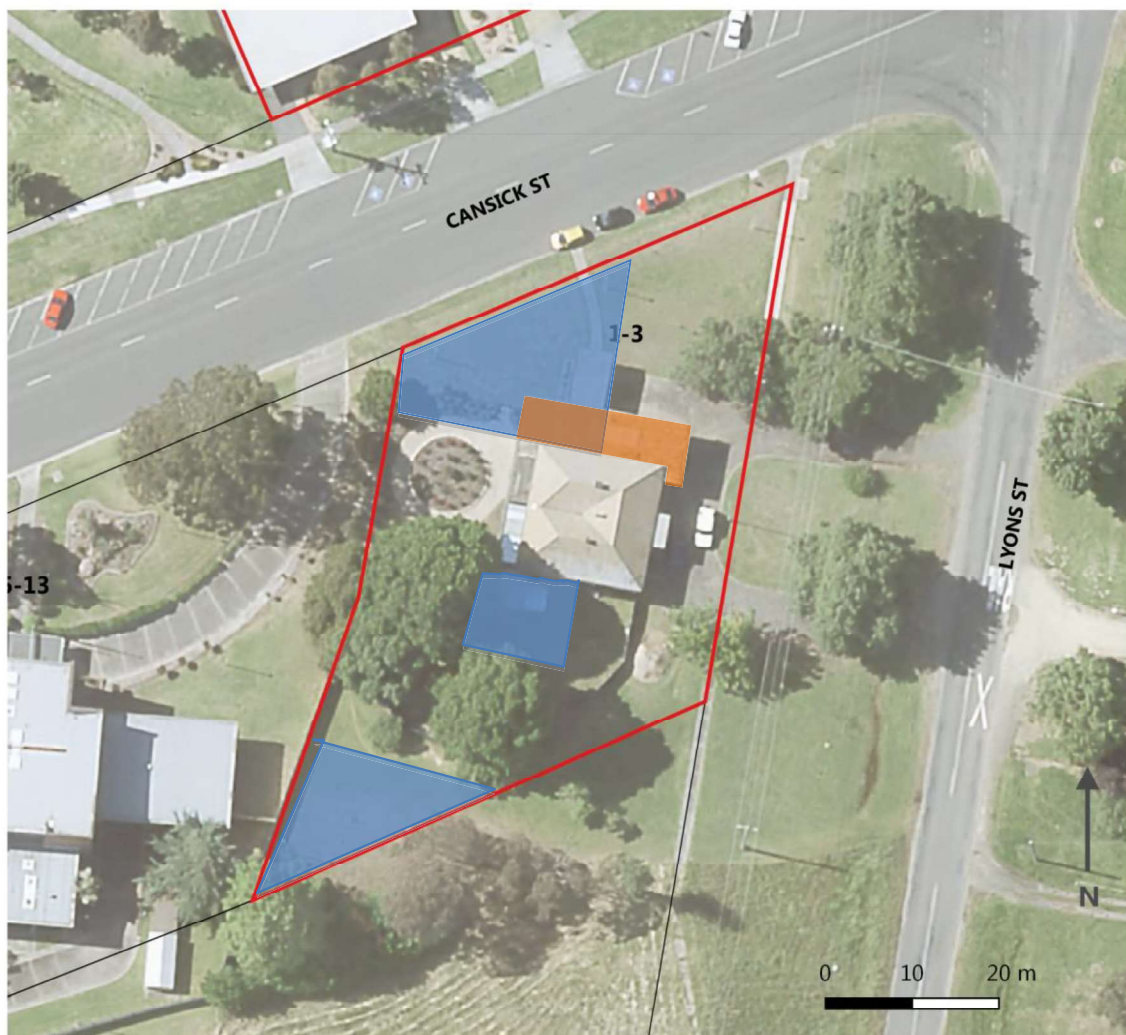
NOTE: The blue shaded area is the preferred location for additions and new development. The orange shaded area is recommended for demolition.
