Locality: ROSEDALE
Place address: 2-10 PRINCE STREET
Citation date 2016
Place type (when built): General Store, Hotel
Recommended heritage protection: Local government level
Local Planning Scheme: Yes
Vic Heritage Register: No
Heritage Inventory (Archaeological): No

Place name: Exchange Hotel (former)

Project: Wellington Shire Stage 2 Heritage Study
Client: Wellington Shire Council
Author: Heritage Intelligence Pty Ltd
Date: 12/2/16

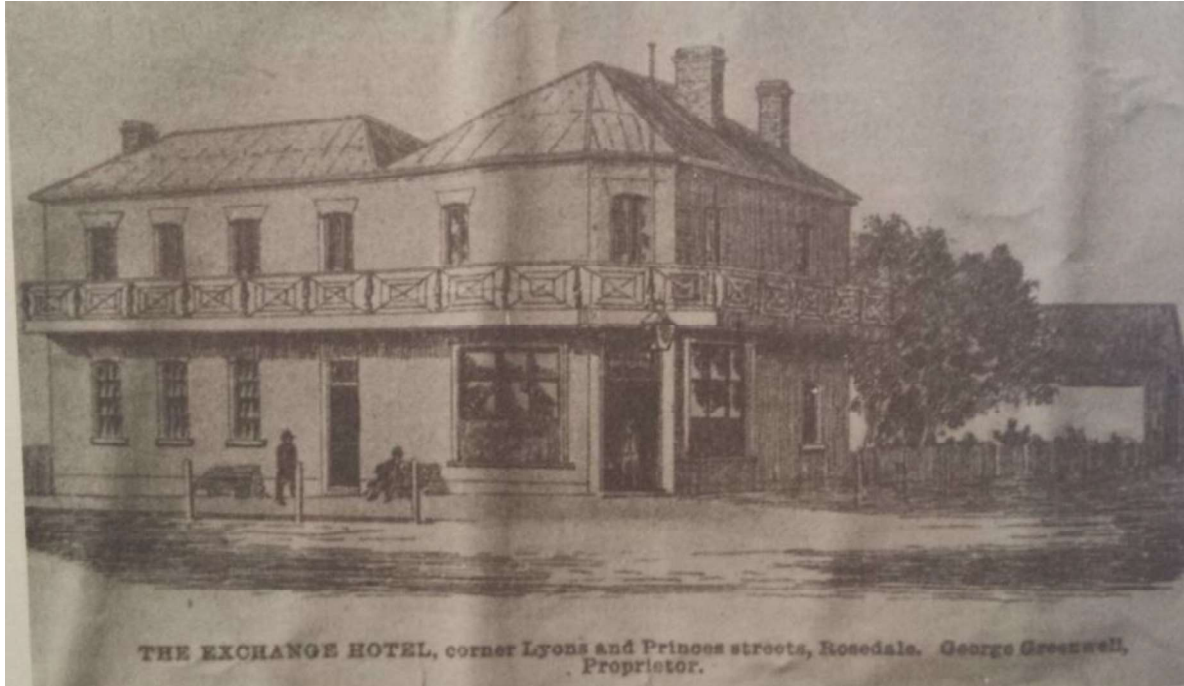
Figure H1. Drawing dating between 1881 and 1890 when George Greenwell was the proprietor. The cantilevered balcony with its cross-pattern is shown. The building looked like two separate buildings at this date (Macreadie 1989:143) and the very steeply pitched roof at the corner is intact in 2016, and may be clad in 'Morewood and Rogers' flat metal tiles in this drawing.

Figure H1 shows that in the 1880s, the building comprised two sections with separate roof forms and separate entrances. This may suggest that Robertson built the first section in 1863, to serve as the general store, and the second section in 1864, to serve as the Royal Hotel. But this has not been confirmed, an internal inspection is required to confirm this.

An early illustration (Figure H1) has an annotation at the bottom 'The Exchange Hotel, corner Lyons and Princes streets, Rosedale. George Greenwell, Proprietor', which dates the illustration between 1881 and 1890. The south and east elevations of the hotel are evident. The roof comprised two separate roof forms at this date; a taller very steep hipped roof to the eastern portion of the building, and a lower hipped roof to the western portion of the building fronting Princes Street (Macreadie 1989:143) Both roofs may be clad in 'Morewood and Rogers' flat metal tiles in this drawing. A cantilevered balcony ran along both facades of the first floor, with a cross-patterned balustrade and turned timber posts. The eastern portion of the building had two brick chimneys and a chamfered corner entrance (with a door and highlight) flanked by two very large windows of six panes and a filled lower portion (one facing each street). The eastern elevation had one sash window to the ground level and two openings on the first floor. The southern elevation consisted of a second entrance on the ground floor, with three multi-paned windows. While the upper floor had five openings with French doors, most with segmental-arches. A timber fence ran along the boundaries and to the rear (north) of the hotel was an outbuilding that was probably the stables, sitting on the

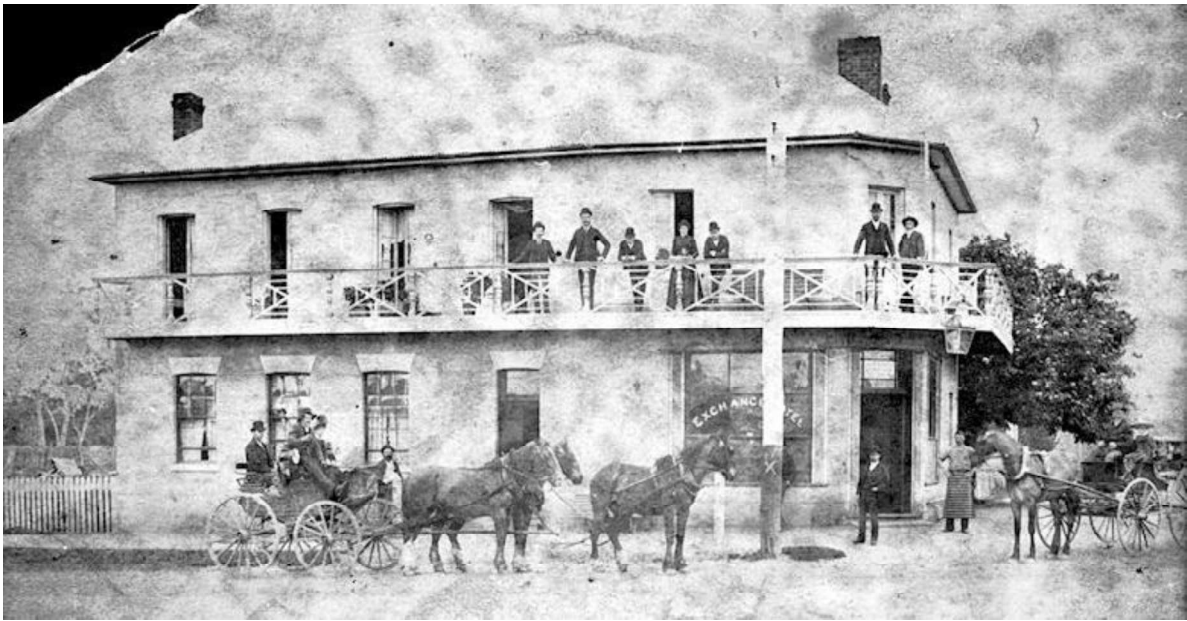
Figure H2. Photo of the hotel in 1890 showing the cantilevered balcony with its cross-pattern balustrade with turned timber posts, rendered walls, and layout of the openings of each level (Museum Victoria).

Photos (Figures H2 & H3) dating to the nineteenth century confirm the details of the illustration. Both photos showed people posing from the street and on the cantilevered balcony with its cross-pattern balustrade. Behind them on the first floor (south elevation) were five openings and a corner opening. Some of these are open, showing that they were French doors, allowing access to the balcony. Above were face brick chimneys (since removed). On the ground elevation, the three windows on the south elevation appear to have been six-over-six sash windows with segmental-arches and rendered voussoirs above. The entrance door on this elevation had a highlight, as did the corner entrance. The large six-paned window (with its bottom third filled/covered) to the ground floor had 'Exchange Hotel' written in arched lettering. The hotel appears to be rendered by this date (Museum Vic; Hardy 1989:52).

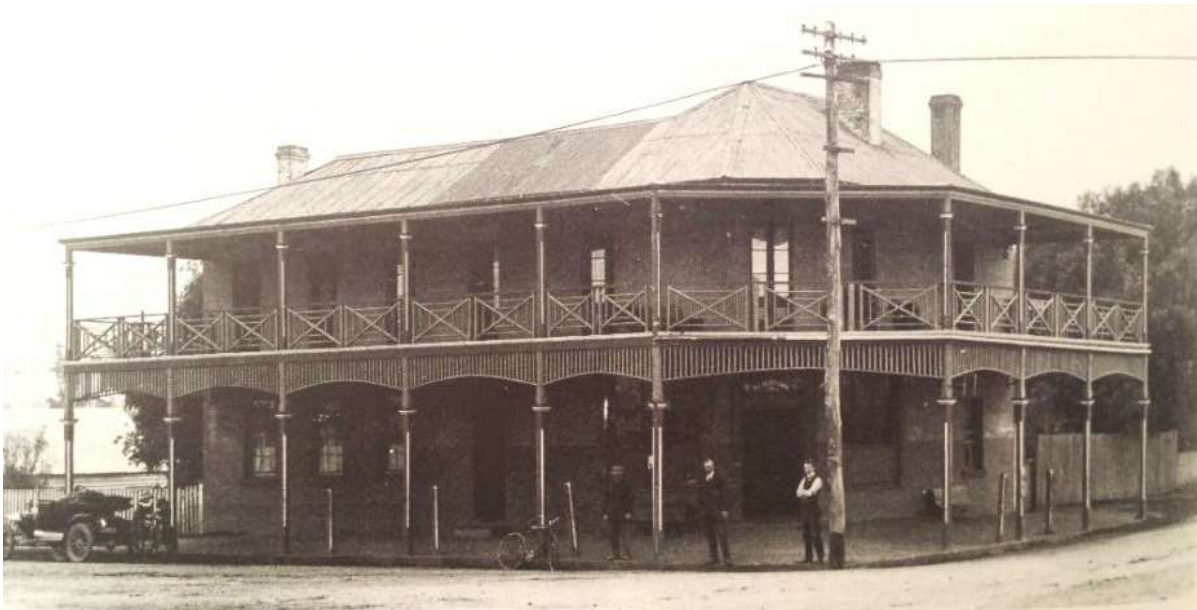
Figure H4. This photo dating to 1920 confirms that either a new balcony was constructed or that the balcony was now supported by timber posts and had a roof to the first floor. The verandah had chamfered timber post supporting both levels, with capitals and an arched timber frieze to the ground level. The cross-patterned balustrade to the first floor appears to have been retained from the earlier balcony (Hardy 1989:182). The French doors are still intact on the first floor and the walls are rendered.

A photo dating to 1920 (Figure H4) confirms that either a new two-storey verandah was constructed, or that timber posts now supported the original balcony and had a roof to the first floor. In the 1920 photo, the verandah had chamfered timber posts supporting both levels, with capitals and an arched timber frieze to the ground level. The cross-patterned balustrade to the first floor appears to have been retained from the earlier balcony. By this date, the gap between the two separate roof forms had been joined (the different coloured sheets of galvanised iron were evident in this photo). Three brick chimneys remained (since removed). The openings to the first floor appear to be large panes while the windows to the ground floor (southern elevation) appear to retain the six-over-six sash windows. A taller timber fence ran along the eastern boundary, while a lower timber picket ran along the southern boundary (Hardy 1989:182)

- 3.1. Demolish the non-significant parts of the verandah (balustrade, metal fascia board) and reconstruct the design as shown in Fig H4. This would include reconstructing the timber cross pattern as the first floor balustrade, the capitals and bases for the timber chamfered posts, and the timber valance to the ground floor, and painting it in a Victorian colour scheme in the light and dark tones as shown in Fig H4, or in the original colours as determined by paint scrapes. Replace the blue Colorbond roof with unpainted galvanised corrugated iron, or paint the roof a light grey to most closely resemble unpainted galvanised iron.
- 3.2. Roofing, spouting and down pipes

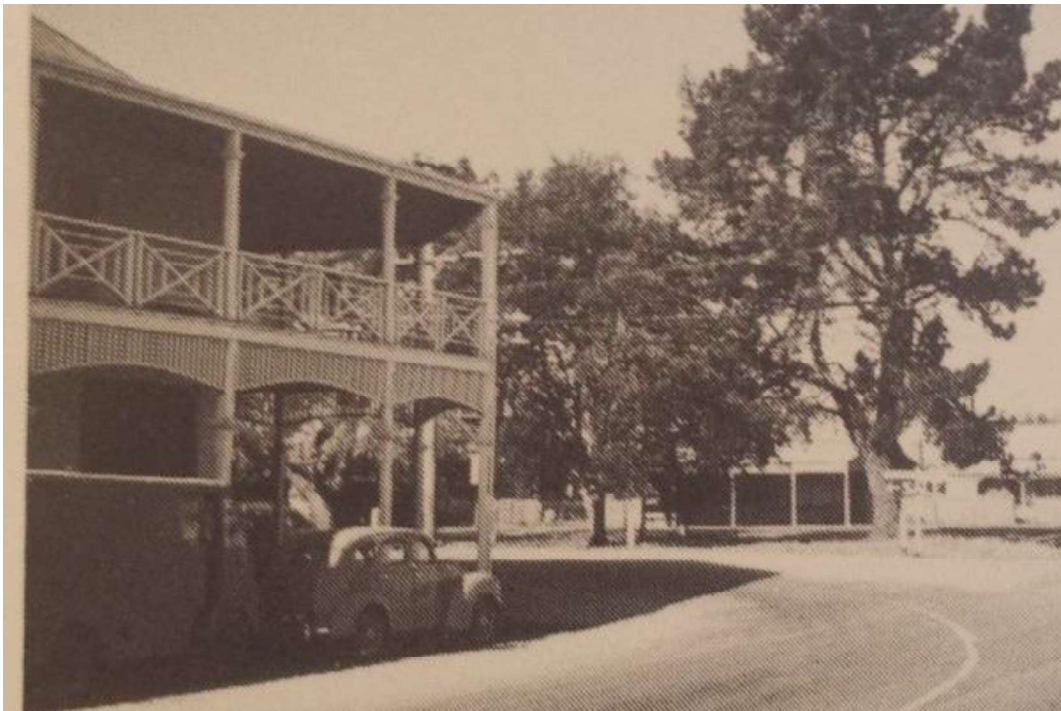
Figure H5. Photo dating to c1950 showing the corner of the hotel, looking east. At this date, the hotel retained the 1911 verandah, comprising the cross-patterned balustrade, capitals to the columns and arched timber frieze to the ground floor (Hardy 1989:590).

In February 1951, the two lots (2-10 and 12 Prince Street) were sold to Maude and Bernard Spain 'both of Exchange Hotel, Rosedale hotelkeepers' (LV: V5803/F455). A c1950 photo (Figure H5) showed the corner of the hotel, looking east. At this date, the hotel retained the 1911 verandah details; the cross-patterned balustrade, capitals to the columns and arched timber frieze to the ground floor (the frieze and capitals have since been removed and the balustrade replaced) (Hardy 1989:590).

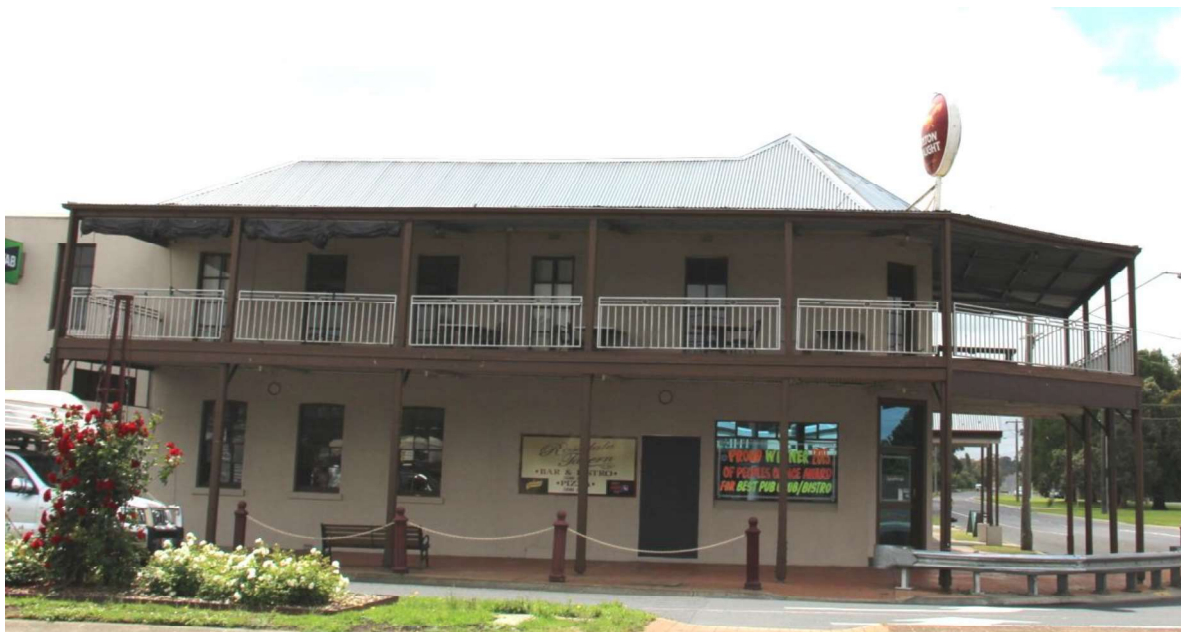
Figure D1 & Aerial. The 1863 two-storey building has an M-hipped roof clad with (recent) corrugated iron and one brick chimney at the west end. The rendered brick building has a two-storey verandah to both the south and east elevations. A cantilevered balcony was originally built in 1863 and this may have been retained in 1911, when timber supports to both levels and a wide hipped roof clad in corrugated iron were added (or the entire verandah may have been constructed in 1911). The verandah retains the 1911 stop-chamfered timber posts (but has lost the capitals and cross-pattern balustrade that probably dated to 1863, and the 1911 timber frieze).

Figure D1. The 1863 two-storey building has an M-hipped roof clad with (recent) corrugated iron and one brick chimney at the west end. The rendered brick building has a two-storey verandah to both the south and east elevations. A cantilevered balcony was originally built in 1863 and this may have been retained in 1911, when timber supports to both levels and a wide hipped roof clad in corrugated iron were added (or the entire verandah may have been constructed in 1911).

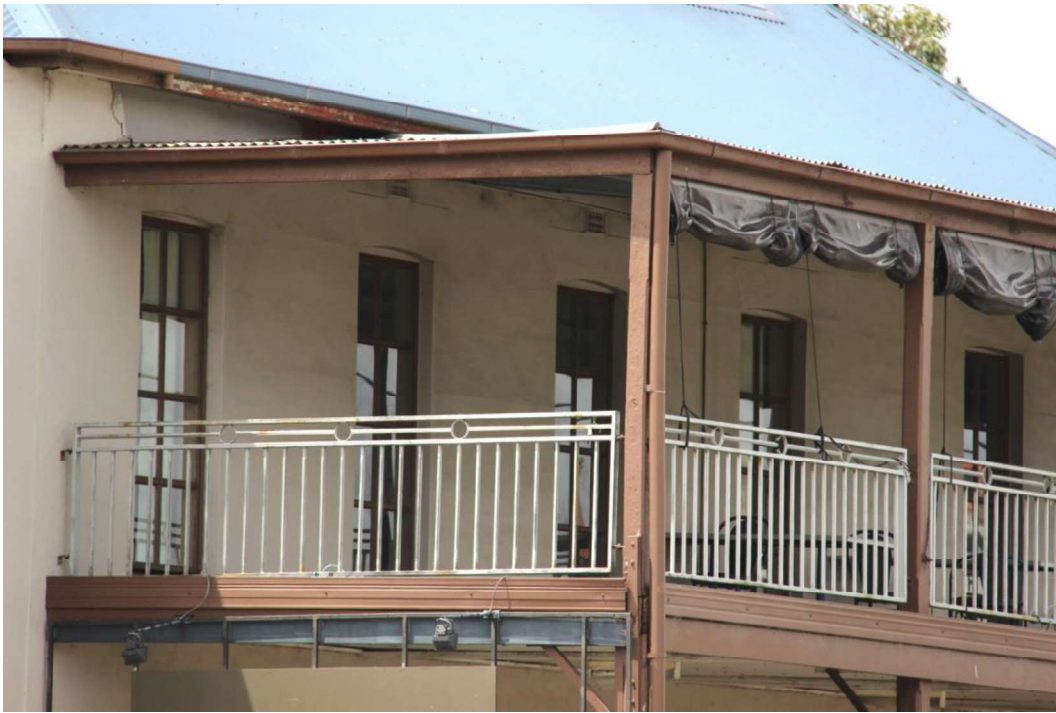
Figures D1 & D2. The tall openings to the first floor of the south elevation are all original (with modern multi-paned windows replacing the original French doors). All openings to the south elevation have radiating voussoirs above, and the windows have angled sills (all rendered and overpainted). The render on the first floor is uneven, this may be due to damp (current or previous) however the reason for this would need close inspection.

Figure D2. The tall openings to the first floor of the south elevation are all original (with modern multi-paned windows that replaced the original French doors).

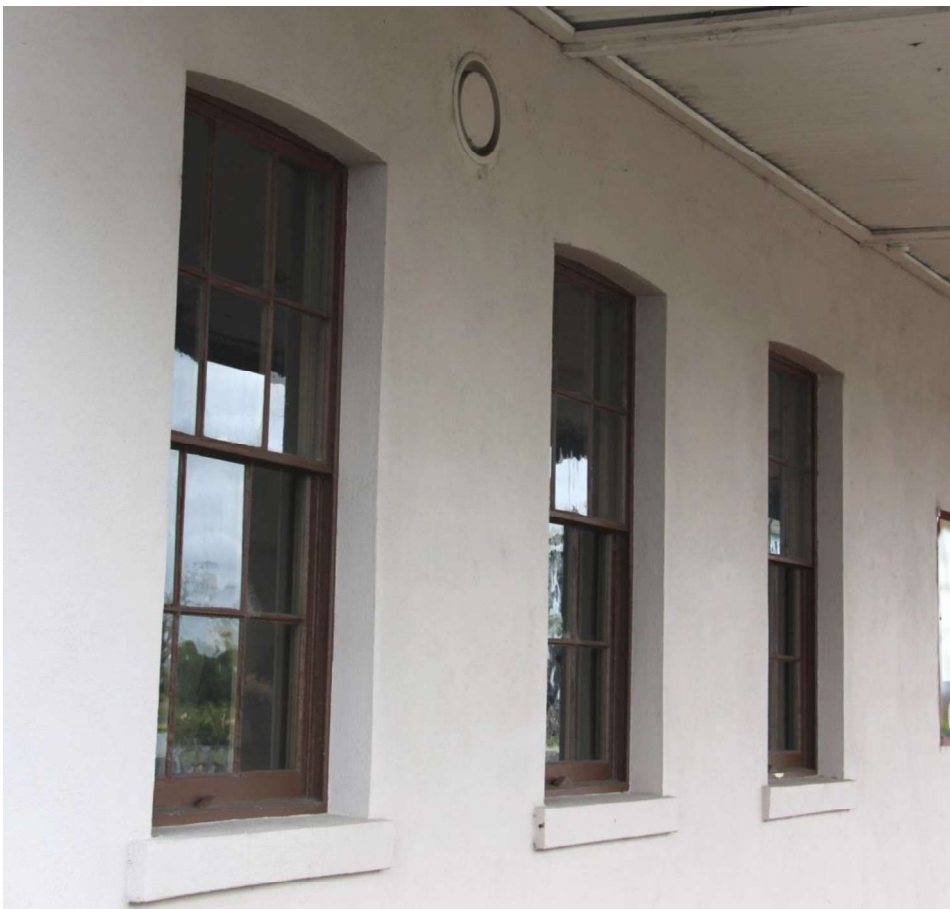
Figure D3. The ground level retains three original six-over-six sash windows to the south elevation.

Figure D3. The ground level retains three original six-over-six sash windows on the southern elevation. All openings to the south elevation have radiating voussoirs above, and the windows have projecting sills (all rendered and overpainted).

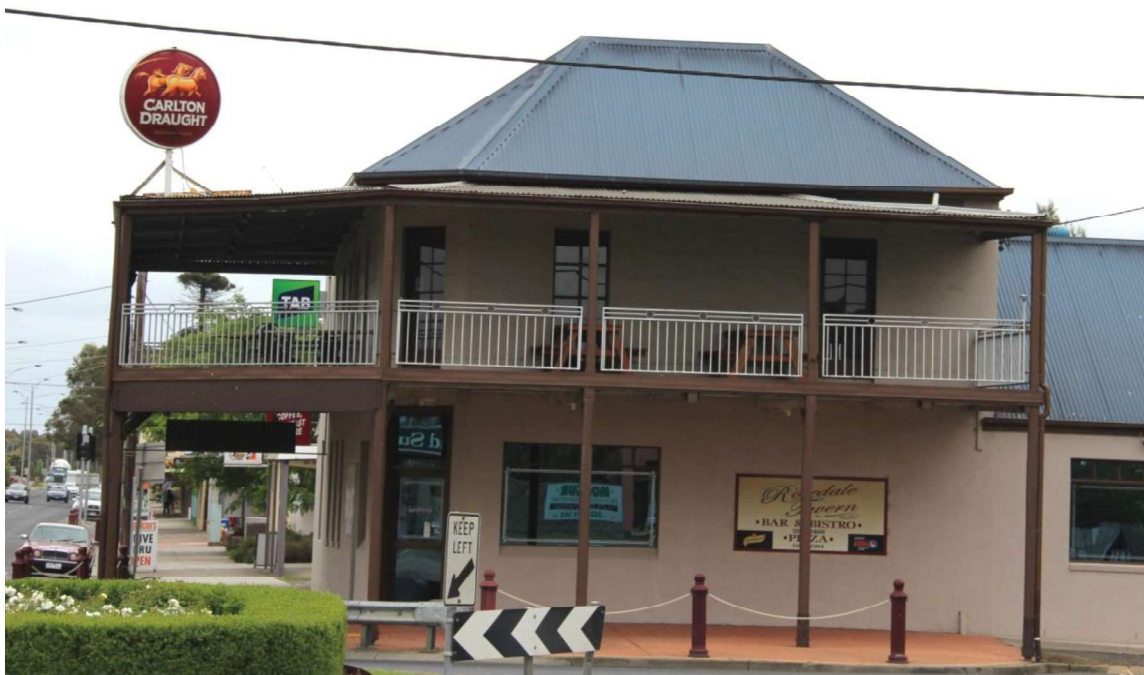
Figure D4. The east elevation is the shorter side, with two tall openings (with modern windows replacing the original French doors) to the first floor and a large opening (shortened) to the ground floor (with a modern window), next to the entrance and the other window has been filled in.

Figure D4. The east elevation is the shorter side, with two tall openings (with modern windows replacing the original French doors) to the first floor and a large opening to the ground floor (with a modern window), next to the entrance.
