Place name: St Rose of Lima Catholic Church

Architectural Style: Victorian Free Gothic
Designer / Architect: Thomas Guthridge
Builders: William Allen and Mr Holder
Construction Date: 1874-75, c1906

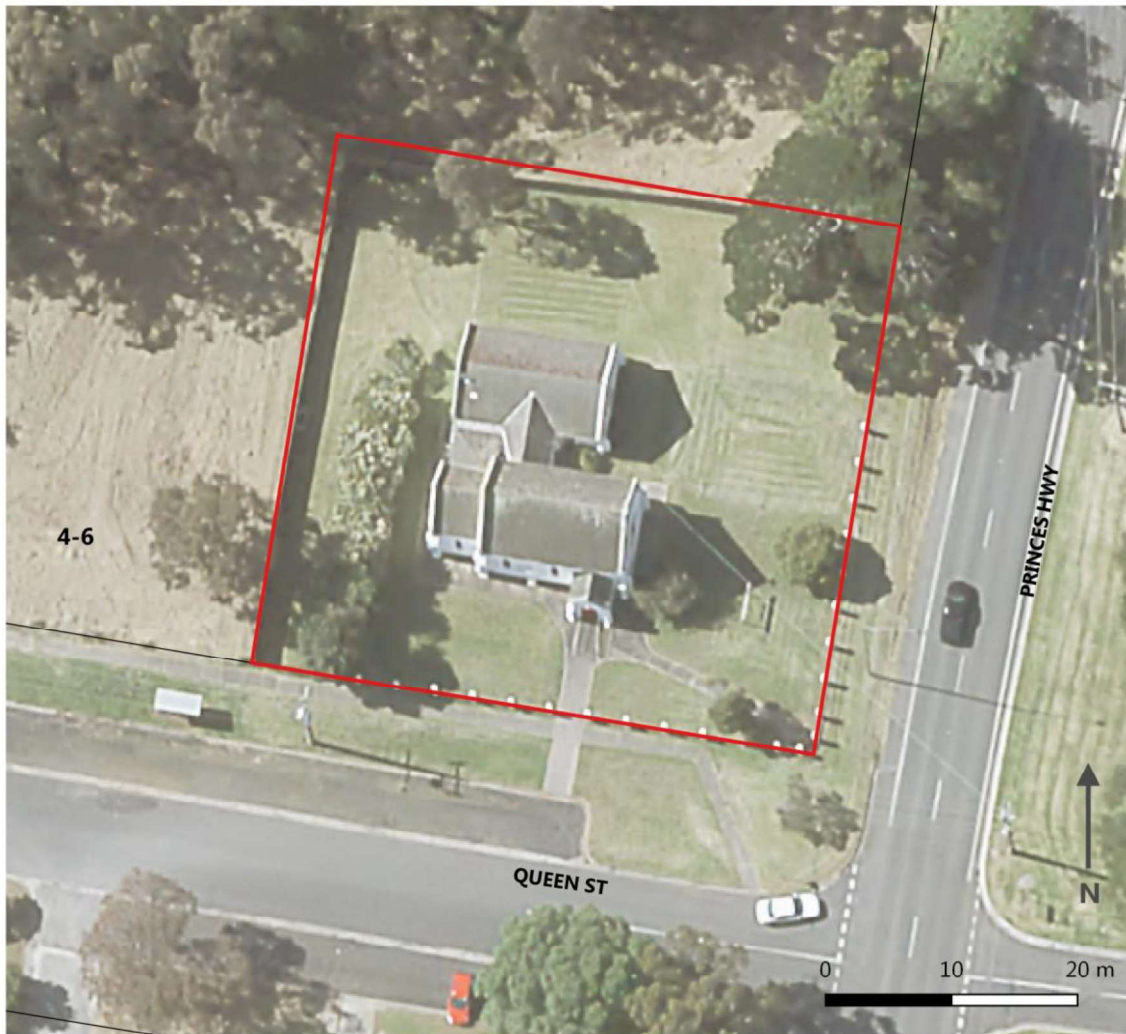
Map of recommended boundary for Heritage Overlay

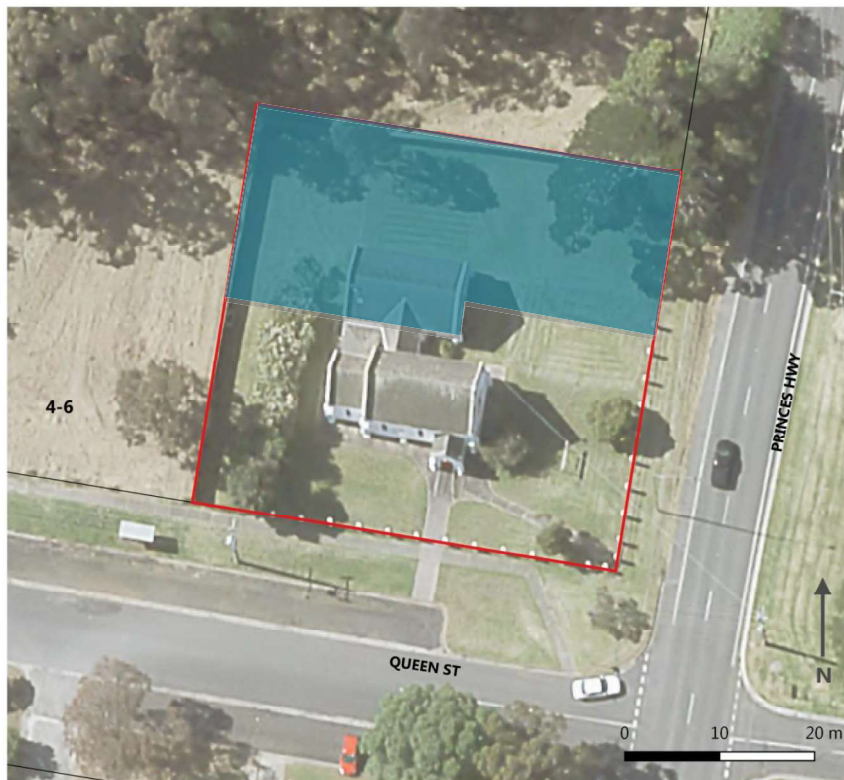
NOTE: The blue shaded area is the preferred location for additions and new development.
