Place name: Presbyterian Manse (former) & Cork Oak

Architectural Style: Victorian Rustic Gothic
Designer / Architect: Not known
Construction Date: 1876-77, c1891

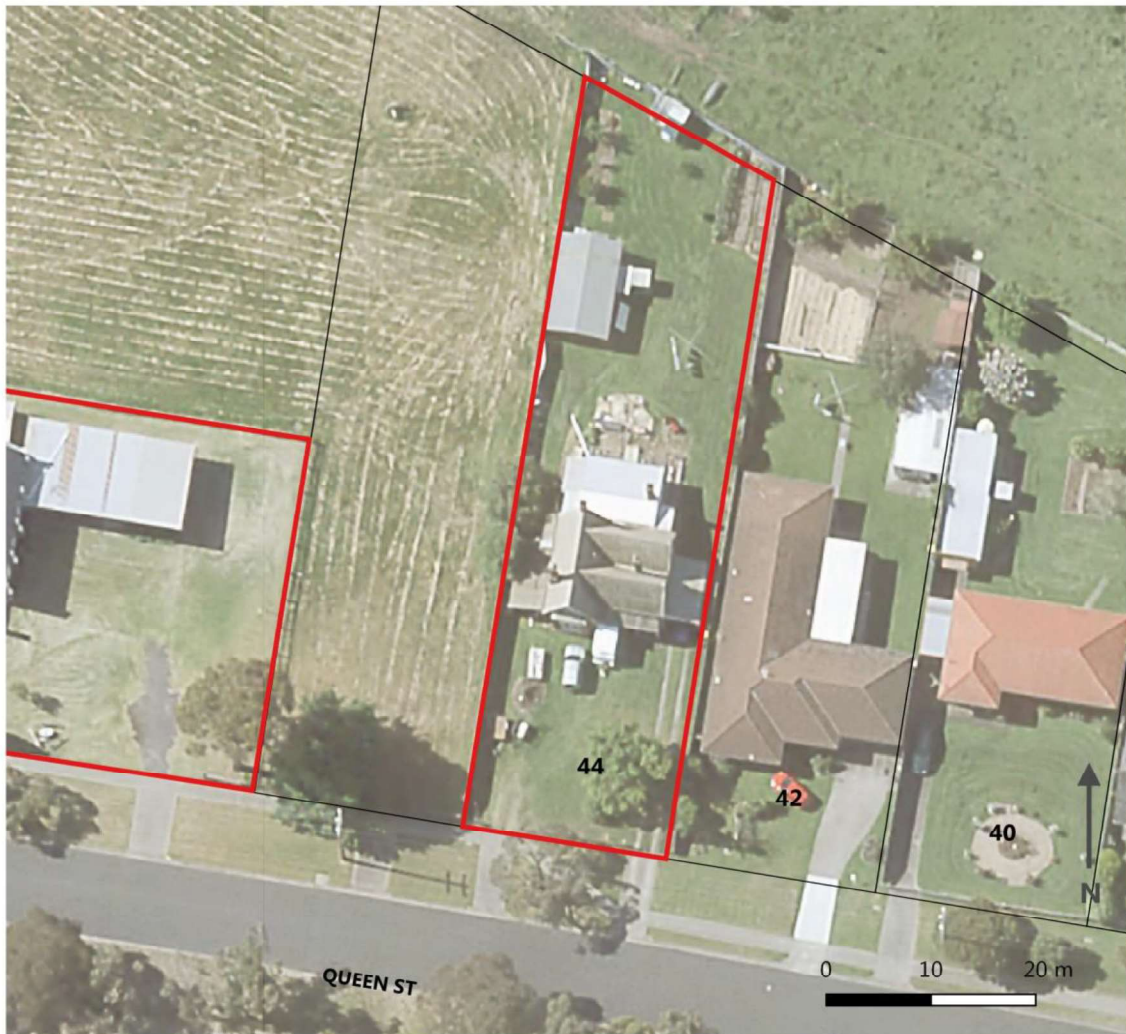
Map of recommended boundary for Heritage Overlay

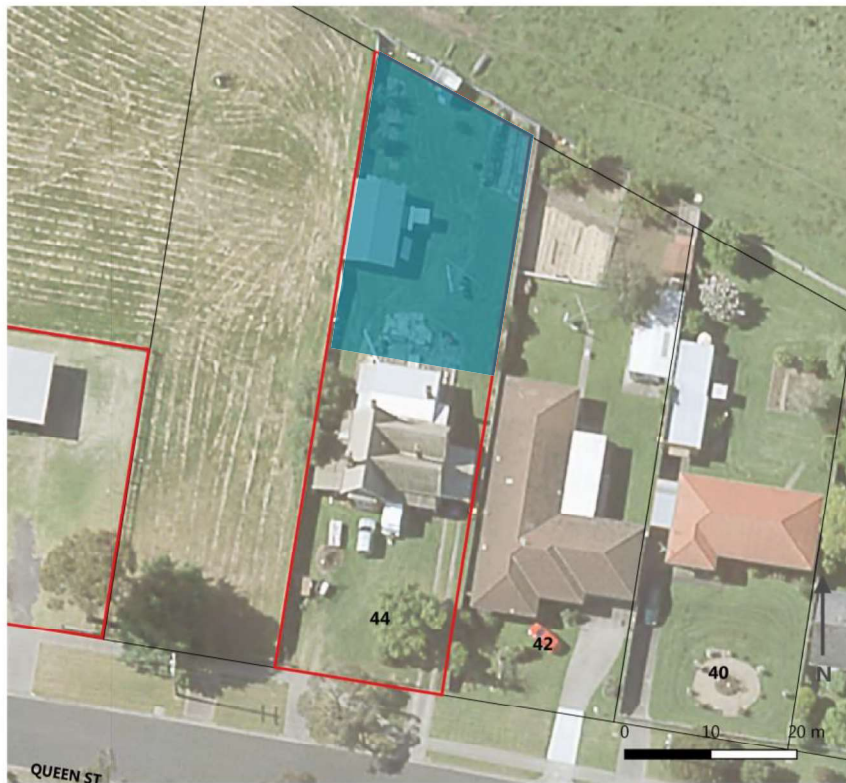
NOTE: The blue shaded area is the preferred location for additions and new development:
