**Locality:** ROSEDALE  
**Place address:** 48-52 QUEEN STREET  
**Citation date** 2016  
**Place type (when built):** Church  
**Recommended heritage protection:** Local government level  
Local Planning Scheme: Yes  
Vic Heritage Register: No  
Heritage Inventory (Archaeological): No

**Place name:** St Andrew's Uniting Church

Project: Wellington Shire Stage 2 Heritage Study  
Client: Wellington Shire Council  
Author: Heritage Intelligence Pty Ltd  
Date: 26/5/16

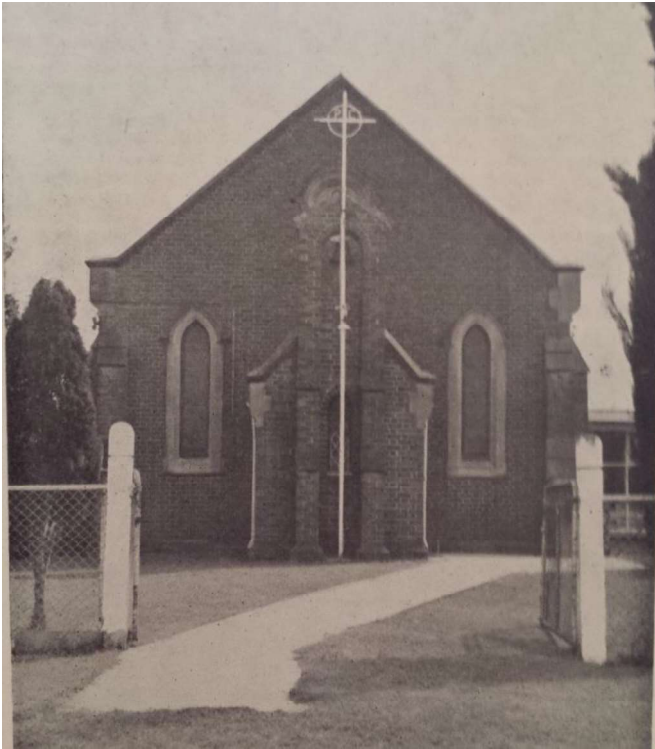
**Figure H1.** Photo dating to pre-1971 photo that showed the facade. The decorative render remained unpainted at this date. An immature cypress was evident inside the left (west) of the gate, while a mature one was growing inside the fence to the right (east) of the gate (remain in 2015) (Maddern 1971:82).

A photo dating to pre-1971 (Figure H1) showed the facade of the church (Maddern 1971:82). The entrance porch with its bell tower had the tall pole with the cross attached and the letters 'P C', all painted white (that remains in 2015). The decorative render remained unpainted at this date. The front boundary had a c1930s metal pole and chain wire fence with timber posts, and a metal pole vehicular gate directly in front of the church. An immature cypress was evident inside the left (west) of the gate, while a mature one was growing inside the fence to the right (east) of the gate (remain in 2015).

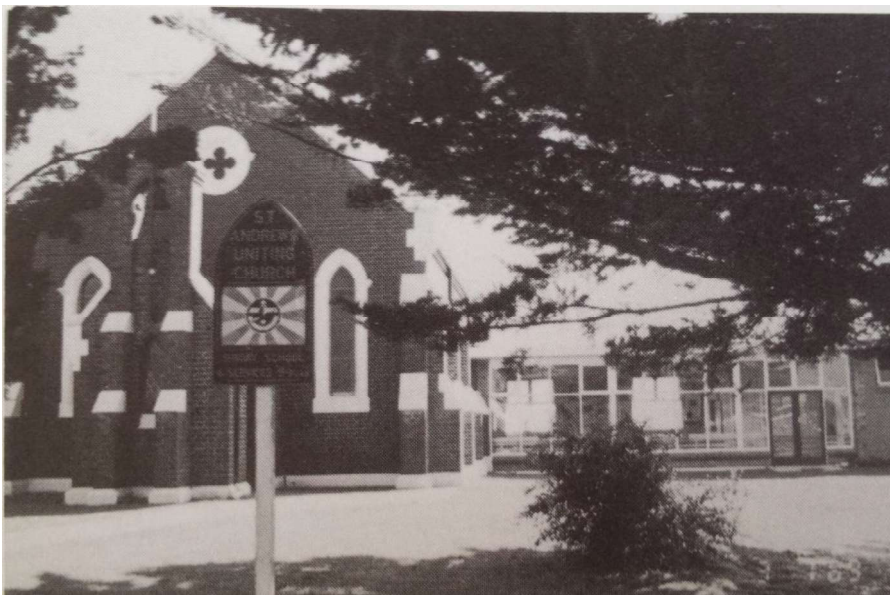
**Figure H2.** A photo dating to 1987 that showed the facade, with the decorative render painted bright white. The 1960s addition was evident to the east of the church and in the foreground a mature pine is partly visible (since removed; probably the large stump which remains in 2015) (Hardy 1989:96).

A photo dating to 1987 (Figure H2) showed the church from Queens Street (Hardy 1989:96). The entrance porch with its bell tower stood in front of the nave section, with coping painted bright white. The 1960s addition was evident to the east of the church and in the foreground a mature pine is partly visible (since removed; probably the large stump which remains in 2015).

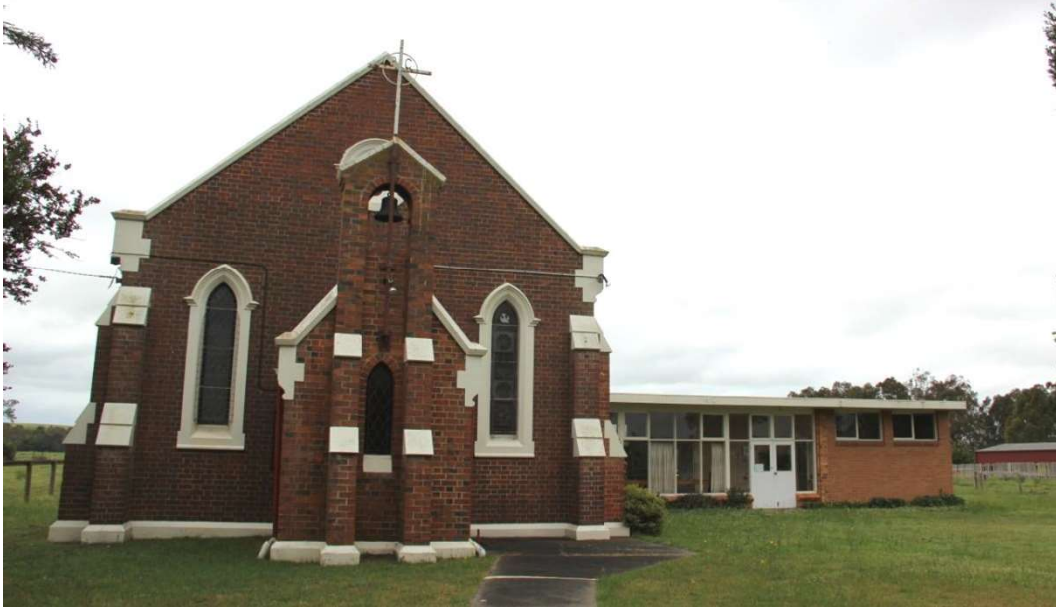
**Figure D1.** The church is constructed of handmade brown-bricks with a rendered plinth and rendered dressings and coping to the parapeted gables, buttresses and window surrounds. The façade has a central entrance porch which also serves as a bellcote. Attached to the rear of the east elevation is a c1960s cream brick hall.

**Figure D1.** The church is constructed of handmade brown-bricks with a rendered plinth and rendered dressings and coping to the parapeted gables, buttresses and window surrounds. The gabled roof is clad with corrugated iron.

**Figure D1 & D2.** The façade has a round niche with a quatrefoil motif at the gabled-end, above a central entrance porch which also serves as a bellcote. The entrance porch imitates the parapeted gabled of the nave behind, and has two tall buttresses on its south elevation, which extend up to form an arched space from which a bell hangs. In front of the bell, a metal pole is fixed with a cross which sits above the bellcote. Both sides of the entrance porch have timber doors. Flanking the entrance are two pointed-arch windows with rendered, moulded frames, with labeling moulds above. All the windows have either pictorial or diaper-patterned leadlight.

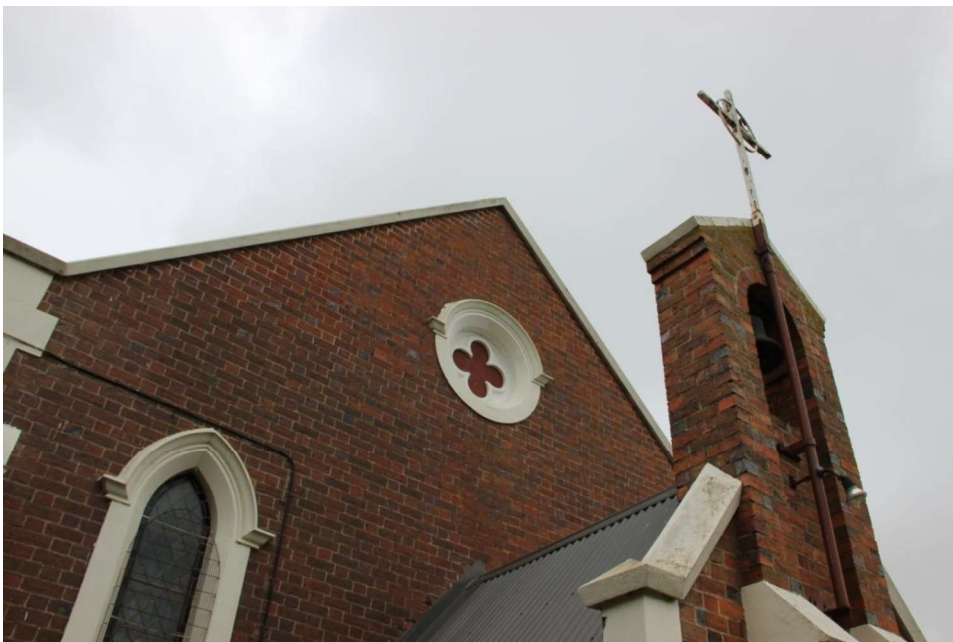
**Figure D2.** The façade has a round niche with a quatrefoil motif to the gabled-end. Flanking the entrance are two pointed-arch windows with rendered, moulded frames, with labeling moulds above. All the windows have either pictorial or diaper-patterned leadlight.

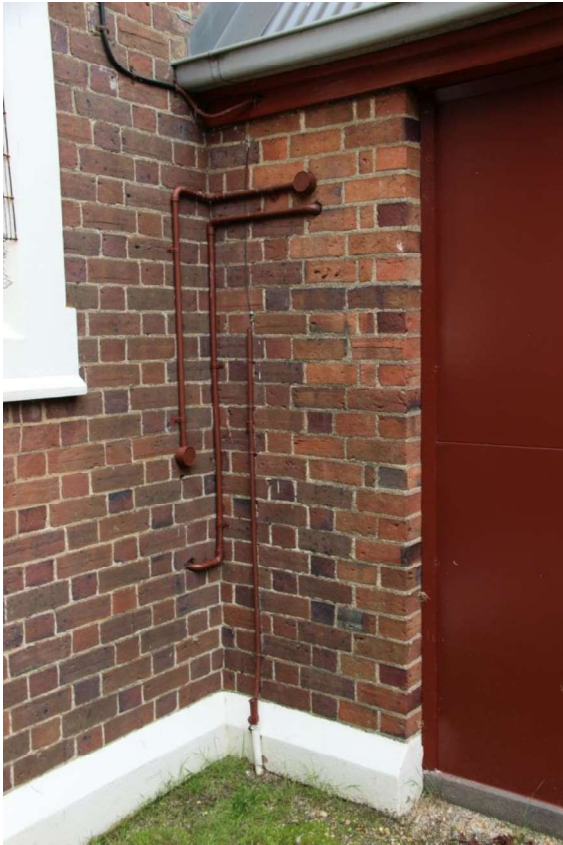
**Figure D3.** The entrance porch is constructed of a different coloured (lighter) handmade brick, which is keyed in to the brown brick of the nave.

**Figure D3.** The entrance porch is constructed of a different coloured (lighter) handmade brick, which is keyed in to the brown brick of the nave. This may suggest a different builder (as two worked on the project, constructing different elements) or that it was built at a later date, but soon after the nave as it has the same architectural details as the nave.

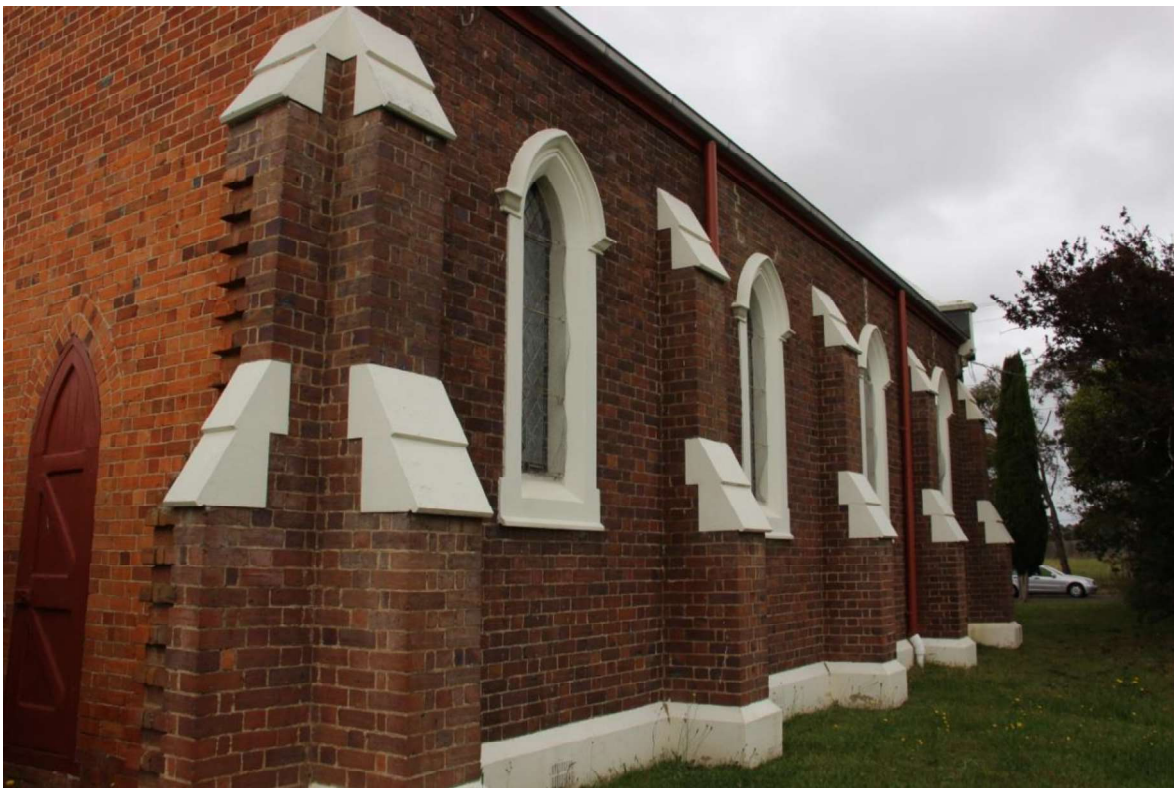
**Figure D4.** The west elevation. The side elevations are broken into four bays but buttresses, each bay with a single window like those of the façade.

**Figure D4 & D5.** The side elevations are broken into four bays by buttresses, each bay with a single window like those of the façade.

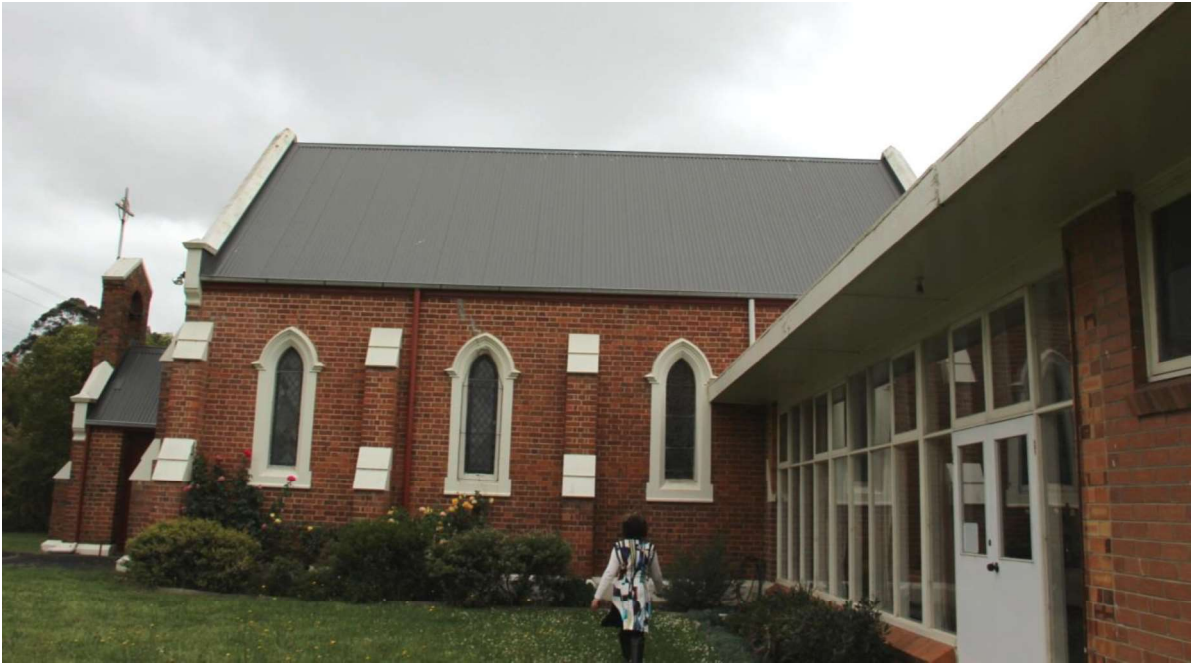
**Figure D5.** The east elevation. Three bays of the east elevation are visible. The c1960s cream brick addition adjoins the church in the fourth bay, at the rear of the church.

**Figure D5.** Three bays of the east elevation are visible. The c1960s cream brick addition adjoins the church in the fourth bay, at the rear of the church.

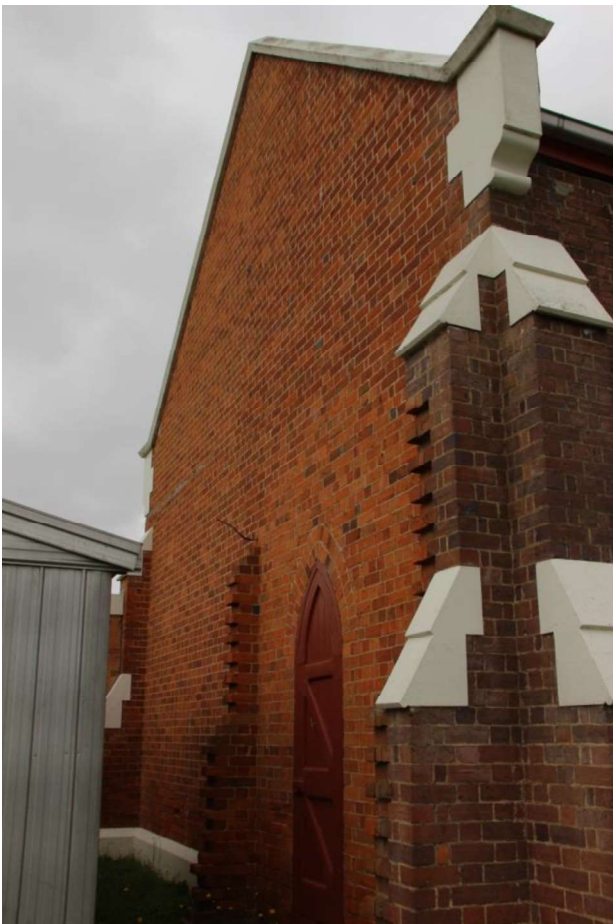
**Figure D6.** The rear (north) elevation is of red brick. Keyed bricks remain on the right side, that were ready for an extensions that never eventuated. The space in between the keyed bricks has a pointed-arch opening with a timber ledged and framed door.

**Figure D6.** The rear (north) elevation is of red brick. Keyed bricks remain on the right side, that were ready for an extensions that never eventuated. The space in between the keyed bricks has a pointed-arch opening with a timber ledged and framed door.

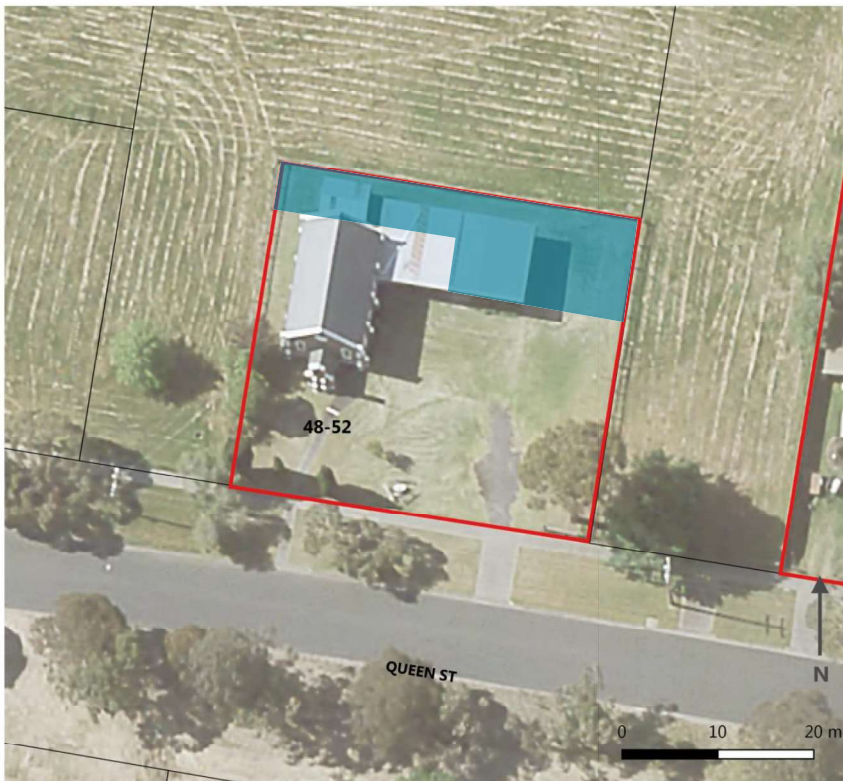
NOTE: The blue shaded area is the preferred location for additions and new development:

- 2.1. New structures should be restricted to the rear of the property as shown in the blue polygon on the aerial map below. It is desirable to retain a visual link with the former Manse.
