**Locality:** STRATFORD  
**Place address:** 17 HOBSON STREET  
**Citation date** 2016  
**Place type (when built):** Mechanics Institute and Free Library  
**Recommended heritage protection:** Local government level  
Local Planning Scheme: Yes  
Vic Heritage Register: No  
Heritage Inventory (Archaeological): No

**Place name:** Mechanics Institute and Boer Memorial Plaque

**Architectural Style:** Federation Free Classical  
**Designer / Architect:** Edgar J. Henderson  
**Construction Date:** 1890

Project: Wellington Shire Stage 2 Heritage Study  
Client: Wellington Shire Council  
Author: Heritage Intelligence Pty Ltd  
Date: 12/2/16

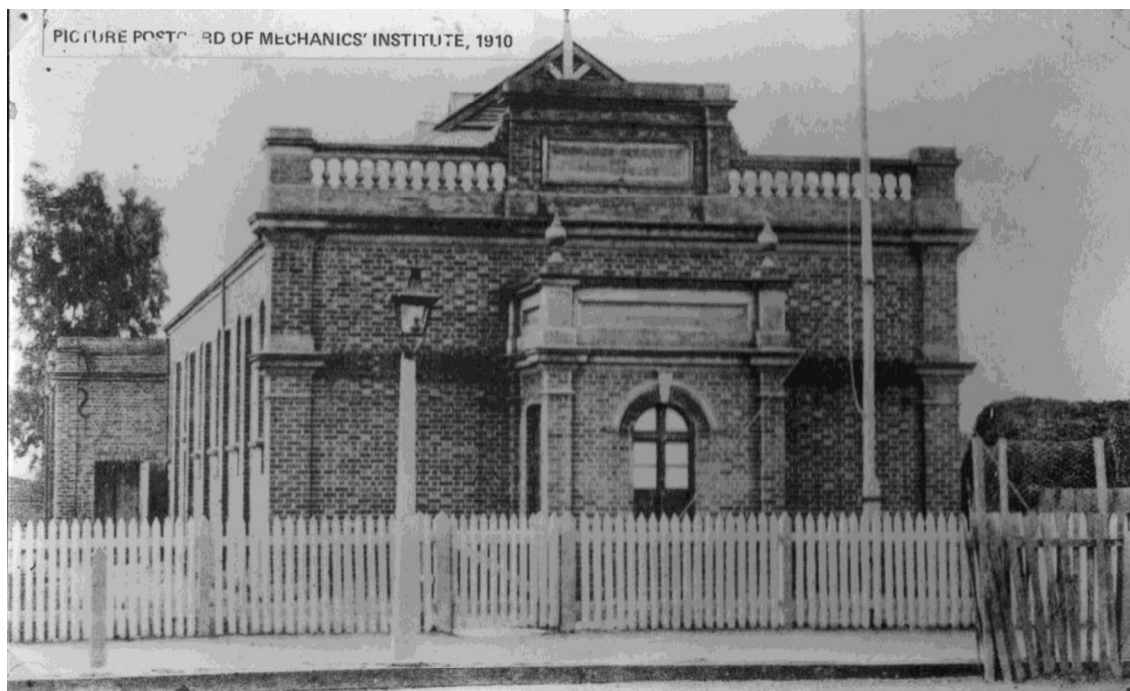
**Figure H1. The hall in 1910. At the peak of the roof the gablette, flying gable end, finial and timber vents were evident, as well as the triangular vents to the roof (since removed). A flagpole stood to the right of the facade, while a timber picket fence and pedestrian gate ran along the front boundary (SDHS).**

A photo dating to 1910 (SDHS) showed the facade and west elevation of the hall (Figure H1). At the peak of the roof, the existing gablette, timber flying gable end, timber vents and the pendant and finial were evident, as well as the triangular vents to the roof (these since removed). The decorative rendered details and coping to the façade, including the balustrade parapet, had retained their original unpainted finish. The projecting porch, which had face brick surrounding the front double doors within a round arched doorway, was demolished in the 1950s for the cream brick extension. The wider section at the rear of the hall was also evident in the photo. A flagpole stood to the right of the facade, while a timber picket fence and pedestrian gate ran along the front (south) boundary. A photo of a similar date also showed the facade and windows of the west elevation (Figure H2). Four triangular roof vents projected from the west roof plane (since removed). The west side of the porch had a panelled entrance door (since removed) (SDHS; PROV).

6.1. The decorative rendered window sills, cornices, capitals, stringcourses, etc have been painted, however, these architectural features were not designed to be painted (see Figures H1 & H2). They were a light-coloured unpainted render. It is recommended that the paint be chemically removed, which will restore the original finish and save on 10 yearly repainting costs.

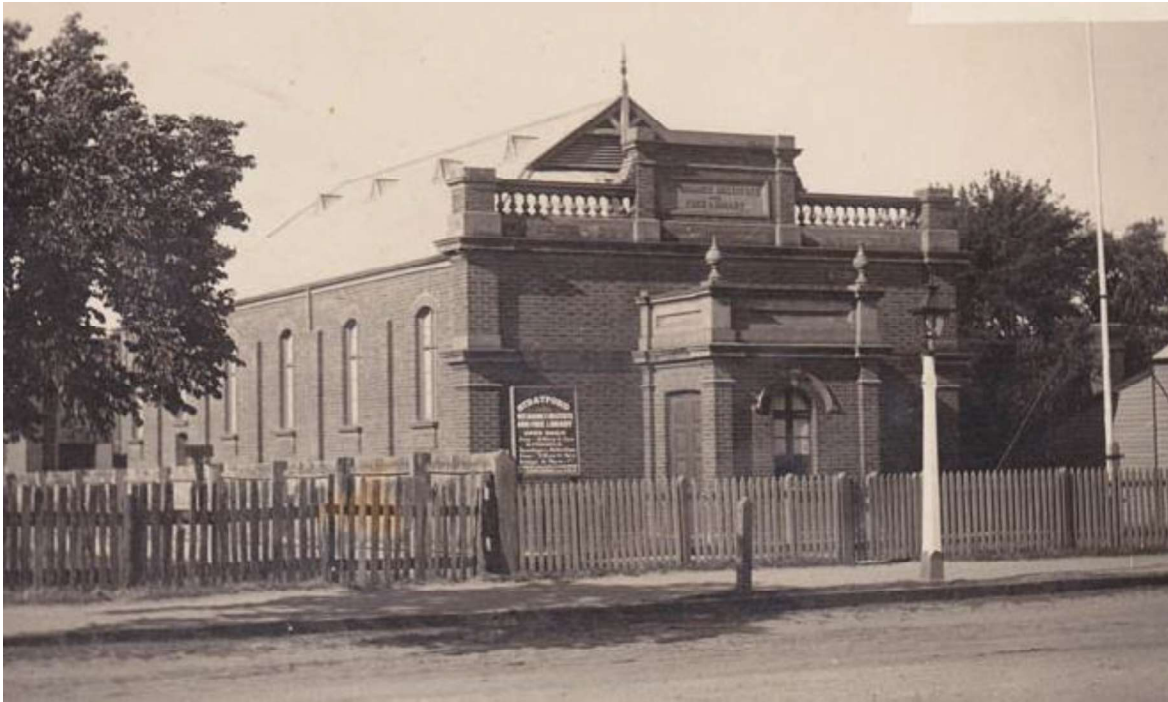
Figure H2. The hall at an unknown early date (similar to 1910 photo). At this date the roof had four triangular roof vents and the west side of the porch had a panelled entrance door (all since removed) (SDHS).

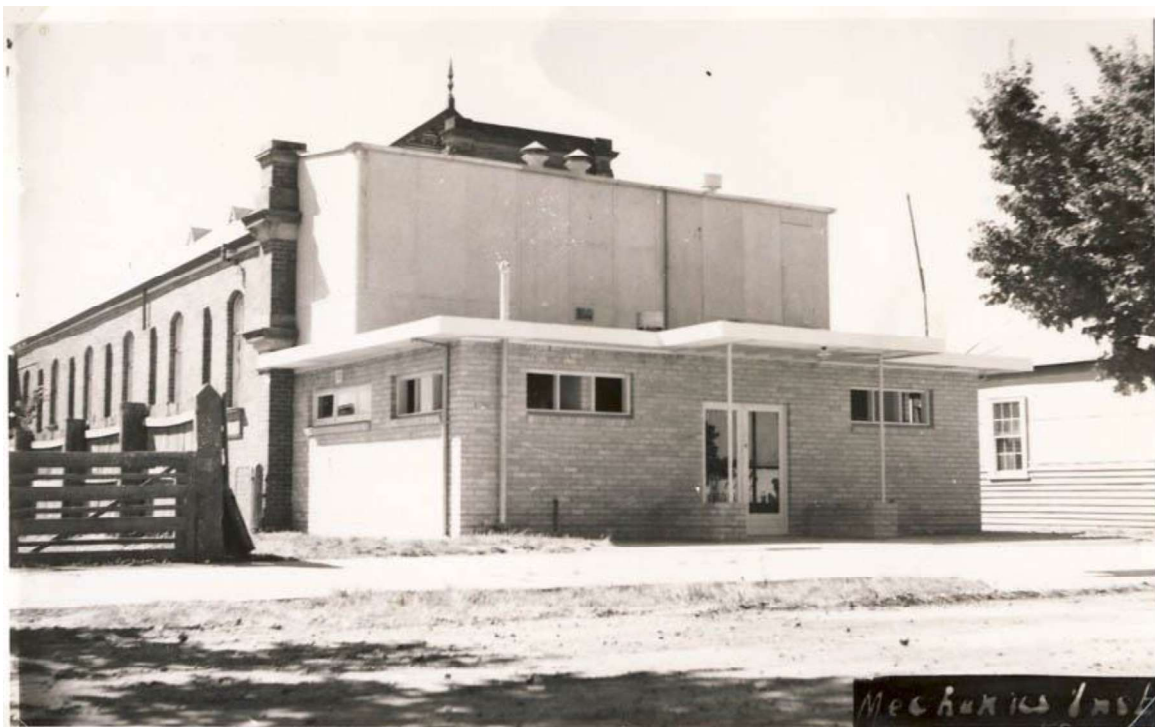
Figure H3. The hall in 1958. The front elevation had been replaced with an intrusive cream brick addition and section above, which covered the entire facade of the hall, all since removed (SDHS).

An unsympathetic and intrusive addition to the façade is evident in a photo dating to 1958, probably taken soon after its construction (Figure H3). No fence remained along the front boundary at this date and the flagpole had been removed. The single-storey cream brick addition (comprising toilets), with a flat roofline, extended almost the width of the facade, and had a central entrance covered by a porch. Above this, a narrow box-like construction was built to the height of the parapet, to conceal the historic façade, providing an entirely new modern facade. These unsympathetic additions were removed between 2005 and 2010 (SDHS).

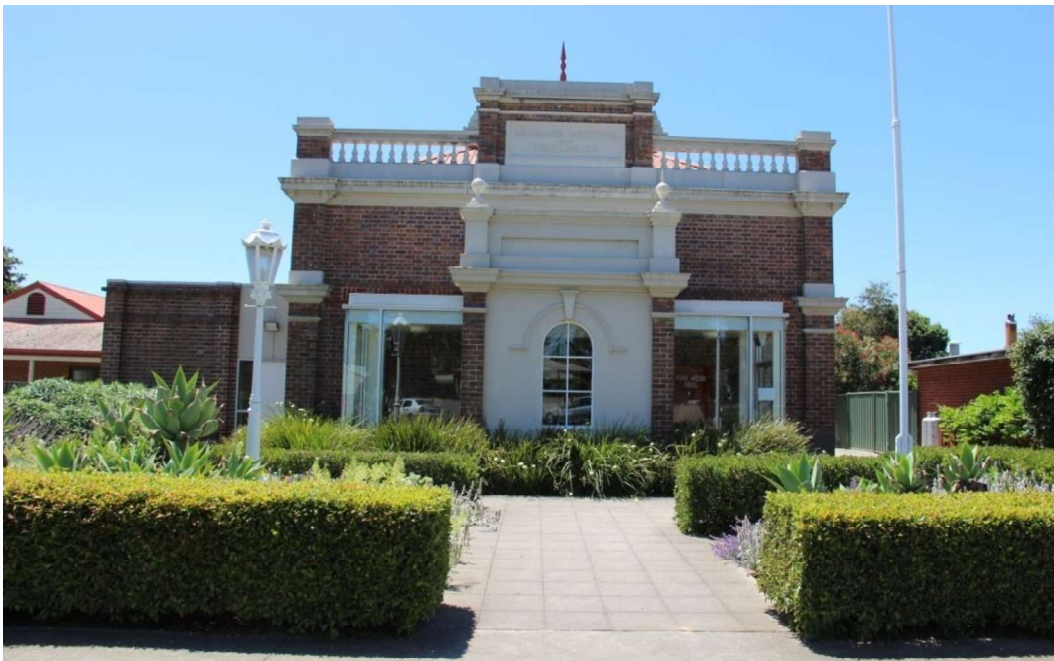
**Figure D1.** The hall setback behind a modern landscaped area with a flagpole. The 1950s cream-brick addition was removed from the facade in 2004 and glass additions were constructed either side of the entrance, and a large brick extension built down the west side of the building. The original bold Classical facade is now visible with its balustraded parapet and entrance porch with its bold parapet. The central arched window is a representation of the original entry doorway.

**Figure D1.** The brick hall is rectangular in plan with a hip and gabled roof (with modern metal tiles). The roof has a ridge vent, and on the gable end facing the street are a timber finial, flying gable end and horizontal vents (see Figure D3). The hall has a bold symmetrical Classical facade with tuckpointed face-brick and rendered dressings (overpainted). A tall parapet bears the name 'Mechanics Institute and Free Library' with a short balustraded parapet to each side. Below this is the central projecting entrance porch with a large rendered parapet with orbs to the corners (not original, see Figure H1). The front wall of the porch may have been reconstructed (to match the original, see Figures H1 & 2) after the intrusive 1950s cream brick addition was recently removed from the facade, as it has a modern window and recent render, but replicated the details of what originally existed. The front two corners of the porch have rendered (overpainted) 'capitals', which are repeated on the corners of the facade.

Two small glass additions have been added either side of the entrance porch. A long addition has been constructed on the west elevation (the original elevation remains on the interior). A concrete driveway (laid after 2009) runs along the east side of the building.

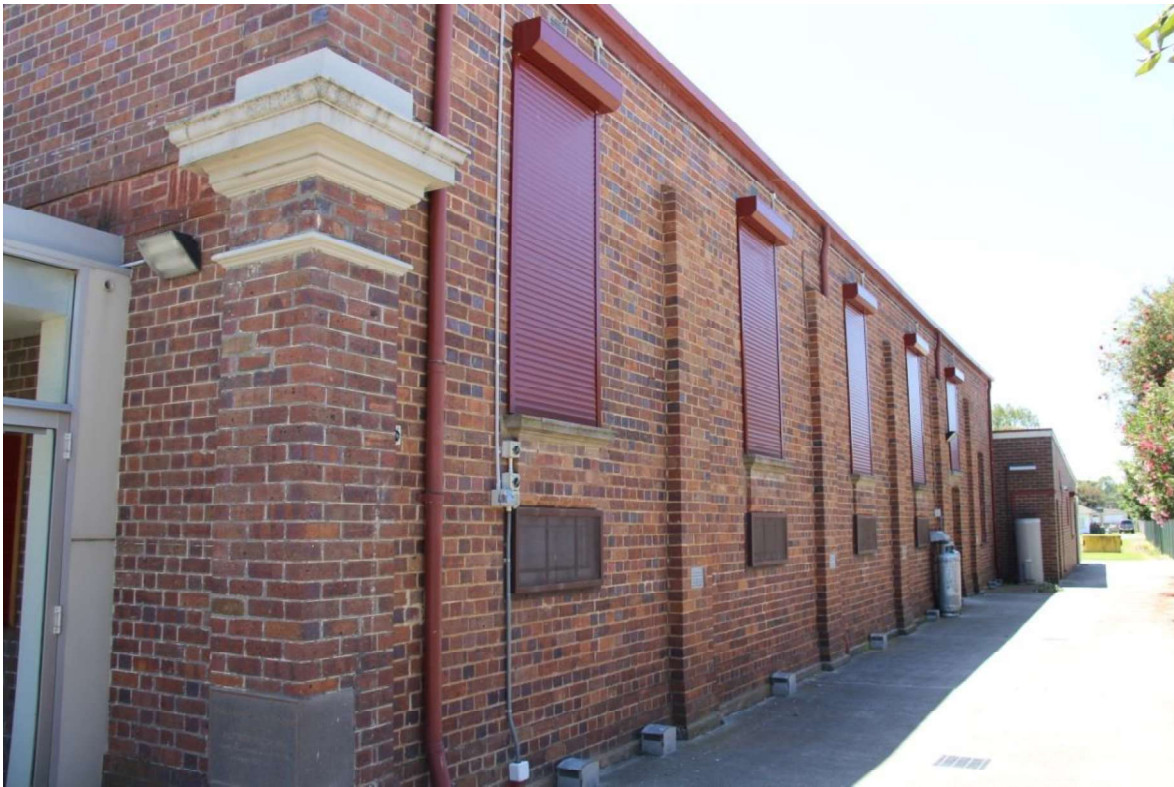
**Figure D2.** The east elevation with windows (behind modern roller shutters) with rendered sills and a brick apron, above a modern vent. Simple engaged buttresses are located between each window. The large modern addition to the rear extends beyond the side elevations.

**Figures D2 & D3.** The side elevations have a rendered plinth. The side elevations have simple engaged buttresses between the windows (covered by modern security roller shutters), which have rendered sills above a brick apron. Below each window is a modern louvre vent. At ground level, multiple metal vents rise to allow for sub-floor ventilation.

The east elevation has a timber paneled door at ground level, below a window, and a ledged timber door above ground level that allowed access to the stage (may have been altered, as a second arch remains in the wall at a higher level).

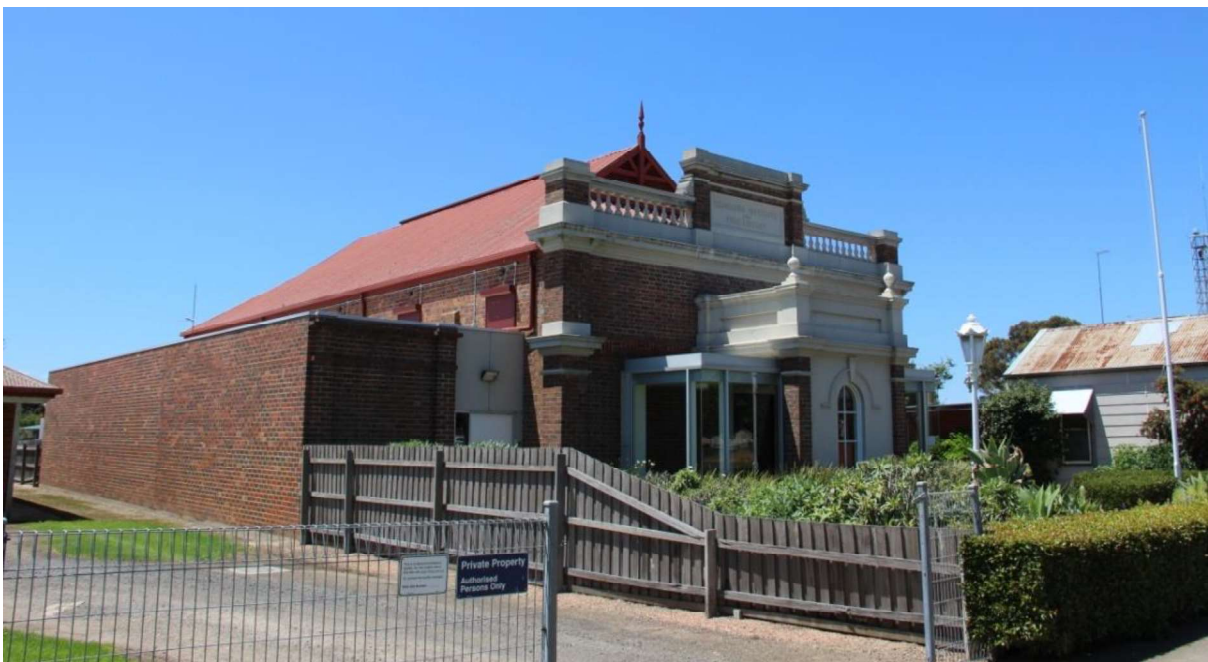
**Figure D3.** The west elevation of the hall is partly visible behind the modern addition. The gablette to the roof is visible, with its timber detail and finial.

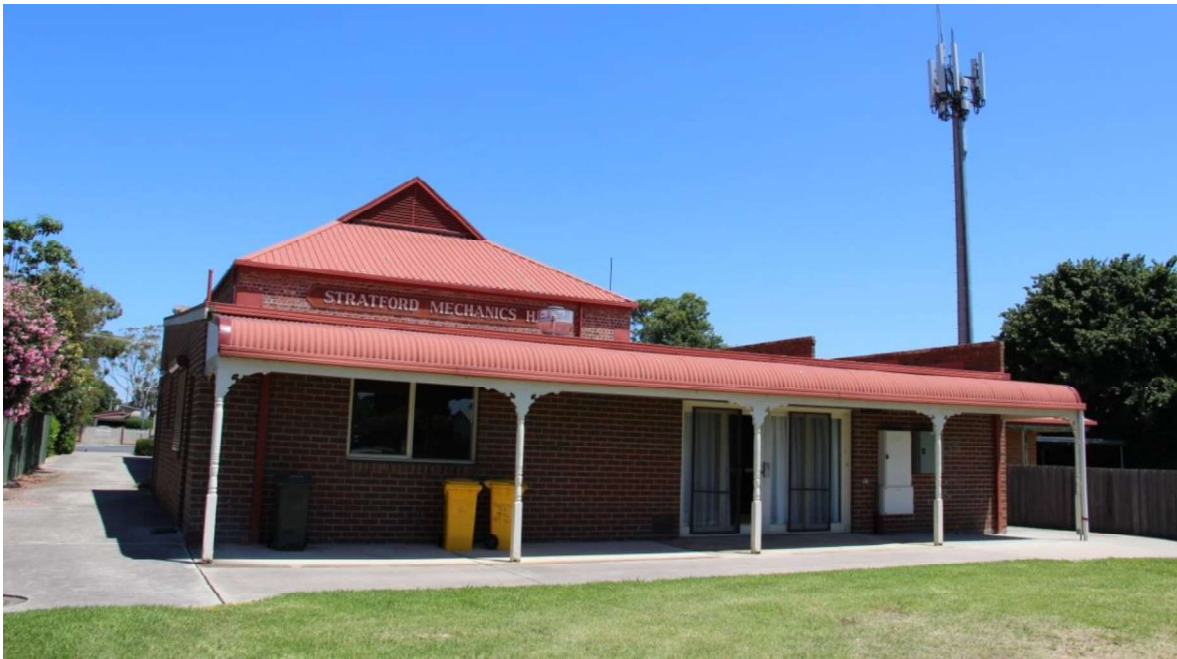
**Figure D4.** The rear (north) elevation with the gablette to the original section of the building, which is clad in modern metal red decking, and the lower roof-form of the modern addition, with its heritage style verandah, clad in modern red Colorbond.

**Figure D4.** The roof at the rear elevation has a longer hip than at the south end (see the aerial map) but it appears to be the original extent. The gablette has the original timber louvred vent, flying gable end, finial and pendant. The large modern brick addition to the rear has a modern verandah with a bull-nosed profile.

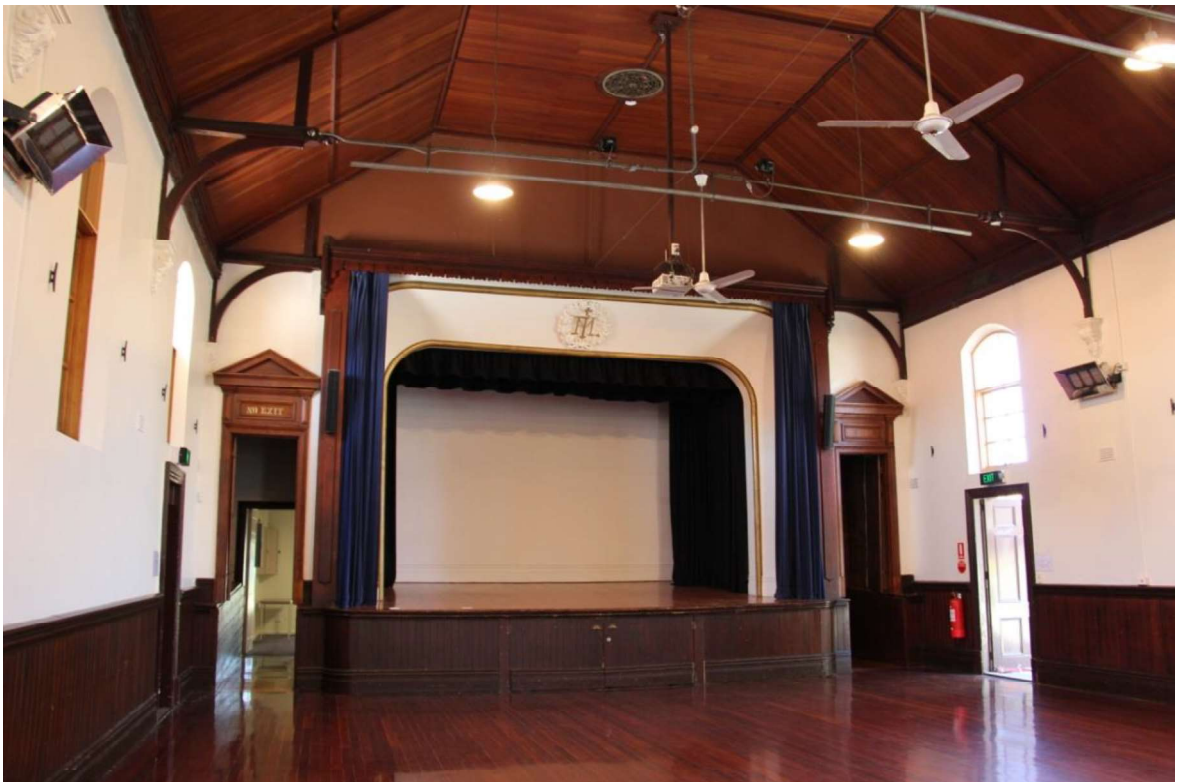
**Figure D5.** The interior of the hall with its original timber stage, proscenium with wreath, timber lined ceiling with cast iron ceiling rose vents, hammer beams, dado to the walls and aedicules to the original doors at the side of the stage.

**Figure D5.** The interior of the hall retains its original timber details including the stage, timber lined ceiling, hammerbeams, dado, doors and aedicules to the doorways either side of the stage (the floor was replaced c1995). The openings and stage height were altered either side to allow access to the rear extension.
