**Locality:** STRATFORD  
**Place address:** 2 MERRICK STREET  
**Citation date** 2016  
**Place type (when built):** Church  
**Recommended heritage protection:** Local government level  
Local Planning Scheme: Yes  
Vic Heritage Register: No  
Heritage Inventory (Archaeological): No

**Place name:** St Patrick's Catholic Church

Project: Wellington Shire Stage 2 Heritage Study

Author: Heritage Intelligence Pty Ltd

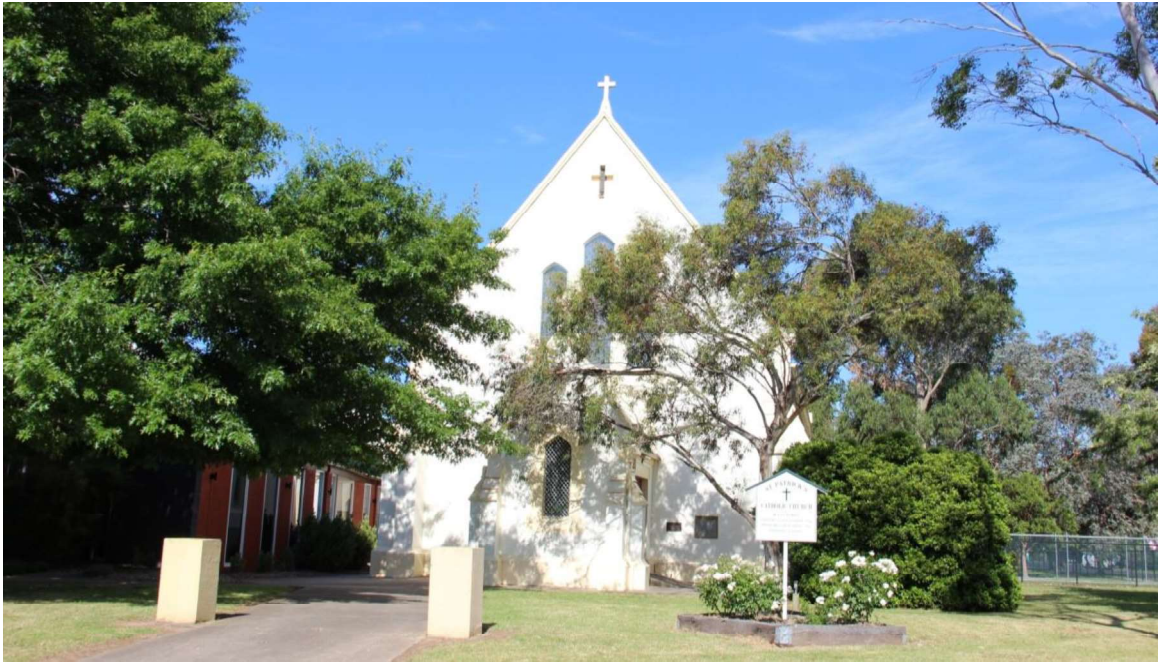
**Figure D1.** The church is a substantial brick structure, sitting on a large rendered plinth, with decorative render (overpainted) to the entire exterior; the render to the wall plains is overpainted white, while the decorative details, including the quoining to the corners, window trimmings and coping to the buttresses and parapeted gables, are painted a cream tone. The steeply-pitched gabled roof is clad with (recent) metal decking which is hidden from Merrick Street by a rendered parapeted gable, which has a cross to the peak, but very visible at the sides. Buttresses support the corners of the façade and divide the sides into five bays. At the top of the gabled end of the facade is a niche in the shape of a cross (may serve as a vent). Below is a set of three pointed-arched windows with pictorial leadlight.

**Figure D1.** The church is a substantial brick structure, sitting on a large rendered plinth, with decorative render (overpainted) to the entire exterior. The steeply-pitched gabled roof is clad with (recent) metal decking with a rendered parapeted gable.

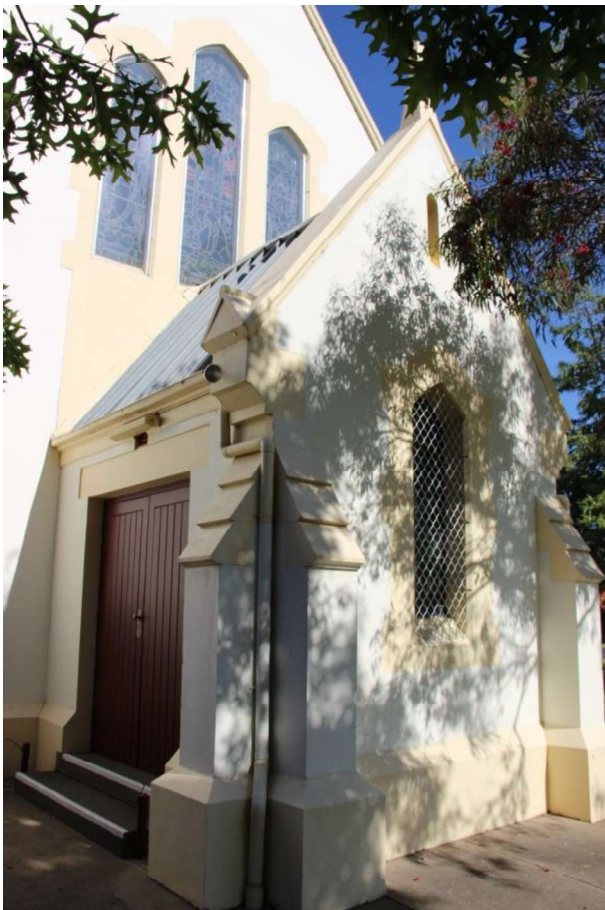
**Figure D2.** At the centre of the facade is the entrance porch, which imitates the details of the nave behind. The front of the porch has a pointed-arch window (covered with a modern security grill), while the sides have double timber ledged and framed doors (in a square opening) with their original handles and plates, incised with a cross. The handle on the right (south) door is inscribed with 'Tom's Door'. The entrance on the left is reached by two bluestone steps, while Tom's Door has a concrete ramp.

**Figure D2.** At the centre of the facade is the entrance porch, which imitates the details of the nave behind. The front of the porch has a pointed-arch window (covered with a modern security grill), while the sides have double timber ledged and framed doors (in a square opening) with their original handles and plates, incised with a cross.

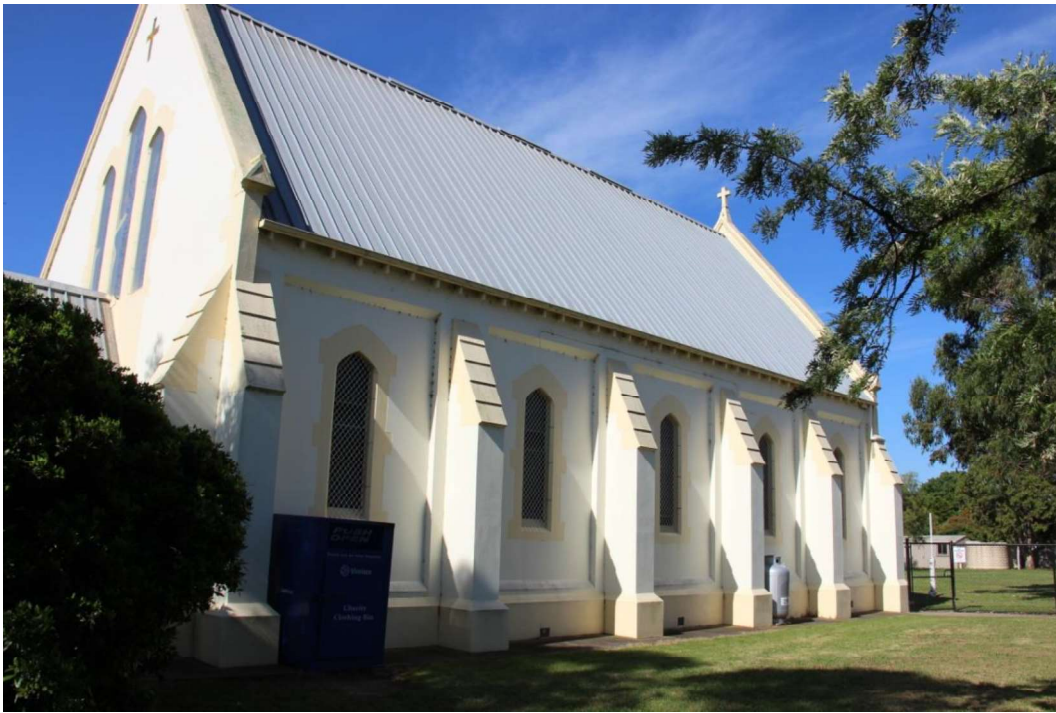
**Figure D3.** From the side elevations, the exposed rafter ends are visible beneath the eaves. The side elevations are broken into five bays by solid buttresses. Each bay has a single window in a large recessed square panel. The windows, like those of the facade, have a pointed-arch, rendered trimmings (overpainted in a yellow tone) and leadlight in pictorial and diaper-patterns.

**Figure D3. The south elevation. The side elevations are divided into five bays by solid buttresses. Each bay has a single window in a large recessed square panel. The windows, like those of the facade, have a pointed-arch, rendered trimmings (overpainted in a cream tone) and leadlight in pictorial and diaper-patterns, covered in modern security grill.**

6.3. Windows. Replace the silver coloured modern metal grills with black security mesh. Internally the windows will not have the shadow of the security grill spoiling the beauty of the leadlight. The black security mesh will not rust and, externally from a distance the windows will look like dark glass windows ( as it does without any security covering) and close up it will look like flywire. Alternatively, paint the silver grill, black, to reduce the contrast and make it less noticeable.

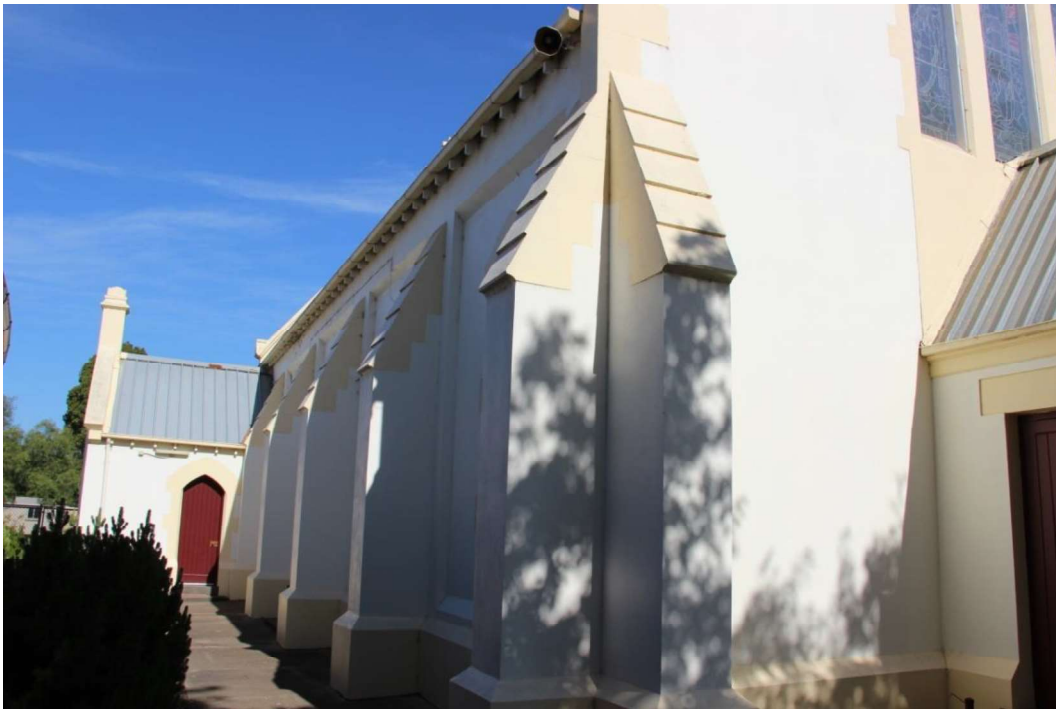
**Figure D4.** The north elevation has a gabled-roof vestry projecting off the chancel end, with timber ledged door (with a pointed arch opening) facing west. It has a large parapeted gable which appears to extend to form a bellcote.

**Figure D4. The north elevation has a gabled-roof vestry projecting off the chancel end, with timber ledged door (with a pointed arch opening) facing west. It has a large parapeted gable which appears to extend to form a bellcote.**

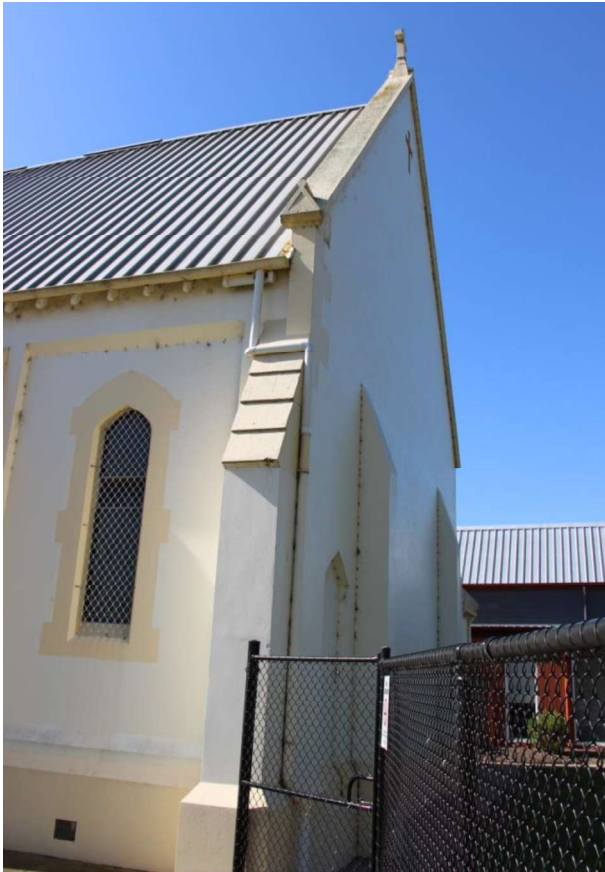
**Figure D5.** The rear (east) elevation has a simple treatment. It has a niche in the shape of a cross at the top of the gabled-end, like the facade, and two simple buttresses. To the left is a pointed-arch entrance door that has been closed over (or perhaps never opened, if anticipating an addition to this end).

**Figure D5. The rear (east) elevation has a simple treatment. It has a niche in the shape of a cross at the top of the gabled-end, like the facade, and two simple buttresses.**

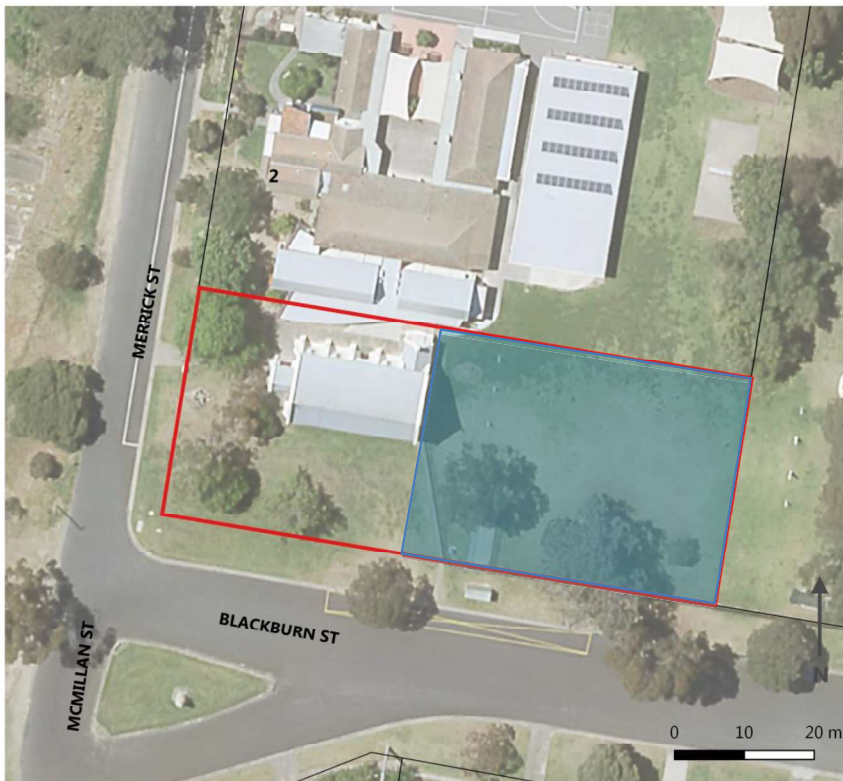
NOTE: The blue shaded area is the preferred location for additions and new development.

2. **Additions and New Structures**
  - 2.1. New structures should be restricted to the area shown in the blue polygon on the aerial map below.
  - 2.2. Sympathetic extensions are preferred. E.g. New parts that are in the same view lines as the historic building as seen from both streets, should be parallel and perpendicular to the existing building, no higher than the existing building, similar proportions, height, wall colours, steep gable or hip roofs, with rectangular timber framed windows with a vertical axis. But the parts that are not visible in those views could be of any design, colours and materials.
