**Locality:** TINAMBA  
**Place address:** 11 TINAMBA-SEATON ROAD  
**Citation date** 2016  
**Place type (when built):** Church, Memorials, Trees  
**Recommended heritage protection:** Local government level  
Local Planning Scheme: Yes  
Vic Heritage Register: No  
Heritage Inventory (Archaeological): No

**Place name:** St Matthews Anglican Memorial Church, Memorials & Trees

Project: Wellington Shire Stage 2 Heritage Study  
Client: Wellington Shire Council  
Author: Heritage Intelligence Pty Ltd  
Date: 12/2/16

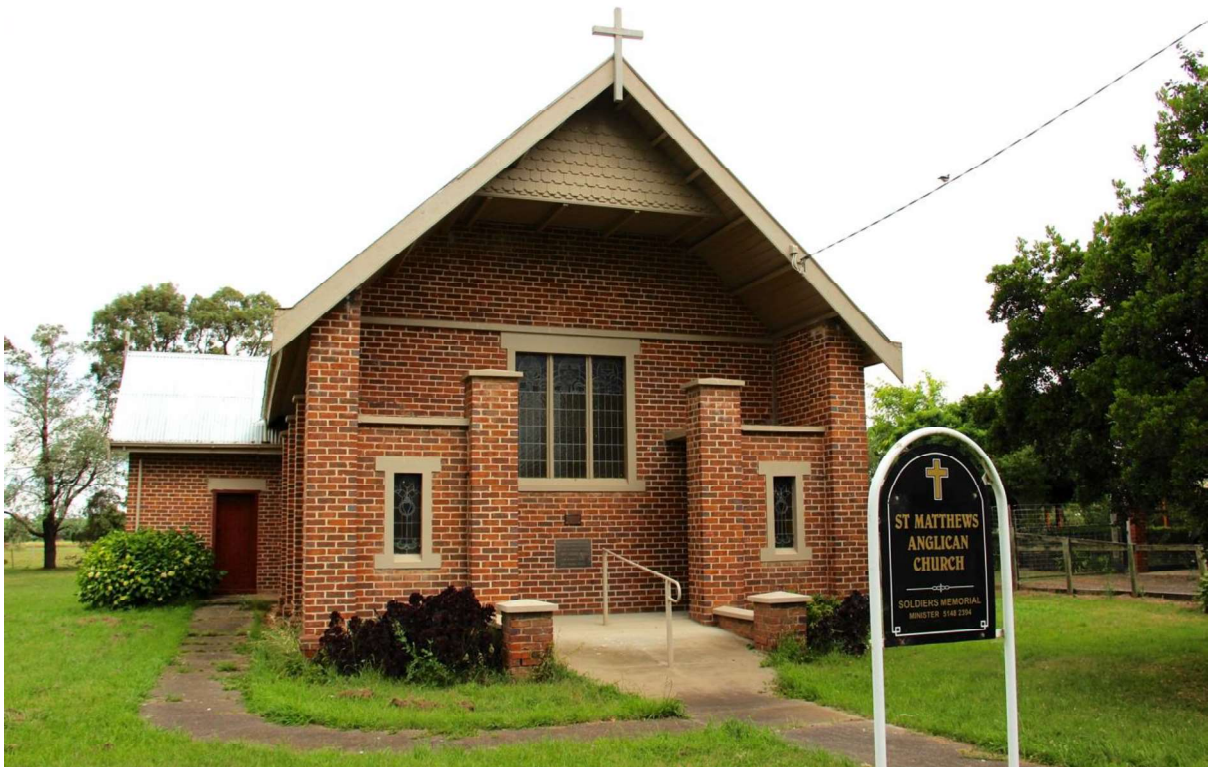
**Figure D1.** The church is constructed of handmade brown bricks and deliberately contrasting light coloured lime mortar, struck flush with the face of the brick, with a brick plinth and gabled roof clad in lapped corrugated iron (recently painted an appropriate colour). The roof projects forward at the façade, creating a deeply recessed entrance porch for the symmetrical façade.

**Figure D1.** The church is constructed of handmade brown bricks and deliberately contrasting light coloured lime mortar, struck flush with the face of the brick, with a brick plinth and gabled roof clad in lapped corrugated iron (recently painted an appropriate colour). The roof projects forward at the façade, creating a deeply recessed entrance porch for the symmetrical façade. The deep 'eaves' of the porch are timber lined. A jettied section at the top of the gabled-end is clad with timber shingles. The entrance path is framed by a low balustrade after two squat piers. At the sides of the façade are two 'enclosed' porches formed by two walls (2/3 the height of the side walls) which have a concealed flat roof, covering the timber paneled entrance doors (with unpainted rendered lintels) at each end. The two short walls each have an Art Nouveau leadlight window framed with rendered trim. The recessed wall of the nave has a large three-part (square-headed) window with leadlight. All the leadlight of the church reflects an Art Nouveau influence. The central entrance has a modern metal handrail and concrete path.

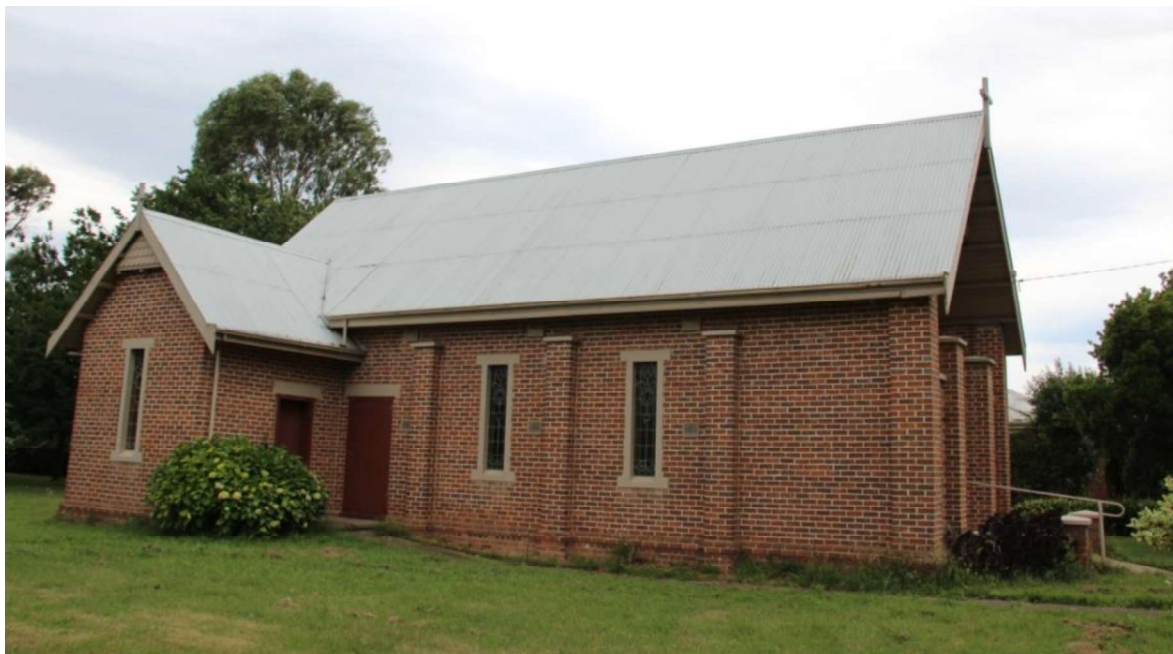
**Figure D2.** The east elevation. The side elevations comprise five bays, broken up by narrow engaged pilasters with a rendered cap. A vestry with a gabled roof projects to the east from the rear of the church, with the same treatment as the nave.

**Figure D2 & D3.** The side elevations comprise five bays, broken up by narrow engaged pilasters with a rendered cap. The east elevation has two square-headed windows with leadlight, framed with rendered trimmings, positioned in the two central bays. A vestry with a gabled roof projects to the east from the rear of the church, with the same treatment as the nave. Two timber ledged and framed doors with rendered lintels are located at the rear of the nave, and adjacent at the vestry.

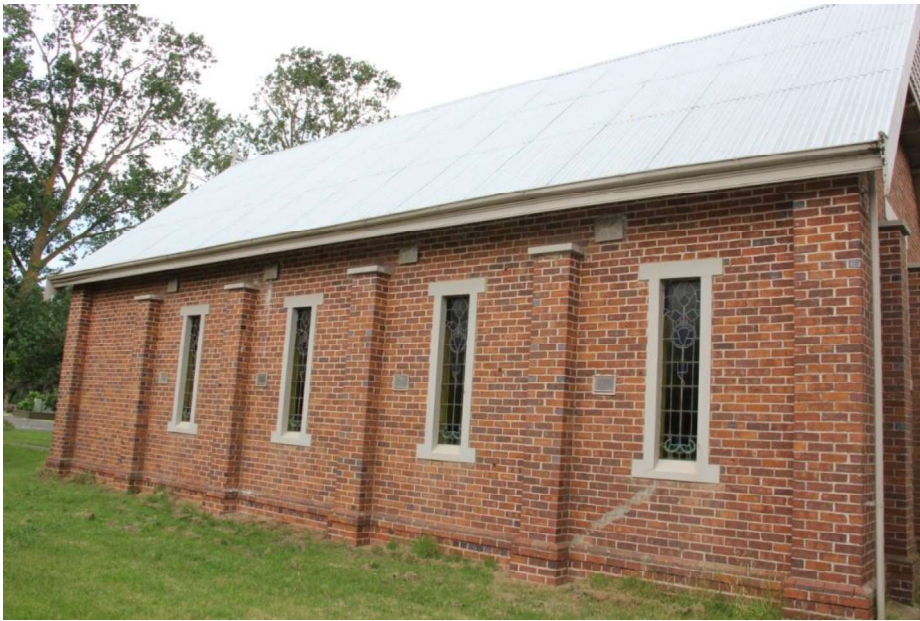
**Figure D3.** The west elevation has four windows (excluding the bay where the porch is, like the east elevation), with the same detail as the east elevation.

**Figure D3.** The west elevation has four windows (excluding the bay where the porch is, like the east elevation), with the same detail as the east elevation.

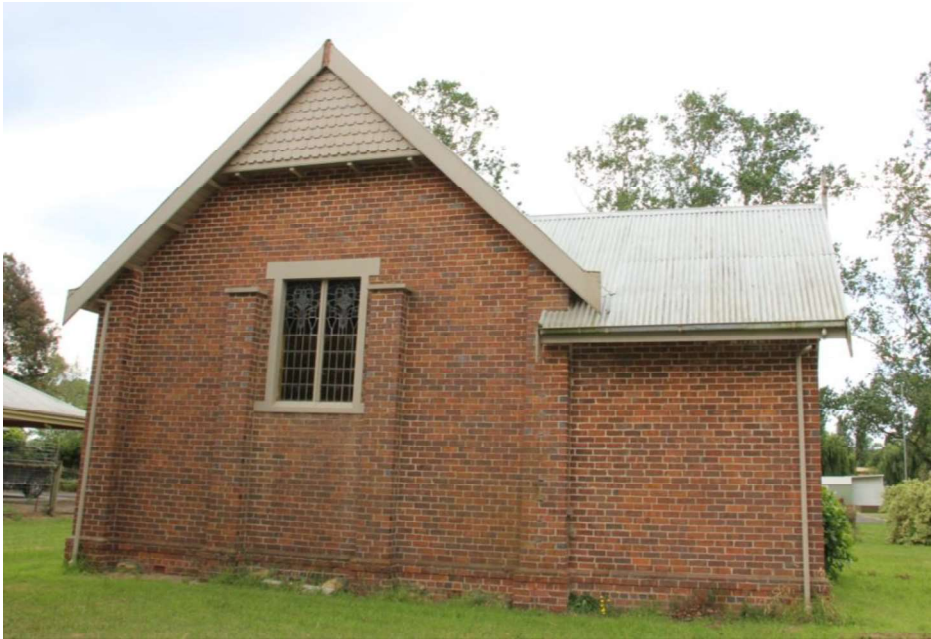
**Figure D4.** The rear (south) elevation has a jettied section at the top of the gabled end, clad with timber shingles, similar to the facade. Below is a double window of leadlight, flanked by a pair of buttresses.

**Figure D4.** The rear (south) elevation has a jettied section at the top of the gabled end, clad with timber shingles, similar to the facade. Below is a double window of leadlight, flanked by a pair of buttresses.

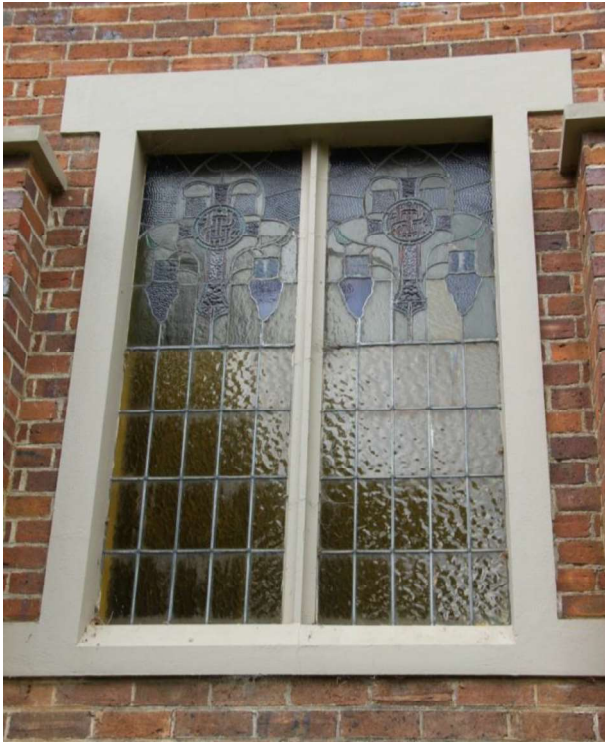
**Figure D5.** A detail of the windows on the south elevation (at the chancel end) show the geometric leadlight pattern to the bottom portion, and curvilinear detail of the Art Nouveau-inspired leadlight to the top.

**Figure D5.** A detail of the windows on the south elevation (at the chancel end) show the geometric leadlight pattern to the bottom portion, and curvilinear detail of the Art Nouveau-inspired leadlight to the top. The window has a rendered sill, lintel and frame at each side.

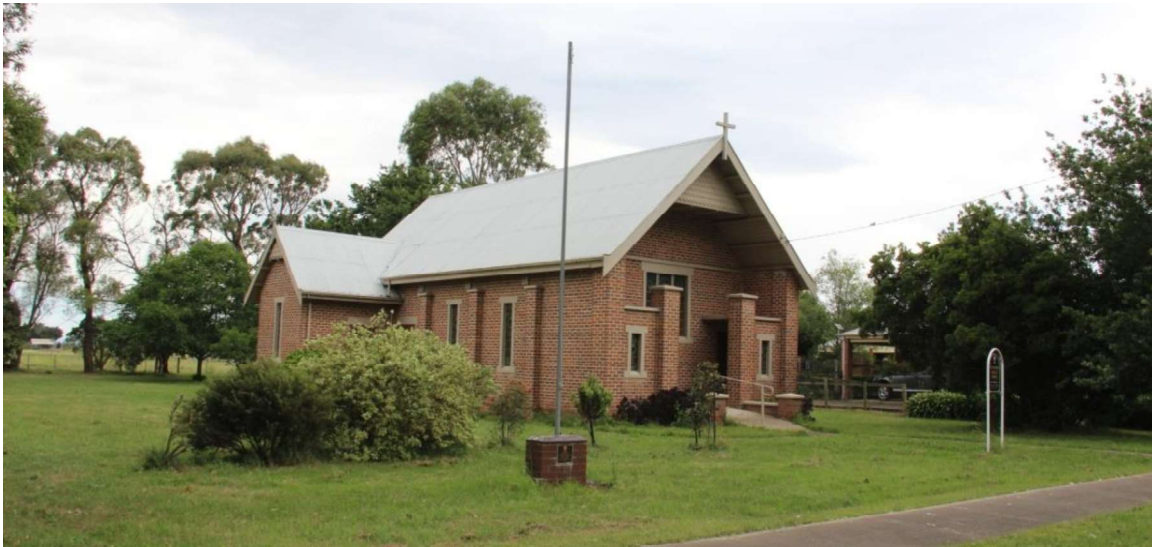
**Figure D6.** The church is set within a large lot, with a number of exotic trees along the west and south boundaries. A flagpole with a brick base stands to the north-east of the church, near the front boundary.

**Figure D6.** The church is set within a large lot, with a number of exotic trees along the west and south boundaries. A plaque placed above the foundation stone of the church notes that there was a 'tree plantation' on 25<sup>th</sup> April 1985 to commemorate Victoria's 150<sup>th</sup> anniversary.

A flagpole with a brick base stands to the north-east of the church, near the front boundary.

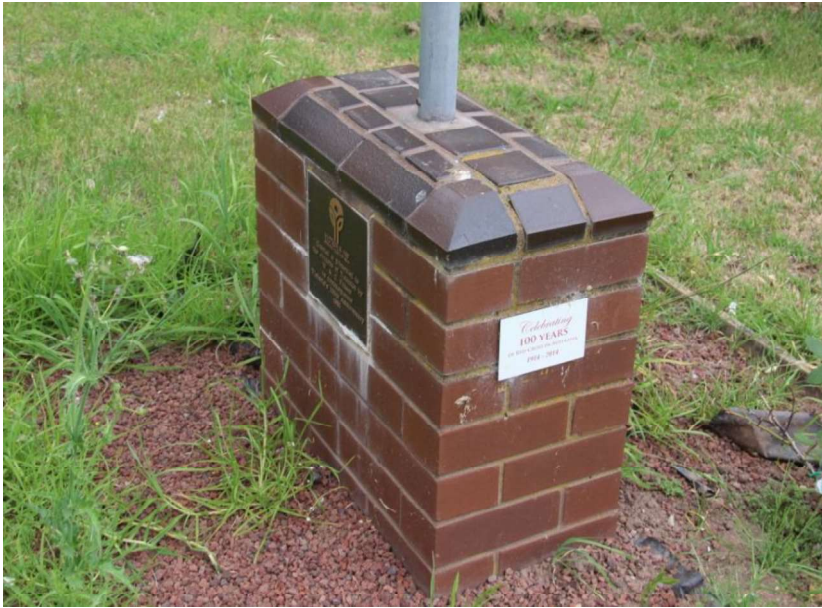
**Figure D7. The base of the flagpole holds two plaques. One states that the flagpole was erected and presented to the citizens of Tinamba by W. & C. Fraser to commemorate Victoria's 150<sup>th</sup> anniversary. A second plaque on the flagpole base reads 'Celebrating 100 years of Red Cross in Australia, 1914-2014'.**

**Figure D7.** The base of the flagpole holds two plaques. One states that the flagpole was erected and presented to the citizens of Tinamba by W. & C. Fraser to commemorate Victoria's 150<sup>th</sup> anniversary in 1985. A second plaque on the flagpole base reads 'Celebrating 100 years of Red Cross in Australia, 1914-2014'.

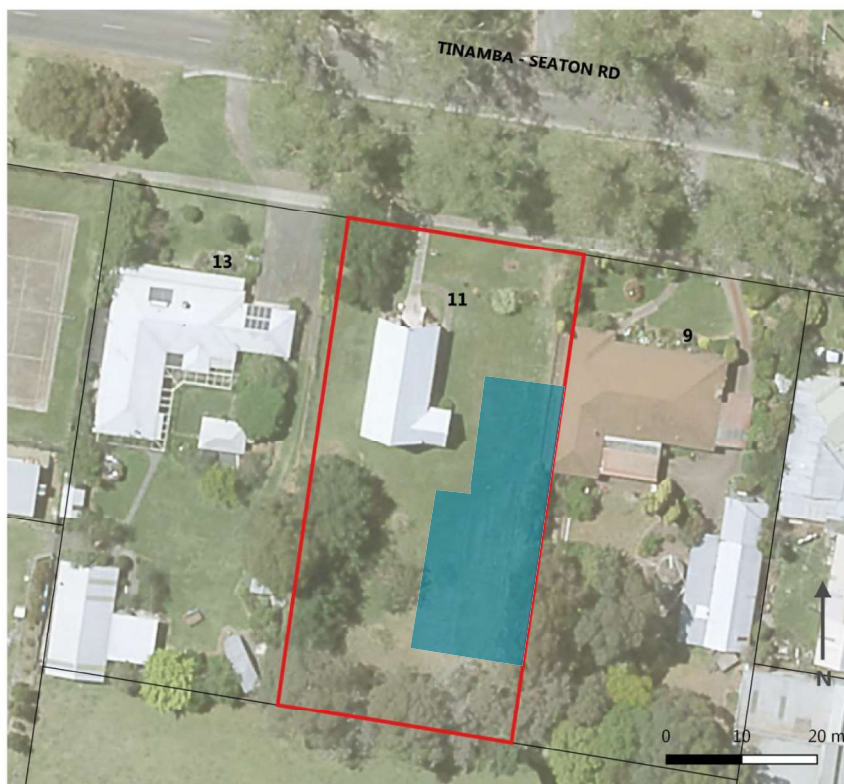
NOTE: The blue shaded area is the preferred location for additions and new development:

- 2.1. New structures should be restricted to the rear of the property, allowing the memorial trees plenty of space to grow, as shown in the blue polygon on the aerial map.
