**Locality:** YARRAM  
**Place address:** 2-4 CHURCH ROAD  
**Citation date** 2016  
**Place type (when built):** Mechanics Institute  
**Recommended heritage protection:** Local government level  
Local Planning Scheme: Yes  
Vic Heritage Register: No  
Heritage Inventory (Archaeological): No

**Place name:** Yarram Mechanics Institute

**Architectural Style:** Victorian Free Classical  
**Designer / Architect:** Not Known  
**Construction Date:** 1885

Project: Wellington Shire Stage 2 Heritage Study  
Client: Wellington Shire Council  
Author: Heritage Intelligence Pty Ltd  
Date: 12/2/16

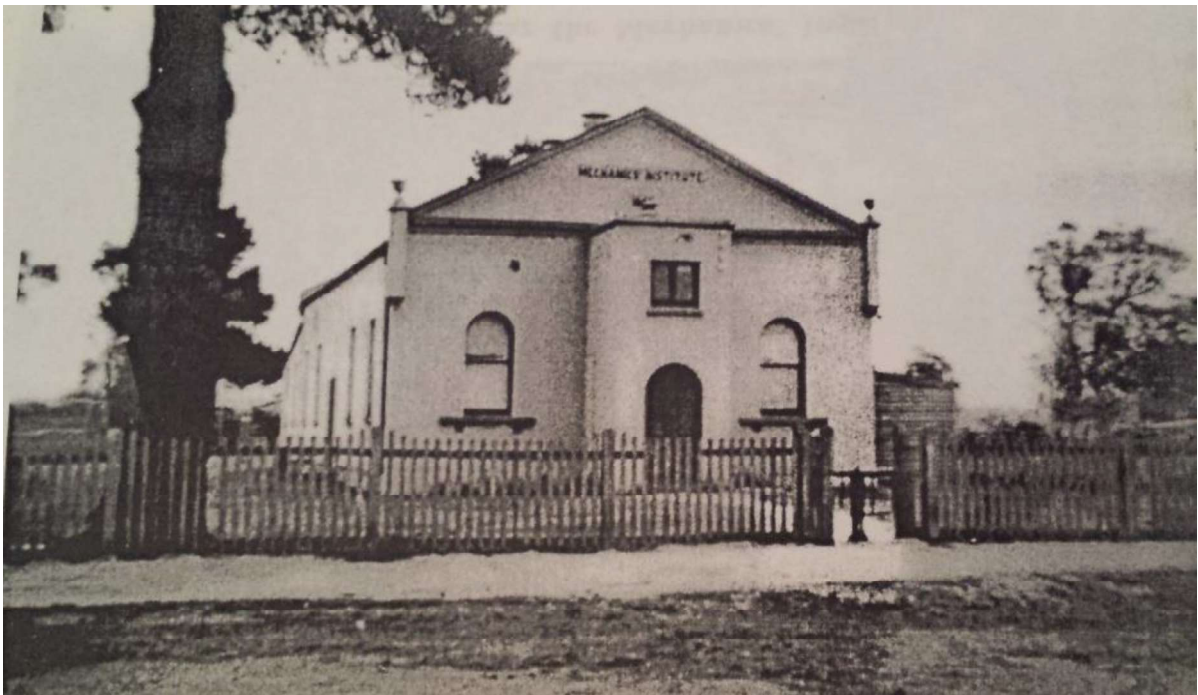
An early photo (date not known) (YDHS) showed the front of the hall from the main street (Figure H1). The original entrance porch could be seen (since removed). It was a projecting porch that reached the height of the gable due to a bio box on top of it, with a round-arched entrance door and small square window above. The pair of short engaged piers with corbelled ends had a small urn at the top of each. The south elevation comprised at least four windows, with a central door, followed by the skillion addition to the rear (with windows). A small timber building could be seen adjacent to the north elevation (may have been attached). The hall was set behind a timber paling fence (on the south-east boundary) with a pedestrian gate in front of the facade (since removed). A mature pine stood inside the fence to the south of the hall) (since removed).

**Figure H1. An early photo (exact date not known) of the hall with its entrance porch on the facade, (Note the porch appears to have been altered at the top, to accommodate a biobox for movies, but the whole structure was removed, filled in, and a new entry placed on the south-east elevation in 1973) (YDHS heritage trail).**

- 4.1. The front porch with a gable roof clad in galvanized corrugated iron (without the biobox on top) and the timber front doors (see Figs H1 and H2.)
- 4.2. Remove the south extension and repair the south elevation.
- 4.3. Roofing, spouting and down pipes
  - 4.3.1. Use galvanised corrugated iron roofing, spouting, down pipes and rain heads.
  - 4.3.2. Don't use Zinalume or Colorbond.
  - 4.3.3. Use Ogee profile spouting, and round diameter down pipes.
- 4.4. Fences and paths
  - 4.4.1. Reconstruct a timber picket fence and gate and path to the front door (see Fig H1).

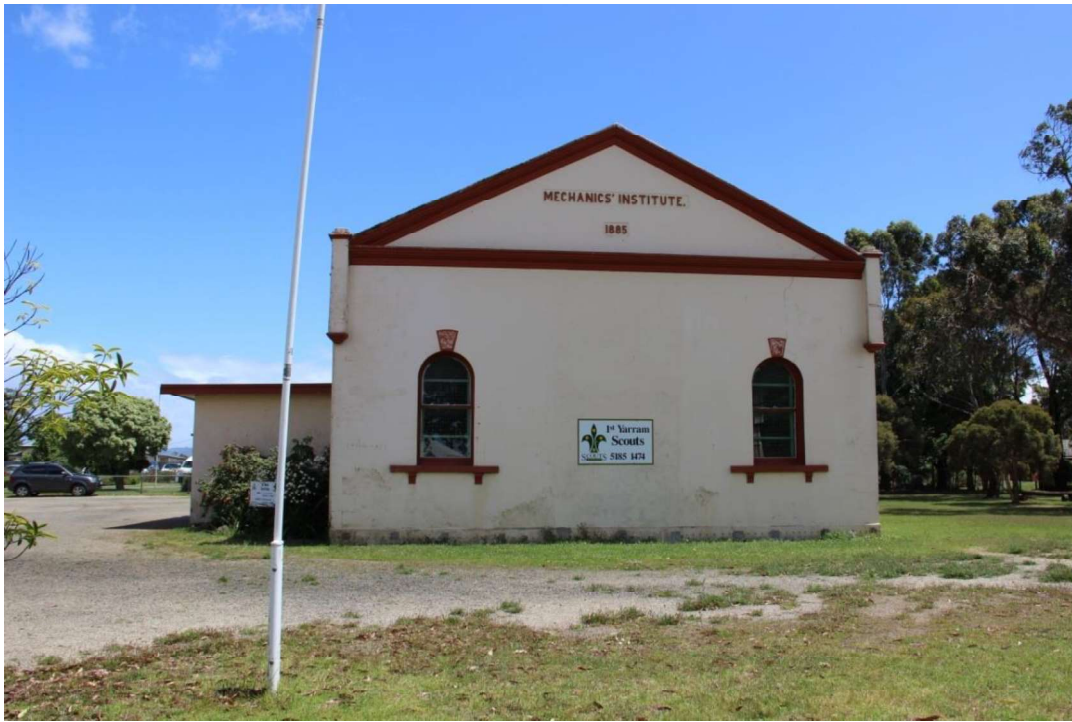
**Figure D1.** The single-storey masonry building was originally rectangular in plan with a gabled roof, with a gabled end to the façade. The roof is clad with corrugated iron and has a long vent to the ridge (Figure D2). The parapeted gabled end to the façade is framed by a bold moulding which creates a pediment effect. The gabled end and entire building is covered with a smooth render (overpainted) and has remnants of incised ruled lines (to create an ashlar effect). The words 'Mechanics' Institute. 1885' are carved in relief in the gabled end. Two short engaged piers with corbelled ends flank the pediment at each end (originally with an urn on each, since removed, see Figure H1). The façade has two semi-circular arched windows with large keystones with a curvilinear detail. The timber sash windows are setback into the wall and have a wide rendered sill with simple brackets. The façade originally had an entrance porch to the centre, which was removed and a new one constructed on the south-west elevation in 1973. A flagpole stands to the south of the hall.

**Figure D1. The facade of the hall which faces the South Gippsland Highway. The bold parapeted gabled-end is framed by a bold moulding, creating a pediment effect. The original front door and porch have been removed.**

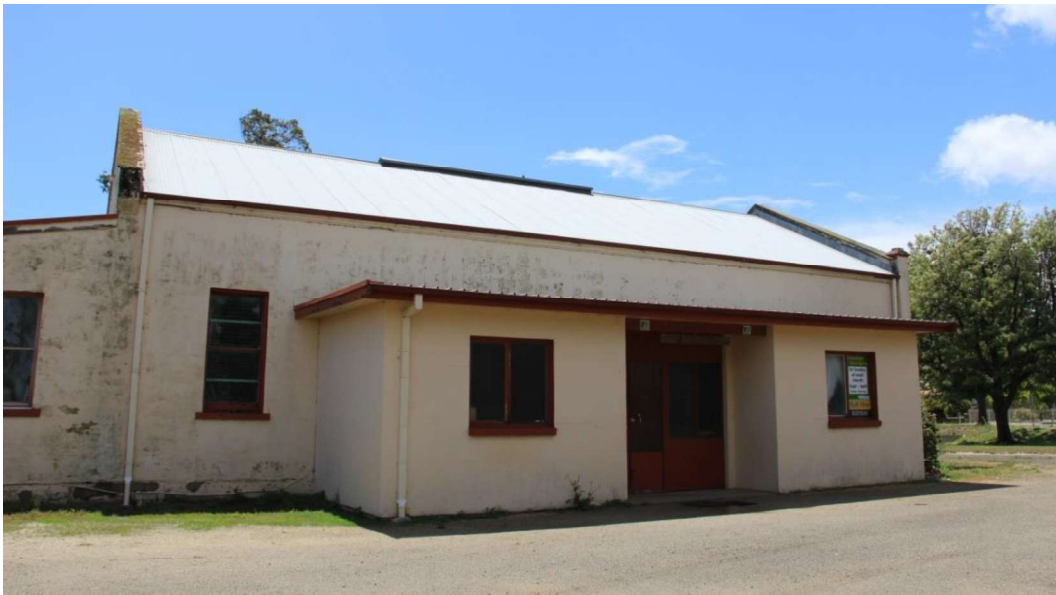
**Figure D2.** The south-west elevation has a single sash window, to the left of the large 1973 entrance porch. It is not known if the original elevation remains on the interior of the addition.

**Figure D2. The south-west elevation with the 1973 entrance porch (not significant).**

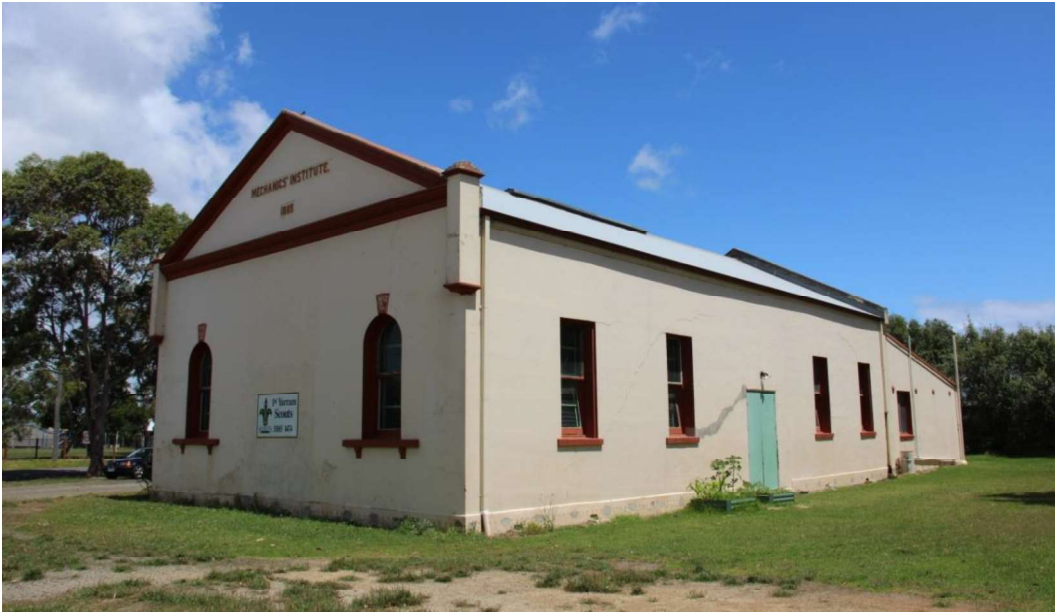
**Figure D3.** The north-east elevation has four timber windows and a central entrance of simple double doors. A skillion-roof section (toilet block) is located to the rear (north-west) elevation and is probably a later construction. (appears in an earlier photo, see Figure H1).

**Figure D3.** The north-east elevation has four timber windows and a central entrance.

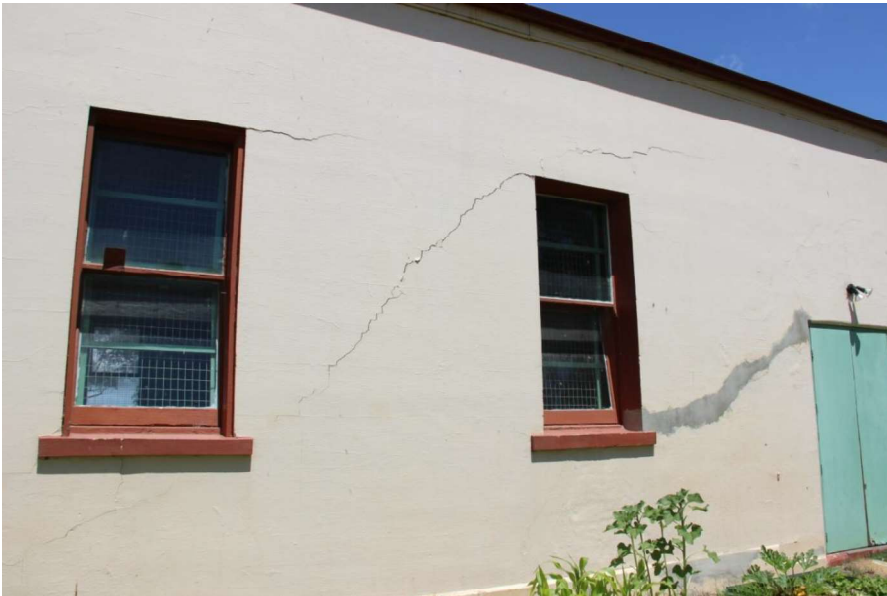
**Figure D4.** The windows to the north-east elevation of the 1885 hall are (later) timber hopper windows with rendered sills. Security grills have been attached to the interior of the windows.

**Figure D4.** A detail of the windows on the north-east elevation, which are (later) timber windows. Note the cement repairs of a large crack.

- 5.1. Mortar. Remove the cement patch repairs in the mortar and render, and repair with lime mortar in the brickwork. Traditional mortar mixes were commonly 1:3 lime:sand.

- 7.8. Remove the dark grey patches on the walls. This is cement mortar which will damage the

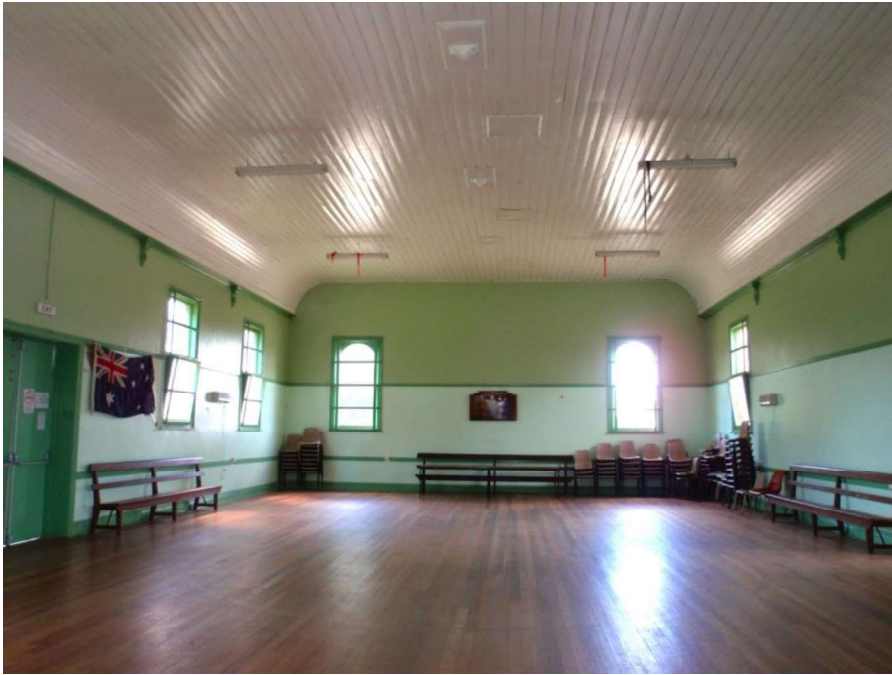
**Figures D5 & D6.** View of the interior looking towards Church Street (where the front entry door has been blocked up). Note the timber panelled coved ceiling and classical consoles.

**Figure D5.** View of the interior looking towards Church Street (where the front entry door has been blocked up). Note the timber panelled coved ceiling, picture rail moulding and classical consoles.

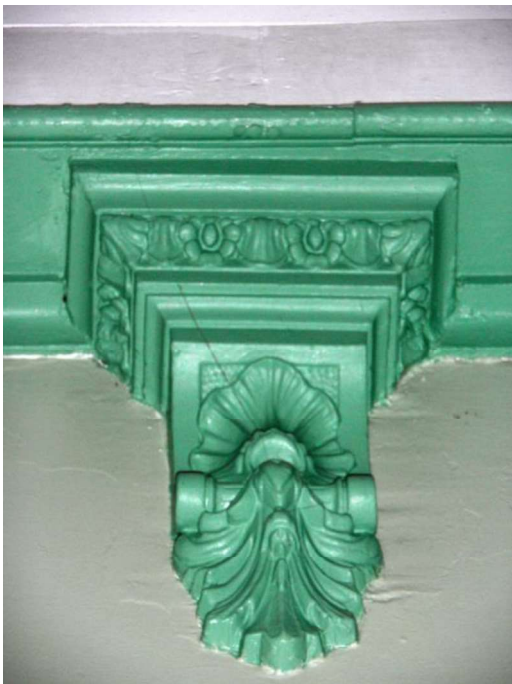
**Figure D6.** Detail of console decoration inside.

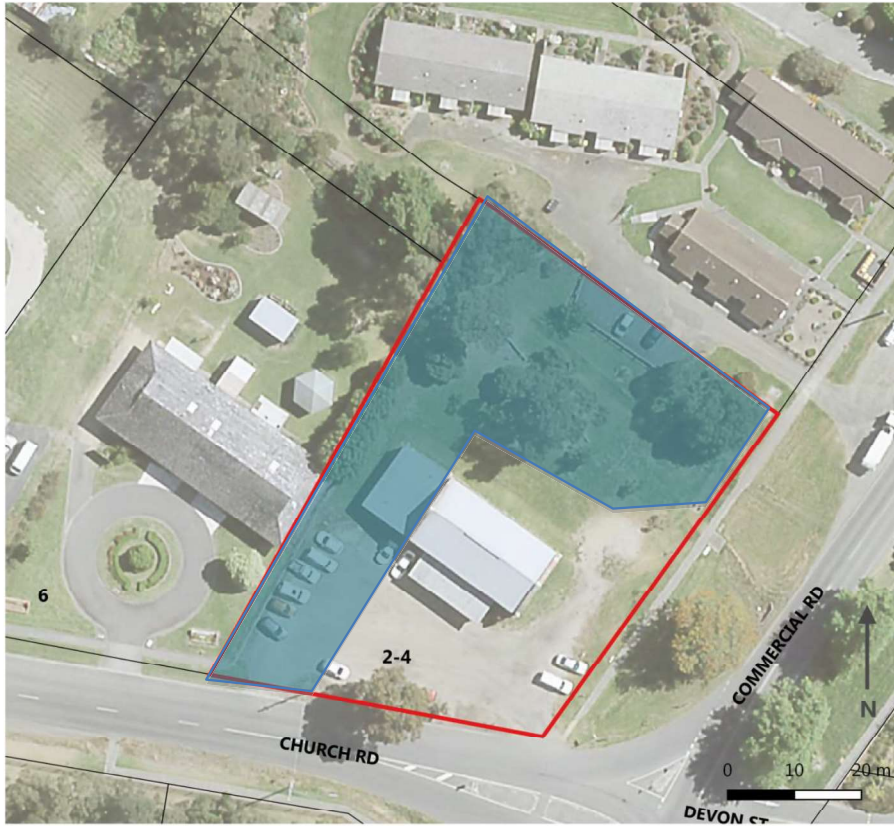
- 2.1. New structures should be set back beyond the two windows closest to the front façade, so that the scale and design of the 1885 building can be appreciated, as shown in the blue polygon on the aerial map below.

NOTE: The blue shaded area is the preferred location for additions and new development:
