**Locality:** YARRAM  
**Place address:** 216 COMMERCIAL ROAD  
**Citation date** 2016  
**Place type (when built):** Post office  
**Recommended heritage protection:** Local government level  
Local Planning Scheme: Yes  
Vic Heritage Register: No  
Heritage Inventory (Archaeological): No

**Place name:** Yarram Post Office

Project: Wellington Shire Stage 2 Heritage Study  
Client: Wellington Shire Council  
Author: Heritage Intelligence Pty Ltd  
Date: 12/2/16

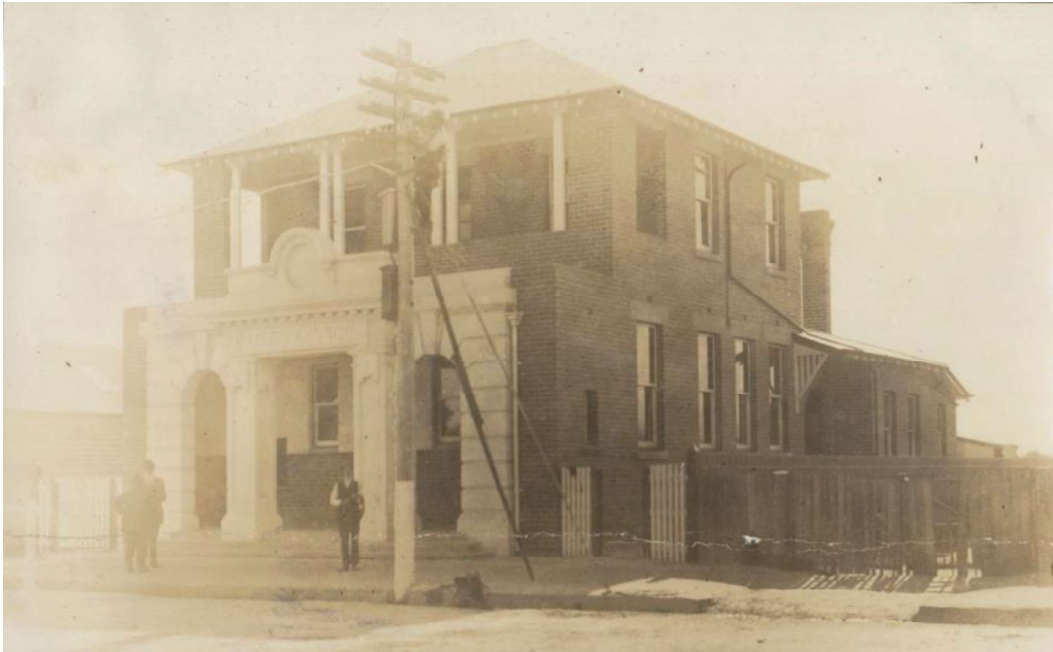
Photos dating between 1917 and 1930 (SLV; NAA) showed the facade and side elevations of the recently constructed post office, and the single-storey residence to the rear (Figures H1 & H2). The facade comprised the entrance porch, without the clock or any attached names or insignia at this date. The interior of the porch was brick with decorative render to the top portion (as remains in 2015) with a central door flanked by a pair of sash windows (since altered; one sash window remains). At each end of the porch was a small window/opening (since altered at the north end). The first floor was an open recessed balcony, supported by single and pairs of slender classical columns (later in-filled). At this date the two-storey portion of the building was three openings deep (at the first floor; extended in the 1950s), while the ground floor residence extended beyond this. The residential entrance was visible on the north elevation (this may remain in 2015), entering the single-storey portion of the building, which had a tall chimney. The residence also had wide eaves with exposed rafter ends. A timber picket fence marked the east boundary, either side of the post office.

**Figure H1. Photo of the post office dating between 1917-1930. The clock had not been installed and the first floor retained its recessed balcony supported on elegant classical columns. The single storey residential residence is visible on the side elevation (SLV).**

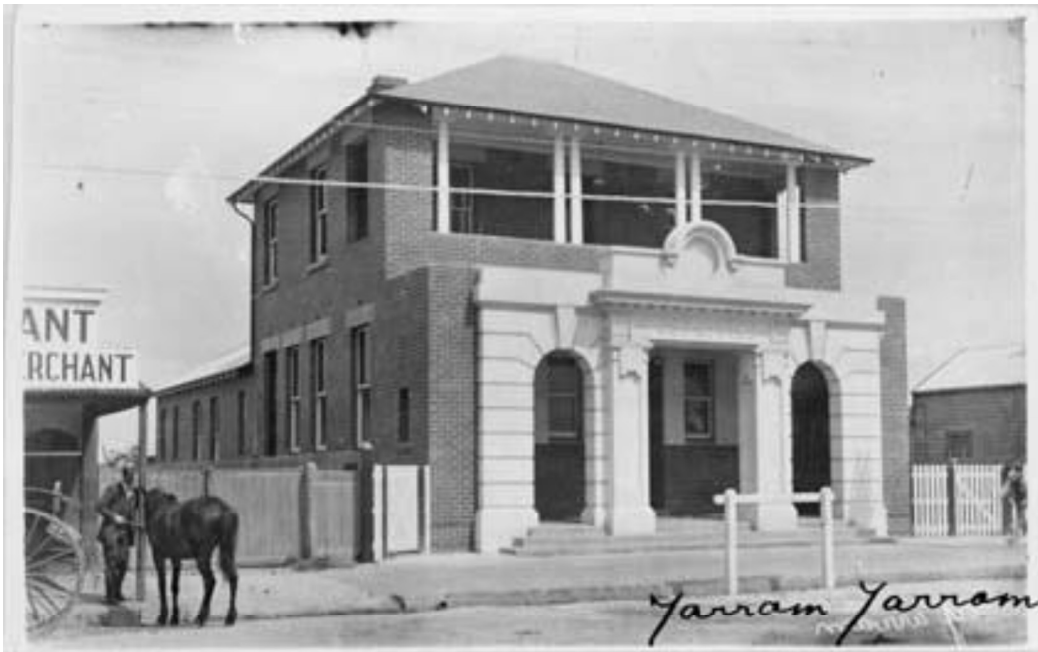
Figure H2. The post office between 1917-1930 in its original unpainted state. The first floor was only three rooms deep (later extended) (NAA).

- 3.4.1. The front façade of the first floor balustrade and classical columns (Fig H2) (perhaps with glass panels across the façade fixed behind the columns enabling the space to remain an internal room.

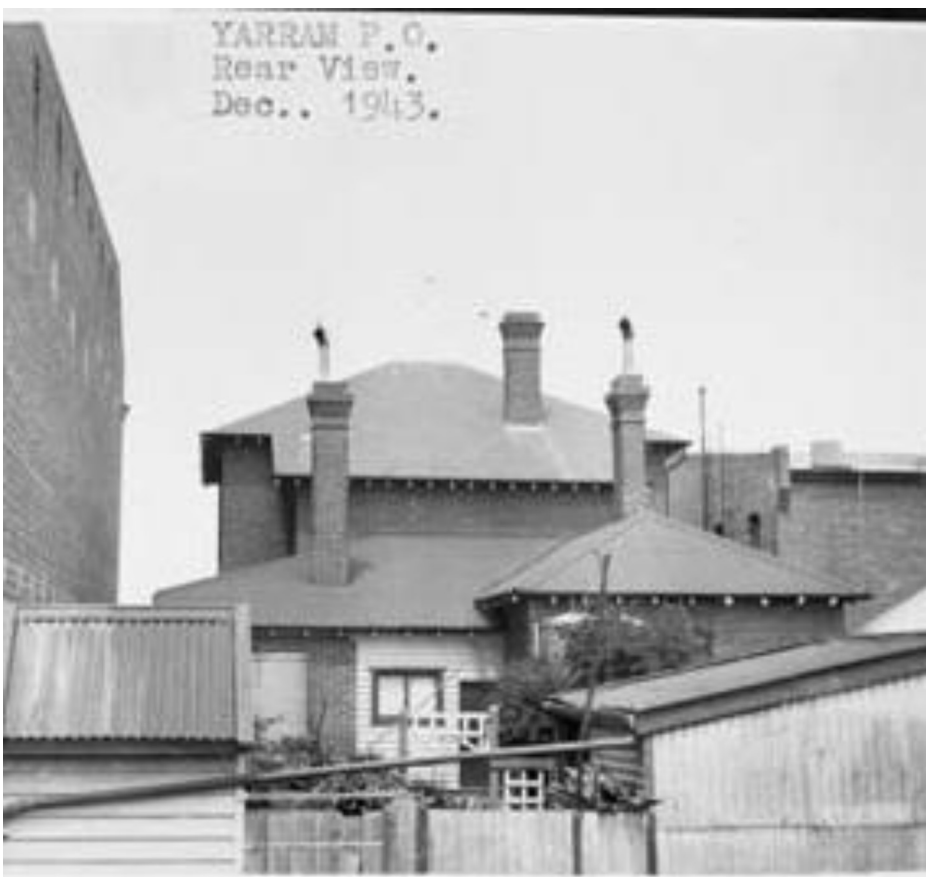
A photo dating to 1943 (NAA) showed the rear elevation of the post office (Figure H3). The two-storey portion was followed by the single-storey portion of the building which had a slate roof and

two tall brick chimneys and a projecting hipped roof bay. A back garden and outbuildings were visible at this date.

Figure H3. The original rear elevation of the post office in 1943, prior to the extension of the first-floor in the 1950s (NAA).

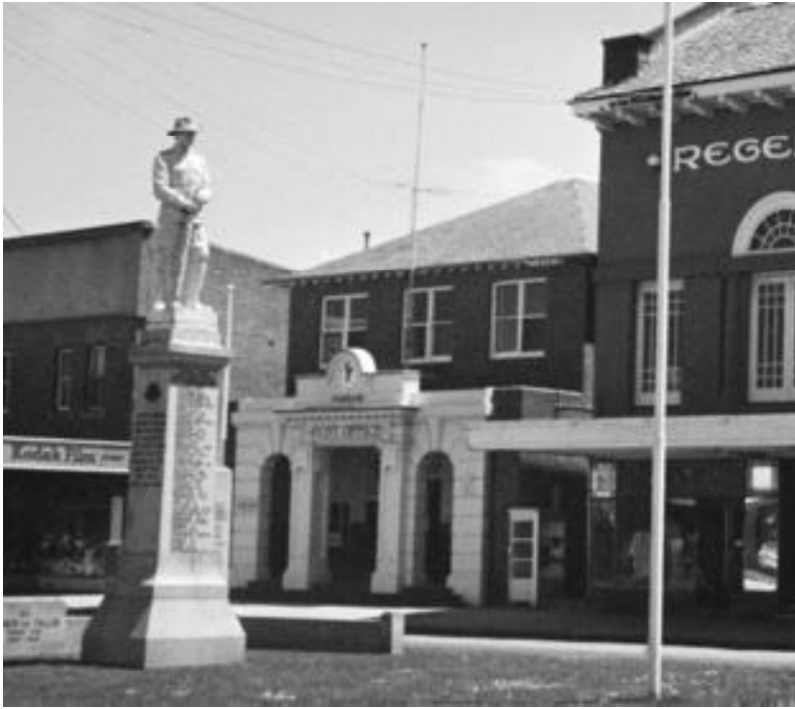
A photo dating to c1969 (SLV) showed that the clock and post office name had been installed on the entrance porch (Figure H4). The recessed balcony to the first floor was also in-filled with three windows by this date.

**Figure H4. The post office in c1969. The first floor balcony had been in-filled by this date. The clock and name had been installed on the entrance porch (SLV).**

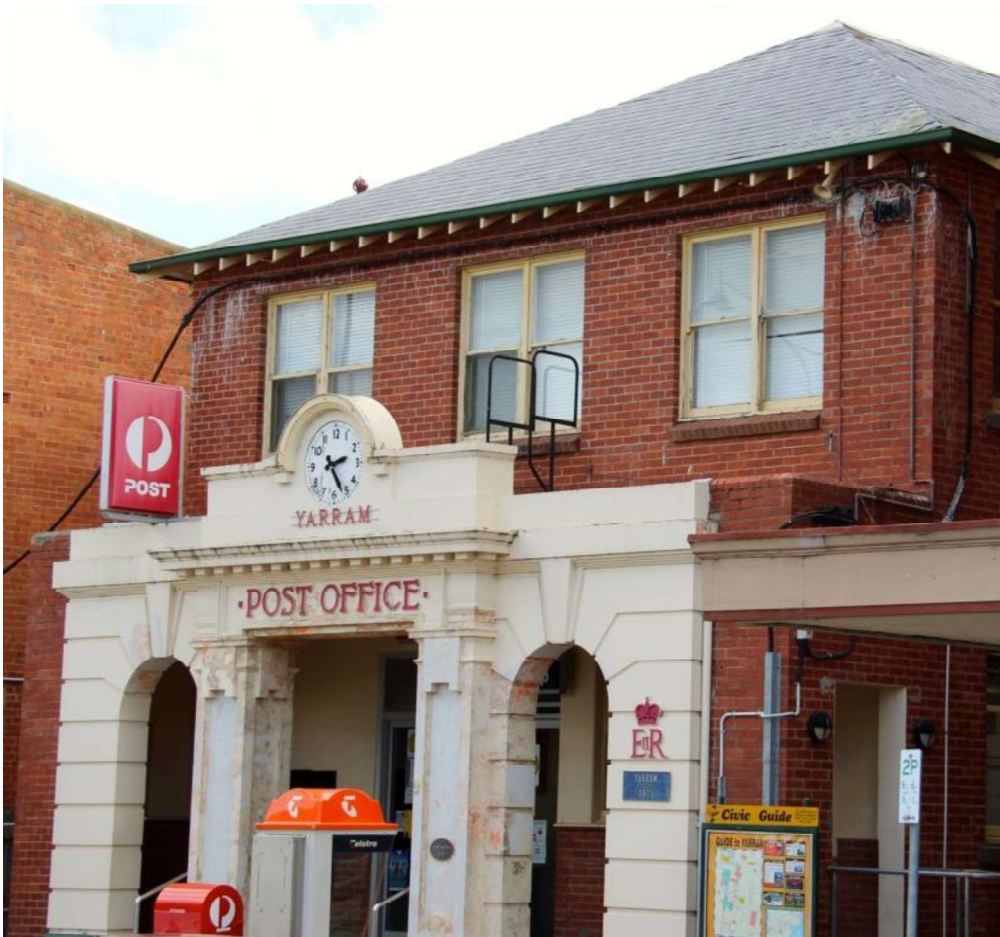
**Figure D1.** The post office is a two-storey red brick building with a hipped roof clad in slate and wide eaves with exposed rafter ends, which reflects an Arts and Crafts influence. The dominating Palladian-inspired portico is finished in Medusa-white Portland cement (overpainted) entered via 4 wide bluestone steps, with its refined banded rustication, arched openings with large keystones either side of the central large opening supported by classical stylised pilasters and capitals, entablature, projecting cornice with dentils, surmounted by a parapet with round arched centre, encompassing the clock. The interior of the portico has brick to the dado level with decorative render to the top portion.

The most important part of the building, the ground floor façade of the 1913 post office building has very high integrity and is in good condition (although the recent paint on the portico is in poor condition) and overall, the building retains a medium level of integrity.

Figure D1. The post office with its hipped roof clad with slate and wide eaves with exposed rafter ends, and the rendered Palladian-inspired Classical portico dominating the facade. The first floor balcony was in-filled with windows by c1969.

3. Reconstruction and Restoration
  - 3.1. The rendered lintels, and entry porch have been painted, and this is in poor condition and has remnants of other colours possibly graffiti, however, these architectural features were not designed to be painted. They were a light coloured unpainted render and in this case it was Medusa-white Portland cement. It is strongly recommended that the paint be removed chemically ( never sand, water or soda blast the building as this will permanently damage the bricks, mortar and render and never seal the bricks or render as that will create perpetual damp problems.) Removal of the paint will not only restore the architecture, but it will remove the ongoing costs of repainting it every 10 or so years. The cost of removing any future graffiti will be the same whether it is on paint, brick or render. However, if it is decided to repaint the render, it should be one colour only, ( do not paint the base a different colour) and closely resemble the colour of Medusa white Portland cement.

- 4.2. The slate roof is now a rare feature in Yarram, and should be maintained to avoid future expensive repairs. The roof has not been inspected but it is evident from Commercial Road, that lichen is growing on parts of it ( this is not doing any harm and is better left untouched), however, the roof has a bow in it on the north side near the ridge lines and if left unrepaired, will require very expensive works, especially if the slates crack and water enters the building.

- 4.3. The timber windows are in urgent need of repainting.
  - 4.4. If there is damp in the walls, or the timber floor is failing, it is imperative that the drainage is fixed first. This may involve the lowering of the ground outside so that it is lower than the ground inside under the floor, installation of agricultural drains, running the downpipes into drainage inspection pits instead of straight into the ground. The reason for the pits is that a blocked drain will not be noticed until so much water has seeped in and around the base of the building and damage commenced (which may take weeks or months to be visible), whereas, the pit will immediately fill with water and the problem can be fixed before the floor rots or the mortar falls out, the bricks start to crumble, and the building smells musty.

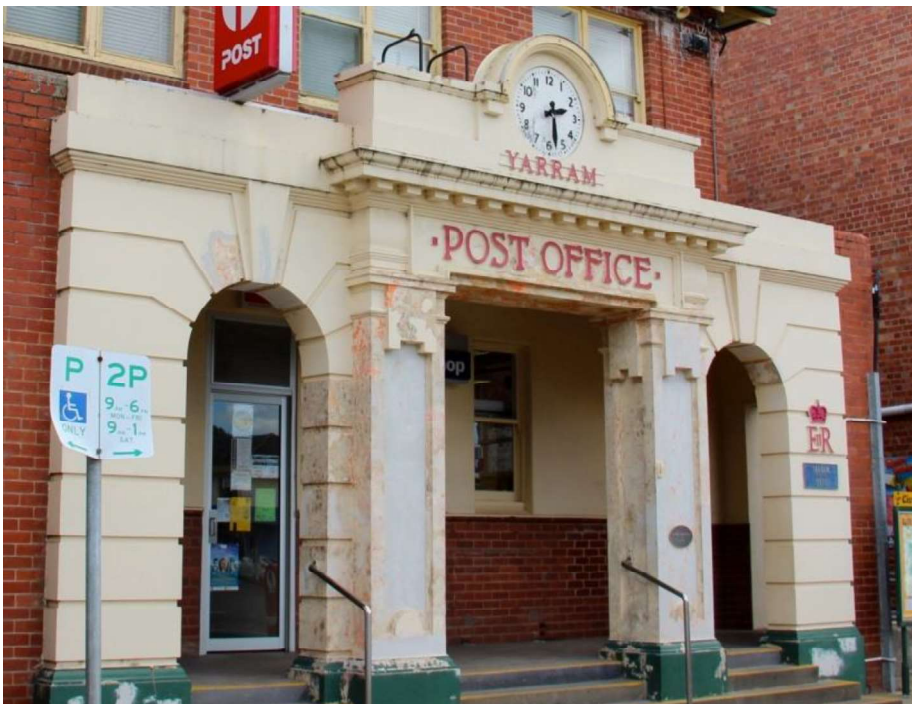
**Figure D2.** The interior of the portico is brick to the dado level with decorative render to the top portion. One-over-one timber sash windows remain, while the entrance doors have been replaced with modern metal-framed doors. Modern signs have been attached above the entrance door.

Figure D2. A detail of the rendered Palladian-inspired Classical portico with the clock and name.

- 3.2. The render inside the porch appears to have damage from damp, indicated by black algae. If the damp is still active the source of the damp must first be solved, then the algae treated.

- 3.3. It is recommended that a heritage specialist industrial cleaner be engaged to do this and remove the paint (including the orange coloured substance) chemically from all the rendered surfaces. The former bank at Rosedale was recently cleaned of paint by this method.

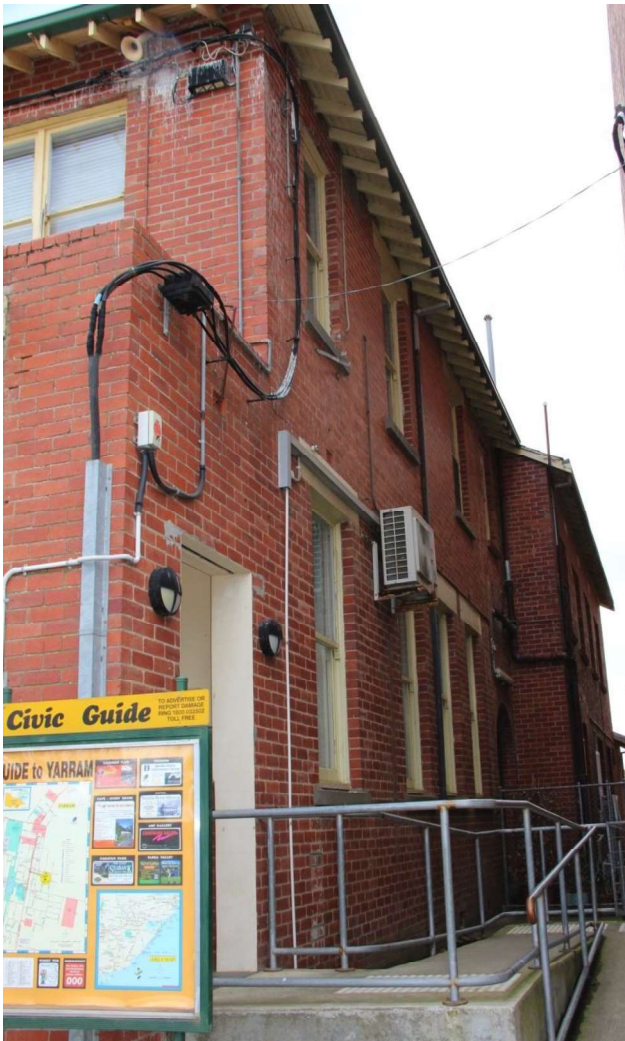
**Figure D3.** The original 1913 extent of the north elevation has single one-over-one double-hung sash windows with bluestone sills and (overpainted) rendered lintels (except for the most eastern window of the first floor, on both elevations, which was originally an opening to the balcony; see Figures H1 & 2). The original extent of the first floor (before the first floor was extended 9 metres in the late 1950s) is evident on the north elevation by the wide eaves with the exposed rafter ends. The original extent of the first-floor is also indicated by the colour of the roof cladding, as seen in the aerial map. The 1913 entrance to the residential portion of the building appears to remain behind an arched entrance. A concrete access ramp with metal balustrade, has been constructed to an opening created to the entrance porch (originally a wall with a small window).

**Figure D3. The north elevation. The 1913 section of the first-floor has the wide eaves and exposed rafter ends. To the rear of this is the 1950s first-floor addition, built on top of the 1913 single-storey residence.**

- 2.1. A concrete ramp has been installed on the north side of the building, forming a new entry. Fortunately it has been installed so that the ramp does not obstruct good airflow under the floor which will allow the wall structure to evaporate moisture and reduce termite and rot attack to the subfloor structure and damp in the brick walls. Ensure water drains away from the subfloor vents, and walls and the gap between the wall and the ramp remains clear of debris. Insert additional sub floor vents if the ramp has blocked any of them.

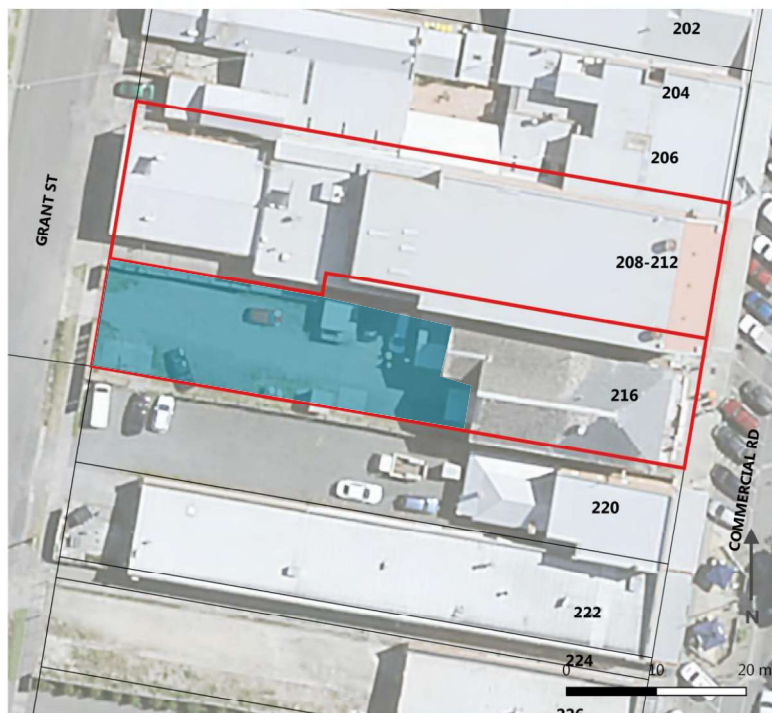
NOTE The blue shaded area is the preferred location for additions and new development

- 1.3. New structures should be restricted to the rear of the property and concealed behind the heritage fabric when viewed from Commercial Road.
2. Accessibility
