Locality: YARRAM
Place address: 287 COMMERCIAL ROAD
Citation date 2016
Place type (when built): Hotel
Recommended heritage protection: Local government level
Local Planning Scheme: Yes
Vic Heritage Register: No
Heritage Inventory (Archaeological): No

Place name: Yarram Club Hotel

Project: Wellington Shire Stage 2 Heritage Study
Client: Wellington Shire Council
Author: Heritage Intelligence Pty Ltd
Date: 12/2/16

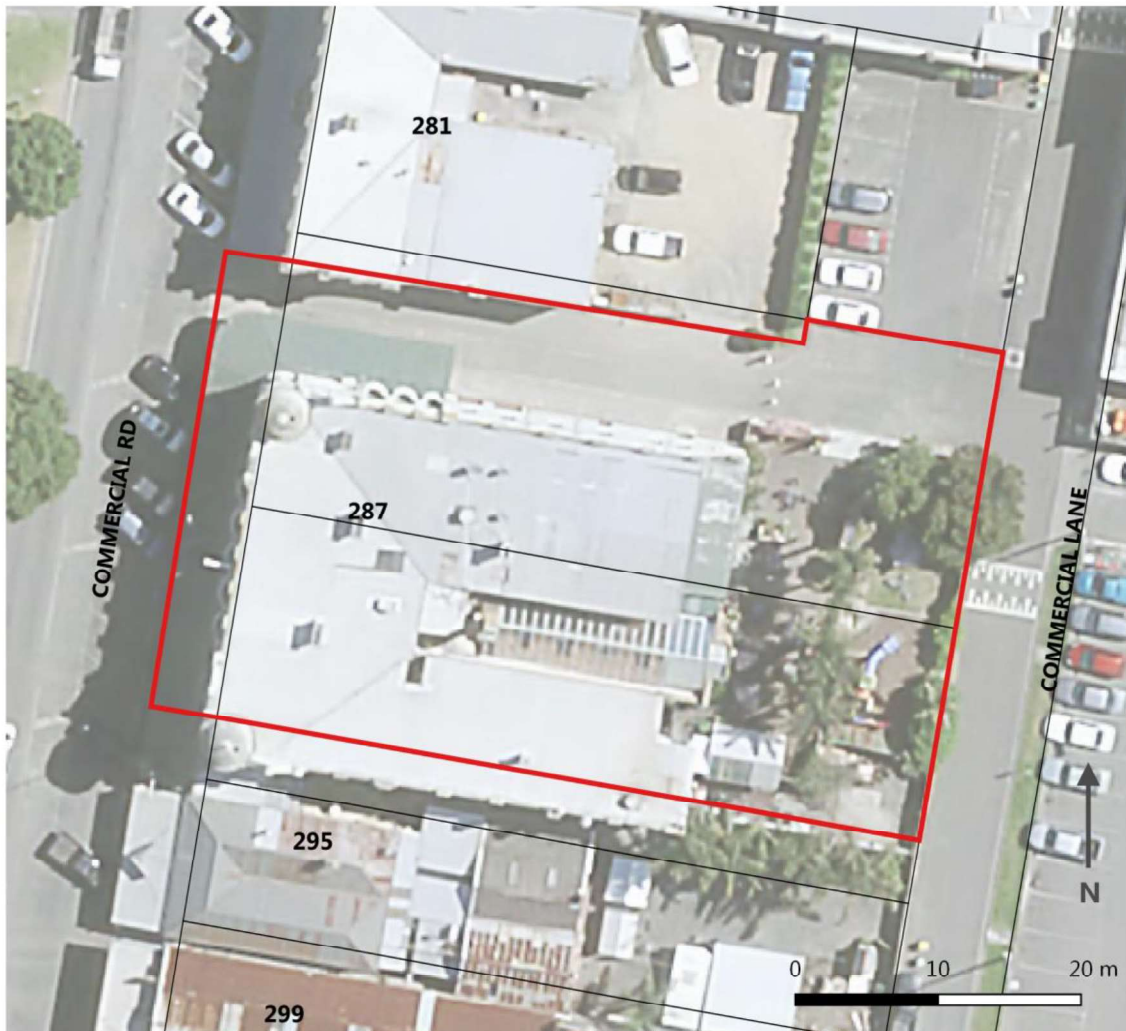
Map of recommended boundary for Heritage Overlay

Note: The aerial photo has a slight error in its position and is not a true depiction of the location of the building. The building is known to sit within the southern title boundary and is recommended to be covered in its entirety with a Heritage Overlay.

- Recommended for Heritage Overlay
- Title boundary

This place is recommended for inclusion in the Schedule to the Heritage Overlay of the Wellington Shire Planning Scheme to the boundaries as shown on the map.

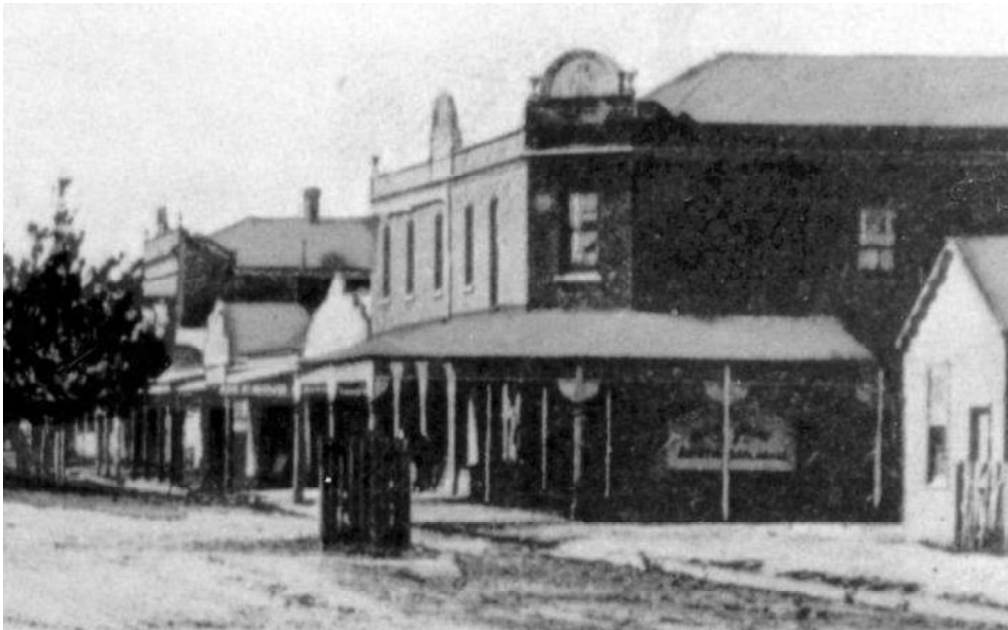
Figure H1. The first Yarram Club Hotel, to the north of the James Buckley's Federal Coffee Palace on the corner of James Street, in the foreground. The first Yarram Club Hotel was a single-storey building two lots up from the Federal Coffee Palace (Stone n.d.:20).

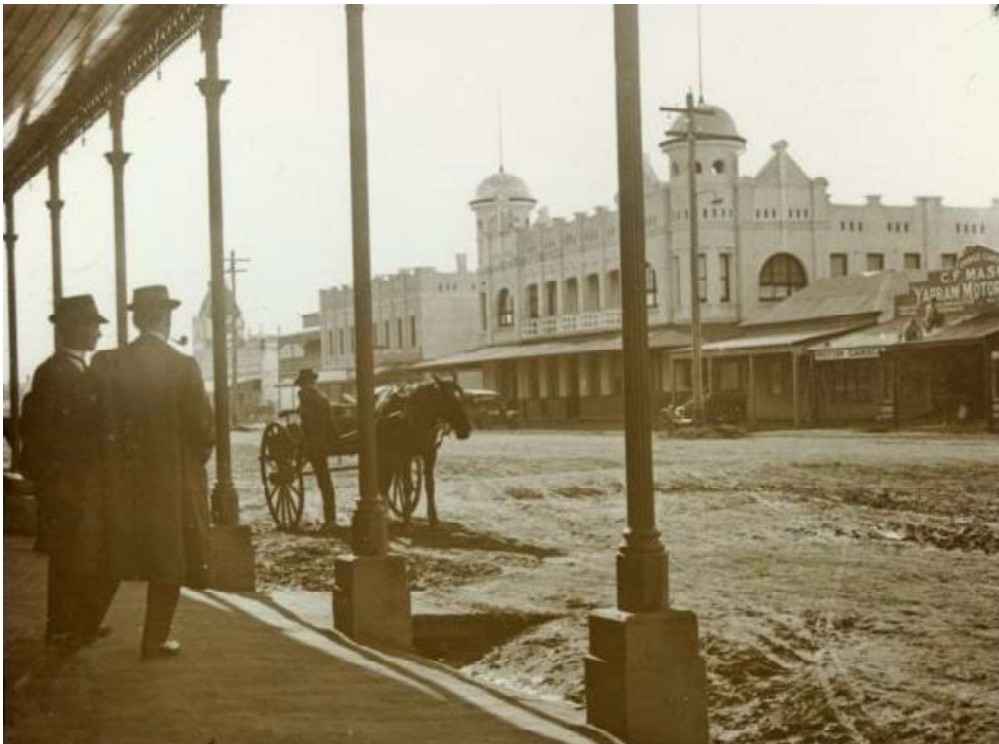
Figure H2. This 1914 photo showed the facade and south elevation of the Yarram Club Hotel at a distance, soon after it was completed. The two-storey facade with its parapets, pediments, corner towers, recessed balcony to the first floor, and return cantilevered verandah appeared as they do in 2015, although one flag pole is missing and the application of light and dark colours is different. (SLV Id no. H92.150/354):

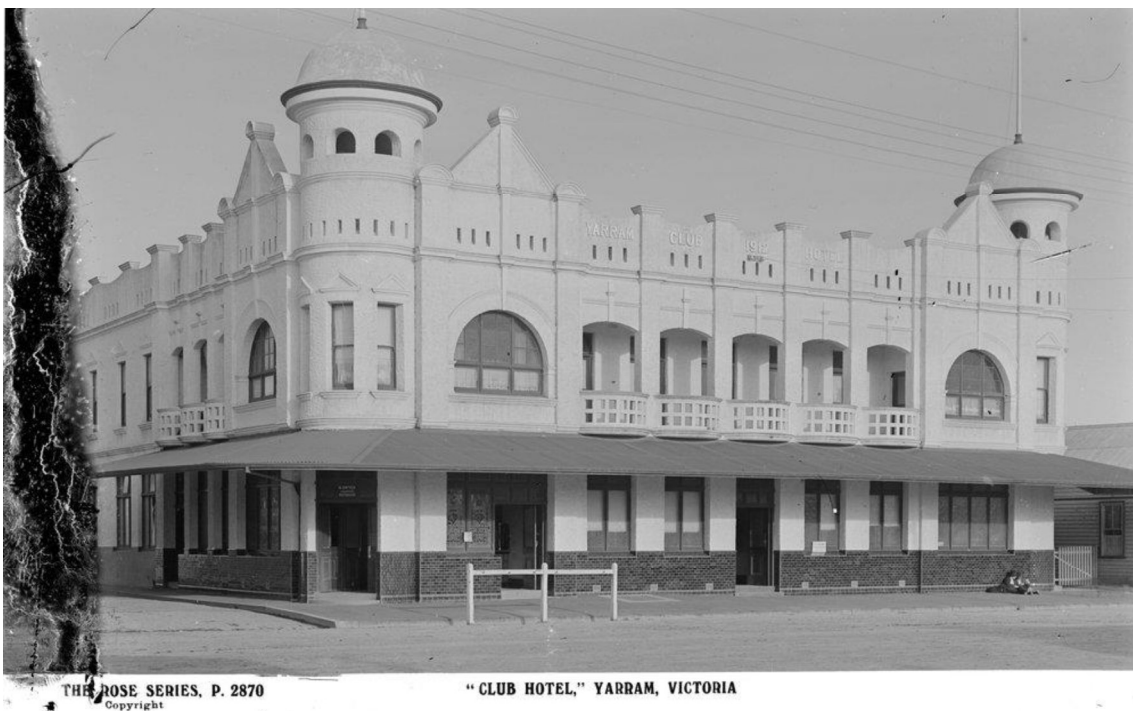
A photo dating between c1920 and c1954 (Figure H3) showed the facade and north elevation of the Yarram Club Hotel in clear detail (SLV). The building above the wide cantilevered verandah appeared as it does in 2015. At ground level, there was an entrance at the north end (next to the corner entrance) that has since been closed, otherwise the openings were the same as those that remain in 2015.

Figure H3. This photo dating between c1920 and c1954 showed the facade and north elevation of the Yarram Club Hotel in clear detail. The building above the verandah appeared as it does in 2015, although the colour application of light and dark is different. At ground level, there was an entrance at the north end (south of the corner entrance) that has since been closed, otherwise the openings were the same as those that remain in 2015 (SLV, H32492/4104).

- 5.2.1. It is recommended to paint the exterior of the building using original colours (paint scrapes may reveal the colours) to enhance the historic architecture and character. Refer to Fig H3 for guidance.

- 5.2.4. However, if it is decided to repaint the stucco, it should closely resemble the light and dark application seen in Fig H3.
- 5.3. Remove any dark grey patches to the mortar joints - this is cement mortar which will damage the bricks, as noted above, and reduce the longevity of the walls. Repoint those joints with lime mortar. The mortar is not the problem it is the messenger, alerting you to a damp problem (also see Water Damage and Damp)

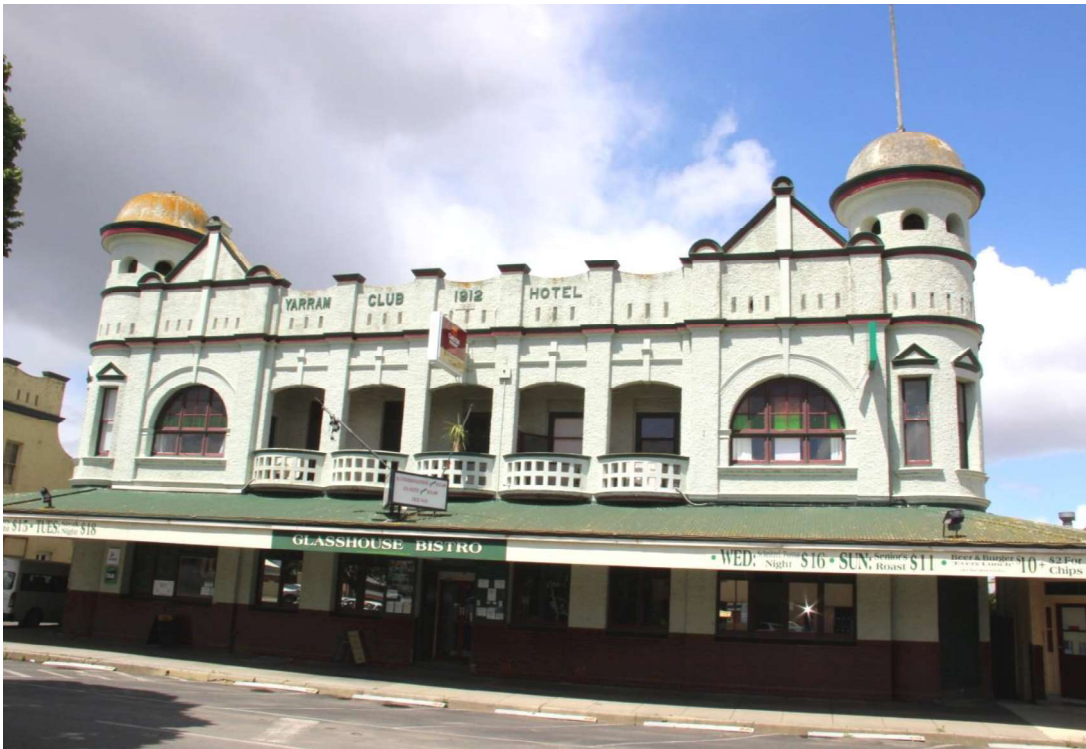
Figure D1 & Aerial. The substantial two-storey building has three main elaborate elevations with Classical details and prominent corner towers, and is highly visible throughout the town. The large skillion roofs slope towards a central, open courtyard (now built over with glass roof) and they are clad in corrugated iron and concealed behind the parapet. The walls are constructed of brick with roughcast render to the exterior (overpainted). The symmetrical facade has picturesque skyline created by a tall parapet with small pediments at the ends, before large round towers are imbedded in the corners to terminate each end of the facade. The round towers have domed roofs encircled by deeply projecting cornices, (the southern dome retains a flag pole but the one on the northern dome is missing). The round towers, at first floor level, have one-over-one timber sash windows with a moulding above that forms an abstracted Classical pediment.

The first floor has engaged pilasters which extend onto the parapet and stop above the parapet with a small capital. The parapet conceals the skillion roof form and undulates between these pilasters, with groups of three small openings to each bay. These groups of small rectangular openings repeat below the pediments and across the towers. The parapet reads 'YARRAM CLUB 1912 HOTEL' in relief.

At the centre of the facade there are five segmental-arch openings to a recessed balcony, each with a projecting round balcony with sharply articulated holes in a 'latticework' pattern. Either side are Diocletian windows with timber-framed windows, some with coloured (green and red) glass. Above the Diocletian windows are round-arched mouldings, with a thin narrow vertical moulding that reflects a keystone.

Figure D1. The substantial two-storey building has three main elaborate elevations with Classical details and prominent corner towers, and is highly visible throughout the town.

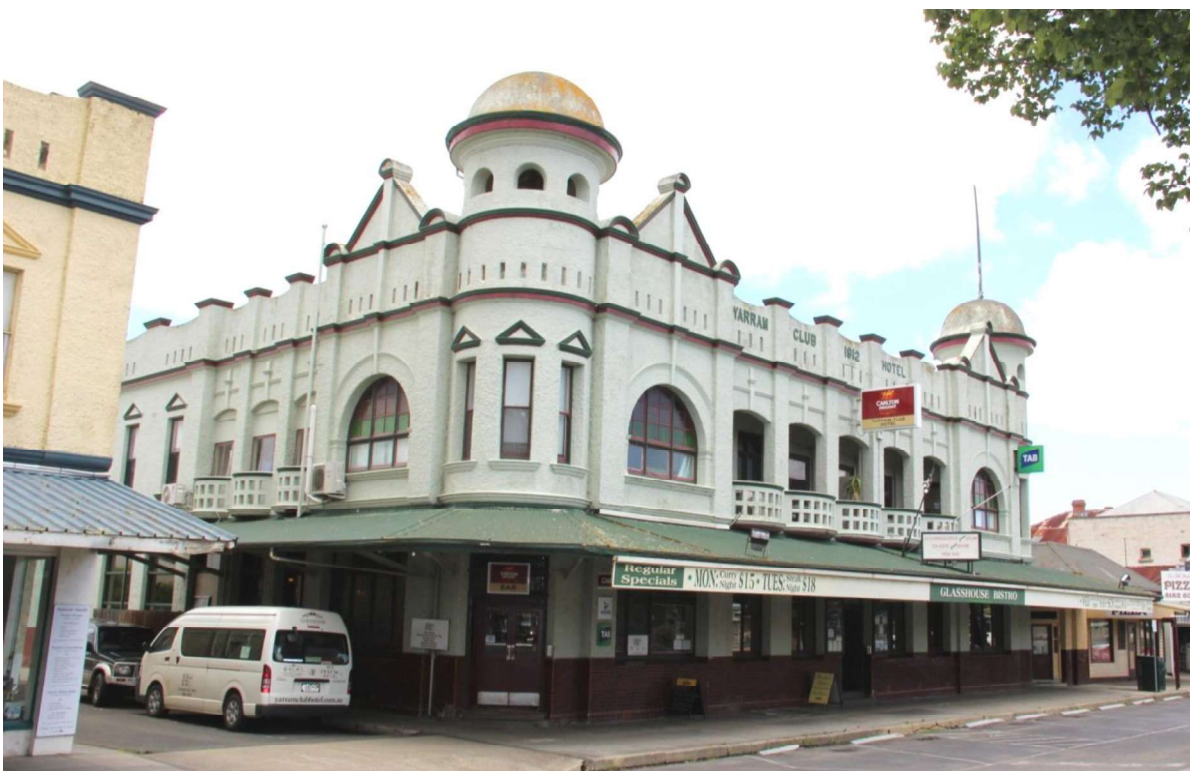
Figure D2. The form and detail to the facade is repeated on the side elevations, including the parapet and pediments, Diocletian windows and the balconies to openings.

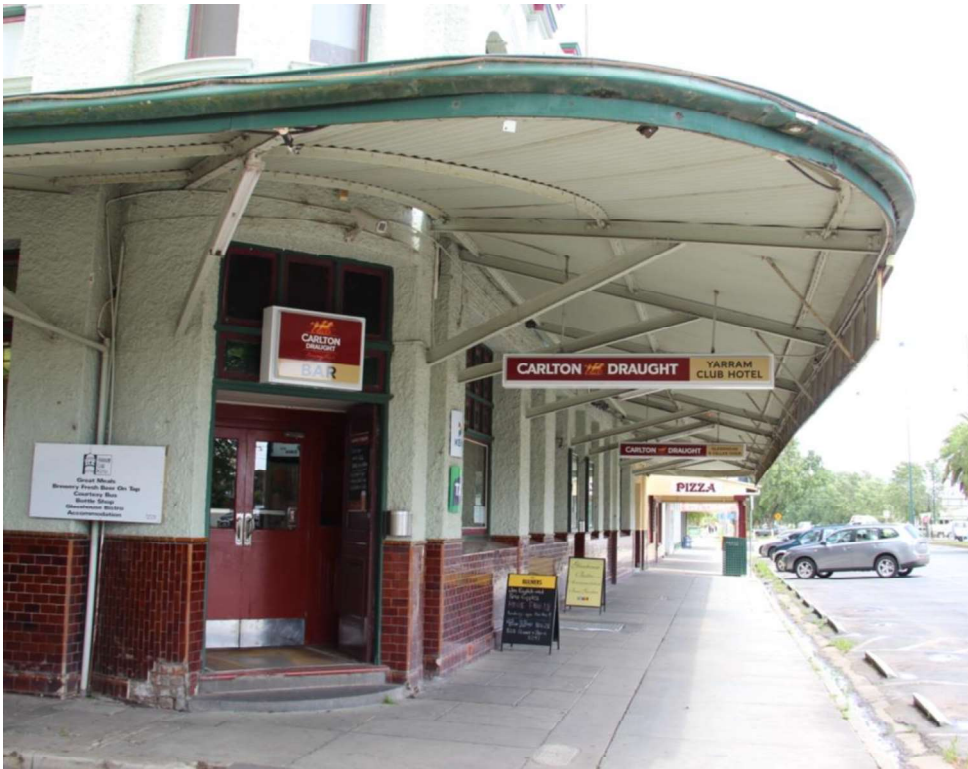
Figure D3. The wide cantilevered verandah runs across the facade and returns on part of the north elevation, with large rounded corners. It has corrugated iron cladding (overpainted) to the roof and retains the original metal support structure underneath. The ground floor has glazed brown tiles to the dado level with roughcast render to the top 2/3 of the wall (overpainted).

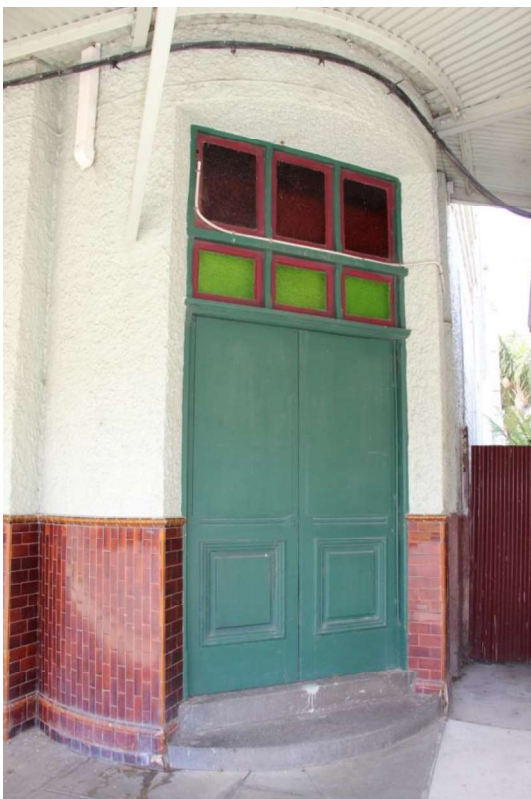
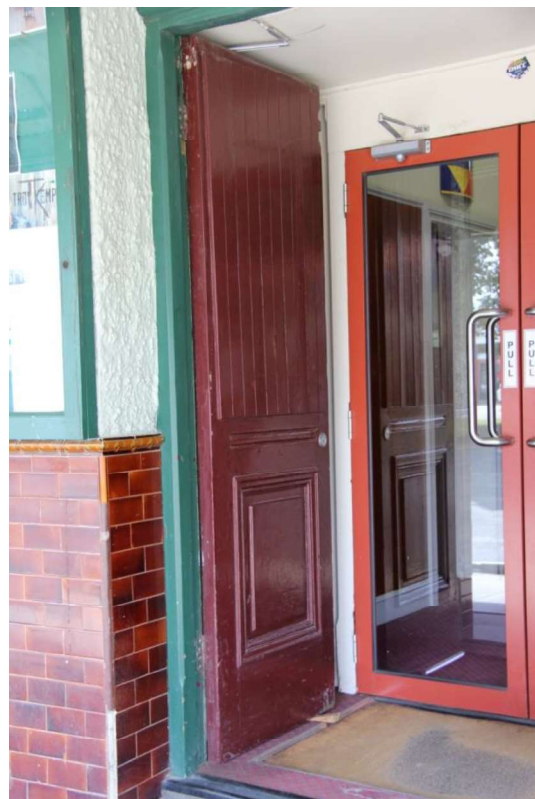
Figure D4. There are three entrances at the ground floor to the facade; two corner, angled entrances (at the base of the towers), and a third at the centre of the facade. Each entrance has an alcove (the corner entrances have timber-lined roofs), entered by original timber panelled doors (that have had the top panel of glazing covered over). Above the corner entrances are large groups of timber square windows with coloured glass. The central entrance has a highlight (with modern glass).

Figure D4. The southern entrance (left) at the base of the tower, and the central entrance to the facade (right). Both have the original timber panelled doors (that have had the top panel of glazing covered over).

- 6.4.2. The original external timber doors and windows require careful repair and painting.

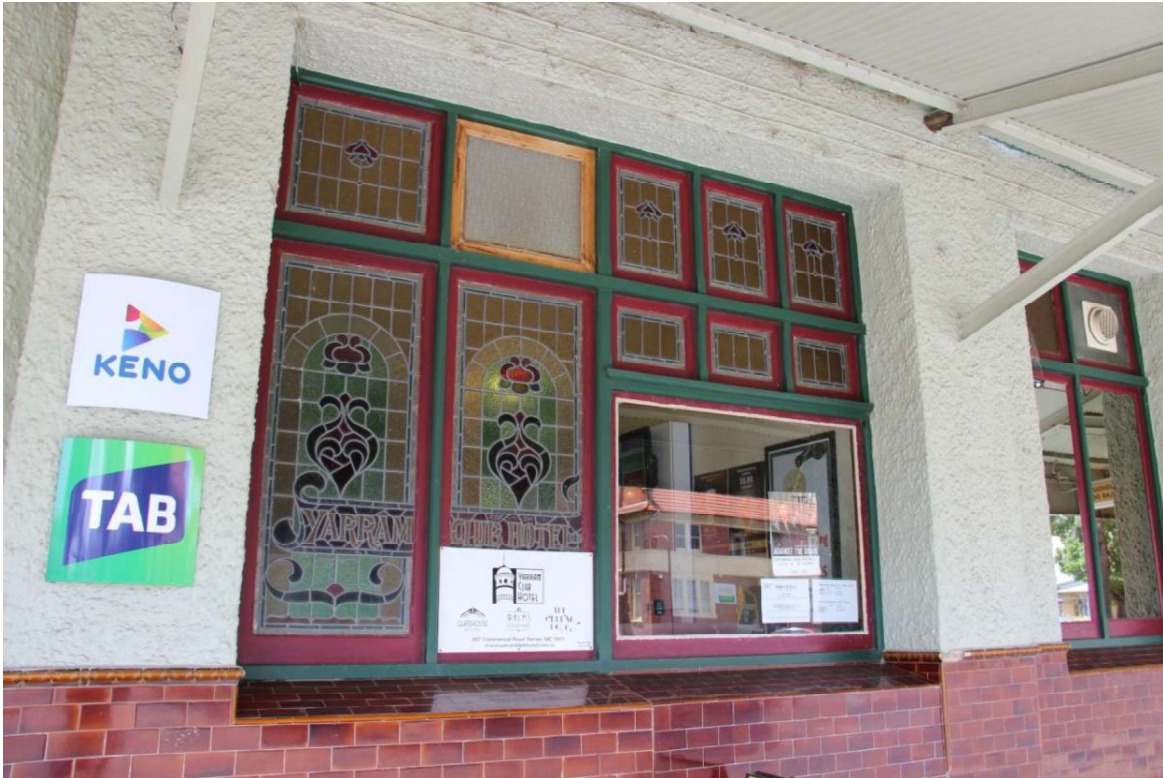
Figure D5. The ground floor (facade and north elevation) has large groups of windows, comprising combinations of timber casement windows and highlights, with clear glass (most with a modern reflective screen) or coloured leadlight. Many of the windows retain coloured geometric and pictorial leadlight, reflecting an Art Nouveau influence. Figure D5 shows the window group to the south (right) of the northern corner entrance. This is the only altered opening to the facade, as it originally had an entrance door in the right half (since closed over sympathetically). The leadlight to this window contains the words 'YARRAM CLUB HOTEL'.

Figure D5. This photo shows the leadlight window group to the south (right) of the northern corner entrance. This is the only altered opening to the facade, as it originally had an entrance door in the right half (since closed over sympathetically). The leadlight to this window contains the words 'YARRAM CLUB HOTEL'.

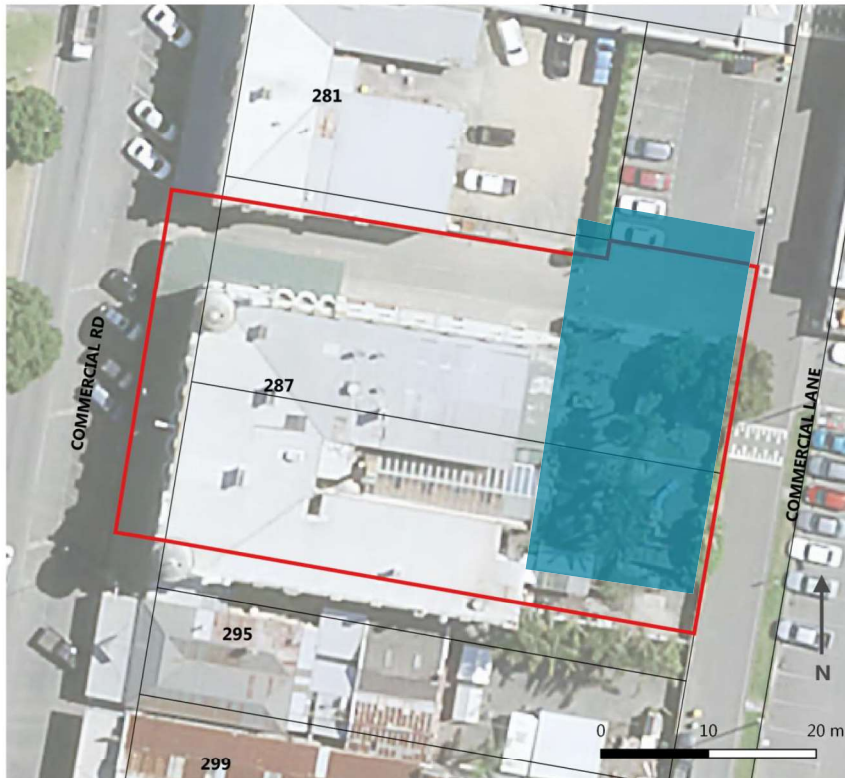
NOTE: The blue shaded area is the preferred location for additions and new development.

- Recommended for Heritage Overlay
- Title boundary
