**Locality:** YARRAM  
**Place address:** 290-292 COMMERCIAL ROAD  
**Citation date** 2016  
**Place type (when built):** Bank  
**Recommended heritage protection:** Local government level  
Local Planning Scheme: Yes  
Vic Heritage Register: No  
Heritage Inventory (Archaeological): No

**Place name:** Union Bank of Australia (former)

Project: Wellington Shire Stage 2 Heritage Study  
Client: Wellington Shire Council  
Author: Heritage Intelligence Pty Ltd  
Date: 12/2/16

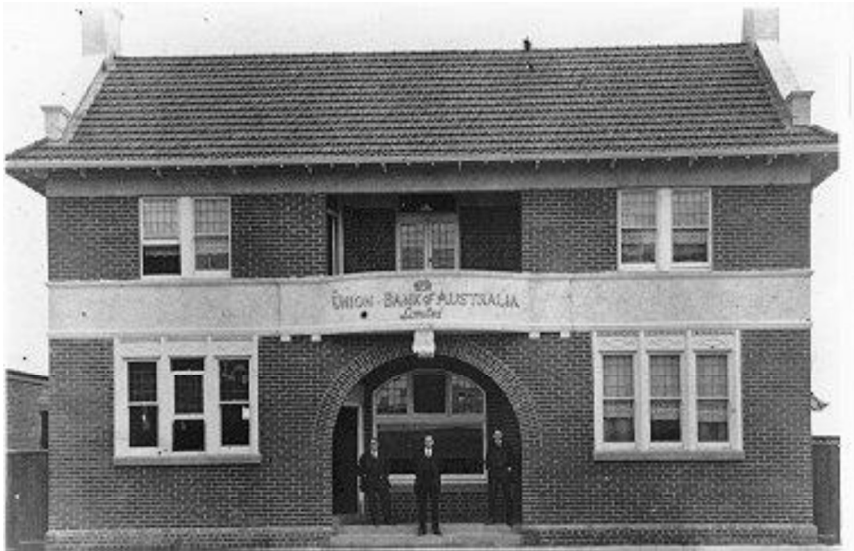
In July 1914, a local newspaper reported that the staff of the Union Bank had moved into the new quarters. The building was described as 'an ornament to the town' (*Gippsland Standard*, 8 Jul 1914:2). The new bank premises were officially opened in August 1914 (plaque on site). A photo dating to soon after the bank was built in 1914 (YDHS) showed the facade of the building, with its tiled gabled roof and parapeted gables with chimneys at each end (Figure H1). The sash windows to the facade appeared as they do in 2015. The central semi-circular arch at the recessed entrance was located below the balcony, with the words 'The Union Bank of Australia Limited' on the solid balustrade (removed, and reinstalled in the 1990s).

Figure H1. The bank in 1914, after completion of the building (YDHS website).

3.7. Repair the roughcast render on the gable ends, and paint it the same colour as the other roughcast render as shown in Fig H1.

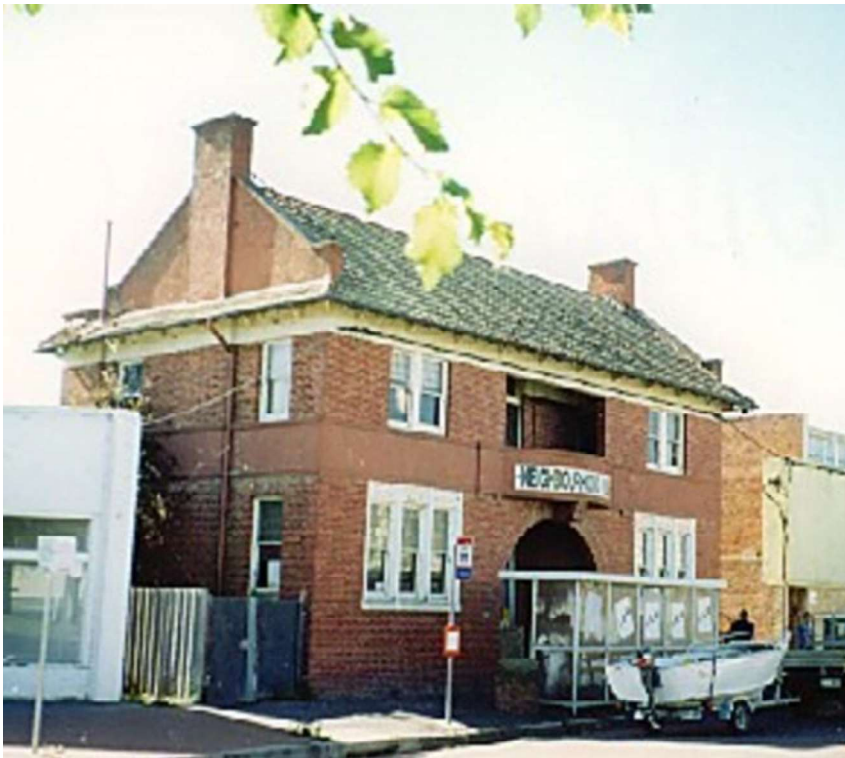
In the 1990s, the building served as a community Neighbourhood House and also housed a number of other community groups and services (YDHS). A photo dating to the 1990s (NT) showed the facade and south elevation of the bank (Figure H2). The rendered decorations were painted brown (except for the rendered band under the eaves) and a sign 'Neighbourhood House' was installed across the projecting balcony.

Figure H2. The bank in the 1990s (National Trust).

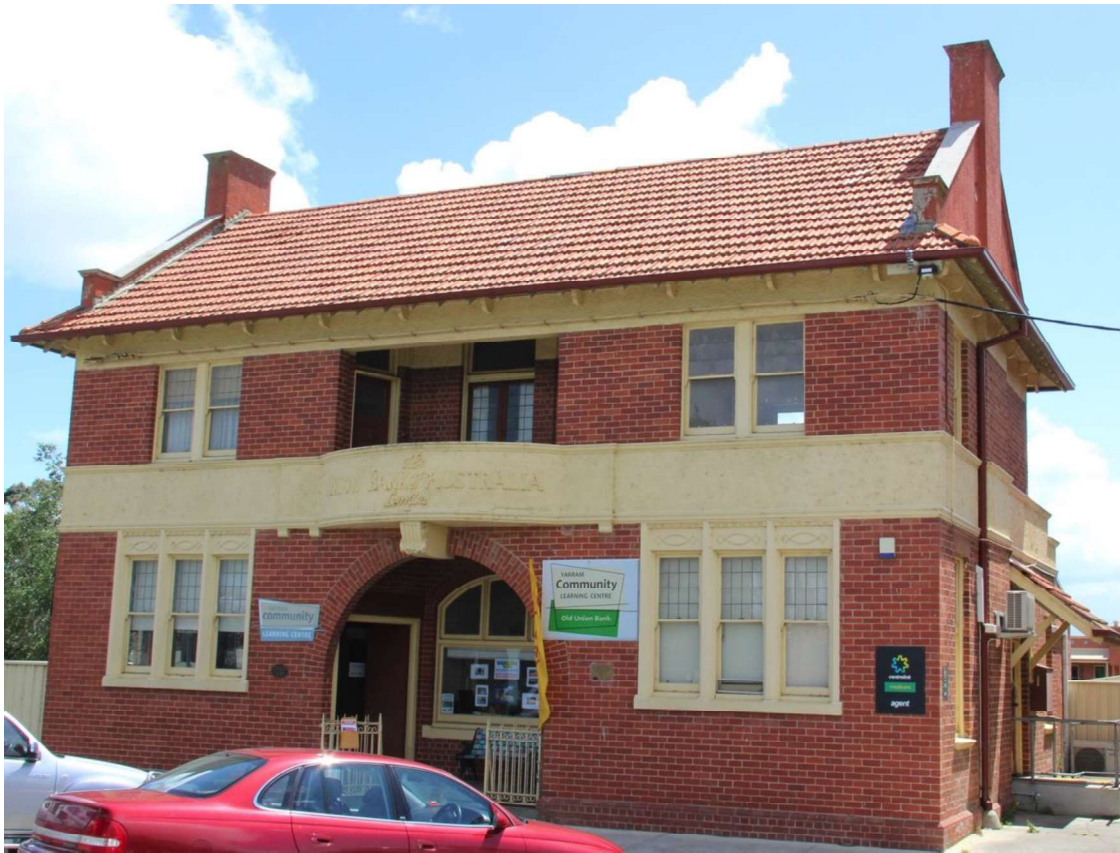
**Figure D1.** The bank has a prominent gable roof clad with terracotta tiles, a pair of roughcast rendered parapeted gables, each with a wide chimney at the apex (overpainted) and short hips to support the continuation of the exposed eaves. The entrance is accentuated at ground level with a large central semi-circular red brick arch, which is further emphasized by the elaborate projecting and rendered (overpainted) bow shaped balustrade above, which was typical of Walter Butler's designs for Union Banks during this period. Butler replicated this design throughout Victoria, with slight alterations to each bank (Trethowan 1976). As typical of the Arts and Crafts style, the wide eaves of the roof have exposed rafters with timber brackets to the cornice. The face-brick building has wide bands of rough-cast render (overpainted) at the eaves and at the ground floor level of the first floor. The central band of render continues across the round projecting balcony which is supported by a bracket which forms the keystone of the large semi-circular arch at the recessed entrance at ground level. The words 'The Union Bank of Australia Limited' were reconstructed on the solid balustrade in the 1990s, replicating what was originally there. The first floor has a pair of double-hung sash windows with geometric leadlight to the top sash, as typical of the style. The first floor recessed behind the balcony, with openings of a similar style.

**Figure D1.** The facade of the bank with the predominantly gabled roof clad with terracotta tiles, exposed eaves, a pair of parapeted gable ends which have small hipped extensions for the continuation of the eaves and central semi-circular red brick arched entrance and wide bank of (over painted) render.

The rendered decorations were painted (except for the gabled ends which have an old layer of paint in fair condition) in the 1990s during a program of internal and external renovations, which also comprised repairs to the roof, painting of the windows and the reinstallation of the name to the balcony. Modern signage has been attached to the facade. A concrete ramp is located on the north elevation, providing wheelchair access to the side entrance, and a modern verandah is attached to the rear (west elevation). A large modern shed has been built to the rear of the building. These elements are not significant. Overall, the 1913-1914 building has a high level of integrity and is in very good condition.

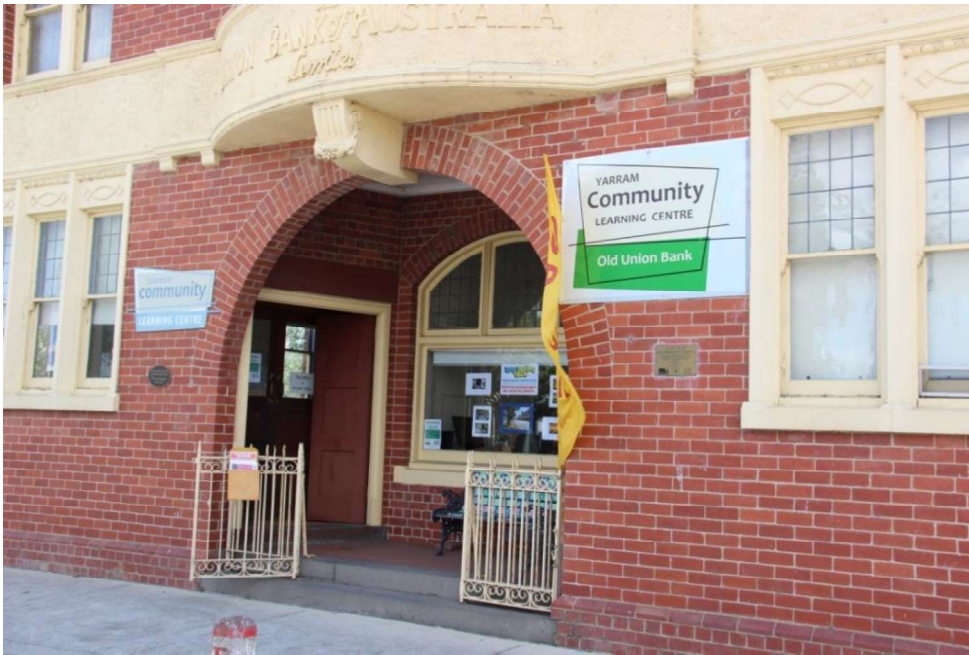
**Figure D2.** The recessed entrance is reached by two bluestone steps and has a tiled floor (possibly original) with a large window (with three leadlight panes to the top portion) and entrance doors and an airlock to the left. A (c1950s ?) wrought iron gate and fence encloses the entrance. Either side of the central arch are groupings of three timber sash windows (with geometric leadlight to the top sash), with a geometric pattern in render above each window.

Figure D2. A detail of the entrance with its large semi-circular red brick arch and (c1950s) wrought-iron gates, in front of the large window with geometric leadlight, which is also evident in the other timber-framed windows.

- 3.2.1. First floor balcony and the entry porch ceiling below it: water has damaged the ceiling of the entry porch and this is most likely due to a break down of the water proofing of the balcony above. It is important to repair the drainage above before the supporting structure of the ceiling in the ground floor entry rots, and falls in.

3.8. Retain the rectangular herringbone patterned red encaustic tiles in entry foyer and the bluestone steps. Figure D2.

4.1. Ensure all signage is designed to fit around the significant architectural design features, not over them. Eg the current signs fixed to both sides of the brick arch, extend over the voussoir (wedge shaped) bricks of this magnificent arch, as though it is insignificant. This is not appropriate.

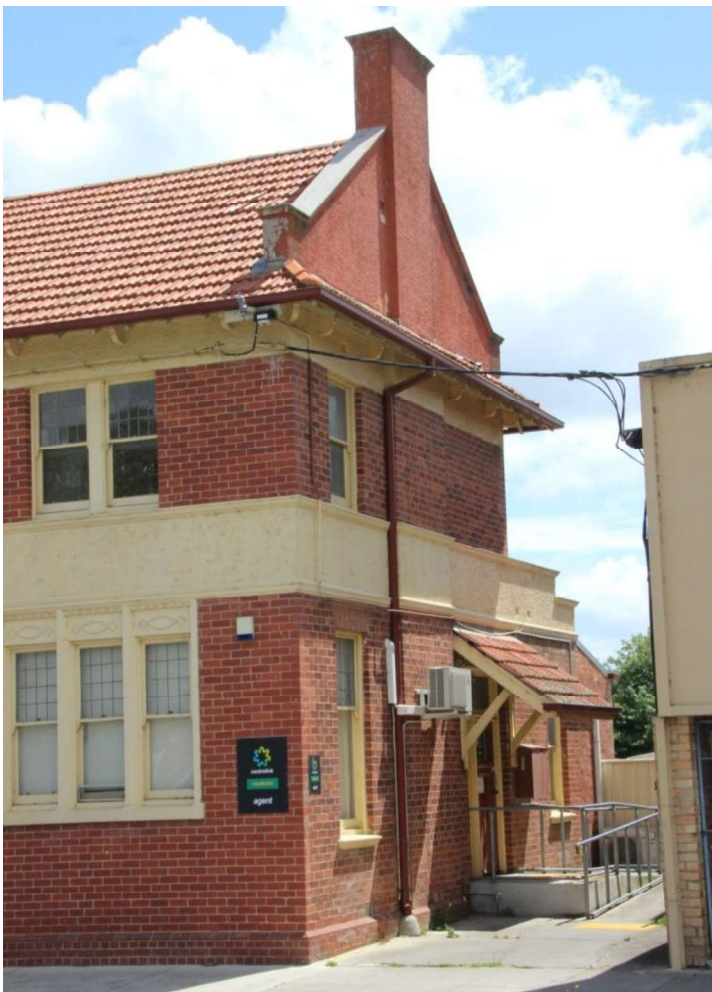
**Figures D3 & D4.** The bands of rough-cast render continue on the side elevations, which have windows in the same style as the facade. An entrance on the north elevation (presumably providing

access to the residence) has a small skillion-roof porch, clad with tiles. This entrance has a high-waisted timber door with glazing at the top and leadlight highlights and sidelights. To the rear of the building is the single-storey residence section of the building with a skillion roof which is partly hidden on the side elevations by the band of render which continues and becomes a parapet. This section is constructed of brick with windows in the same style (ground floor level with leadlight).

Figure D3. The north elevation with the domestic entrance porch and recently added concrete ramp for access.

- 3.3.1. E.g. along the wall where the concrete ramp has been installed.
- 3.4. Never install a concrete floor inside a solid masonry building as it will, after a year or so, cause long term chronic damp problems in the walls. Do not install a new damp proof course (DPC) until the drainage has been fixed, even a DPC may not work unless the ground has been lowered appropriately.

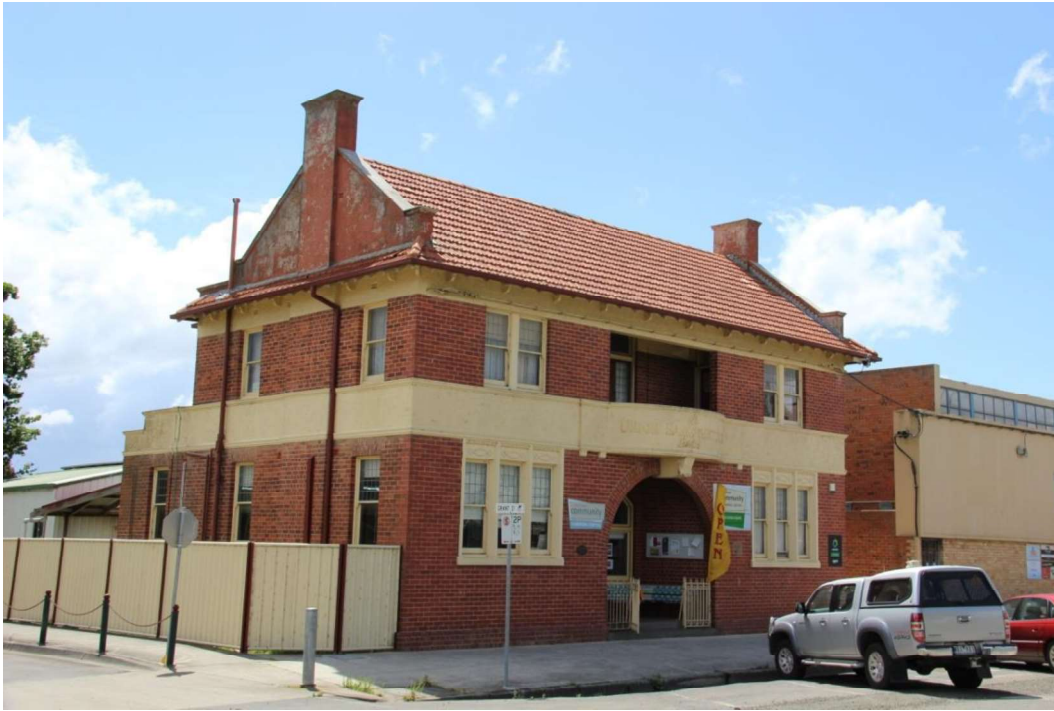
**Figure D4. The facade and south elevation, showing the single-storey section to the rear and modern skillion verandah.**

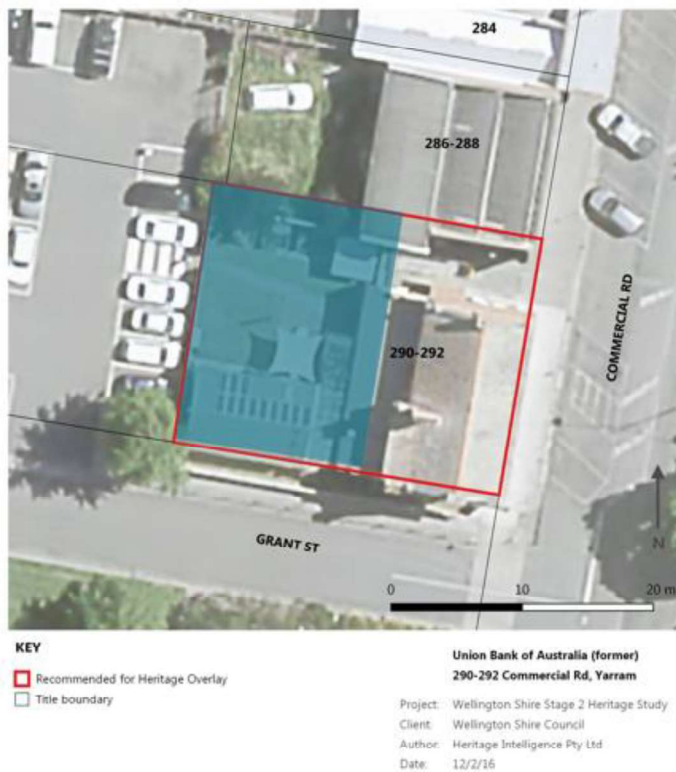
NOTE: The blue shaded area is the preferred location for additions and new development

- 1.1. Retain clear views of side elevations of the building, as well as the front elevation.
- 1.2. New structures should be restricted to the rear of the property and largely concealed behind the heritage fabric when viewed from Commercial Road.
- 1.3. Additions and new buildings should be a maximum of two-storeys tall
