<b>Locality:</b>	<b>STRATFORD</b>
<b>Place address:</b>	<b>64-66 TYERS STREET</b>
<b>Citation date</b>	2016
<b>Place type (when built):</b>	Post office, court house, and council chambers/offices
<b>Recommended heritage protection:</b>	Local government level Local Planning Scheme: Yes Vic Heritage Register: No Heritage Inventory (Archaeological): No
<b>Place name:</b>	<b>Stratford Post Office, Court house (former) and Council Chambers (former)</b>

**Court house (former), council chambers (former) and post office and residence  
64-66 Tyers St, Stratford**

Project: Wellington Shire Stage 2 Heritage Study  
Client: Wellington Shire Council  
Author: Heritage Intelligence Pty Ltd  
Date: 12/2/16

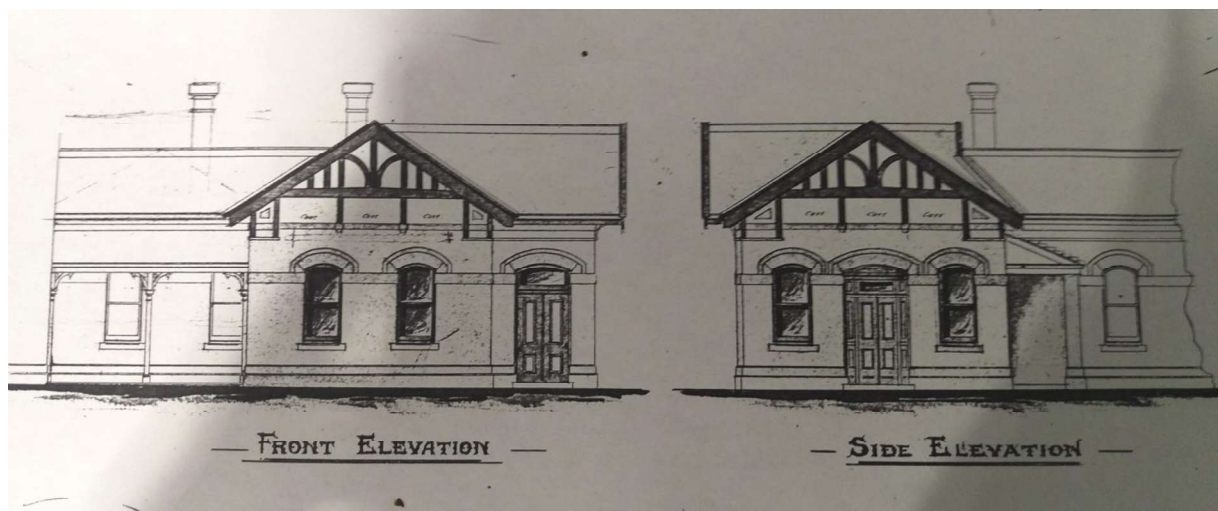
Figure H6. 1899 drawings of the proposed new gabled-bays to Tyers and Hobson streets, with their taller roof forms (Saleta 2016).

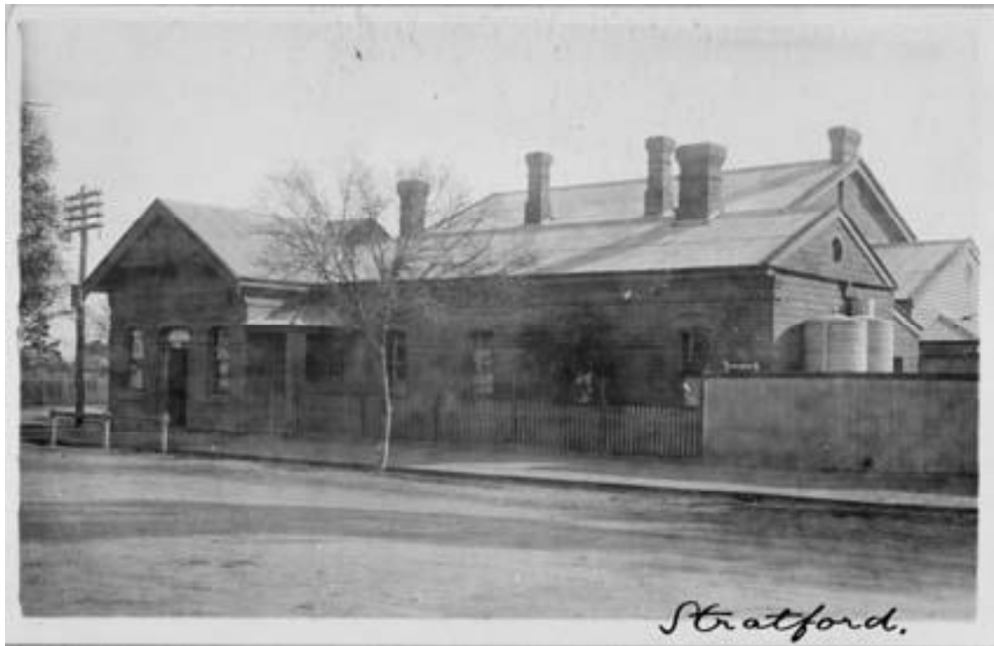
Figure H8. The south elevation of the post office section in 1901, and the rear (east) elevations of the complex) (NAA).

A number of early photos exist for the buildings, after the c1900 addition of the gabled-bays to the post office. A photo dating to 1901 (NAA) showed the south and east (rear) elevations of the brick buildings (Figure H8). The roofs were clad with galvanised corrugated iron and note the taller roof of the gabled bays to the post office, in comparison to the lower roof of the original 1884 section of the building. The post office building appeared mostly as it does in 2015, with a gabled bay on the corner, a pair of windows flanking a central door (later altered and replaced with a window), a small hipped-roof porch in the corner, and the long gabled-roof portion (residence) along Hobson Street. The photo showed a second chimney towards the rear of the building (since removed). A picket fence ran along the southern boundary, with a taller fence at the east end. In the background, the roof of the court house was evident, with its three chimney stacks, and the smaller gabled-roof addition to the rear (all as remains in 2015). It appears that a further addition was attached to this section at this date.

- 3.2.5. Replace the metal palisade fence with a timber picket fence to match the one shown in Figures H8 and H10, and the timber gate on the south side of the post office.

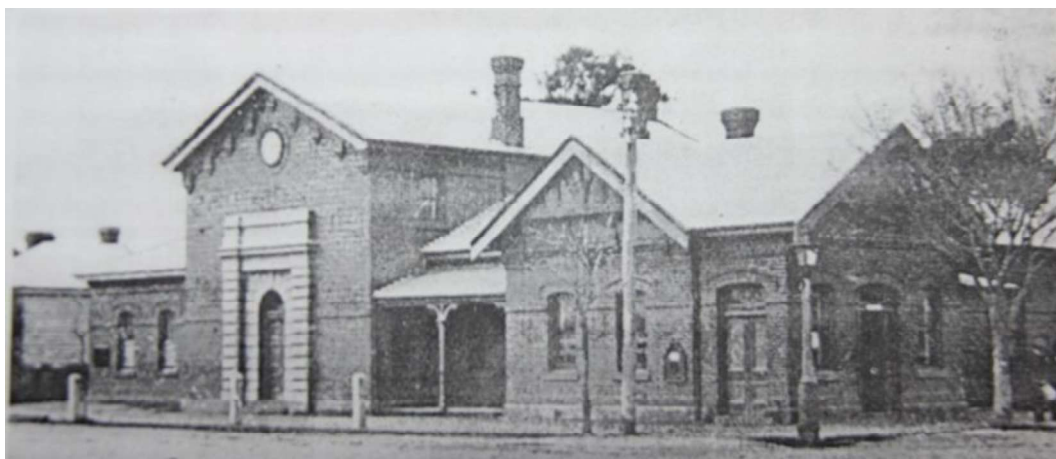
Figure H9. Photo dating to 1906, showing the facade of the post office, court house and Council chambers and picturesque skyline. Note all the roofs are unpainted galvanised corrugated iron, and the verandah and projecting gabled bays of the post office (SDHS).

A photo dating to 1906 (SDHS) showed the facade (west elevation) of the buildings (Figure H9). The post office section comprised an entrance on both elevations, with double doors and a highlight. The bay between the two sections comprised a verandah, with simple timber brackets against a single (central) supporting timber post (since altered), possibly for the benefit of the residence. To the north of this, the court house building appeared as it does in 2015. The arched windows were evident at the north wing (as evident on the rest of the building; window hood since added). A photo dating to c1914 showed that the building remained as it was in 1906, in clear detail (Figure H10). By 1917, the timber brackets had been removed from the verandah on the facade (west elevation) and the space partially enclosed with trellis (the top portion open) (Figure H11).

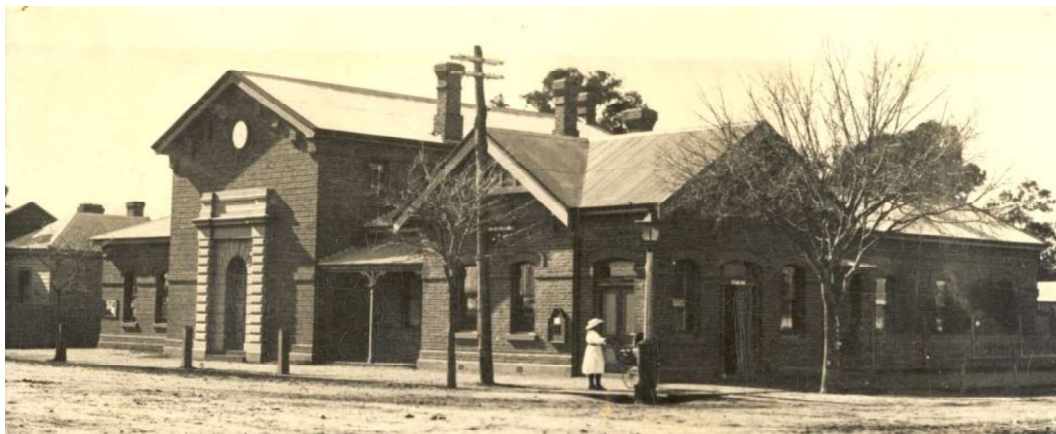
Figure H10. Photo of the complex dating to c1914 (between World War I and the early 1920s) (SDHS).

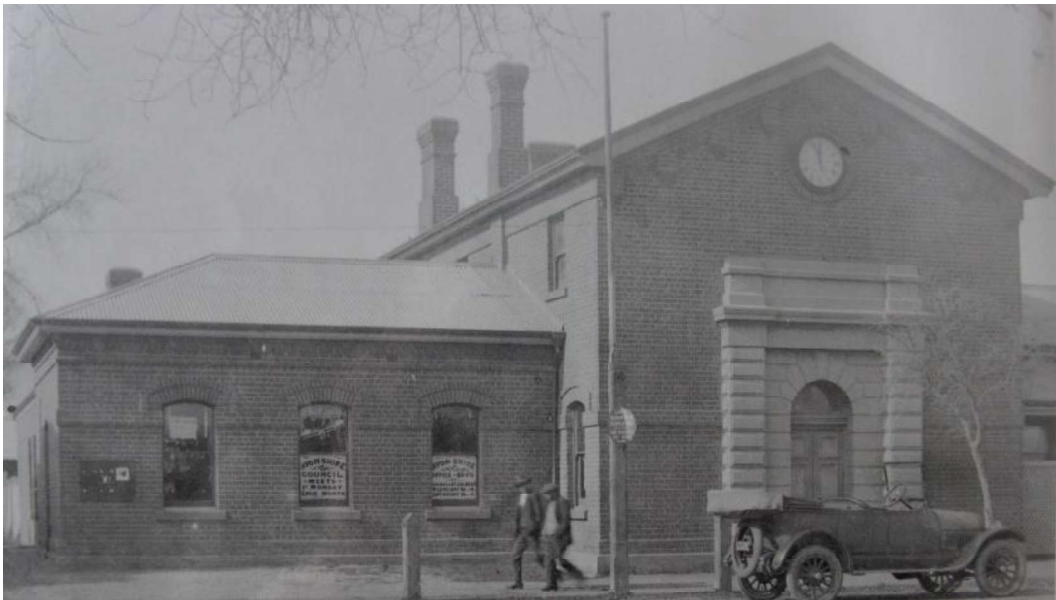
**Figure H12.** The facade of the court house and the northern wing in 1935. A flag pole stood on the foot path (SDHS).

A photo dating to 1935 (SDHS) showed the facade of the court house and the northern wing, as they appear in 2015 (except for recent signage) (Figure H12). The court house had the clock to the gabled-end, above the grand entrance, while the northern wing had the three arched windows, with Avon Shire Council notices in two. In front of this, on the footpath, stood a flag pole (remained in the 1950s; since removed).

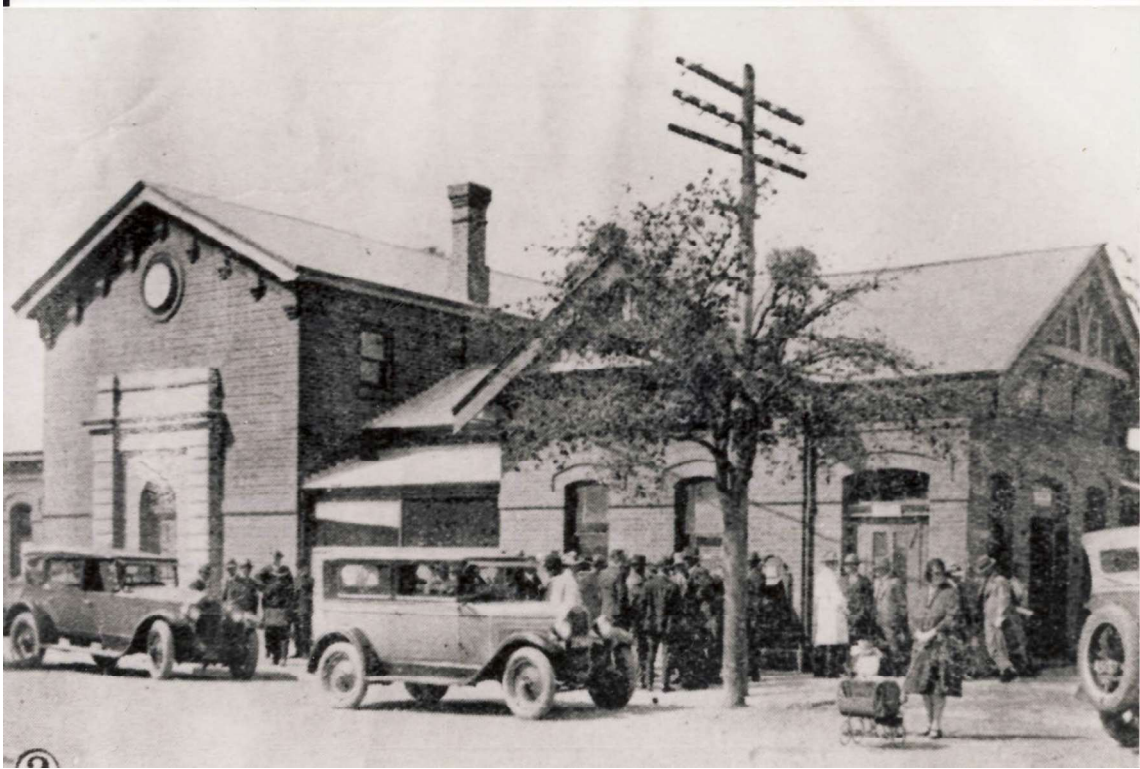
Figure H13. Photo dating to 1920s-1930s. The post office as a meeting place, and entrance door facing Hobson Street remained and the render was still unpainted (SDHS).

Figure H13 dating to 1920s-1930s illustrates the post office as a meeting place, and shows that the entrance door facing Hobson Street remained and the render was still unpainted (SDHS).

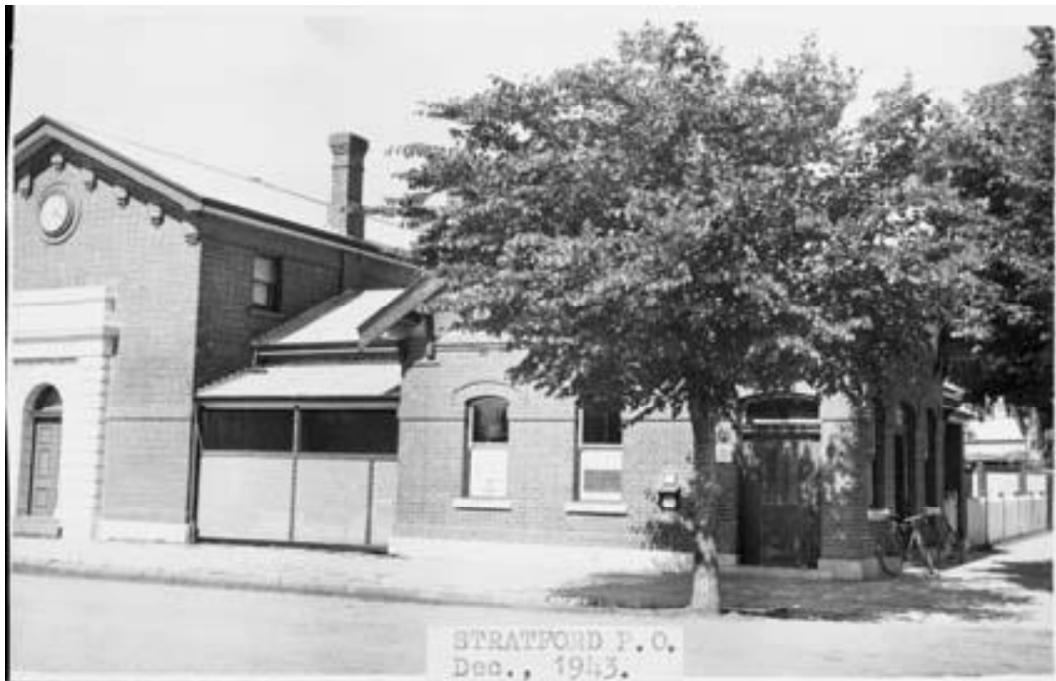
Figure H14. Photo dating to 1943 showing render and window sills have been painted. (NAA).

A photo dating to 1943 (Figure H14) showed that the render and window sills had been painted by this date. The post office entrance facing Tyers Street comprised a panelled timber door below a highlight (since replaced and the light covered) (Figure H7) (NAA).

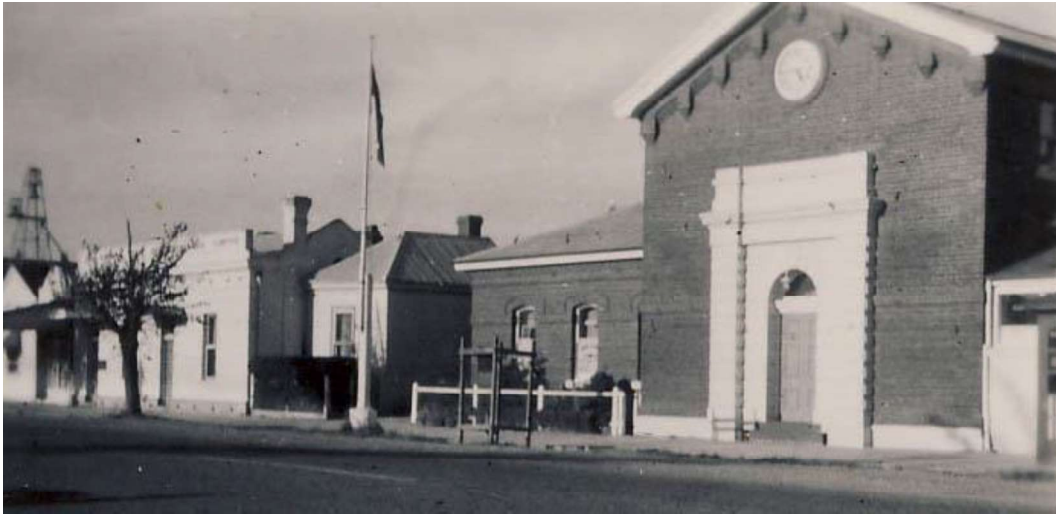
**Figure H15. The complex c1950s, with a telephone box to the right in front of the post office, flag pole and fenced garden in front of the Council chambers (SDHS).**

From the c1950s, a timber fence enclosed a garden area in front of the northern wing (the Council Chambers) (Figure H15). The entrance of the court house comprised a pair of timber panelled doors (since replaced). A telephone box stood in front of the verandah space. Also in the 1950s, an enclosed timber bus shelter stood in front of the post office (since removed) (Figure H16) (SDHS). A plan of the post office in 1952 showed that the building retained the same plan since 1916 (Figure H17) (Saleta 2016).

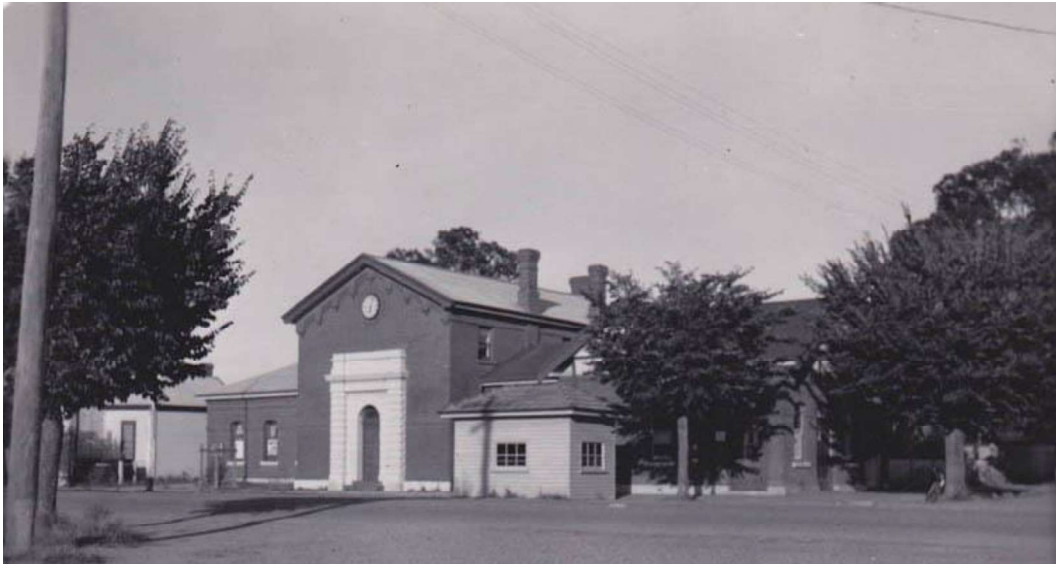
**Figure H16. The complex in c1950s, with the bus shelter in front of the post office (SDHS).**

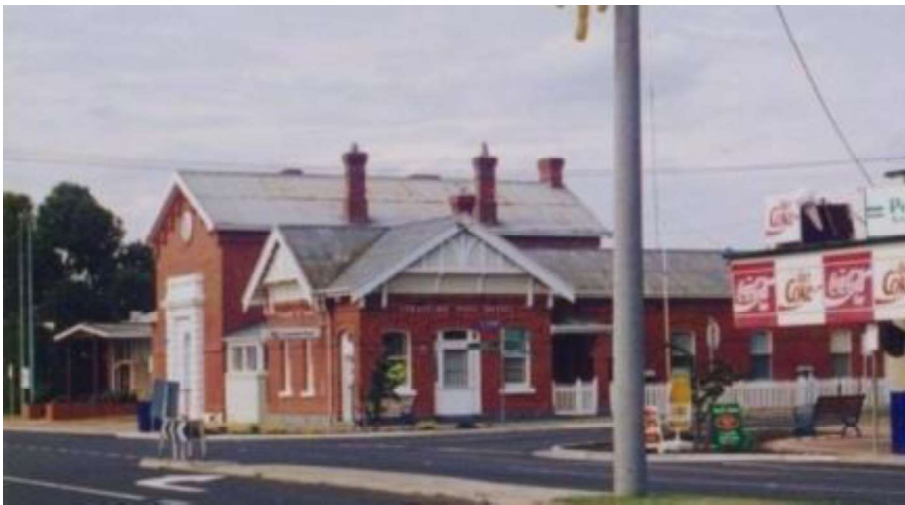
**Figure H19. View from a distance in 1998. The southern entrance to the post office had been altered to a window by this date (Victorian Places).**

house at this date were those that remain in 2015. By 1998, the post office entrance facing Hobson Street (at the centre of the gabled-bay) had been altered to a window (Figure H19). It appears that the timber picket fence along the south boundary remained in 1998 (in 2015, it remains at the porch entrance only) (Victorian Places).

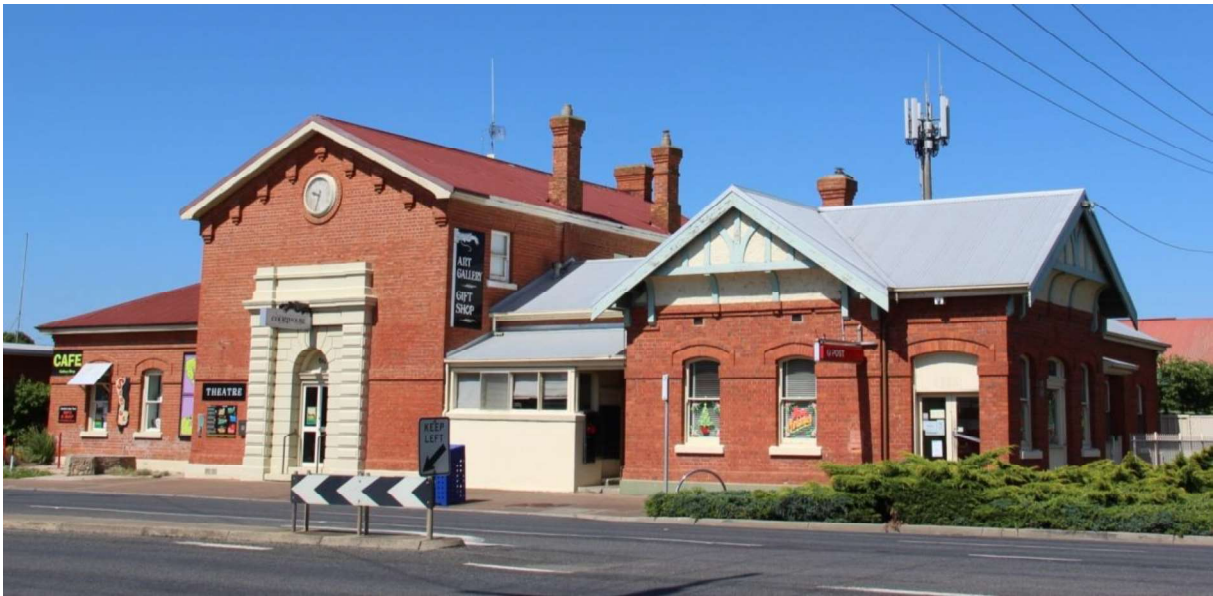
**Figure D1.** The main elevations of the (left to right) council chambers, two-storey court house and post office with the attached residence to the rear. Stylistically, the buildings are tied together by corbelled courses of brickwork that run horizontally below the eaves and at the tops of the windows, extending over the voussoirs of each window.

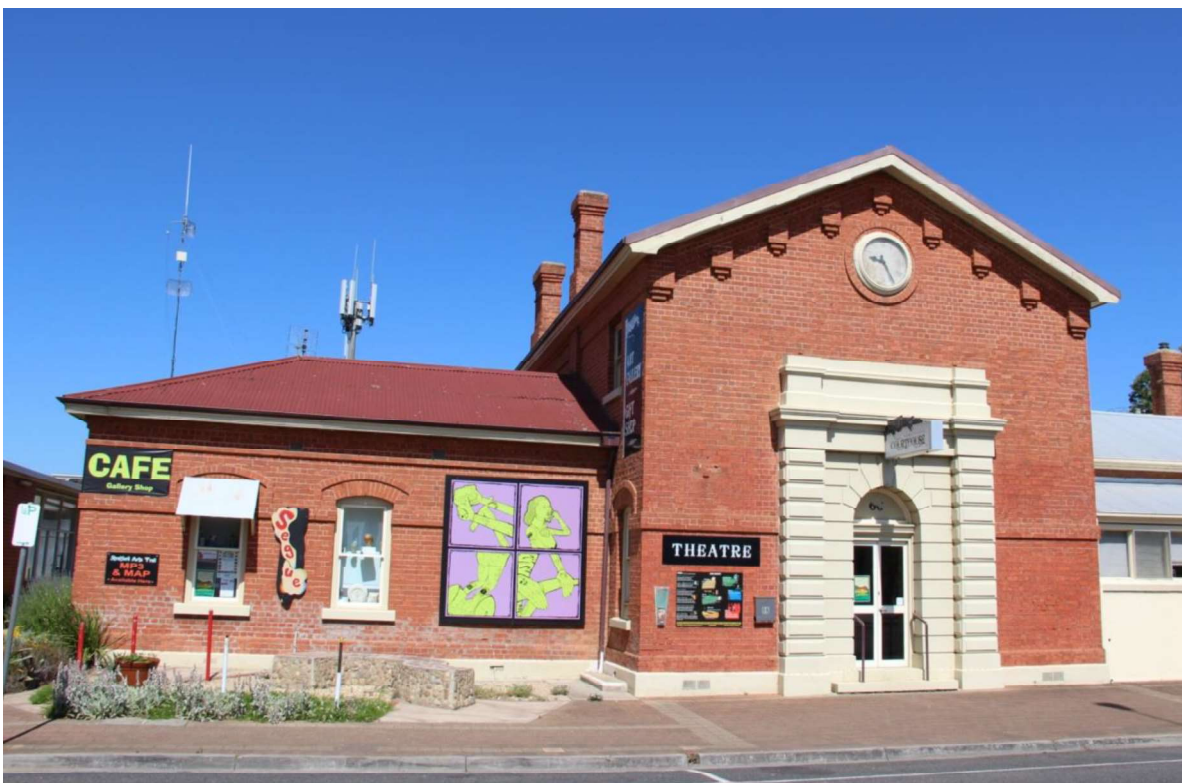
**Figure D2.** The taller, single storey **court house** is located at the centre of the complex. It has a gabled roof with bold machicolation (corbelled-brick brackets originally used to pour boiling water, arrows etc onto enemies below) to the eaves of the gabled end and a large clock. Two tall corbelled-red brick chimneys stand on the northern roof plane, with another two on the southern plane, and a squat version at the east end of the building. An imposing Classical aedicule in light coloured render (overpainted), with prismatic rustication surrounding the single round arched doorway dominates the symmetrical façade, as the entrance to the courthouse (the entrance doors, which are clearly visible in Fig H5, have been replaced). There are large segmental-arched windows to the side elevations at ground level, with smaller square-headed windows to the side elevations at the higher level. The 1884-1885 court house is in very good condition and has a very high degree of integrity.

**Figure D2.** The council chambers (left) and the two-storey court house with the dominant Classical portico, clock and bold corbelled brackets to the eaves.

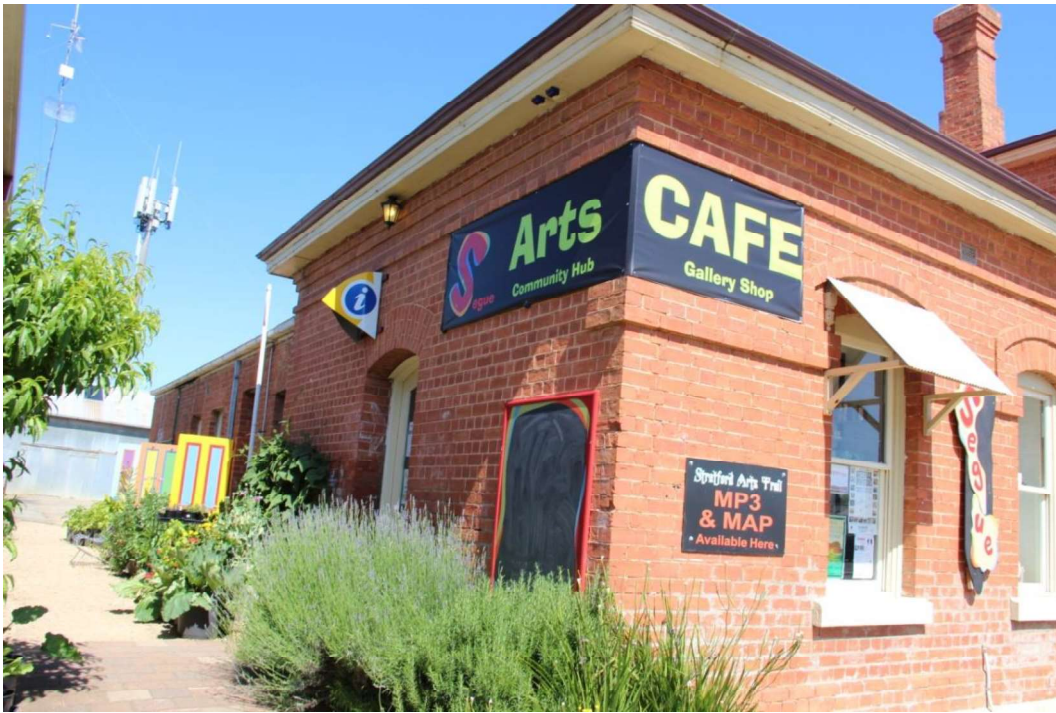
Figure D3. The north elevation of the council chambers.

- 4.5.2. The north wall of the council chambers has the most evidence of severe damp. This would be exacerbated by watering plants near the wall, and if a concrete floor has been inserted inside the building or a concrete path on the outside. Refer to the manual, by David Young, listed below for a full explanation of the problem and how to fix it. Water falling or seeping from damaged spouting and down pipes is also causing severe and expensive damage to the brick walls.

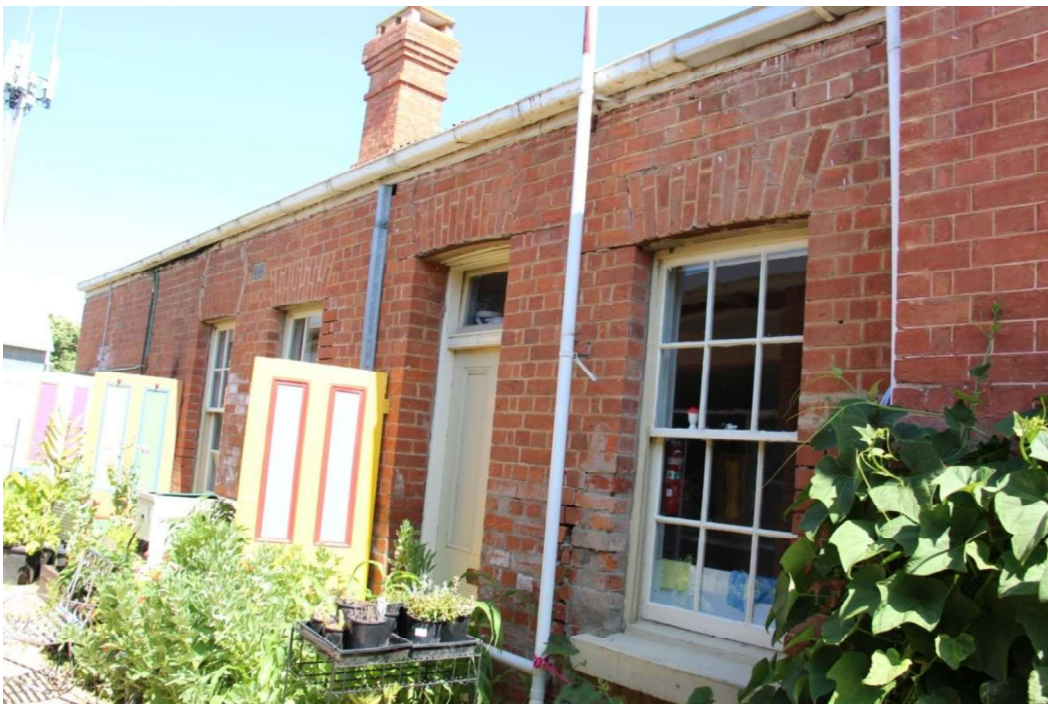
Figure D4. The north elevation of the council chambers, towards the rear, with its six-over-six timber windows.

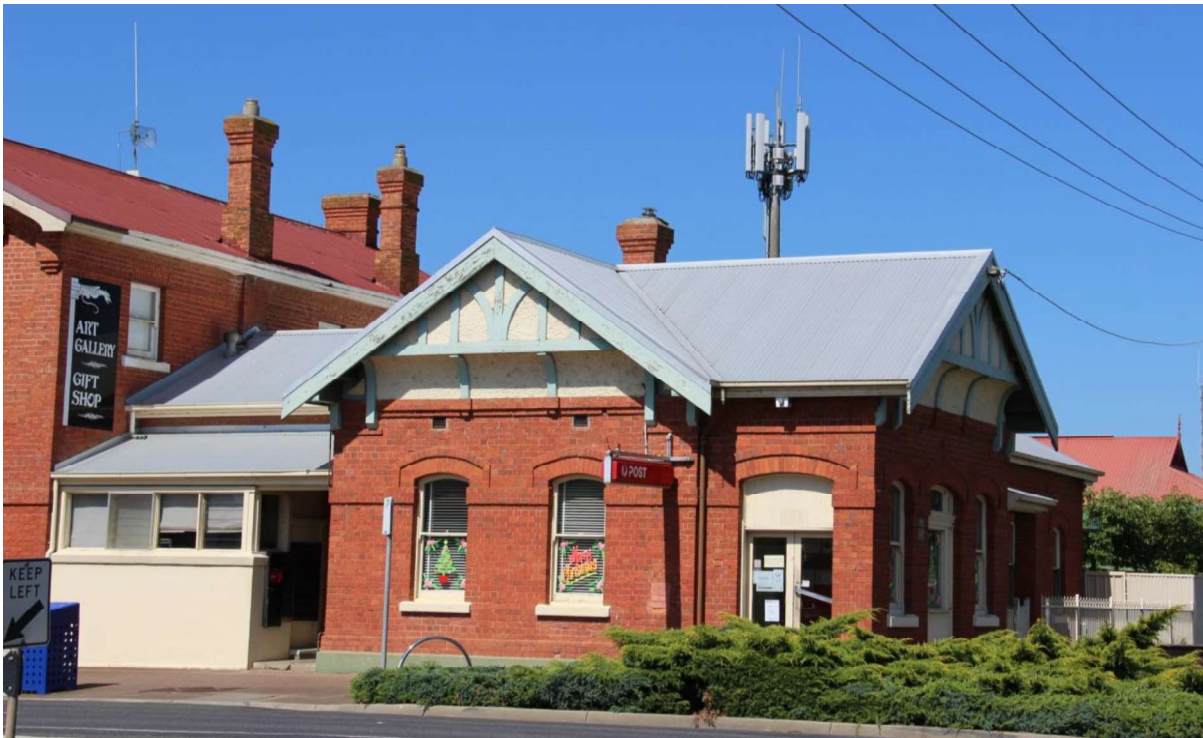
**Figure D5.** The main elevations of the post office, and the verandah to the left (with later in-fill). The two jettied gabled-ends have roughcast render and timber strapping, creating a half-timbering effect. Note the historic picturesque skyline of roofs and chimneys.

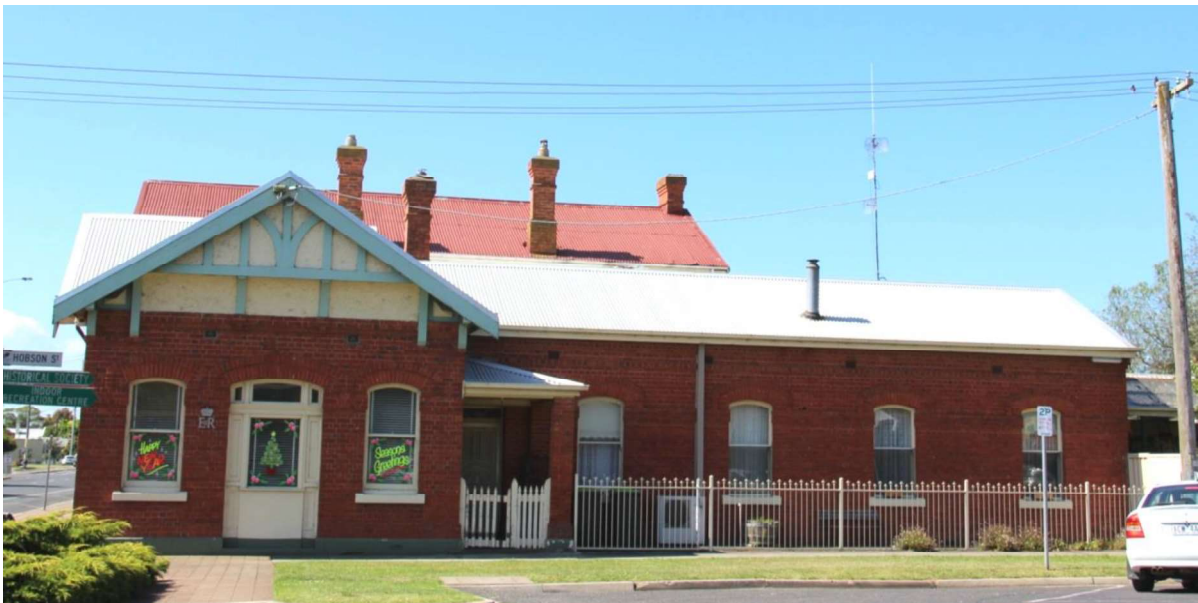
**Figure D6.** The south elevation of the post offices comprises the second gabled bay and the long elevation of the residence to the rear. The roof of the residence has one tall corbelled-brick chimney. The second gabled bay of the post office that fronts Hobson Street has two one-over-one double-hung sash windows. At the centre is a window, in an opening that originally held a door to the public room of the post office (altered between 1943 and 1998, see Figure H10). To the right (east) of this is a porch, supported by an original brick pier, that covers two entrance doors; to the post office and residence. The door to the left is a paneled timber door, while the entrance to the residence has a highlight (the door is not visible behind a modern security door). The early (possibly original) timber picket fence remains beneath the porch (since replaced along the rest of the boundary with a modern metal fence). The residential section (east end) comprises four single one-over-one double hung sash windows to the south elevation.

**Figure D6.** The south elevation of the post office and residence to the rear. The entrance at the centre of the gabled-bay has been altered to become a window. A section of the early (possibly original) fence remains beneath the porch. Note the historic picturesque skyline of roofs and chimneys.

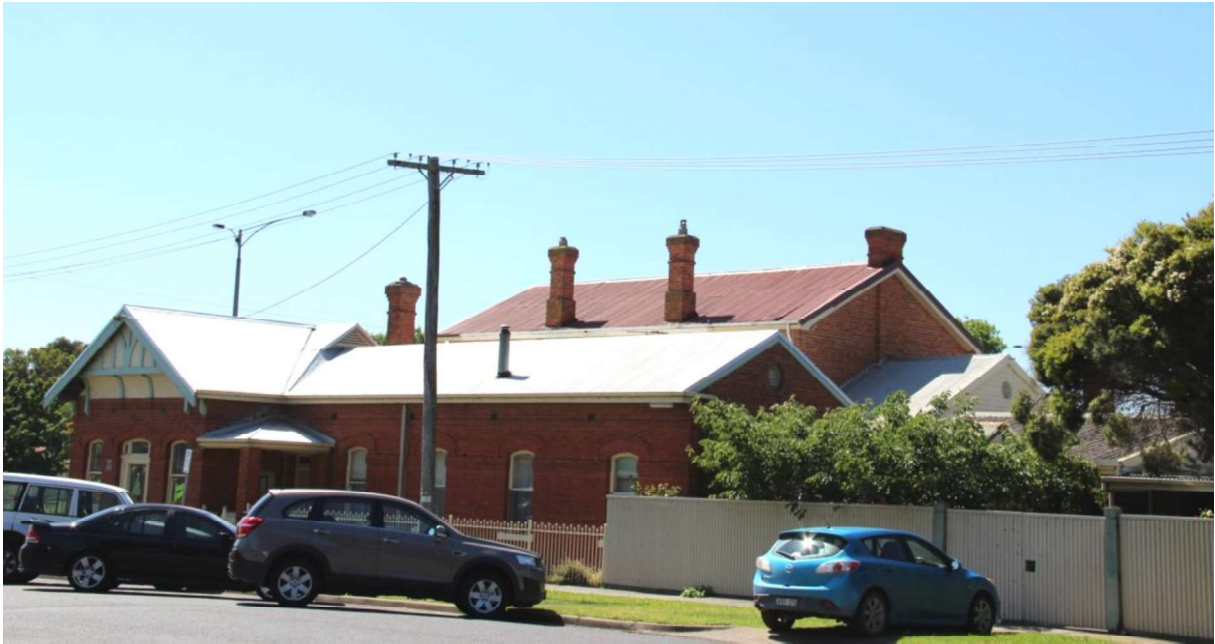
**Figure D7.** The view from the east shows the rear sections of each building in the complex. It appears that additions (which may date to a later period) have been constructed to the rear of each building, most of which have gabled roofs. To the rear of the post office is an addition with corrugated fibro-cement roof cladding. To the rear of the court house is a weatherboard addition with a gabled roof. An aerial also indicates that additions have been built at the rear of the council chambers (the date of these additions has not been confirmed).

**Figure D7. The rear (east) elevations and the complex of historic roofs, which are a significant feature when viewed from Hobson Street.**
