Locality: BOISDALE
Place address: 6 BOISDALE-VALENCIA CREEK ROAD
Citation date 2016
Place type (when built): Church, Memorial fence and gates, 3 memorial trees
Recommended heritage protection: Local government level
Local Planning Scheme: Yes
Vic Heritage Register: No
Heritage Inventory (Archaeological): No

Place name: St George's Anglican Memorial Church

Architectural Style: Interwar Arts and Crafts
Designer / Architect: Not known
Construction Date: 1924 (moved to current site in 1953)

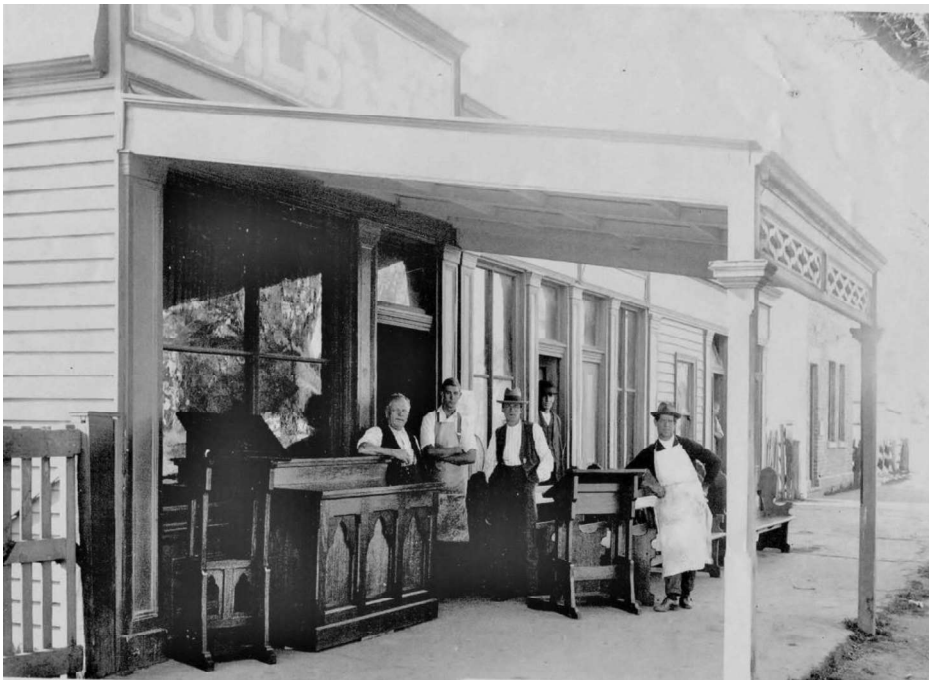
Figure H1. St George's church furniture, made in Maffra and still in use in the church today. (. MDHS, ID. No. 02009VMFF).

St George's held annual harvest festivals at the Public Hall in the 1950s and 60s, where Claude Tatterson would auction produce and supper would be served. The 50th anniversary of St George's was held in 2003, with a grand afternoon tea held at the Public Hall. The church continues to hold services in 2015 (Montague 2004:8). The furniture shown in Figure H1 is still used in the church in 2016 (MDHS).

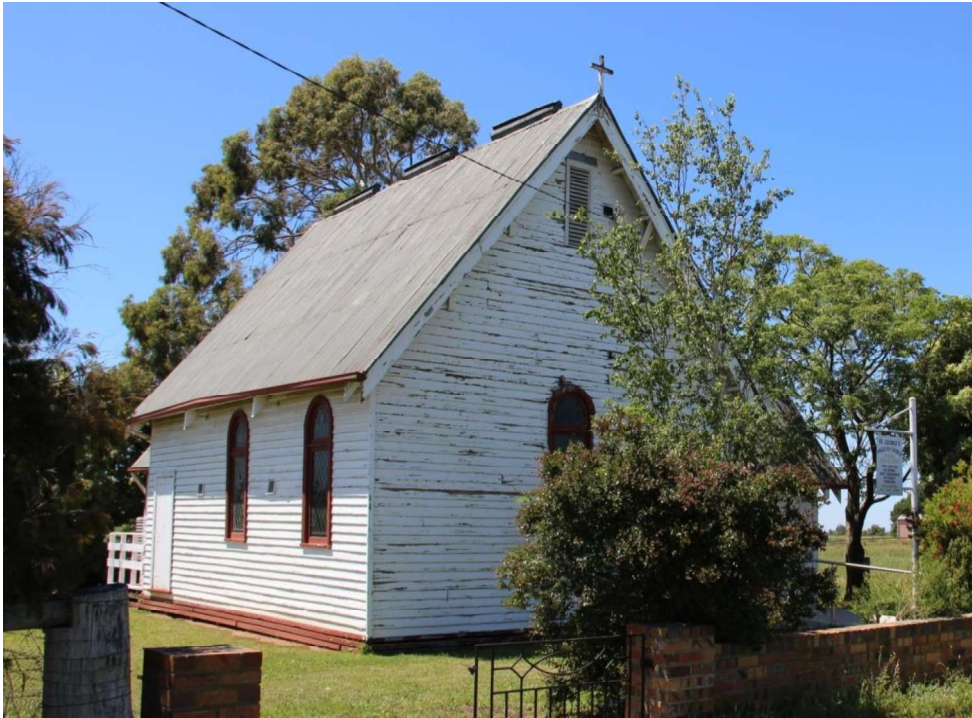
Figure D1. The weatherboard nave has a steep-pitched gabled roof clad in corrugated iron and semicircular-arched windows with coloured leadlight.

Figure D1. The church is a weatherboard clad building with a rectangular plan and a steep gabled roof, with brackets to the eaves at the gabled-ends. The roof is clad with short sheets of corrugated iron (overpainted) with three long ridge vents and a cross at the apex of the gable to the façade. Tall rectangular louvered vents are located at the top of the gabled ends. The nave of the church has timber-framed semicircular-arched windows with the original coloured leadlight to the arched top and diaper-patterned to the casement windows below leadlight (there is replacement coloured glass to the one window of the façade).

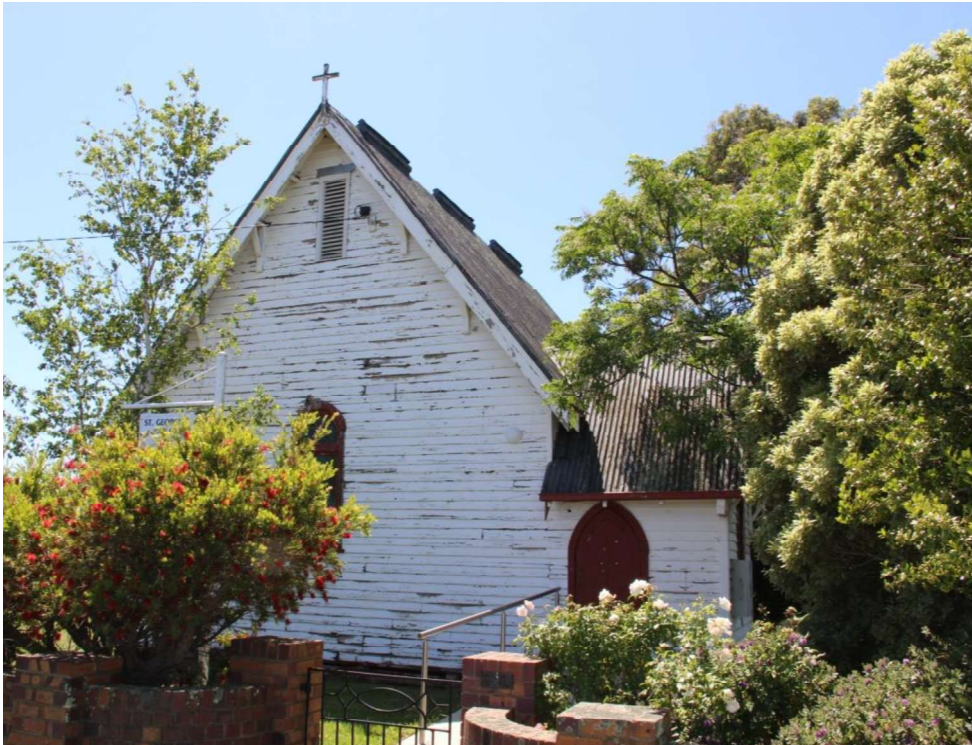
Figure D2. The entrance porch on the south elevation has a timber door with a pointed-arch on the west elevation. To the left is the Silver Birch (*Betula pendula*) first planted in 1967 was in memory of Mrs Ollie Clarkson. To the right is the White Cedar tree (*Melia azedarach*) and its associated plaque that commemorates the life of Gladys Tatterson (1899 – 1995).

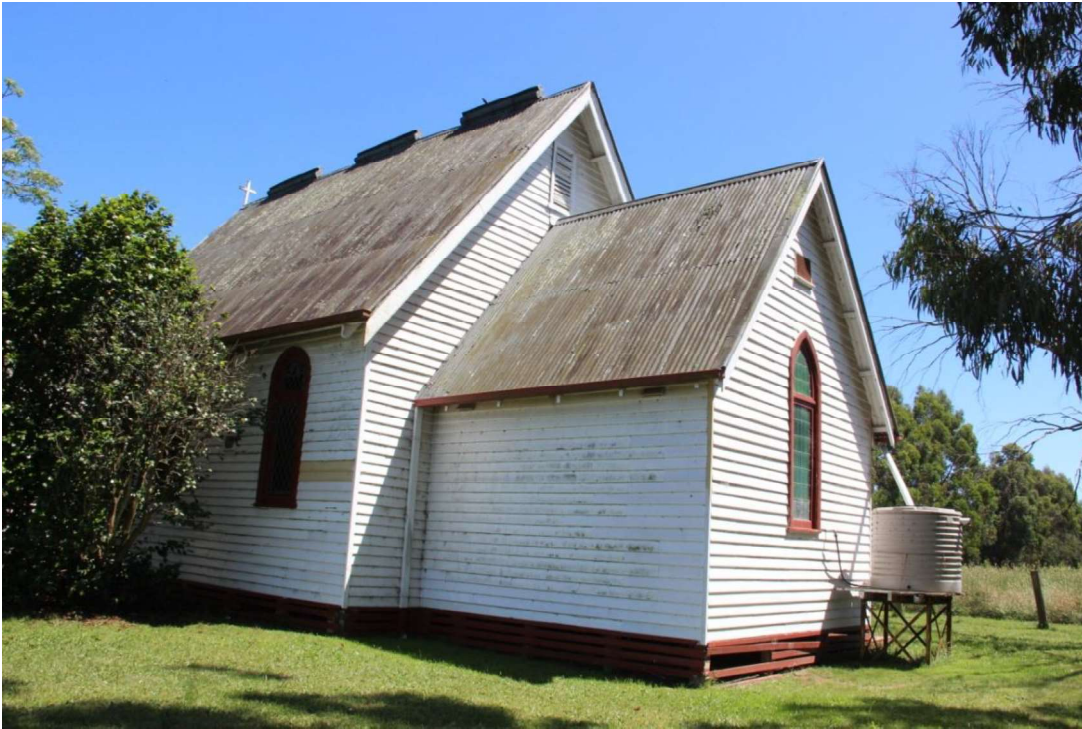
Figure D3. The chancel at the east end of the church is clad in the same weatherboards as the nave of the church, but has a pointed-arch window with simple coloured leadlight. To the left is the camellia, which was donated by a parishioner in the 1950s.

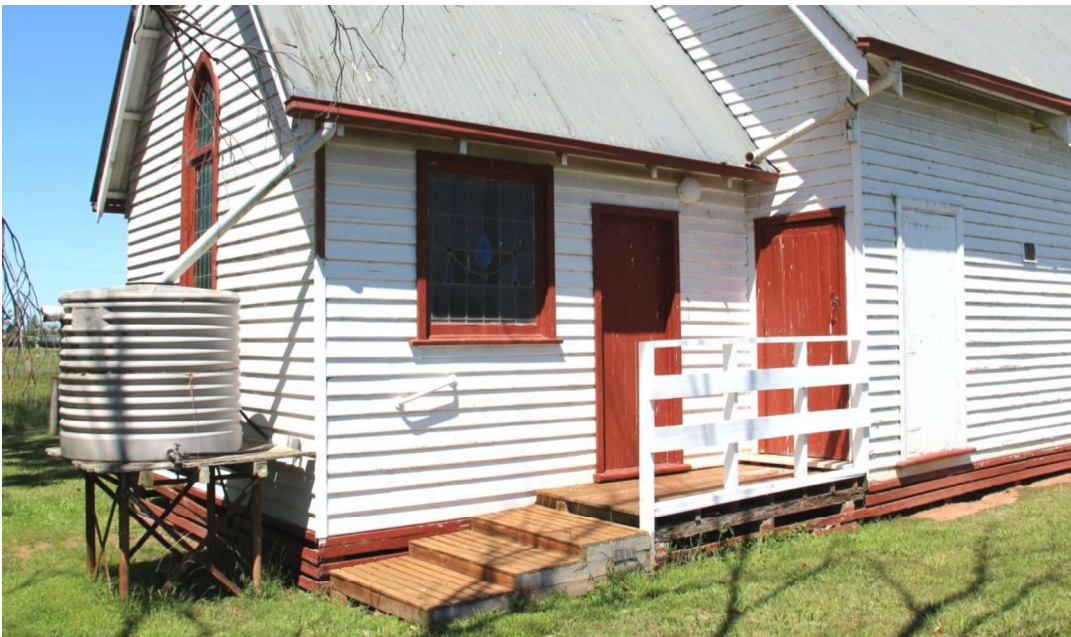
Figure D4. The north elevation comprising the square leadlight window to the chancel. Two timber doors provide access to the chancel and nave, while the third appears to not be in use.

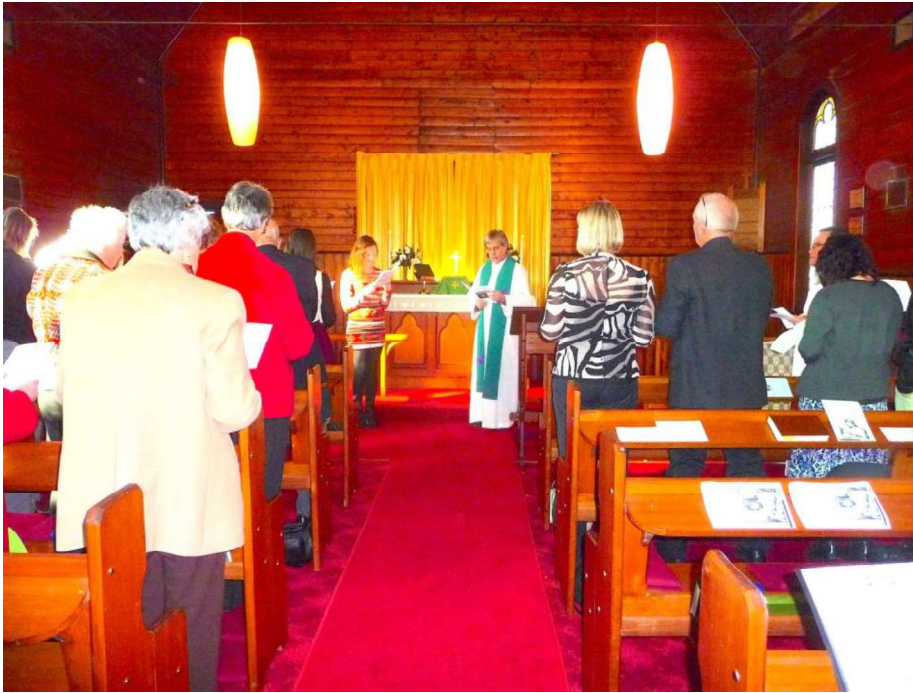
Figure D5. The interior of St George's looking towards the original timber furniture (see Fig H1) and the unpainted Baltic pine timber lined walls. (Helen Montague).

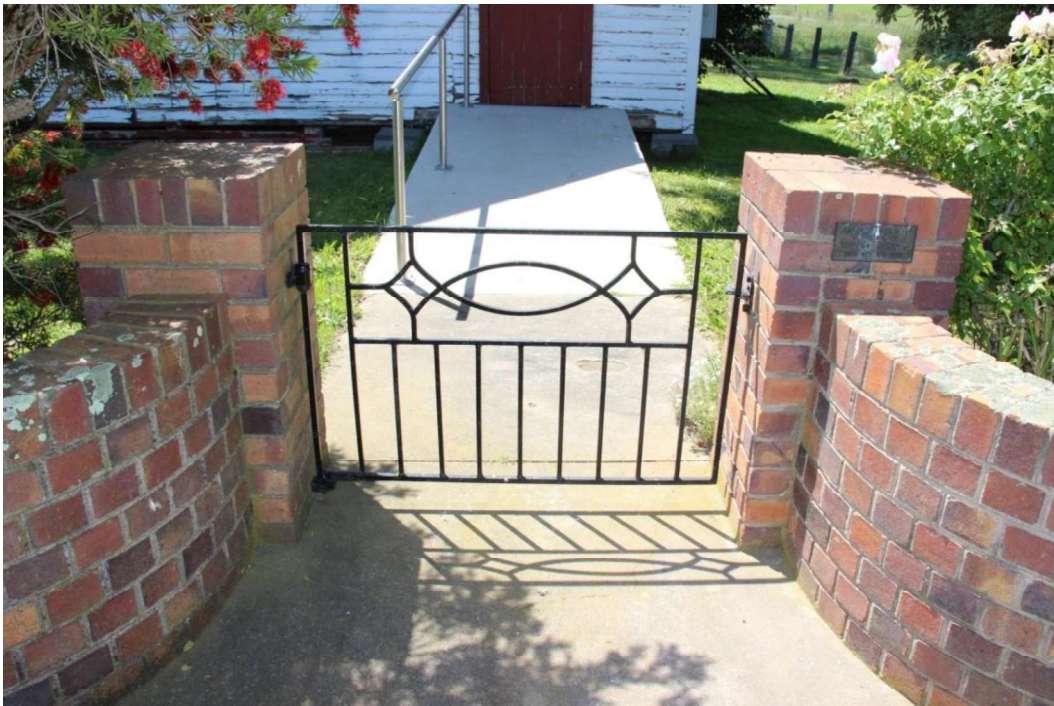
Figure D6. A 1950s brick fence and mild steel vehicular and pedestrian gates remain along the front (east) boundary. The brass plaque on the pier to the right of the gate states that it was erected in memory of Trevor Harvey, who died on 9 December 1952.

Figure D6. A 1950s brick fence with wrought iron vehicular and pedestrian gates remain along the front (east) boundary. A brass plaque on the pier to the right of the pedestrian gate records that the

fence was erected in memory of Trevor Harvey, who died on 9 December 1952. The fence and gates are in good condition and retain a very high level of integrity.
