Locality: MAFFRA
Place address: 14 CHURCH STREET
Citation date 2016
Place type (when built): Church, Hall, Rectory, Memorials, Trees, Lych Gate, Columbarium, Fence
Recommended heritage protection: Local government level
Local Planning Scheme: Yes
Vic Heritage Register: No
Heritage Inventory (Archaeological): No

Place name: St John's Anglican Church Complex

Architectural Style:	Victorian Gothic (former Guild Hall); Federation Gothic w/ Queen Anne components (Church); Interwar Arts and Crafts (Lych Gate); Federation Arts and Crafts Bungalow style (Rectory)
Designer / Architect:	W. A. Butler (church); Stephen P. Ashton (Lych Gate)
Builder	John Ashton (former Guild Hall), Alex Hardie (rectory)
Construction Date:	1889 (former Guild Hall); 1900 (church), 1912 (rectory)

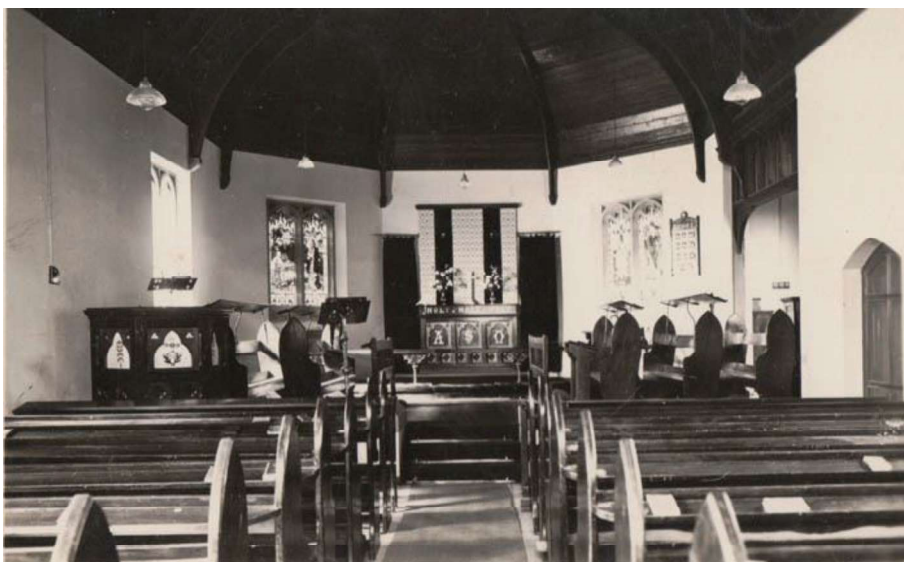
Figure H1. The interior of the church c1924. Note the Riggall memorial window on the left and the timber screen to the organ-chamber on the right (Rev A.J. Maher albums, Anglican Diocese Gippsland, provided by Linda Barraclough).

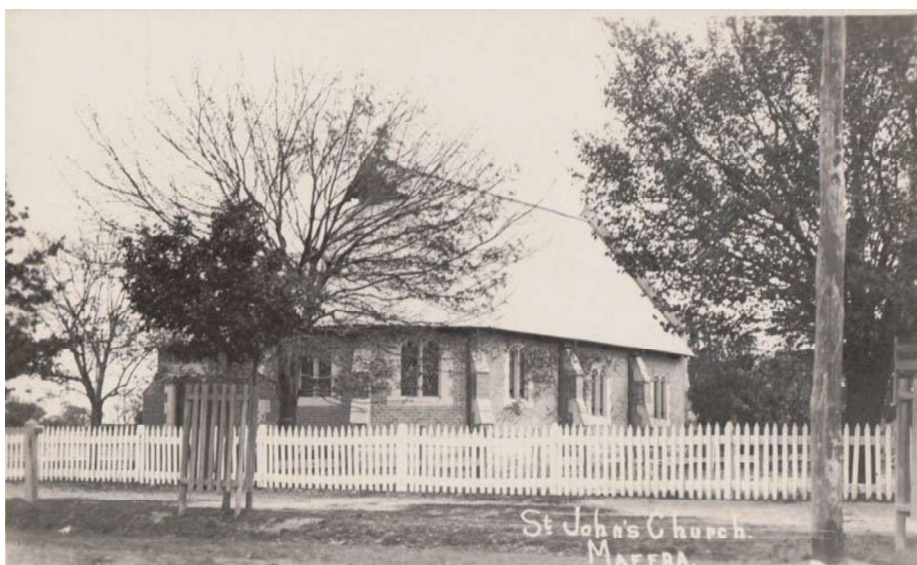
Figure H2. Early photo showing the north-east and south-east elevations, showing the chancel below the projecting gablet and to the right (the north-east elevation) comprised three bays broken up by buttresses (MDHS, ID. P02481VMFF).

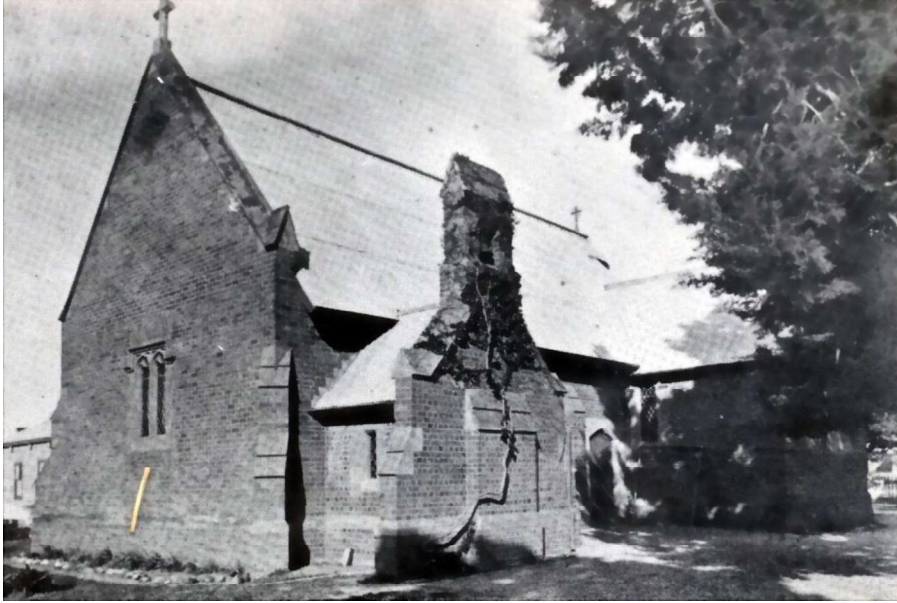
Figure H3. The north-west and south-west elevations (between 1900 and 1929). Note the cross at the apex of the gabled (since removed), the bellcote and the large entrance bay to the right (MDHS, ID. P02470VMFF).

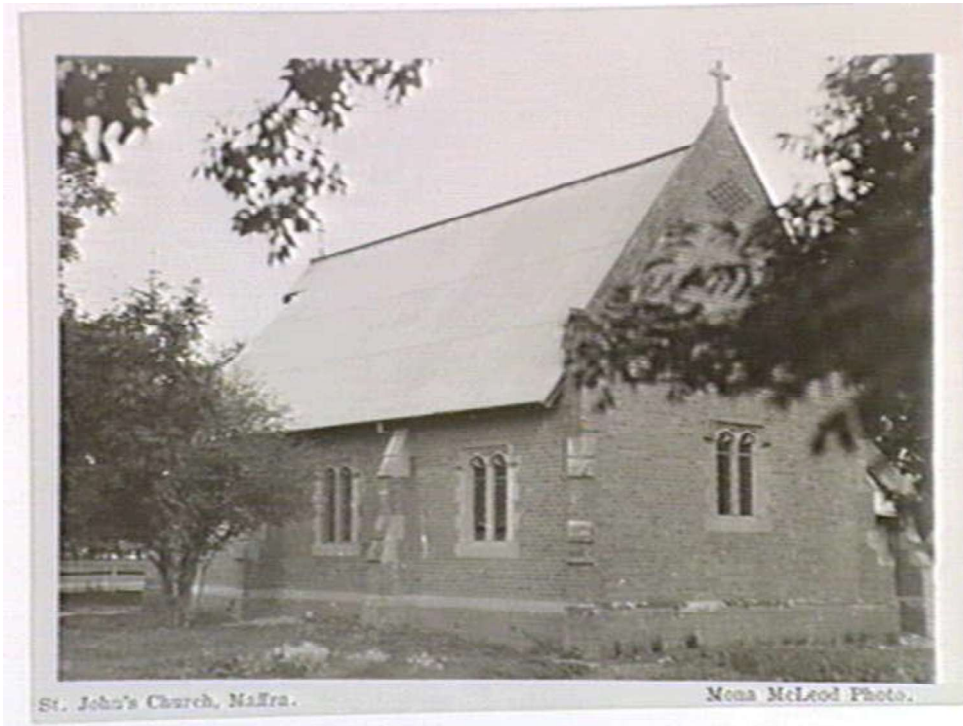
Figure H4. Photo inscribed 'St. John's Church, Maffra - May 1932', showing the north-west and north-east elevations of the church. The north-west elevation (before the 1968 addition was attached) comprised a pair windows (SLV, Image No: b51724).

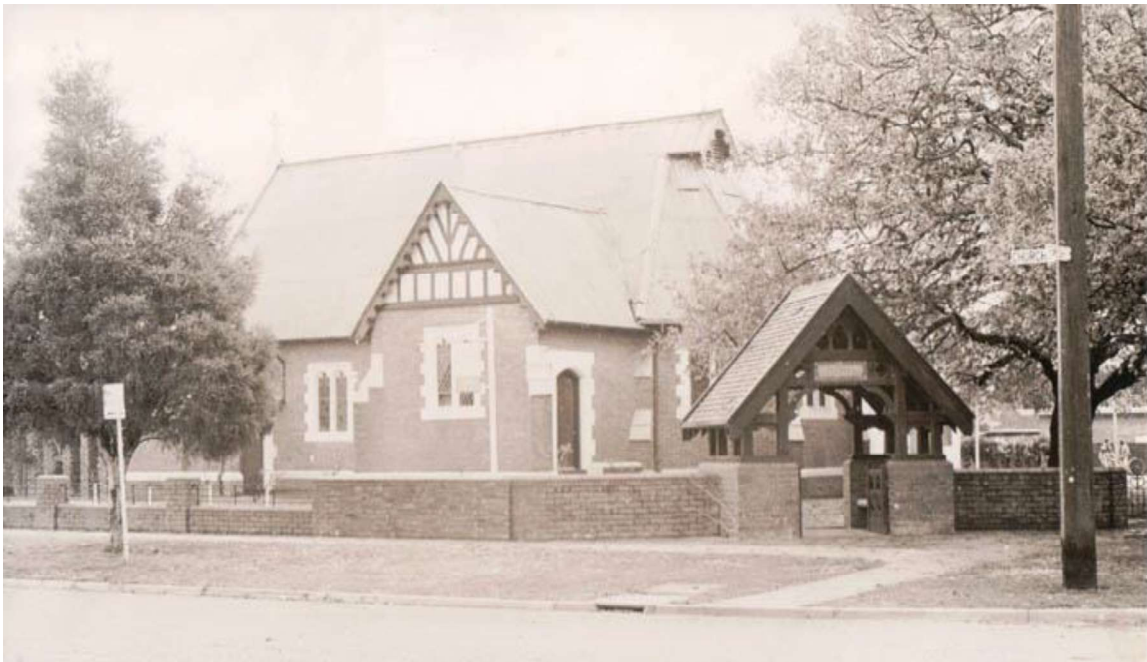
Figure H6. Photo of the Lych Gate and church complex from the south (photo dates post-1929 when the gates were erected) (MDHS, ID. P02480VMFF).

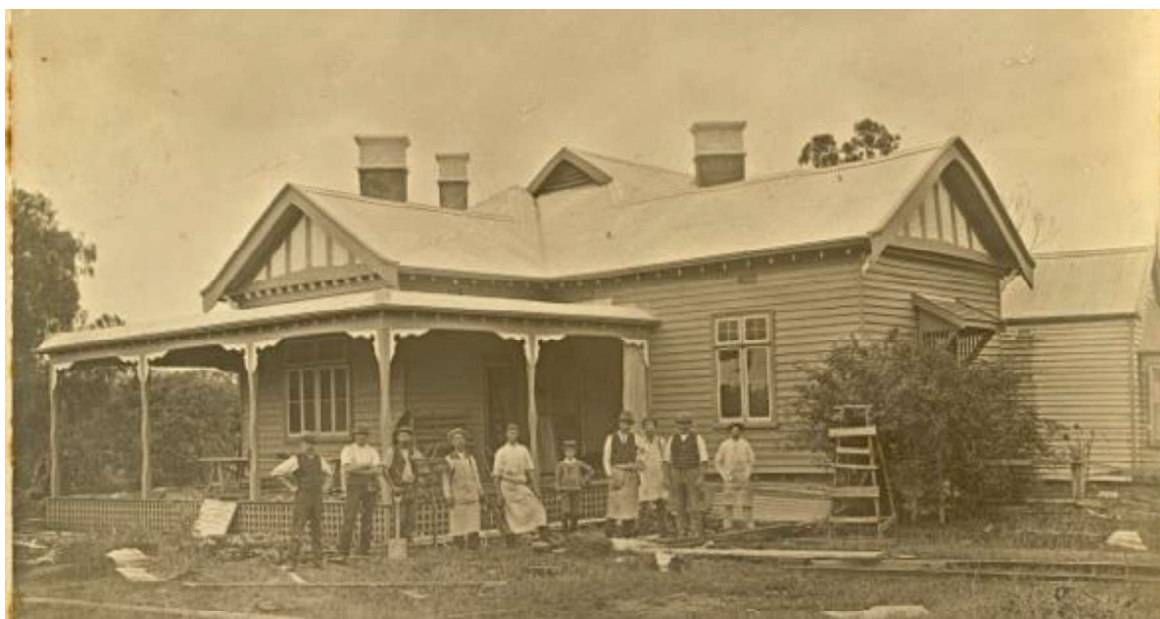
Figure H7. A 1912 photo of the almost-finished Anglican rectory at Maffra in 1912. A sign can be seen that notified that the building was being constructed by Alex Hardie, a well known Maffra builder (MDHS, ID. P04767VMFF).

St John's rectory was built in 1912 by local builder by Alex Hardie (MDHS) in the Federation Arts and Crafts style, to the west of the church (Figure H7). An article in the July 1910 reported that the decision was made to build a new rectory, to replace an earlier one on the same site which would be demolished (*Maffra Spectator*, 4 Jul 1910:3). The residence continued to serve as a rectory, but was vacant in 2015.

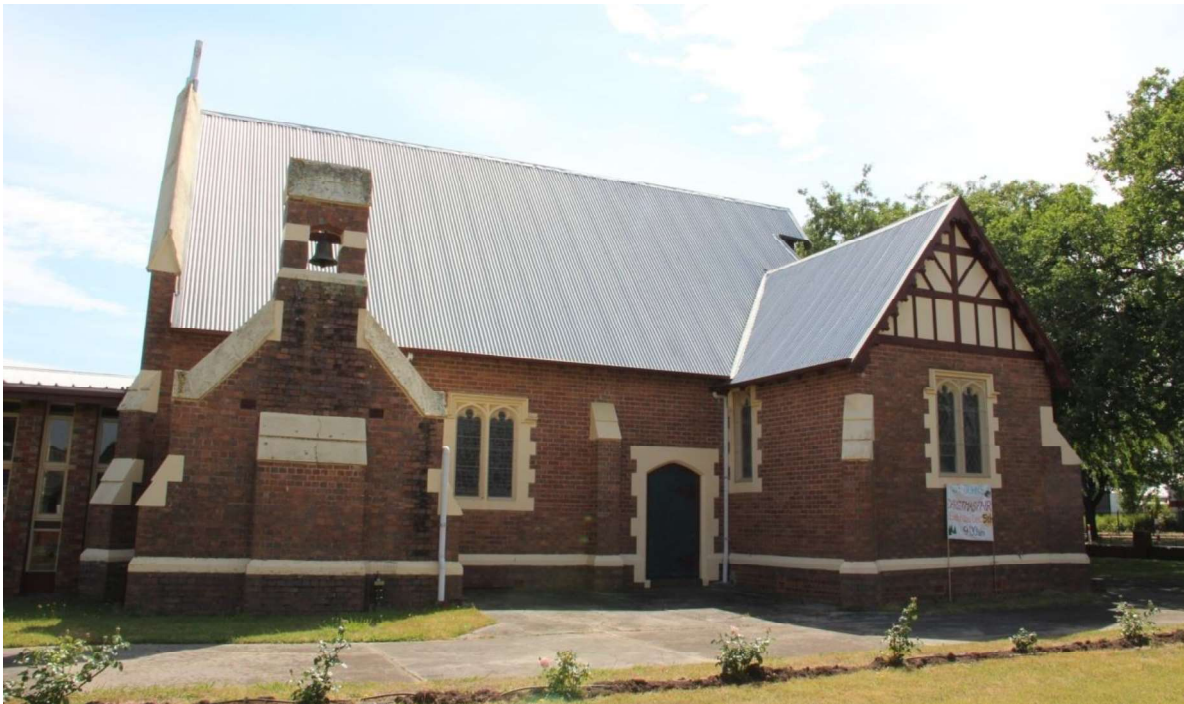
Figure D1. The brown brick church (1900) reflects the Federation Gothic style. It's steeply pitched gabled-roof is clad with (recent) corrugated iron and has a parapeted gabled to the north-west elevation. The south-west elevation fronting church street has the bellcote at the left end, which a parapeted gable and the details of the nave. To the right is the large gabled-end of the projecting entrance porch with the timber strapping forming a cross.

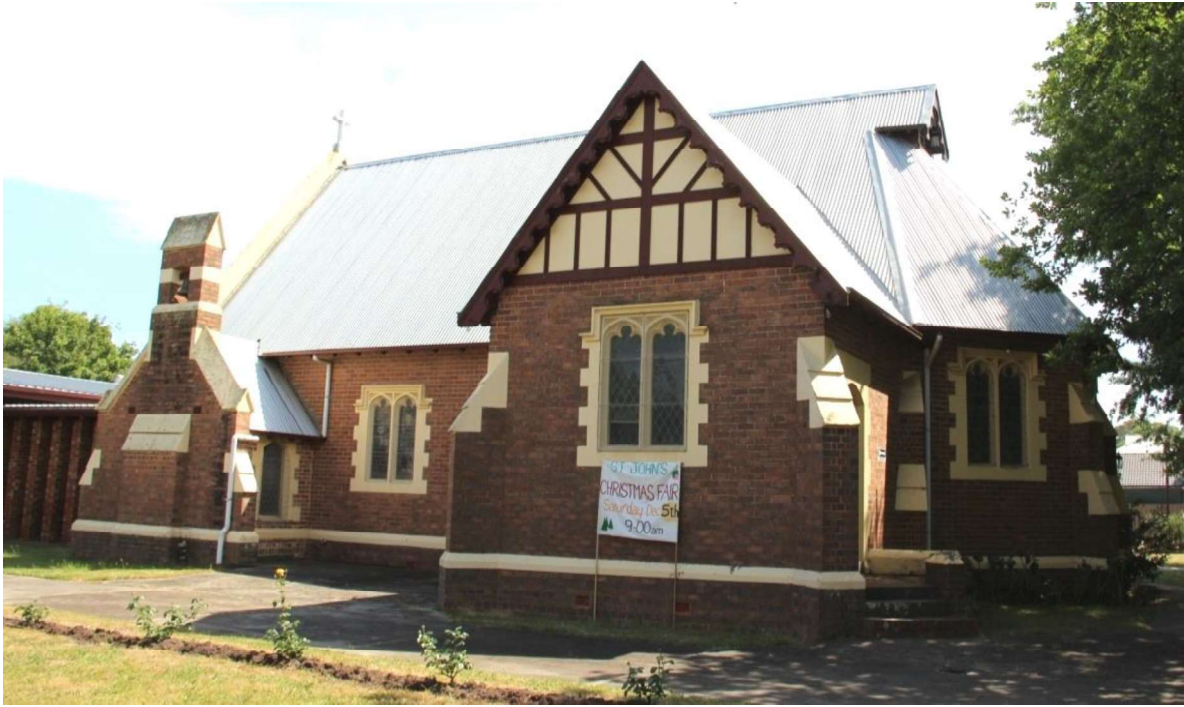
Figure D2. To the right, the south-east elevation has a flying gablette off the ridge, above the projecting bay of the chancel end with Queen Anne architectural detailing.

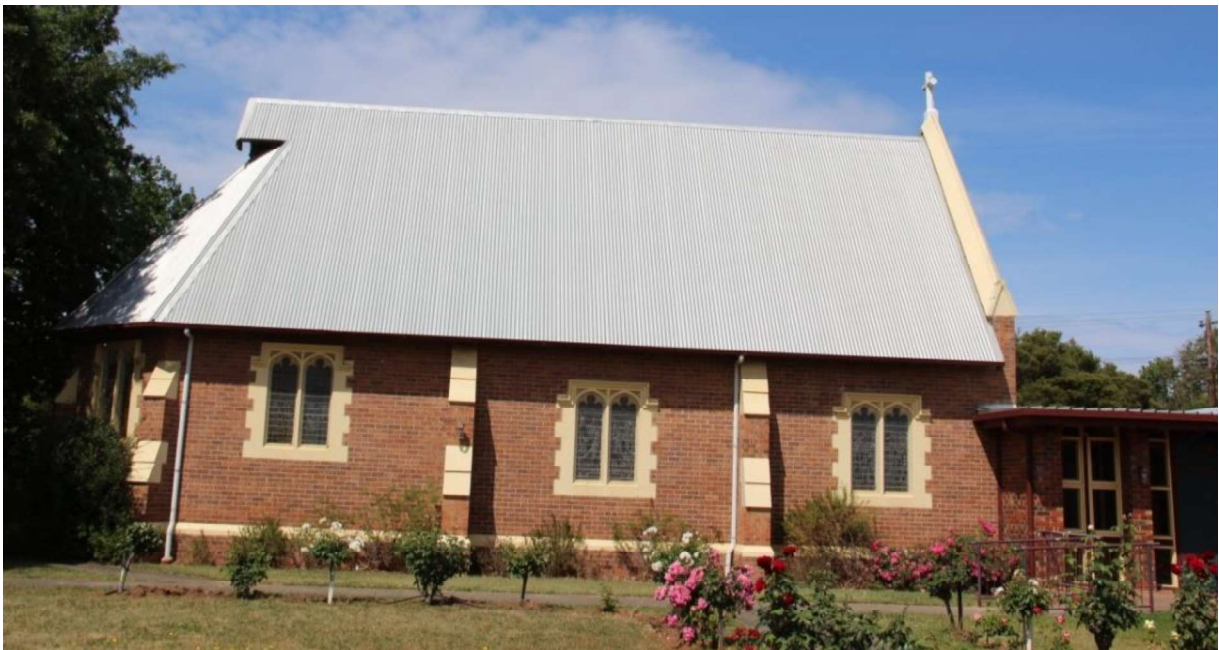
Figure D3. The north-east elevation comprises three bays, broken up by buttresses with rendered coping. Each bay has a pair of windows in the same detail as the rest of the church.

Figure D3. The north-east elevation comprises three bays, divided by buttresses with rendered coping. Each bay has a pair of windows in the same detail as the rest of the church. The windows at the chancel end of the church are raised, to allow for the internal platform. The 1900 brick church is in very good condition and retains a very high level of integrity.

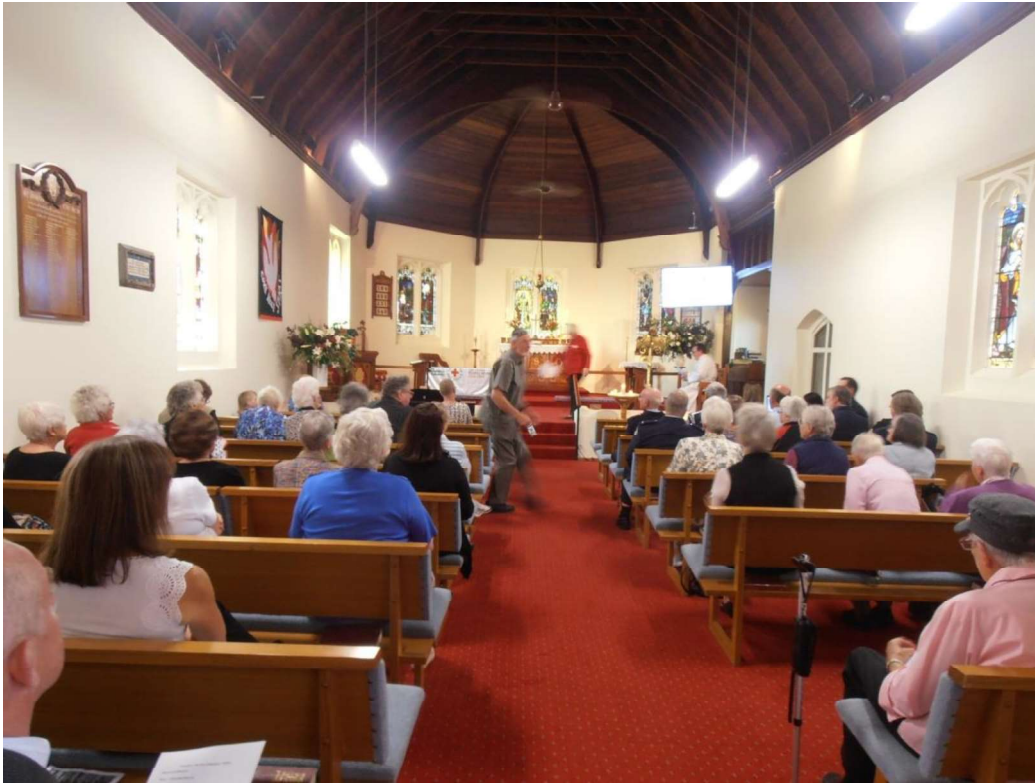
Figure D4. Interior of the church looking along the nave to the chancel. Note the organ gallery screen on the right (Helen Montague, MDHS).

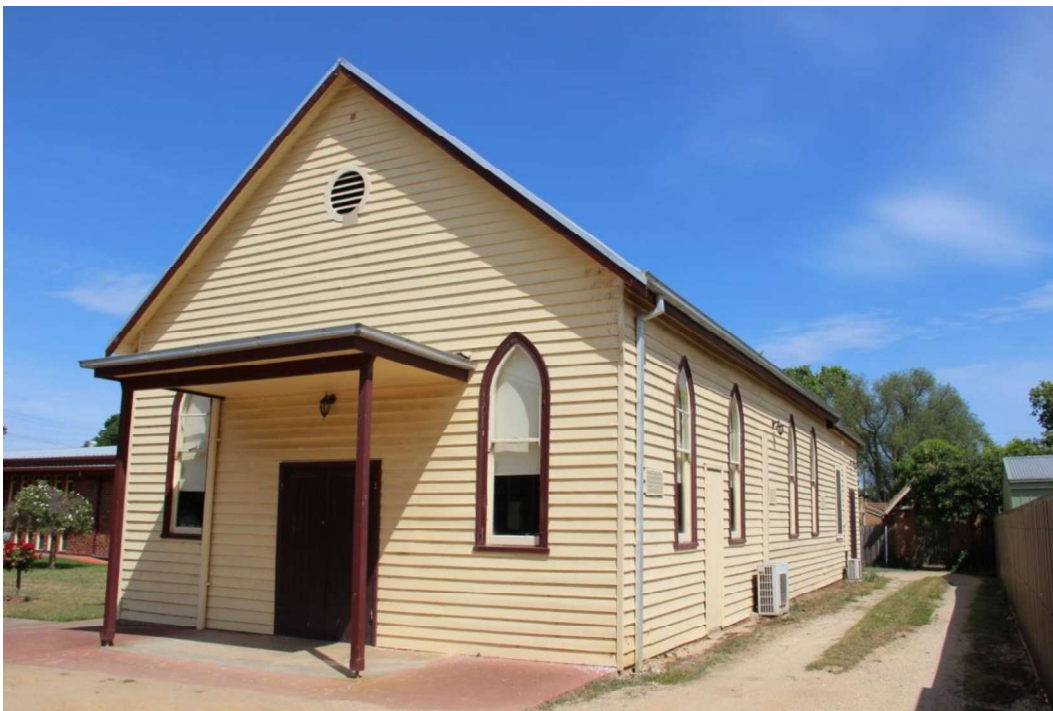
Figure D5. To the north of the church is the 1889 weatherboard hall. The long building has a gabled-roof clad with (recent) corrugated iron with a gabled end fronting Thomson Street, with pointed-arch windows.

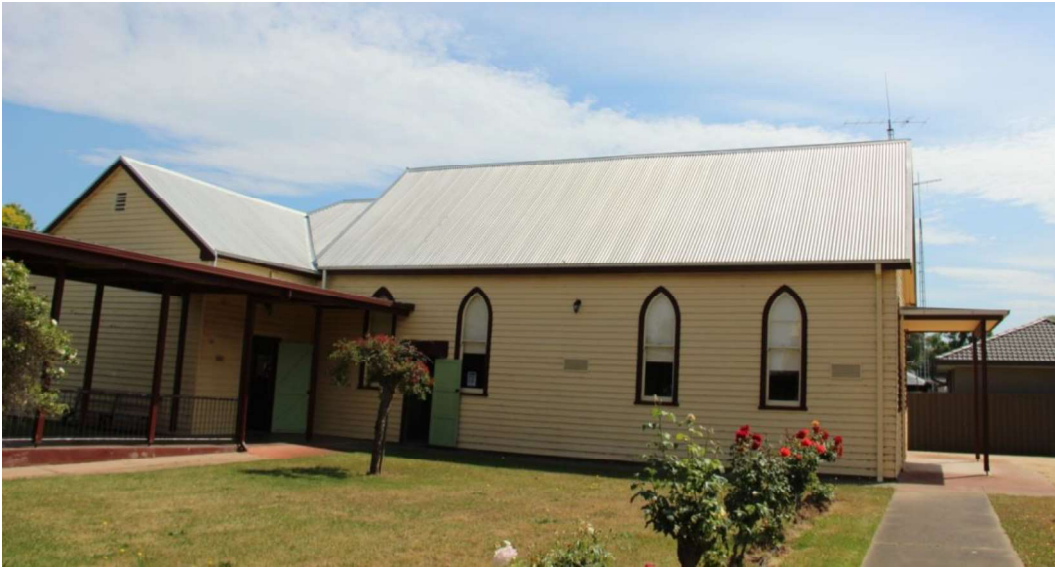
Figure D6. The side elevations of the church have four tall windows, and one or two doors on each side. To the rear of the church is a smaller weatherboard addition with a transverse gable.

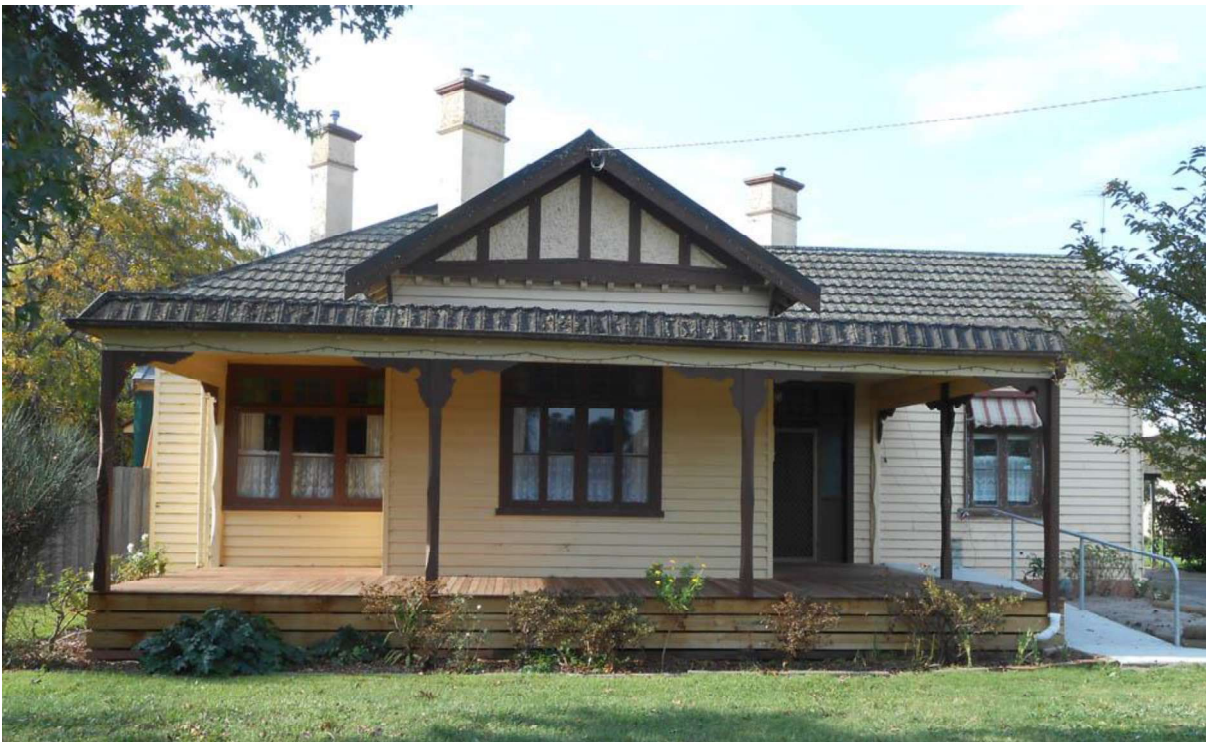
Figure D7. St John's Rectory to the north-west of the church is a large weatherboard residence with a complex hip-and-gabled roof clad in tiles, with exposed rafter ends to the eaves. The facade has a central projecting gabled-bay with rough-cast render and timber strapping to the gabled-end, creating a half timbering effect. (L Barraclough 2016)

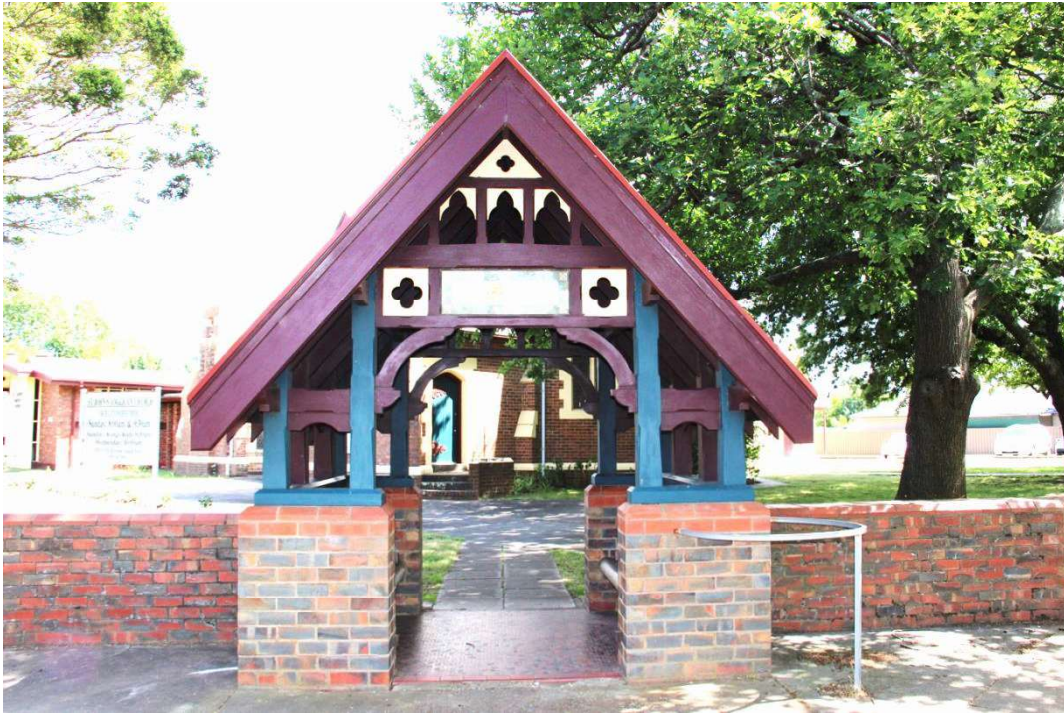
Figure D8. A picturesque Interwar Arts and Crafts, gabled-roof lych gate is located at the southern corner to the property. The roof is clad with slate and supported by posts with ornate timberwork with Gothic-inspired foil motifs. Adjoining the gate are the brick columbarium, which holds a number of plaques, and memorial brick fence with mild-steel railings.

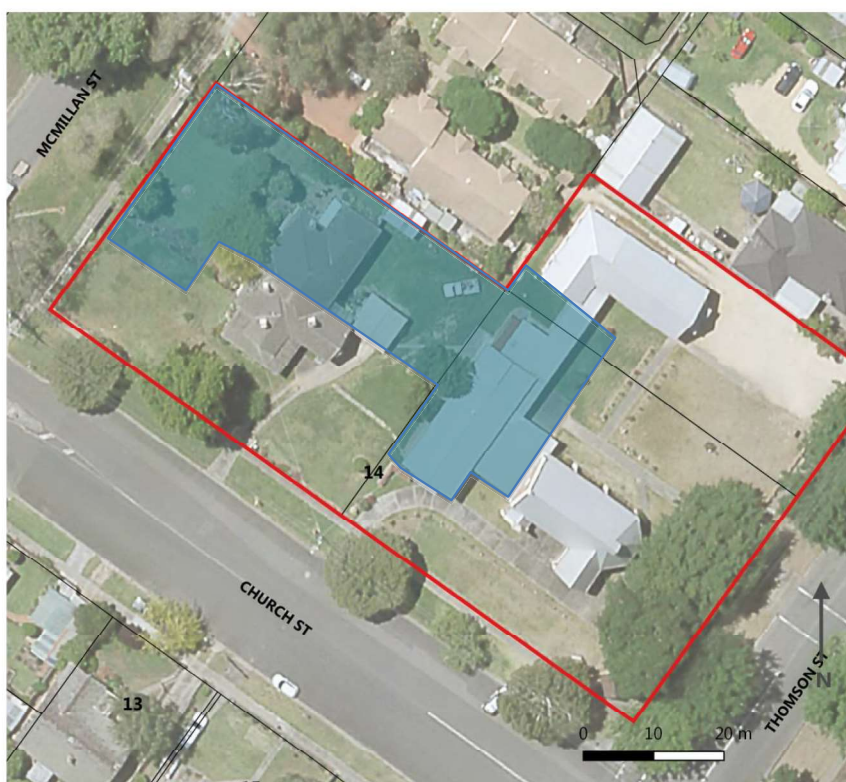
NOTE: The blue shaded area is the preferred location for additions and new development
