Locality: MAFFRA
Place address: 50 JOHNSON STREET
Citation date 2016
Place type (when built): Bank
Recommended heritage protection: Local government level
Local Planning Scheme: Yes

Place name: Commercial Bank of Australia (former)

Architectural Style: Federation Free Style
Designer / Architect: Hyndman & Bates (1898)

Project: Wellington Shire Stage 2 Heritage Study
Client: Wellington Shire Council
Author: Heritage Intelligence Pty Ltd
Date: 12/2/16

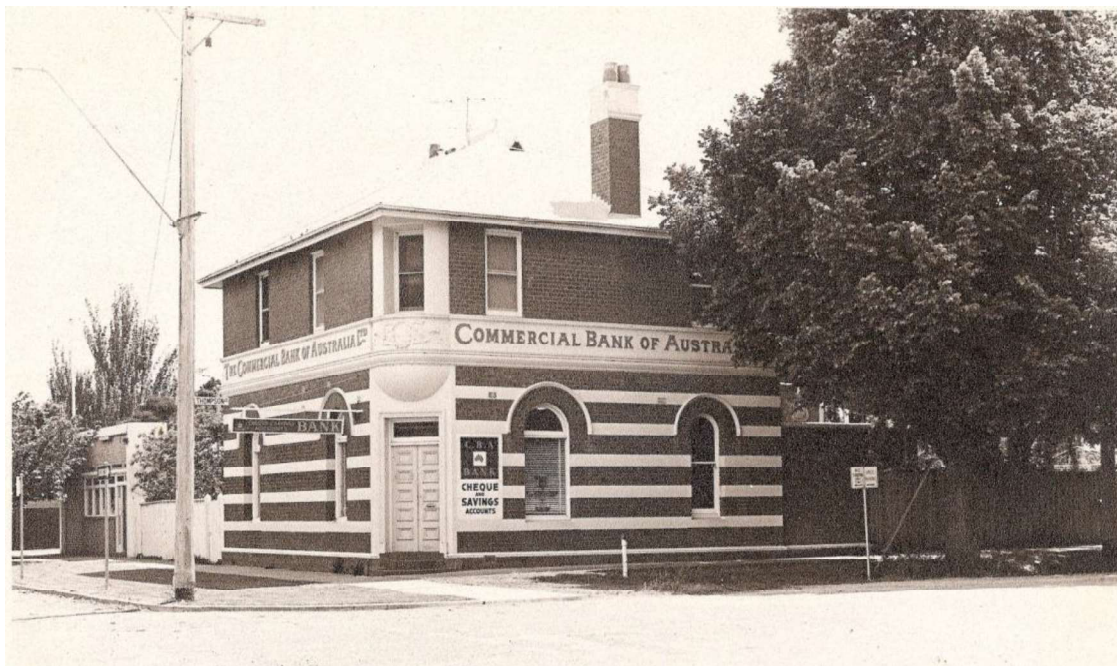
Figure H4. The bank at an unconfirmed date, when it still served as the Commercial Bank of Australia (pre-1990s). It illustrates that by this date the bank had painted rendered decoration (MDHS, ID. P02055VMFF).

A later photo (date not known) (MDHS) showed the bank from the south when still operating as the Commercial Bank of Australia (Figure H4). The two facades appeared as they do in 2015. The formerly unpainted cement render details had been painted bright white/cream by this date. The words 'Commercial Bank of Australia Ltd' still appeared on the cement rendered band, and the emblem to the corner was also intact. The glass entrance doors had been replaced with a pair of solid panelled doors, retaining the highlight. To the north of the two-storey building (on the east boundary) was the tall brick wall, before a tall fence. A sign 'CBA Bank, cheque and savings accounts' appeared to the right of the entrance. A long sign projected from the left of the door (over the footpath) reading 'Bank' (after indistinguishable words).

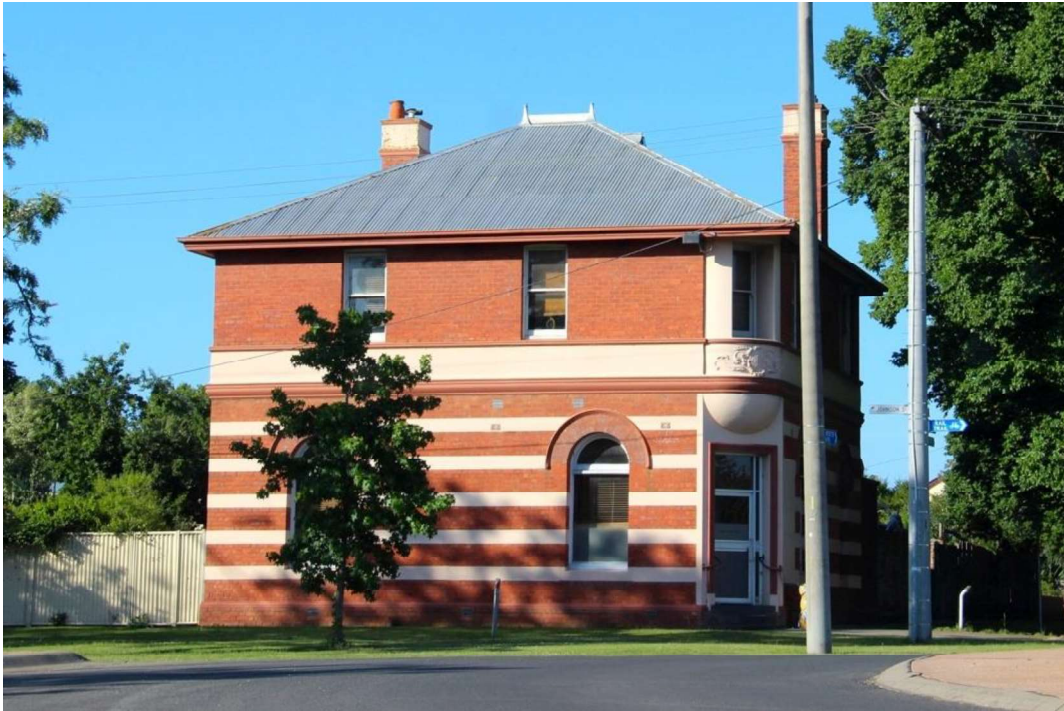
Figure D1. The Johnson Street elevation with the chamfered corner entrance and projecting oriel balcony.

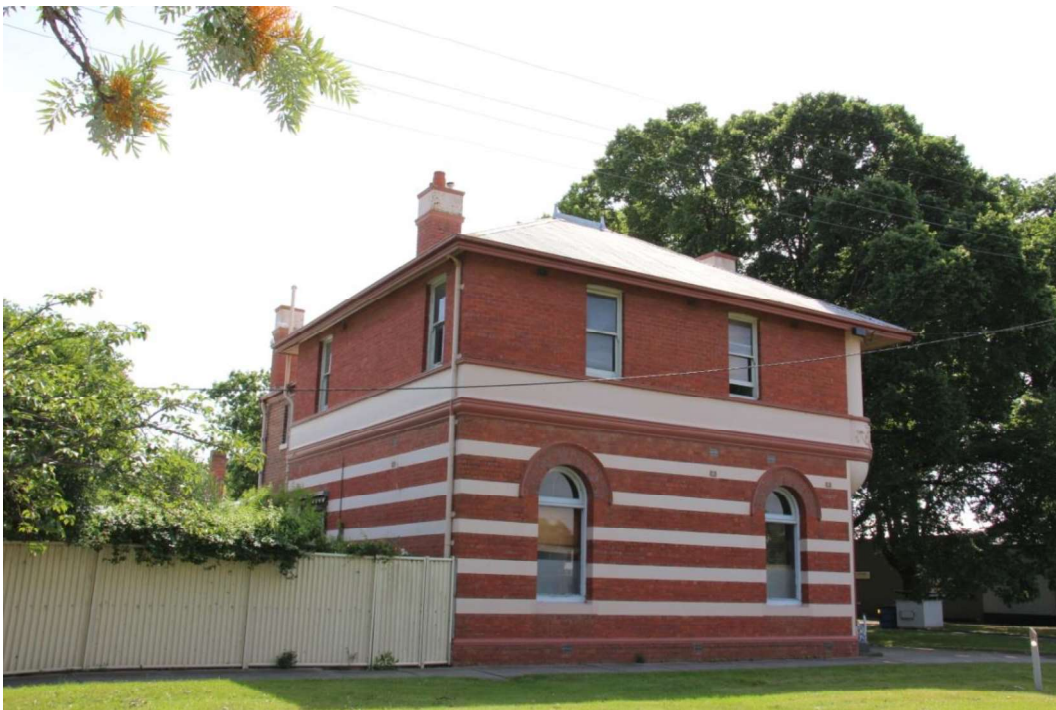
Figure D2. The north-west and south-west elevations. The chimneys are consistent in style on the front and rear portions of the building.

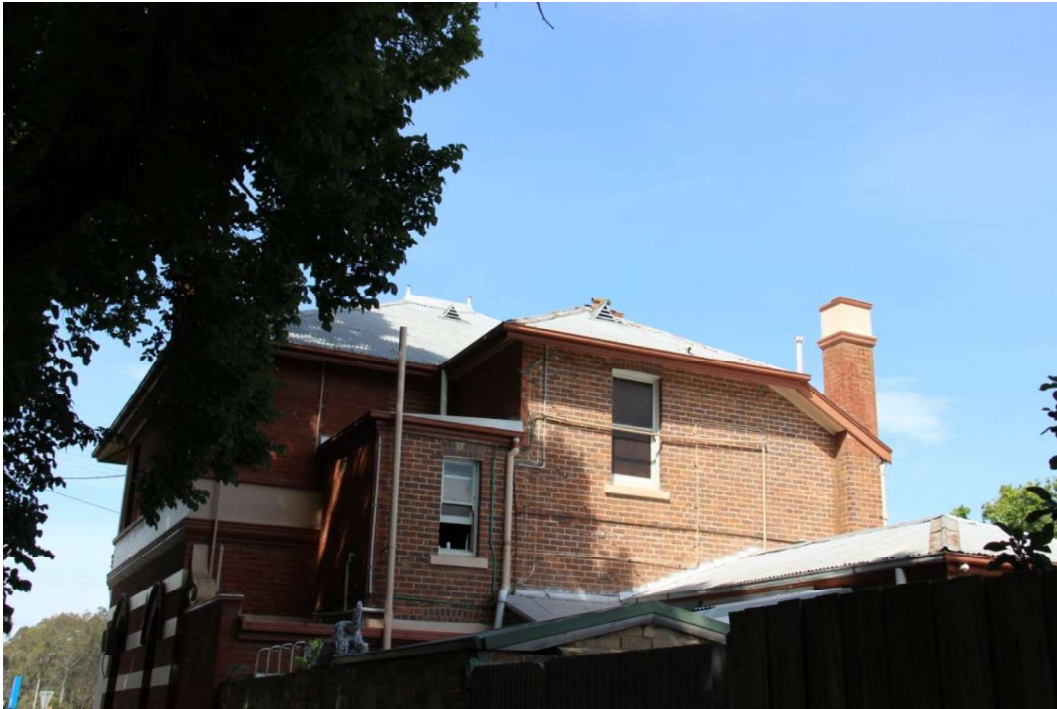
Figure D3. The rear elevation constructed of brown brick (not tuckpointed), and the northern roof faces with the triangular roof vents. The hipped roof of the single-storey portion of the building is evident; the tall corbelled-brick chimney is just out of frame to the right.

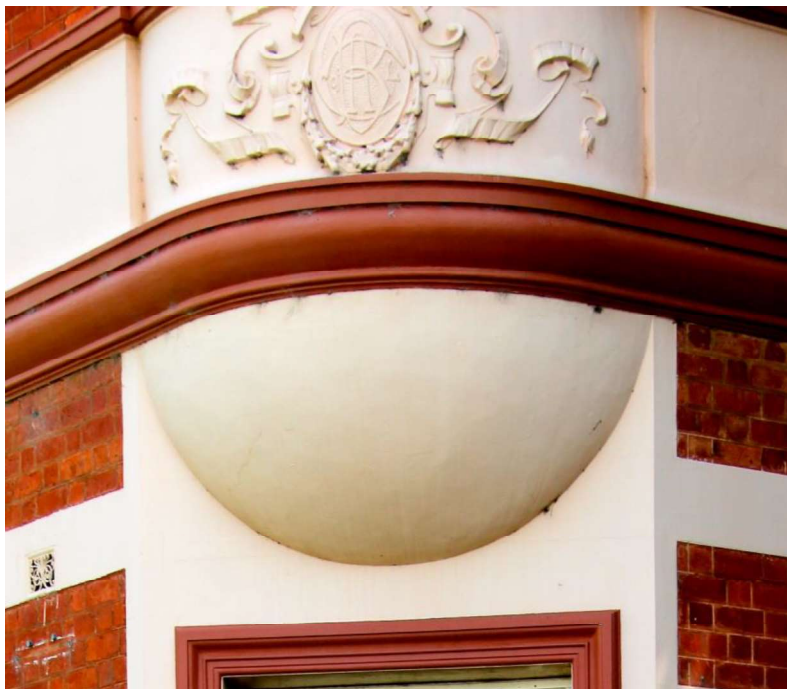
Figure D4. Detail showing the oriel balcony, rendered moulding, flat rendered bands, bank insignia in relief render, decorative wall vent and tuckpointed red brickwork. All the render on this building was originally unpainted and remained that way for about 80 years.

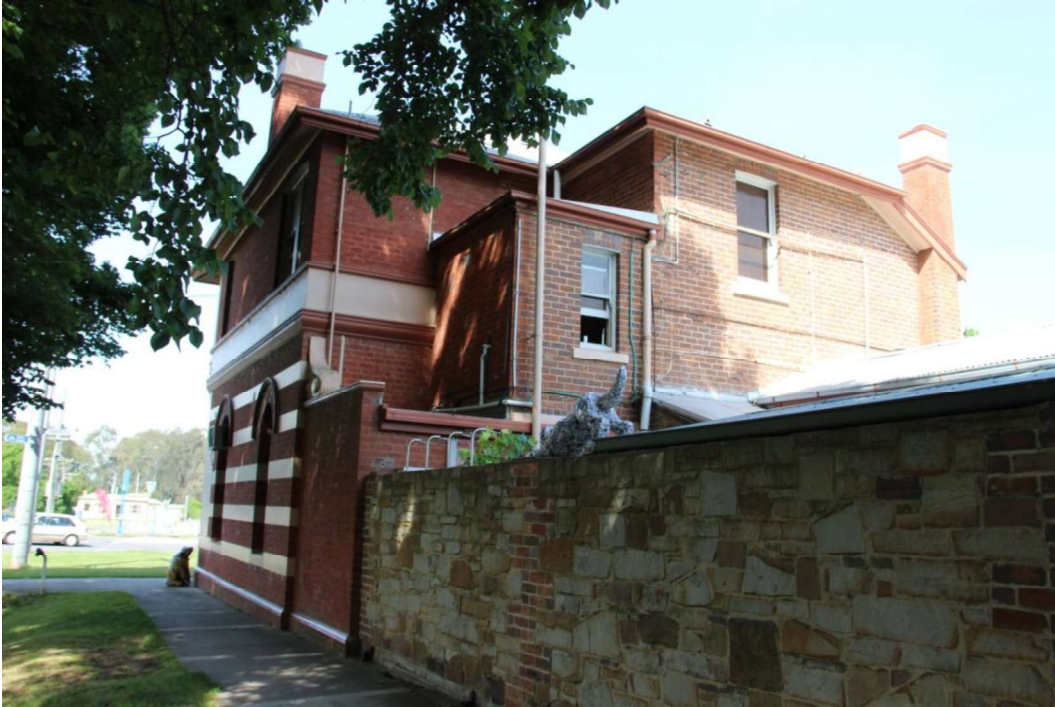
Figure D5. The rear (north-east) elevation. This boundary comprises the original tall red-brick wall with rendered scroll bracket, and the post--2000 sandstone wall with red brick quoins.

Figure D5. Attached to the building, along the south-east boundary is a tall 1898 red brick wall (appears to be the wall of a room attached to the rear of the building) with rendered scroll bracket. Following this on the boundary is a post-2000 random rubble sandstone wall with red brick quoining, which also forms the wall of a recent outbuilding.

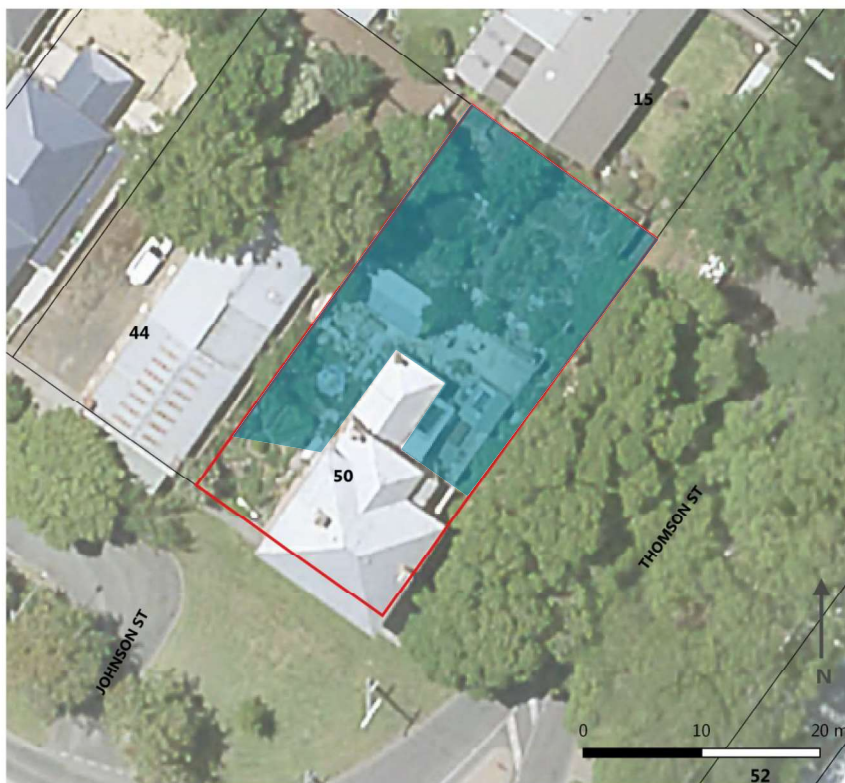
NOTE: The blue shaded area is the preferred location for additions and new development.
