Locality: STRATFORD
Place address: Lot 8 (LP215327) & 28 MCFARLANE STREET
Citation date 2016
Place type (when built): Church, Hall, Rectory, Memorials
Recommended heritage protection: Local government level
Local Planning Scheme: Yes
Vic Heritage Register: No
Heritage Inventory (Archaeological): No

Place name: Holy Trinity Anglican Church, Hall, Rectory & Memorials

Architectural Style: Victorian Free Gothic & Federation Free Gothic (church); Federation Carpenter Gothic (hall); Federation Arts and Crafts (rectory)
Designer / Architect: Not known
Construction Dates: 1868, 1880s, 1907 (church); 1901 and later (hall); 1910 (rectory)

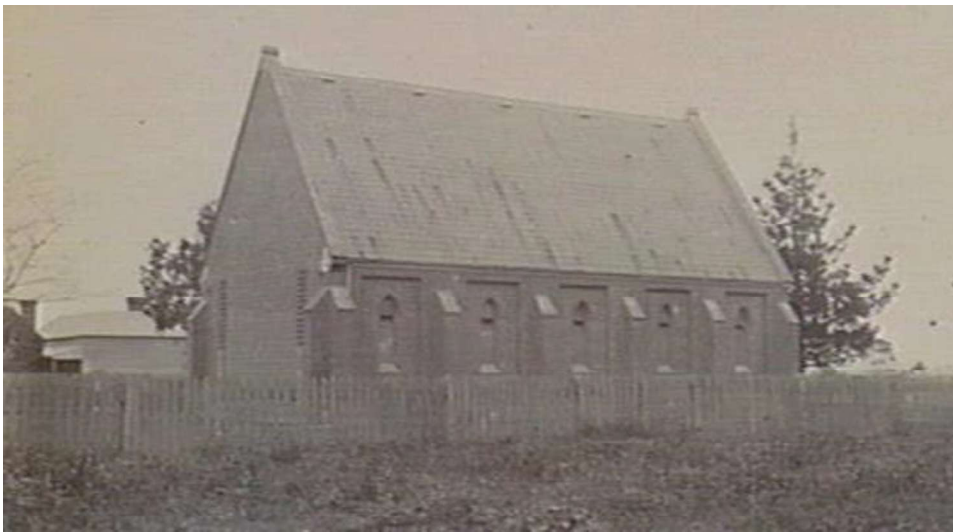
Figure H1. A photo dating between c1894 and c1907 that showed the brick church with slate roof, from the north-east, before the chancel was constructed (in 1907). To the south of the church there was a hipped-roof house which may have been the first rectory. (SLV).

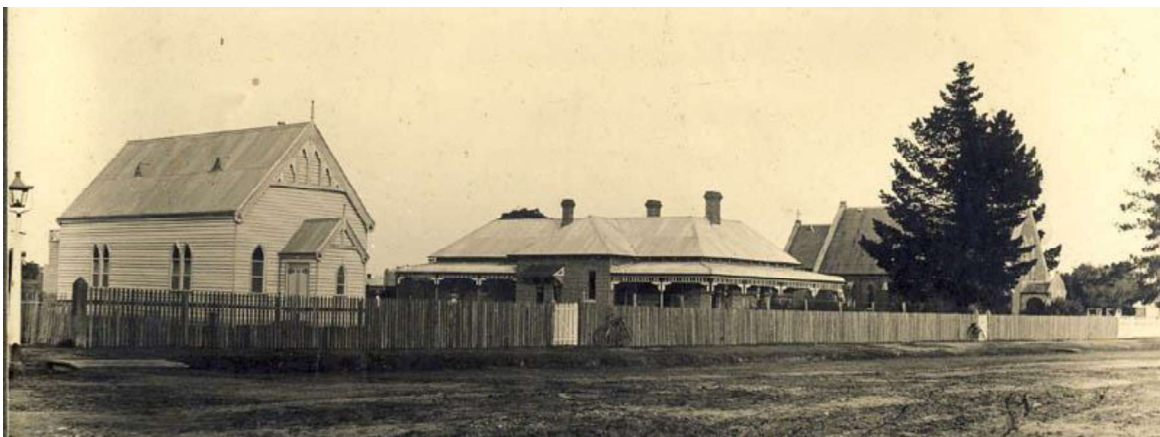
Figure H2. A photo dating post-1910 showed the complex from the north. At the north end was the timber hall with lapped corrugated iron and roof vents, and finial, in its original location, the brick rectory with lapped corrugated iron roof cladding, was central and the church was at the south end, behind a pine tree. Note the long picket fence. (SDHS).

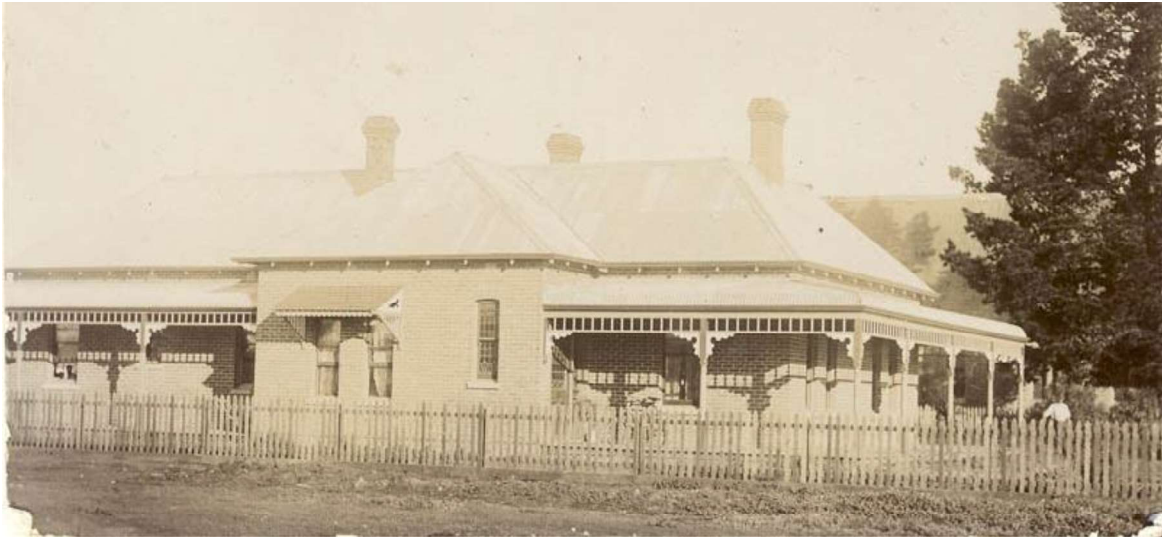
Figure H3. An early photo (post-1910; when the rectory was built) showed the north elevation of the rectory in more detail and the long picket fence. (SDHS).

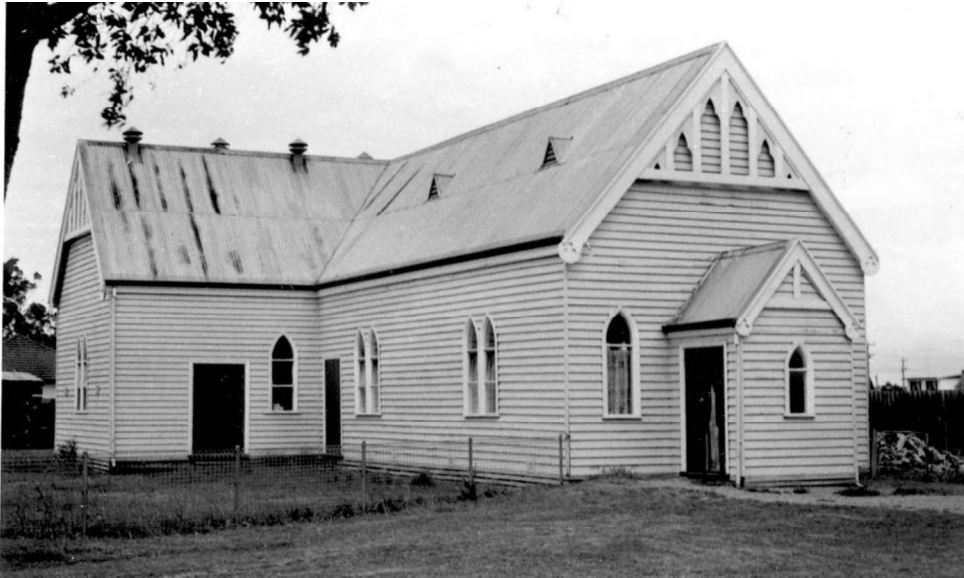
Figure H5. A photo dating to 1980 that showed the timber hall in its original location to the north of the rectory. At this date the hall comprised the entrance porch, the original gabled-roof section clad in galvanised corrugated iron, and the large transverse-gable section at the rear, projecting to the north (SLV).

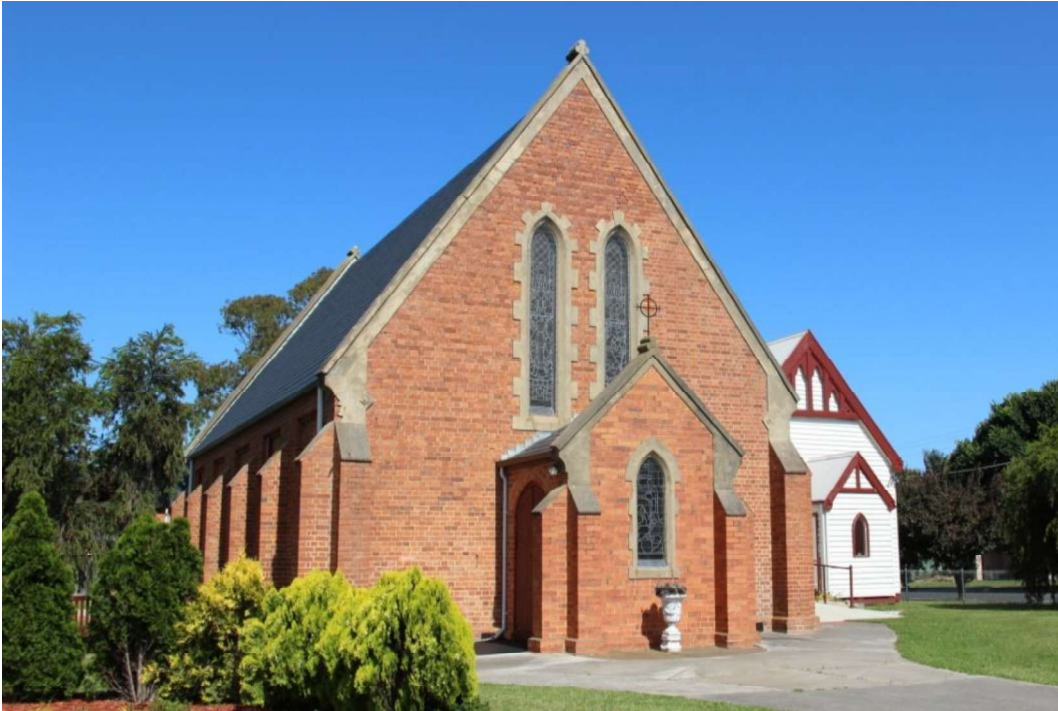
Figure D1. The church is constructed of handmade red brick in an English bond, with a small brick plinth and steeply-pitched gabled roof clad in slate. To the facade, rendered dressings (not painted) are applied to the parapeted gables, buttresses, and to the window surrounds with a quoining pattern to the sides.

The 1868 church, with its 1880s and 1907 additions are in very good condition and retain a very high level of integrity.

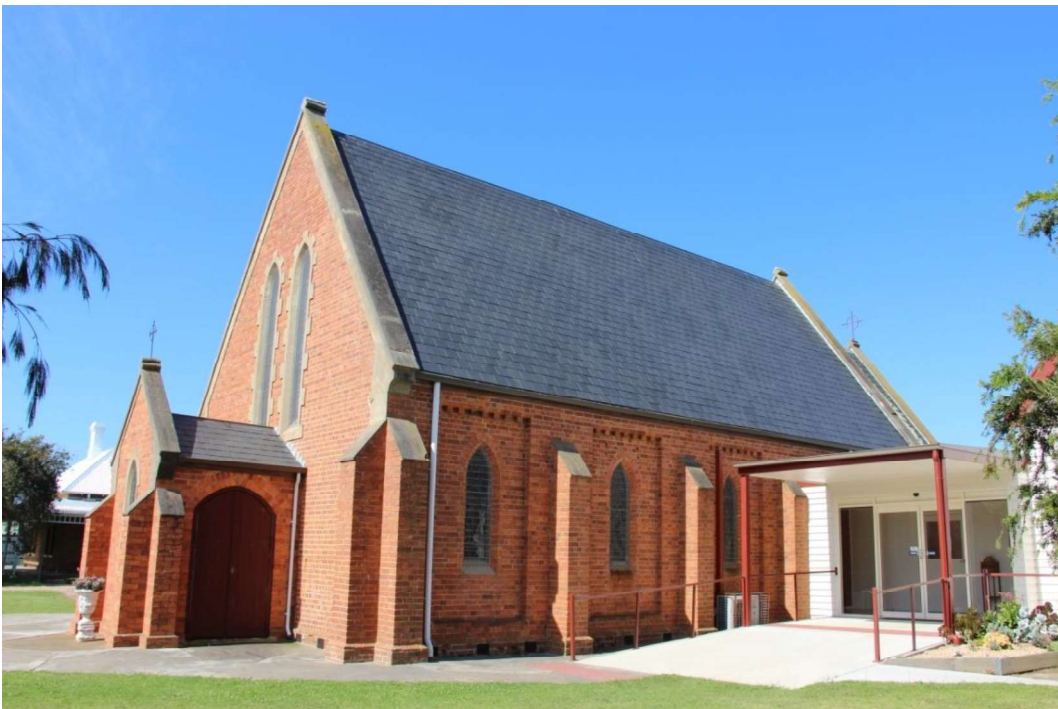
Figure D2. The south elevation. The side elevations comprise five bays, created by buttresses. Each bay has a slightly recessed panel with a row of corbelled bricks at the top. Each bay has a pointed-arch window with radiating voussoirs above and pictorial leadlight. A modern building connects part of the south elevation of the church (enveloping the two rear bays) and weatherboard hall to the south.

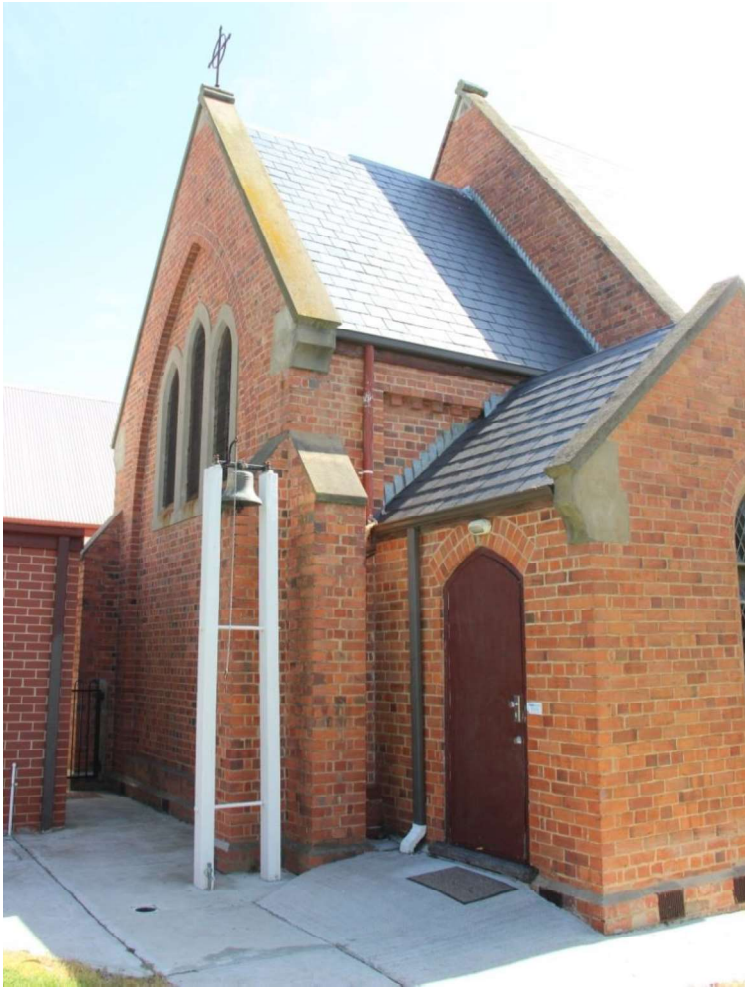
Figure D3. At the rear (east) end of the church is a large chancel (1907) with a group of three pointed-arch windows with rendered surrounds and pictorial leadlight. Projecting off the north side of the chancel is a small vestry (1907) with the same architectural details as the nave and chancel. Concrete has been built up to floor level at the doorway. A small timber bell tower stands at the rear (east end) of the church.

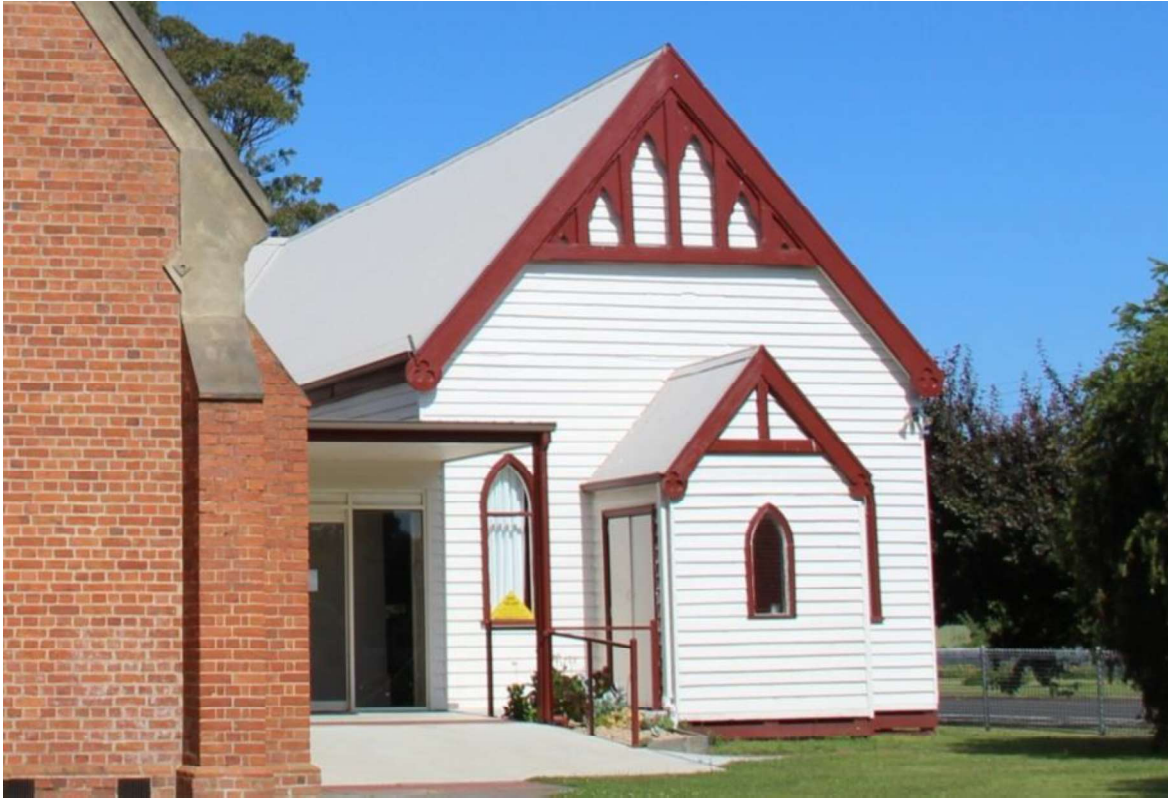
Figure D4. The 1901 weatherboard hall to the south of the church has a steeply-pitched gabled roof clad with (recent) corrugated iron, with a decorative timber valence to the gabled end of the facade. The wide bargeboards finish at the ends with lobes with a trefoil motif. A central entrance porch imitates the details of the elevation behind.

The weatherboard hall, comprising the 1901 building and later addition in the same style, are in very good condition and retain a medium-high level of integrity

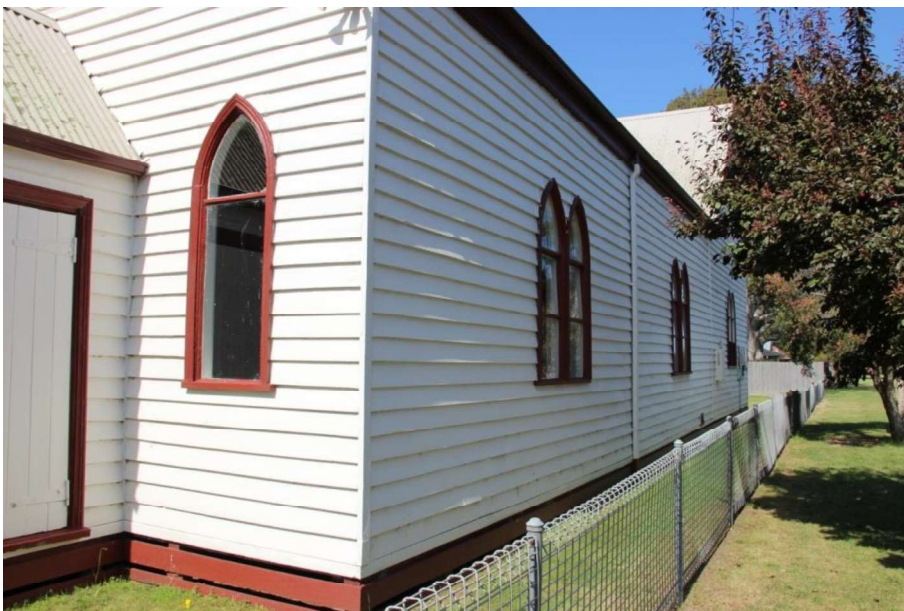
Figure D5. The south elevation of the hall has three pairs of pointed-arch windows (with clear glass) with central hoppers. There is excellent underfloor ventilation between the gaps in the base boards.

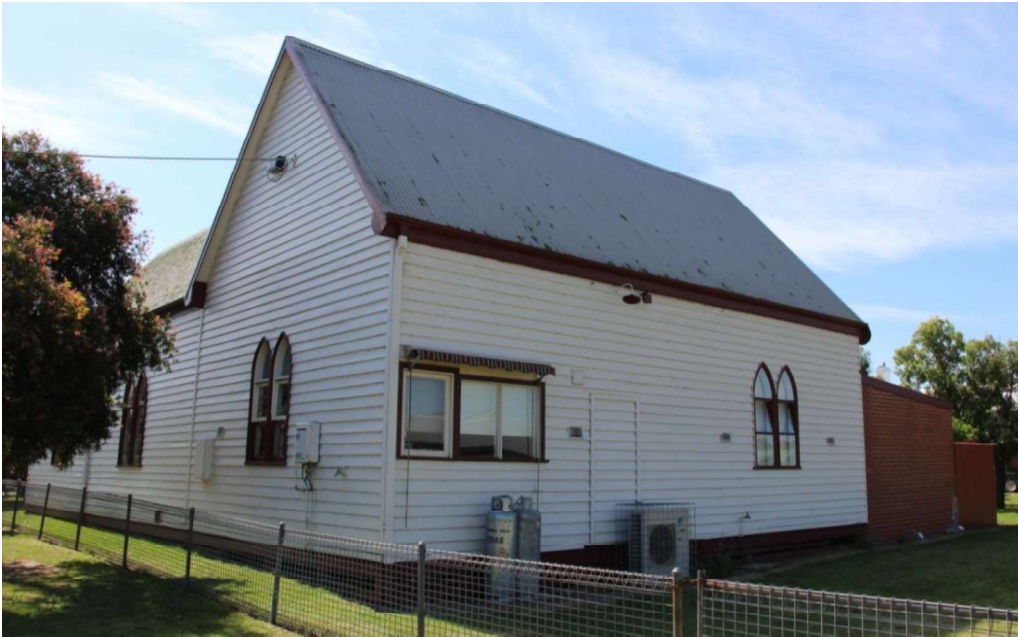
Figure D6. The east (rear) section of the hall is a weatherboard building with a transverse gable. The section contains pairs of pointed-arch windows in the same style as the 1901 building, but also has later square-headed timber-framed windows to the rear elevation.

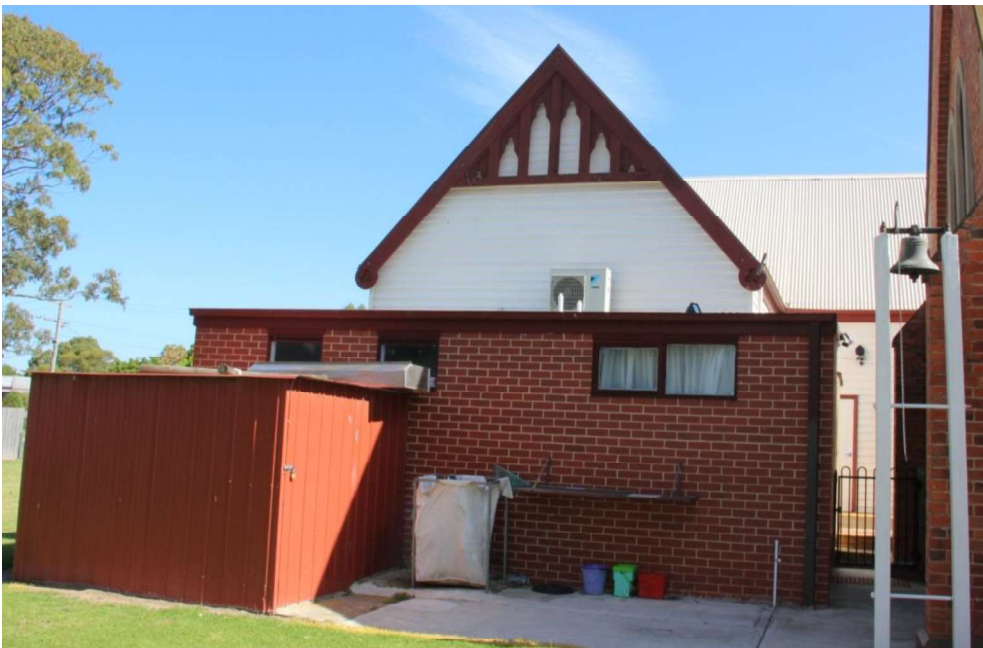
Figure D7. The gabled-end of the north elevation of the rear section of the hall retains the bargeboards and timber valance that imitate those of the facade of the 1901 hall. A modern brick addition is attached to rear of the hall.

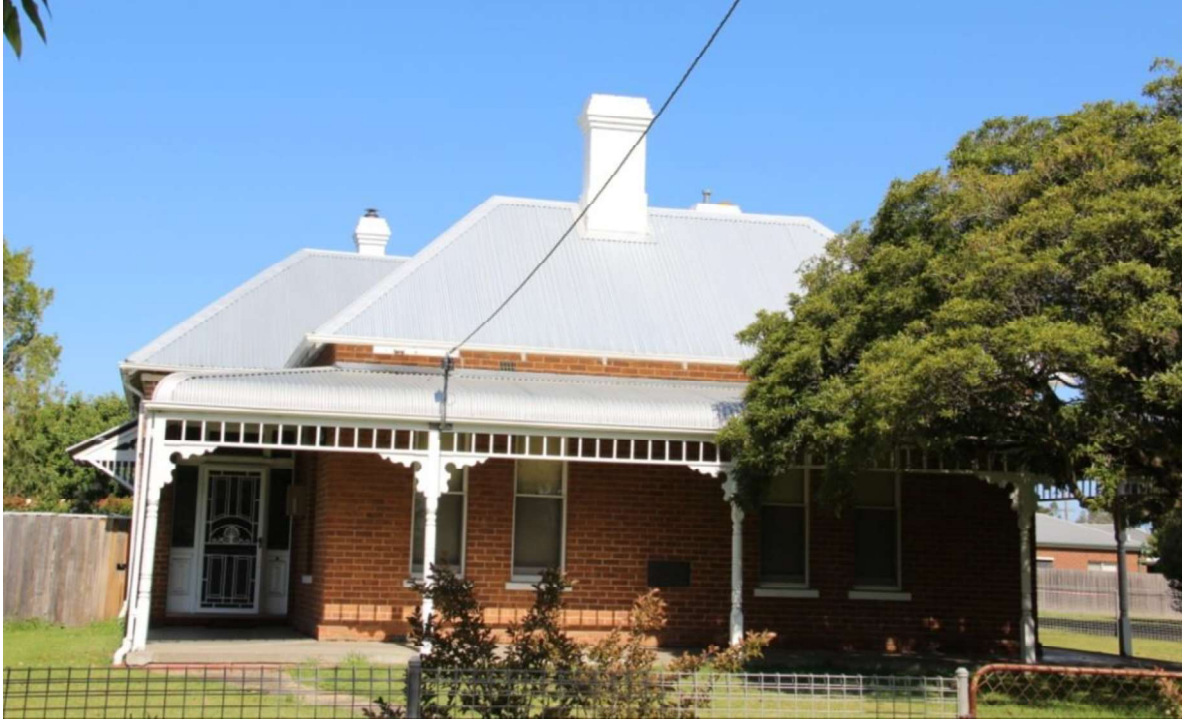
Figure D8. The 1910 rectory is a substantial brick residence with a large M-hip roof clad in (recent) corrugated iron, retaining three (overpainted) corbelled brick chimneys. A verandah with a bull-nosed profile and a concrete floor, returns on the north and south elevations, stopping at projecting hipped-roof bays.

The 1910 brick rectory is in very good condition and retains a very high level of integrity.

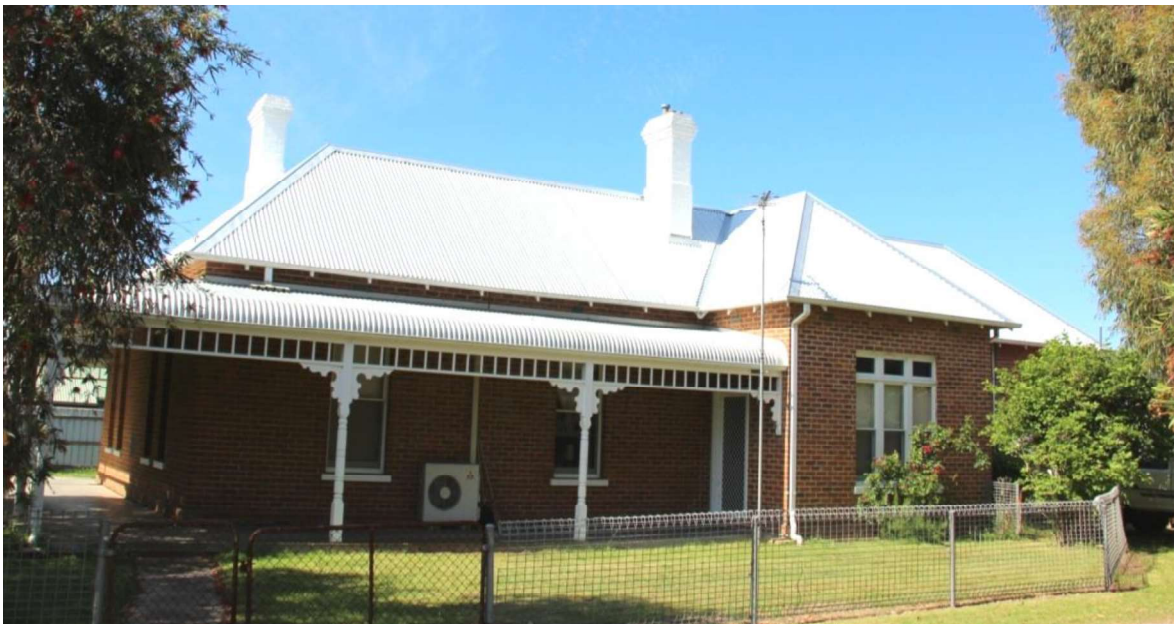
Figure D9. Windows underneath the verandah are tall narrow one-over-one sash windows, while the projecting bay on the south elevation has a large group of windows comprising three narrow one-over-one sash windows with coloured highlights. All windows have (overpainted) rendered (or stone) sills.

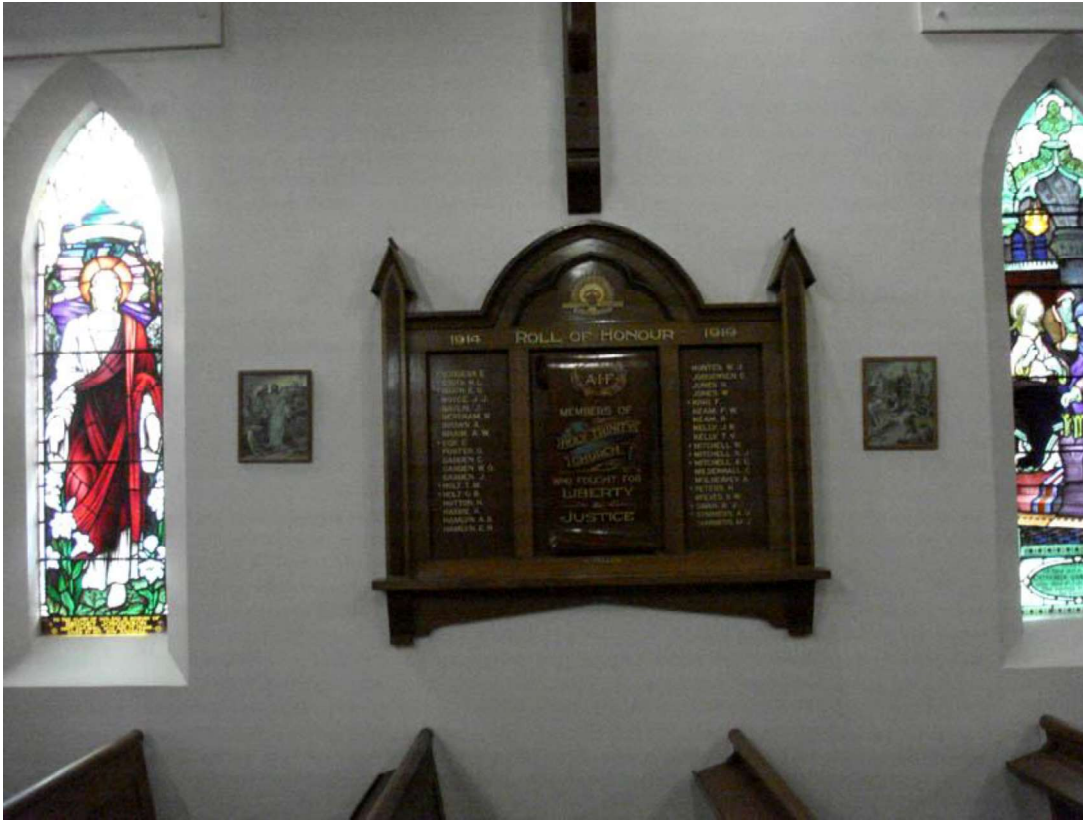
Figure D10. The World War I Honour roll is retained inside the church. Either side are pictorial leadlight windows. (Barraclough, photo dates to 2009).

Figure D10. The World War I Honour roll is retained inside the church. Either side are pictorial leadlight windows.
