# Final Study Report

## Latrobe River Flood Study

Prepared for  
West Gippsland CMA

March 2015

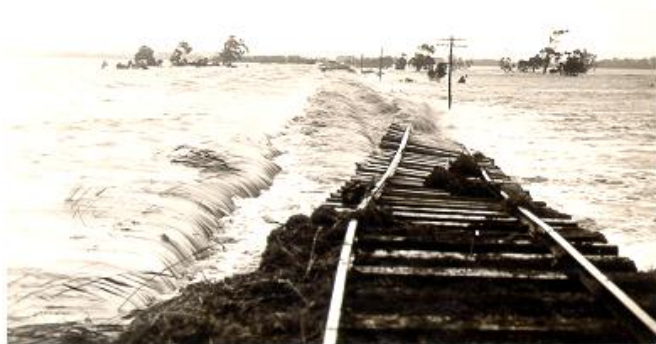
**Plate 1 Water overtopping the Traralgon-Maffra railway embankment in 1934 (looking North)**
