**Locality:** COWWARR  
**Place address:** 31-33 MAIN STREET  
**Citation date** 2016  
**Place type (when built):** Hall, Mechanics Institute  
**Recommended heritage protection:** Local government level  
Local Planning Scheme: Yes  
Vic Heritage Register: No  
Heritage Inventory (Archaeological): No

**Place name:** Cowwarr Public Hall & Memorials

Project: Wellington Shire Stage 2 Heritage Study  
Client: Wellington Shire Council  
Author: Heritage Intelligence Pty Ltd  
Date: 12/2/16

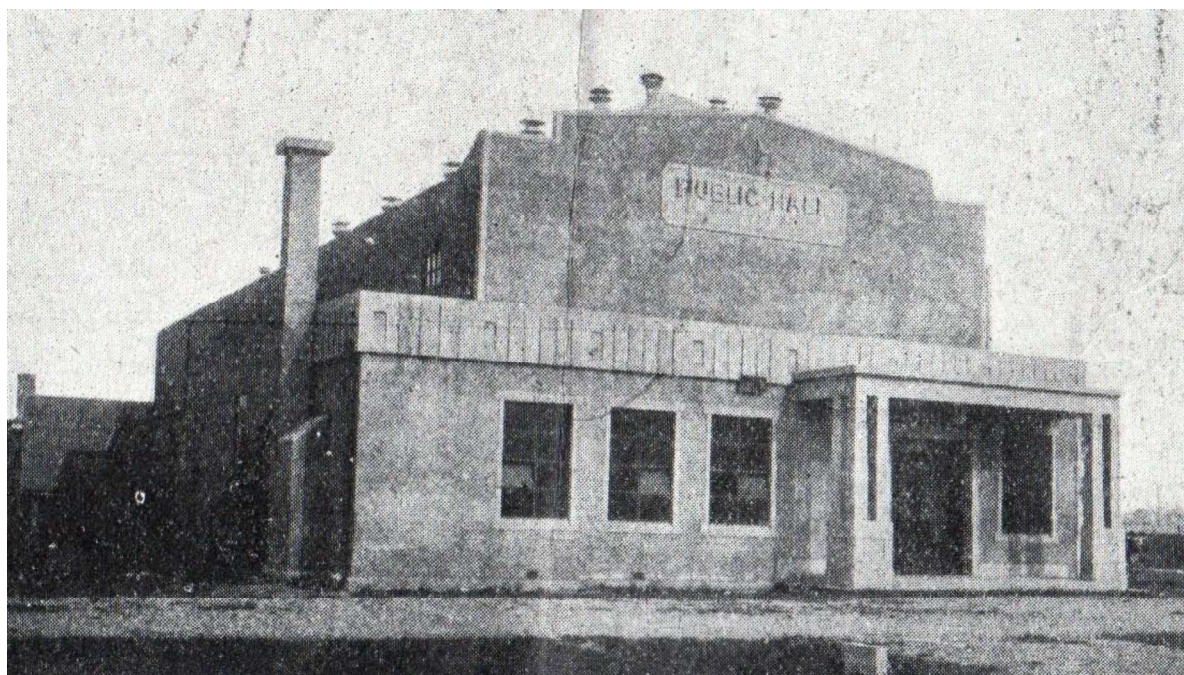
**Figure H1.** This photo showed the facade of the unpainted hall c1971, with many round vents to the roof (which have since been removed), the tall chimney on the east elevation and the entrance porch (Maddern 1971).

A photo dating to c1971 showed the facade of the unpainted hall. The photo showed many round metal vents to the roof (which have since been removed), the tall chimney on the east elevation and the entrance porch (Maddern 1971).

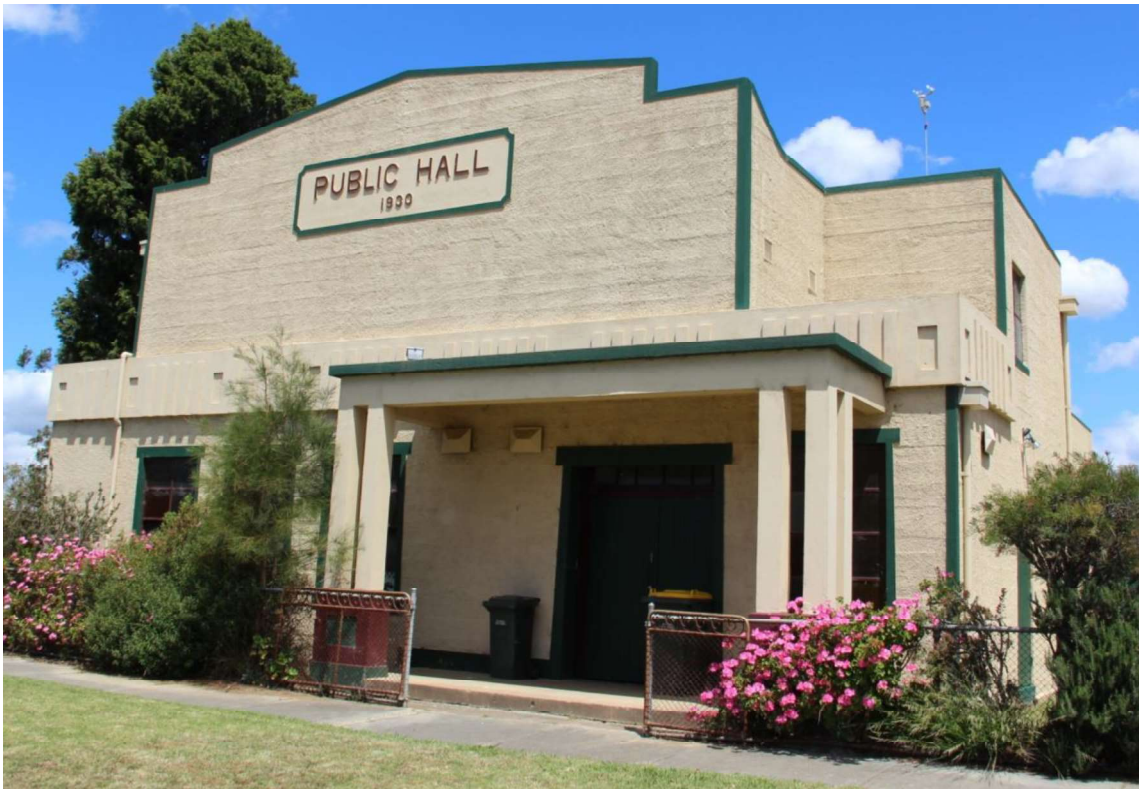
**Figure D1 & Aerial.** The hall is a concrete construction with a hipped roof (gabled to the rear) clad with (recent) corrugated iron. The wall structure forms horizontal bands to the exterior, which suggests a formwork method of construction, with a thin render applied internally and in places externally (overpainted). The corners of the building have thick narrow bands of smooth render (overpainted in contrasting green).

The facade comprises a tall parapet that has a flat triangular pediment, and steps back at the sides. At the centre of the facade is a smooth-rendered panel with a rendered frame that reads 'PUBLIC HALL 1930' in relief. In front of the tall parapet is a wider section with a lower roofline, creating a foyer. The top of this section has a tall band of smooth render with a geometric pattern in recessed and projecting vertical panels. Attached to the right is a flat-roofed entrance porch, supported by three large square timber posts at each corner. The porch has a concrete floor.

**Figure D1.** The hall sits behind a metal fence and gates which are likely to be original. The facade comprises a tall parapet that has a flat triangular pediment, and steps back at the sides. At the centre of the facade is a smooth-rendered panel with a rendered frame that reads 'PUBLIC HALL 1930' in relief. In front of the tall parapet is a wider section with a lower roofline, creating a foyer. Attached to the right is a flat-roofed entrance porch.

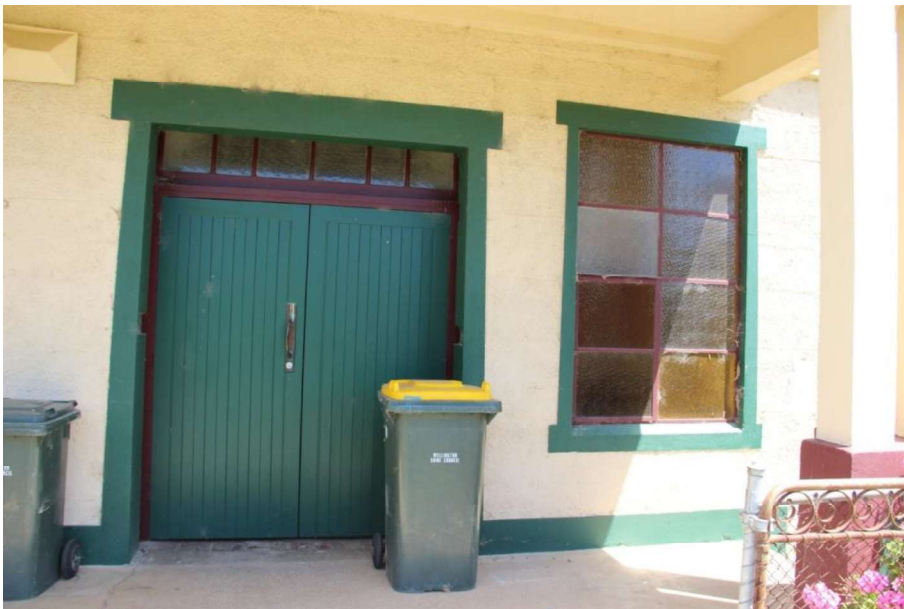
**Figure D2.** Underneath the porch is an entrance with a pair of wide timber ledged and framed doors with a multipaned metal-framed highlight. The door has a rendered lintel and sides (overpainted); the render to the sides tapers to the tops, giving an Egyptian nuance to the entrance. To the right is a metal-framed 8-paned window of yellow pressed glass, with a rendered sill, lintel and sides, forming a frame to the window. Three windows of the same style are located to the left of the entrance.

**Figure D2.** Underneath the porch is an entrance with a pair of wide timber ledged and framed doors with a multipaned metal-framed highlight. The door has a rendered lintel and sides (overpainted); the render to the sides tapers to the tops, giving an Egyptian nuance to the entrance. To the right is a metal-framed 8-paned window of yellow pressed glass, with a rendered sill, lintel and sides, forming a frame to the window.

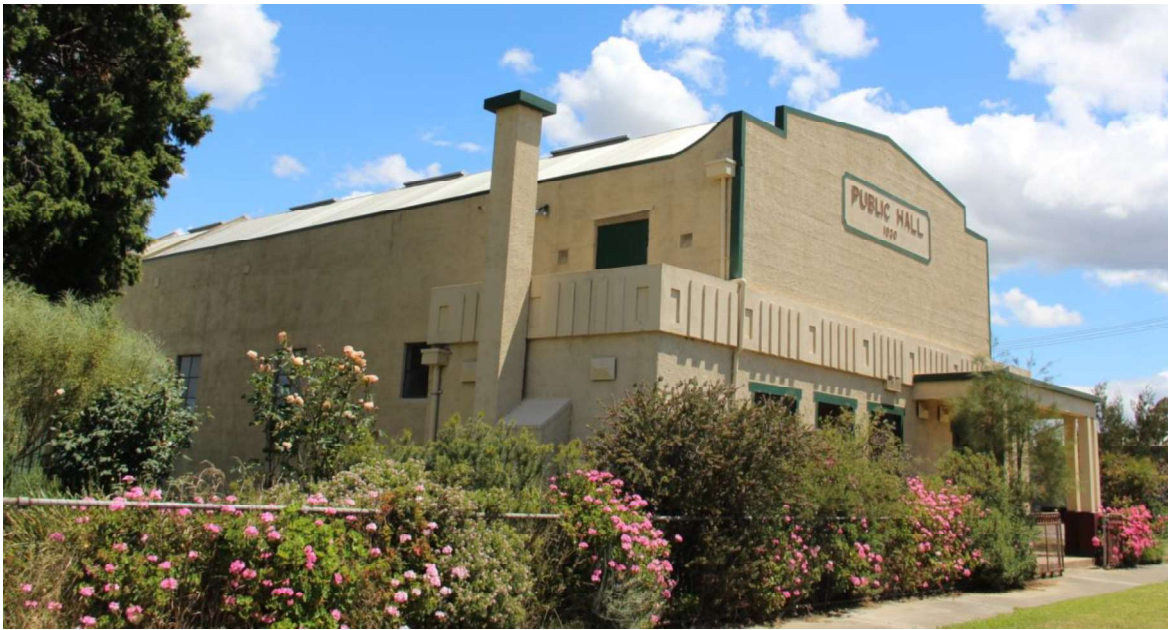
**Figure D3.** The height of the tall building is evident on the side elevations, which allows for a second floor behind the facade; with openings at this height. A tall rendered chimney with a simple flat cap is located on the exterior of the east end of the foyer. The east elevation of the hall has 4 and 8-paned metal-framed windows.

**Figure D3.** The height of the tall building is evident on the side elevations, which allows for a second floor behind the facade; with openings at this height and a balcony inside the hall. A tall rendered chimney with a simple flat cap is located on the exterior of the east end of the foyer.

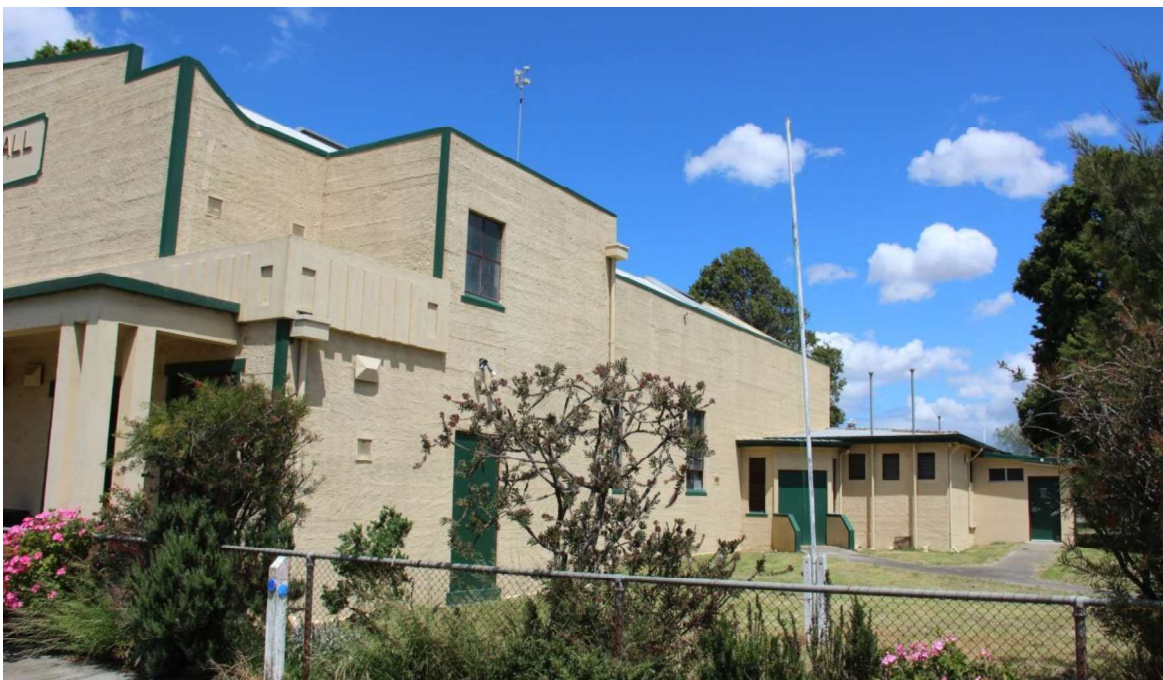
**Figure D4 & Aerial.** The west elevation has a timber ledged and framed door at the north end and 4 and 8-paned metal-framed windows with rendered sills. A large single-storey section is constructed off the rear (south) and west elevation of the hall, which serves as the toilets. This section is constructed in the same concrete technique as the hall and has an angled entrance, with a pair of timber ledged and framed doors, tall narrow windows either side, and solid balustrades to the path.

**Figure D4.** The west elevation has a timber ledged and framed door at the north end and 4 and 8-paned metal-framed windows with rendered sills. A large single-storey addition is constructed off the rear (south) and west elevation of the hall, which serves as the toilets.

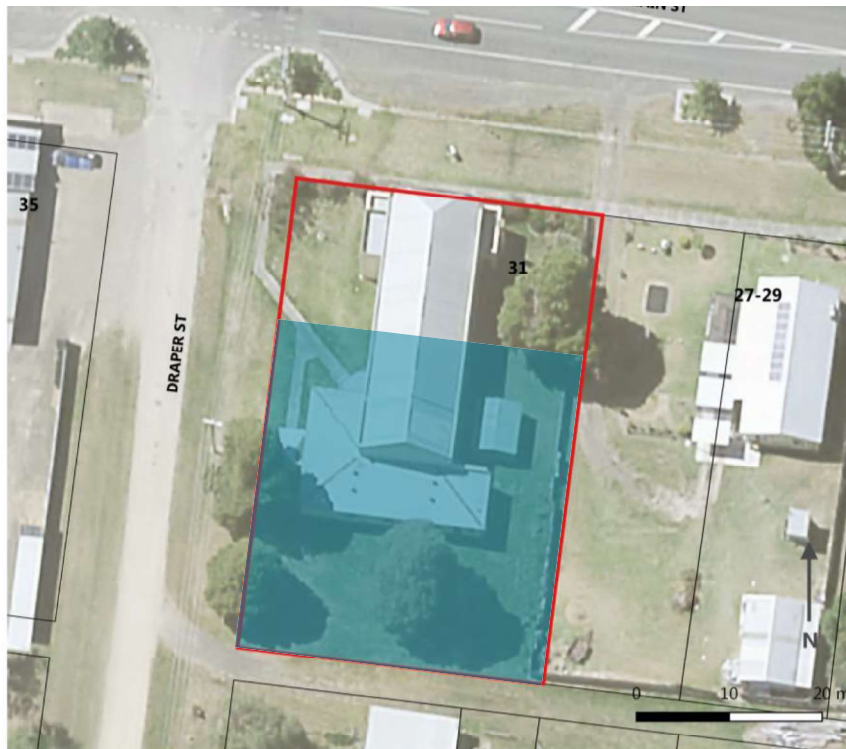
NOTE: The blue shaded area is the preferred location for additions and new development

- 2.1. New structures should be restricted to the area shown in the blue polygon on the aerial map below.
- 2.2. Sympathetic extensions are preferred. E.g. New parts that are in the same view lines as the historic building as seen from Main Street, should be parallel and perpendicular to the existing building, no higher than the existing building, similar proportions, height, wall colours, steep gable or hip roofs, with rectangular timber framed windows with a vertical axis. But the parts that are not visible in those views could be of any design, colours and materials.
